Pleasant Prairie Power Plant Sulfate in Groundwater
Pleasant Prairie Power Plant, Pleasant Prairie, WI
BRRTS#: 02-30-527479

February 14, 2020

On behalf of We Energies, O'Brien & Gere Engineers, Inc., a Ramboll Company (Ramboll), has prepared this letter report discussing the presence of sulfate in groundwater at the Pleasant Prairie Power Plant (P4), BRRTS#: 012-30-527479. This letter report was prepared with the intent of obtaining a No Action Required or No Further Action determination from the Wisconsin Department of Natural Resources (WDNR). On August 1, 2019, We Energies submitted a technical memorandum, *Pleasant Prairie Power Plant (P4) Sulfate in Groundwater BRRTS#:02-30-527479*, and technical assistance form (Form 4400-237) and associated fee. In email correspondence on October 1, 2019, WDNR provided comments on the technical memorandum; the comments were further discussed on a conference call on October 18, 2019. This letter report was prepared to address comments received from WDNR.

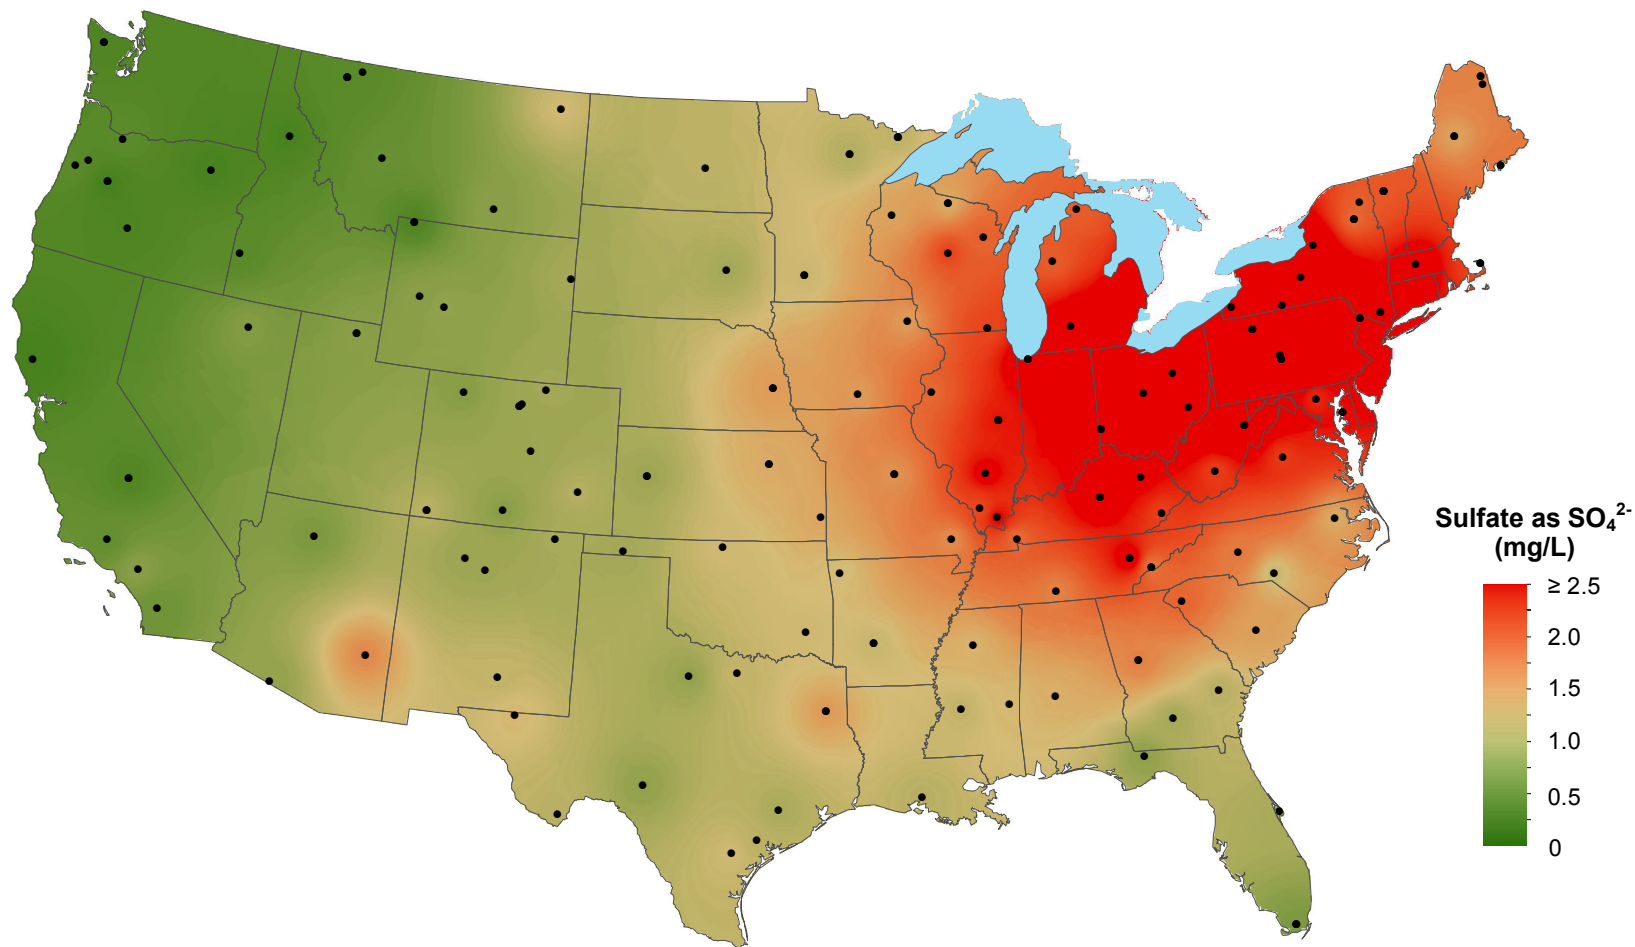
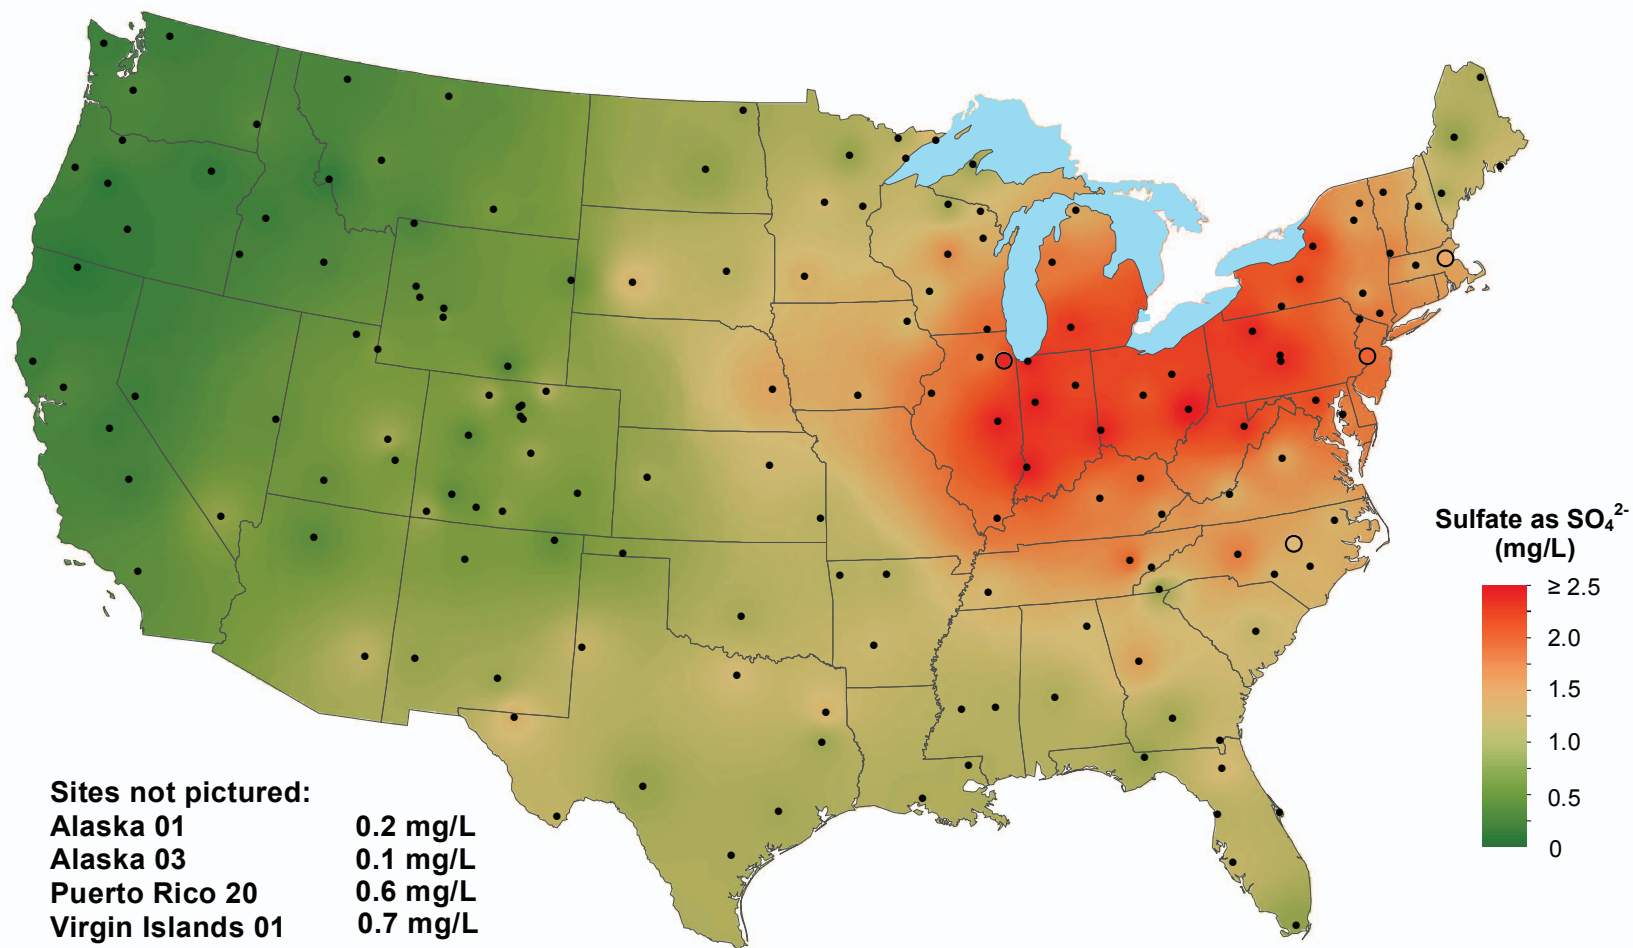
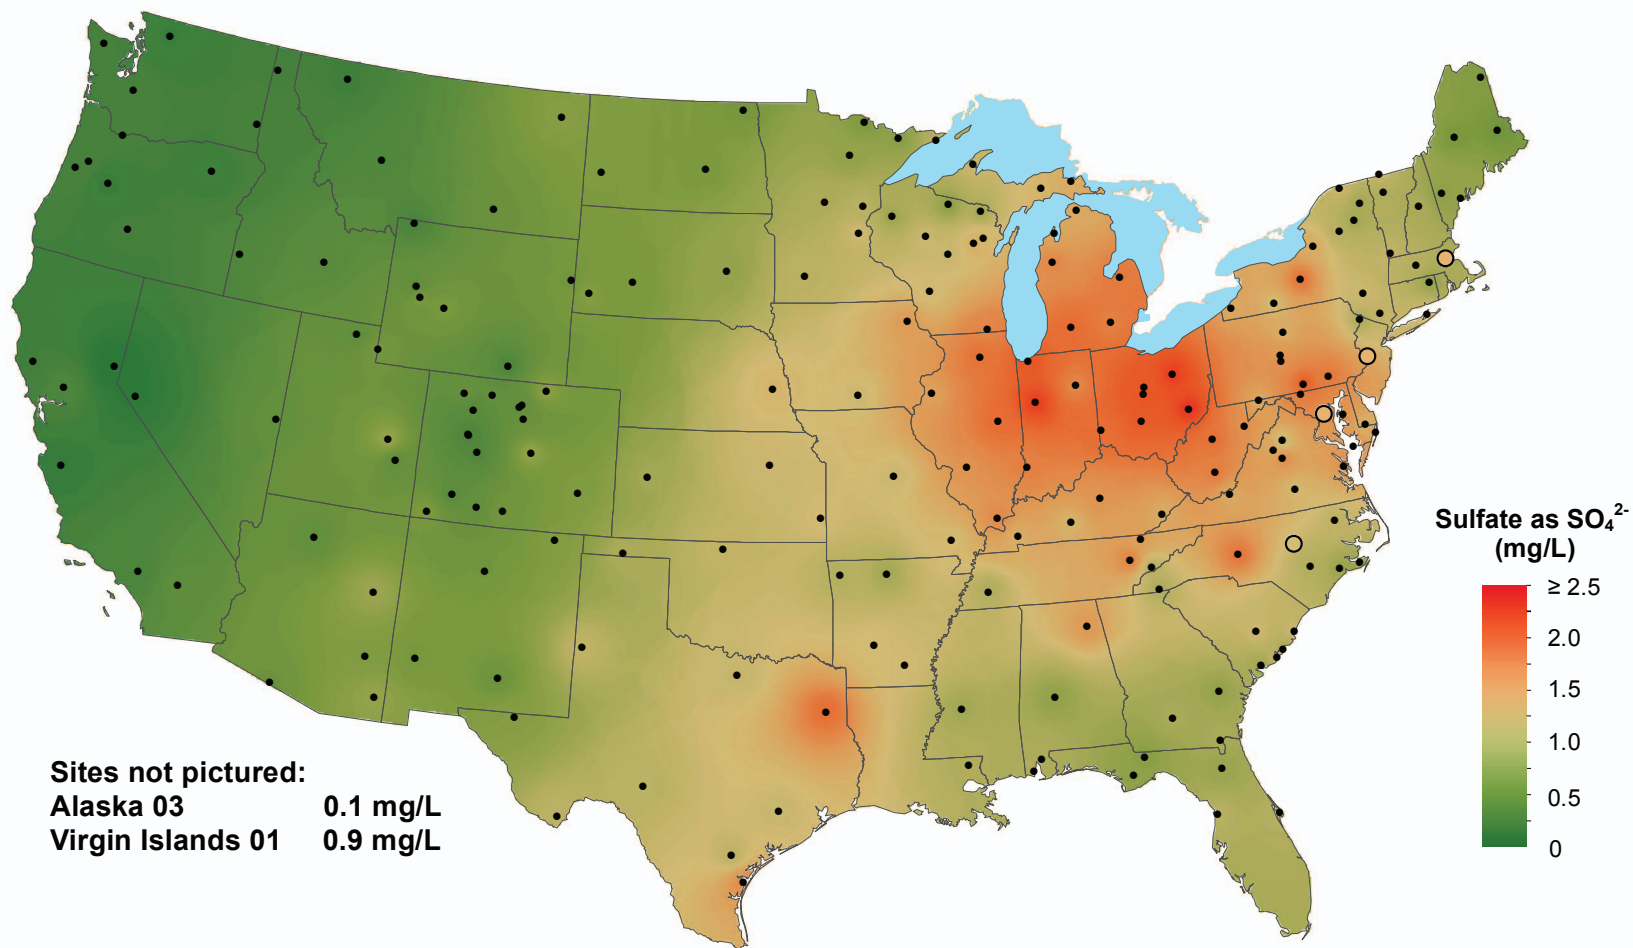
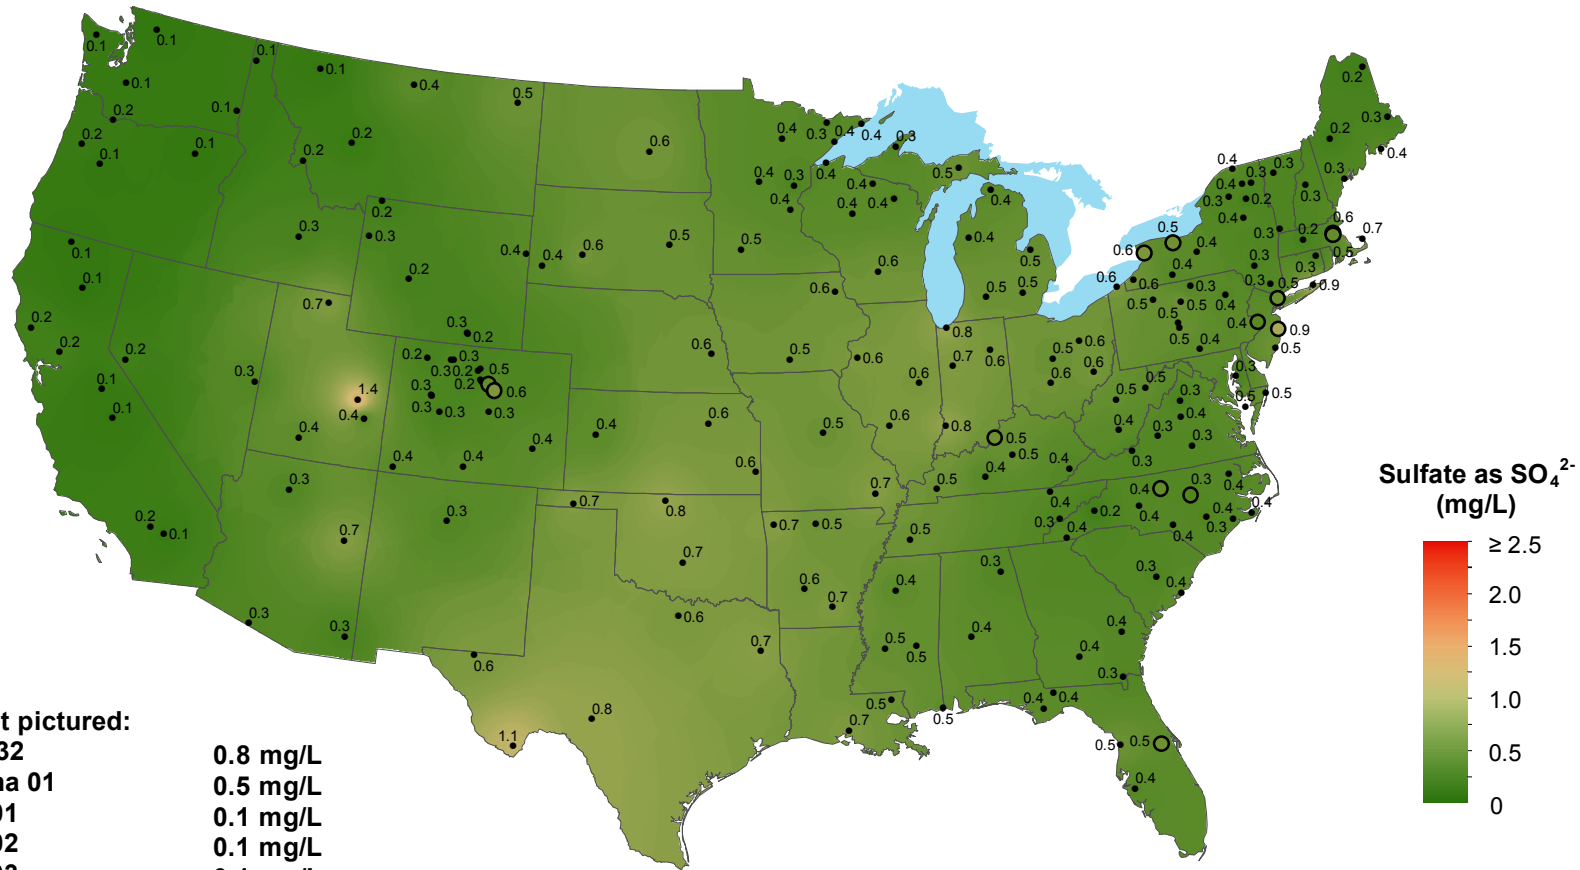
ATTACHMENT C1

Sulfate ion concentration, 1985

Sulfate ion concentration, 1998

Sulfate ion concentration, 2005

Sulfate ion concentration, 2017

Sulfate in precipitation is elevated in the southeast portion of the state, including Milwaukee, Racine, and Kenosha Counties (see Figure 12-6 below.) Sulfate deposition occurs when sulfur dioxide reacts with water in the air to form sulfate and sulfuric acid. The sulfate and sulfuric acid are deposited or transferred to surface or groundwater when it rains. Through evaporation and evapotranspiration water is removed and sulfate may become concentrated in soils, surface water, and groundwater. Due to the distribution of industry and heavy transportation traffic in southern Wisconsin and northern Illinois, the southeast portion of Wisconsin is susceptible to higher concentrations and more sulfate deposition with acidic precipitation as shown in the figure below.

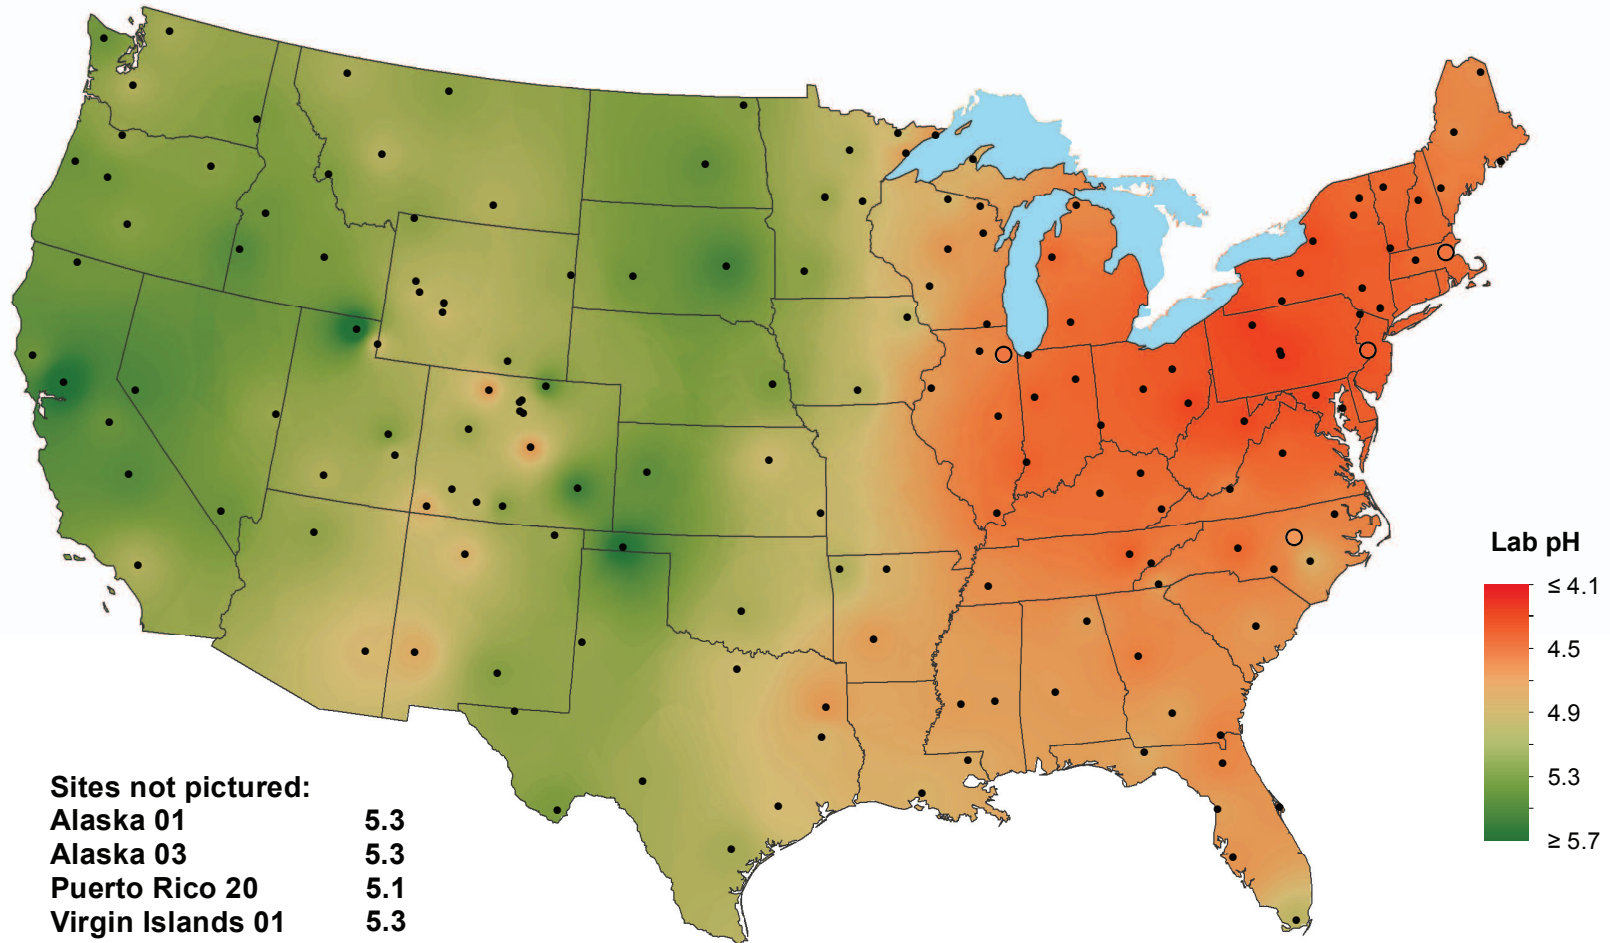
ATTACHMENT C2

Hydrogen ion concentration as pH from measurements made at the Central Analytical Laboratory, 1985

Hydrogen ion concentration as pH from measurements made at the Central Analytical Laboratory, 1998

Hydrogen ion concentration as pH from measurements made at the Central Analytical Laboratory, 2005

Hydrogen ion concentration as pH from measurements made at the Central Analytical Laboratory, 2017

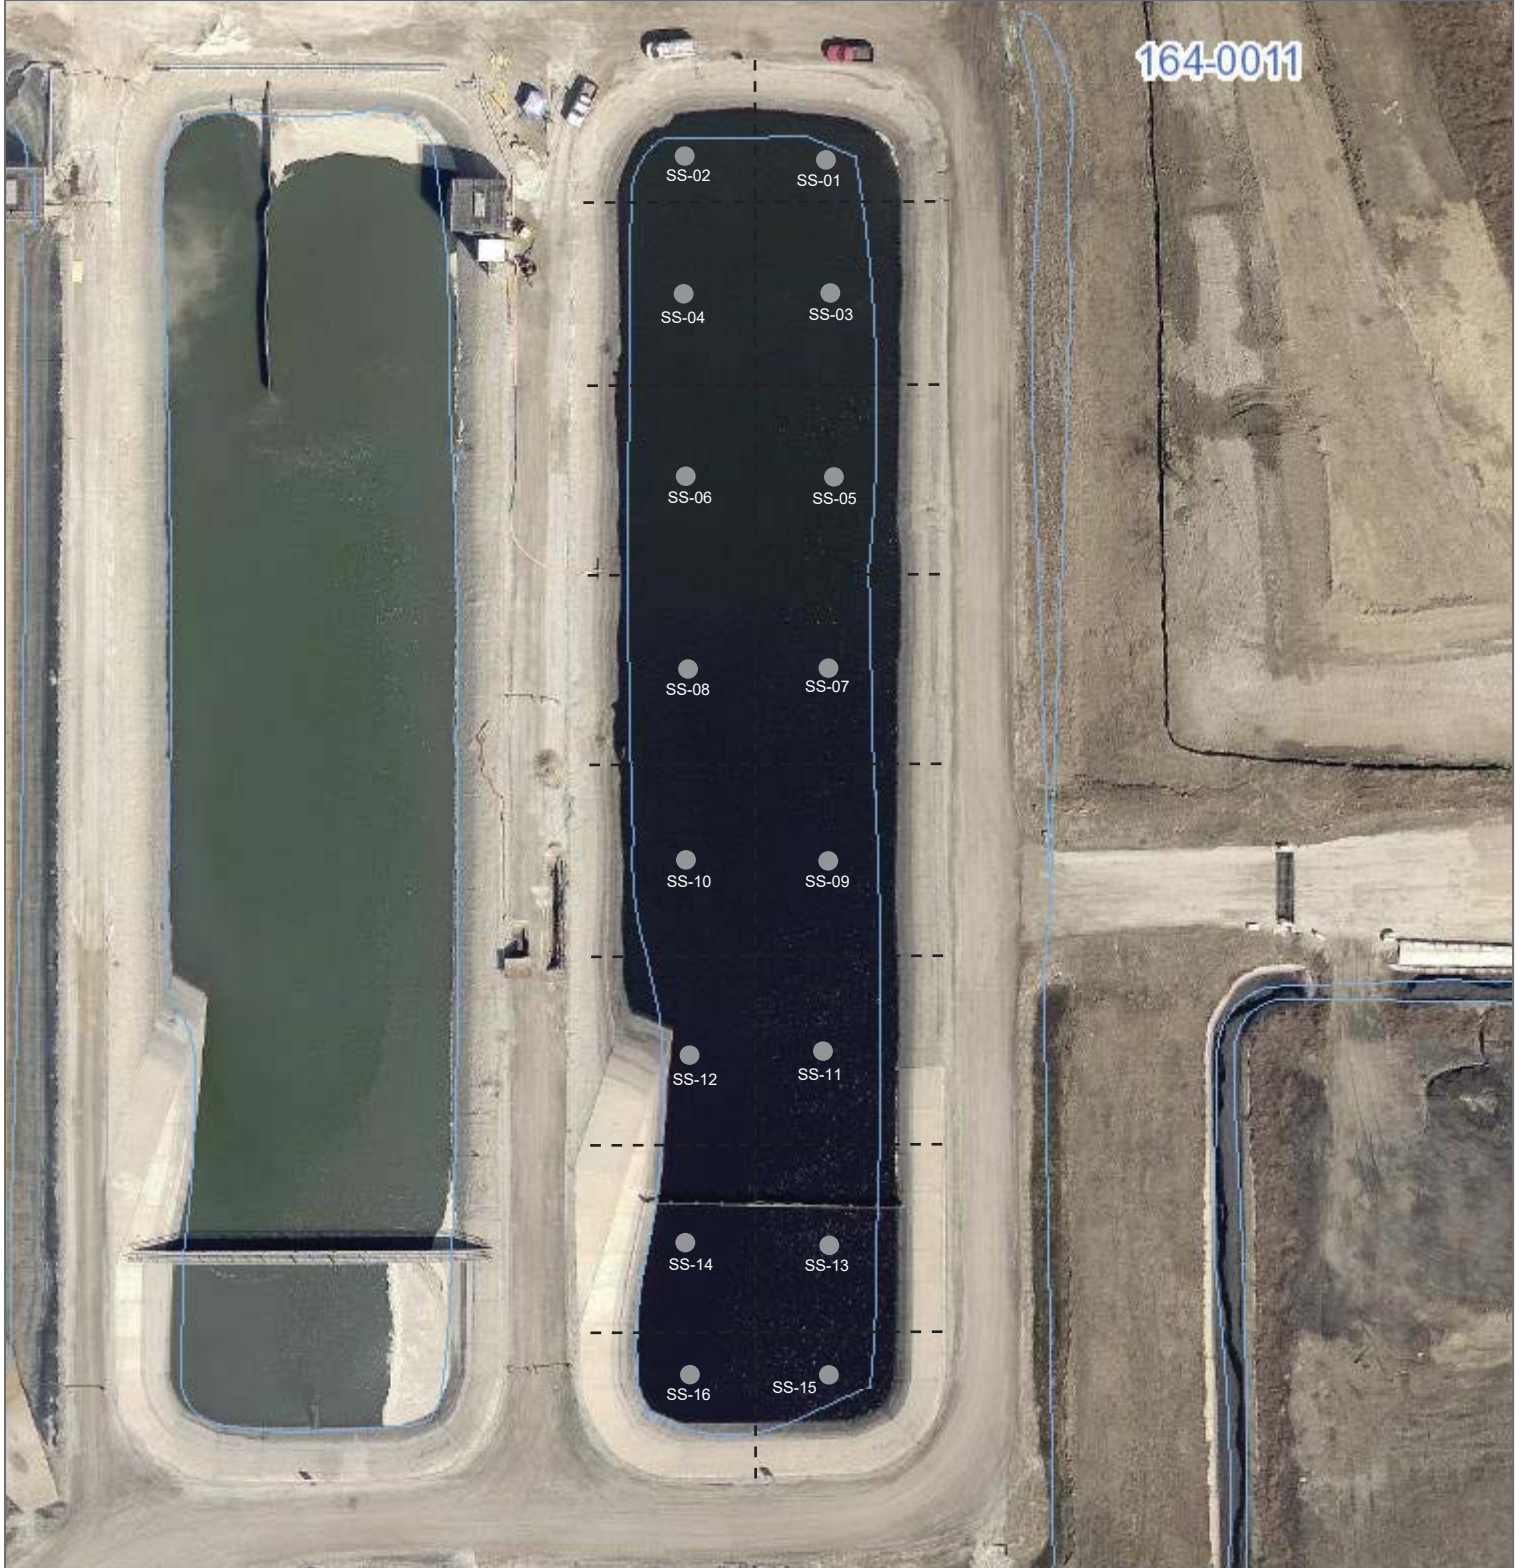
FIGURE 1 - SOIL SAMPLE LOCATION MAP

● APPROXIMATE POST-LINER REMOVAL
SOIL SAMPLE LOCATION

Following removal of the Coal Pile Runoff Basin, soil samples were collected from the soils underlying the basin. The samples were analyzed for metals and indicators of potential impacts, and the results are provided in Table 2a and 2b and locations are shown in Figure 1 in Attachment D. The results indicate that only arsenic in two samples was detected above the industrial direct contact residual contaminant level (RCL). Arsenopyrite (Fe, As-S) and pyrite often are found in similar settings and as expected, concentrations of arsenic and sulfate were reported coincidentally within the clay till and road base materials. Sulfate was detected at concentrations ranging from 97.9 to 376 mg/kg. The presence of these compounds and their concentrations are representative of the clay till and gravel fill below the liner and because they are not significantly elevated are not indicative of a release from the basins.
