# **Extent of Contaminated Sediment at the Moss-American Superfund Site**

Little Menomonee  
River

Milwaukee,  
Wisconsin

Wisconsin  
Department of  
Natural Resources

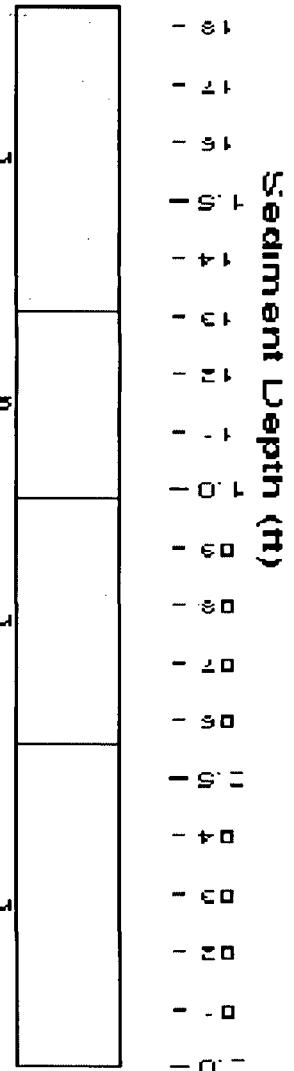
Station: SD02-0012    Dist Downstream: 8400 ft

POD DNB0013 TO 9.7811FT BLACK SILTY TRACE CARBONATE ONLY CAVOCAGE (INCUBATION) HYDROCARBON ODOR

POD DNB0013 TO 9.7811FT BLACK SILTY OILY RESIDUE IN EARTH COLOR AND SWELL INDICATED BY RESIN
