**Subject: Phase 4 Soil and Sediment Management Documentation - West Silver Spring Drive
Bridges Over Little Menomonee River, Milwaukee, Wisconsin
(WisDOT ID #2090-08-70/2090-09-70)**

This letter provides documentation of the Phase 4 soil and sediment management activities that occurred during the rehabilitation of the eastbound and westbound West Silver Spring Drive bridges over the Little Menomonee River in Milwaukee, Wisconsin.

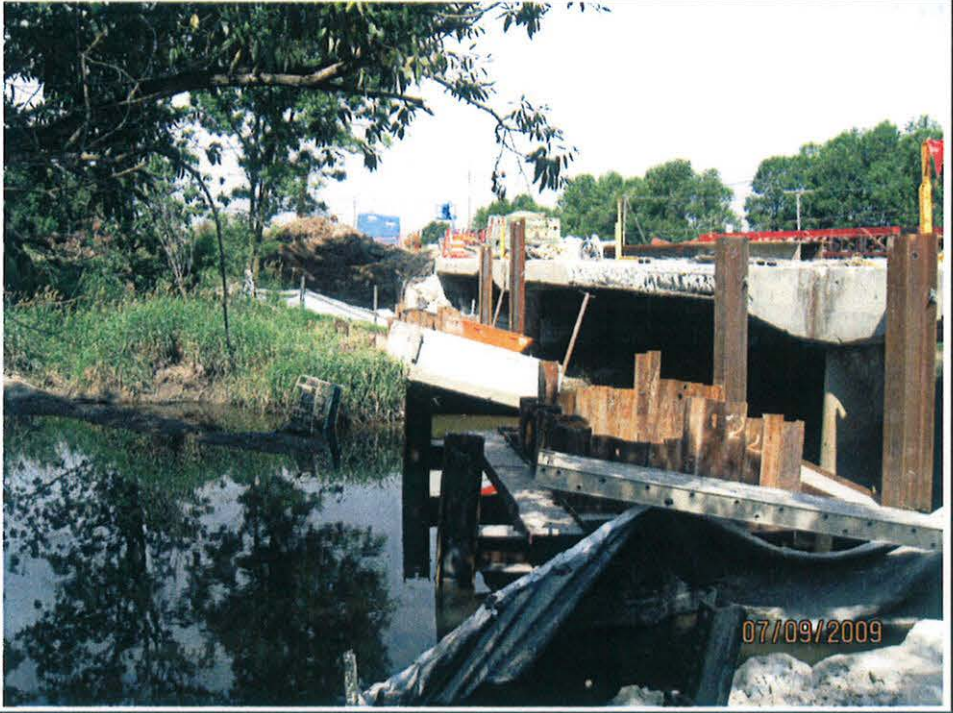
1	July 2009		
Description			
Looking west at coffer dams on south side of W. Silver Spring Drive.

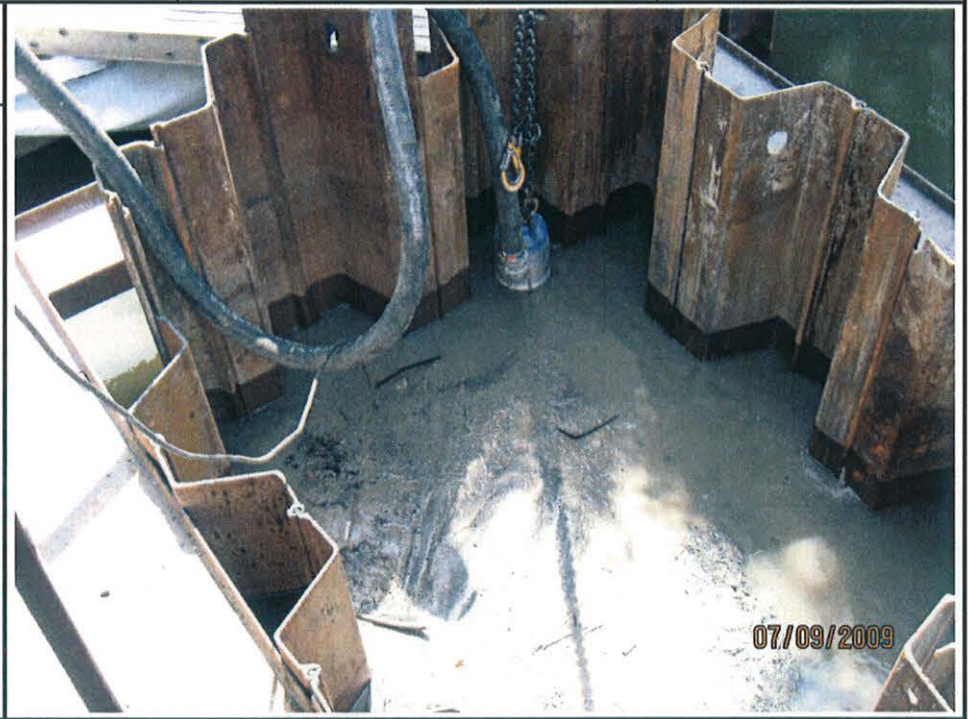
Photo No. 3	Date July 2009
-----------------------	--------------------------

During coffer dam excavations no free product was noted. Prior to coffer dam excavation, the area was dewatered into a sedimentation basin construction on the rip-rap at the rivers edge. The excavated sediment and underlying materials were also dewatered, prior to disposal. The excavated material and sediment captured in the sedimentation basin during dewatering was placed into a box made of jersey barriers and lined with filter fabric, see attached photos. The materials were allowed to dewater for a minimum of 48 hours prior to disposal at Orchard Ridge.

Description
Dewatering of coffer dam.

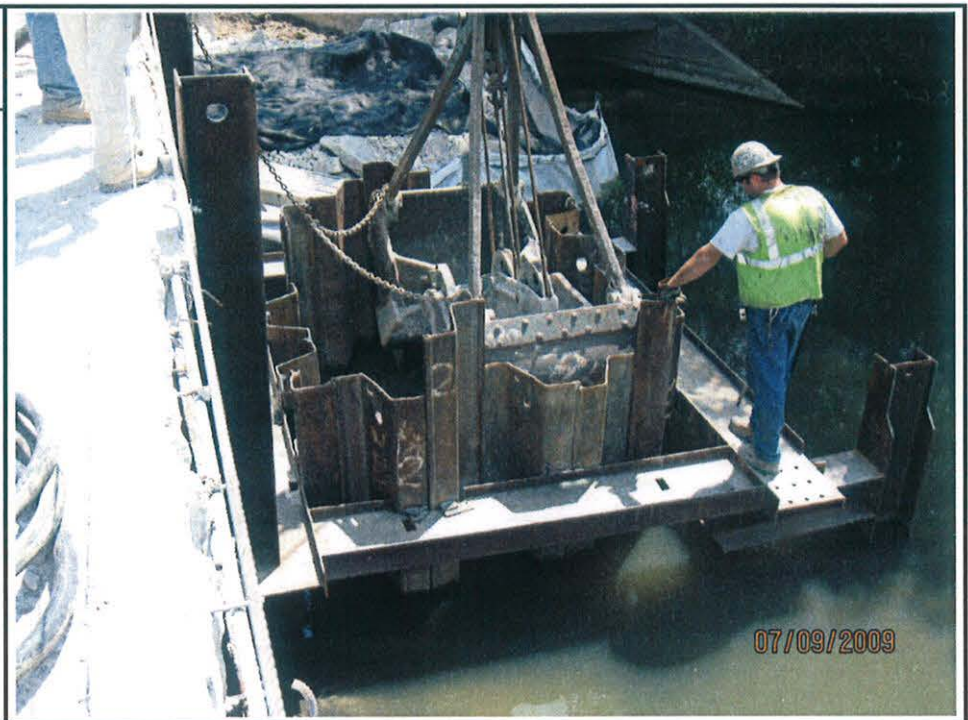
Photo No. 4	Date July 2009
-----------------------	--------------------------

Description
Clam shell scoop used to excavate sediments and underlying soils within coffer dam.

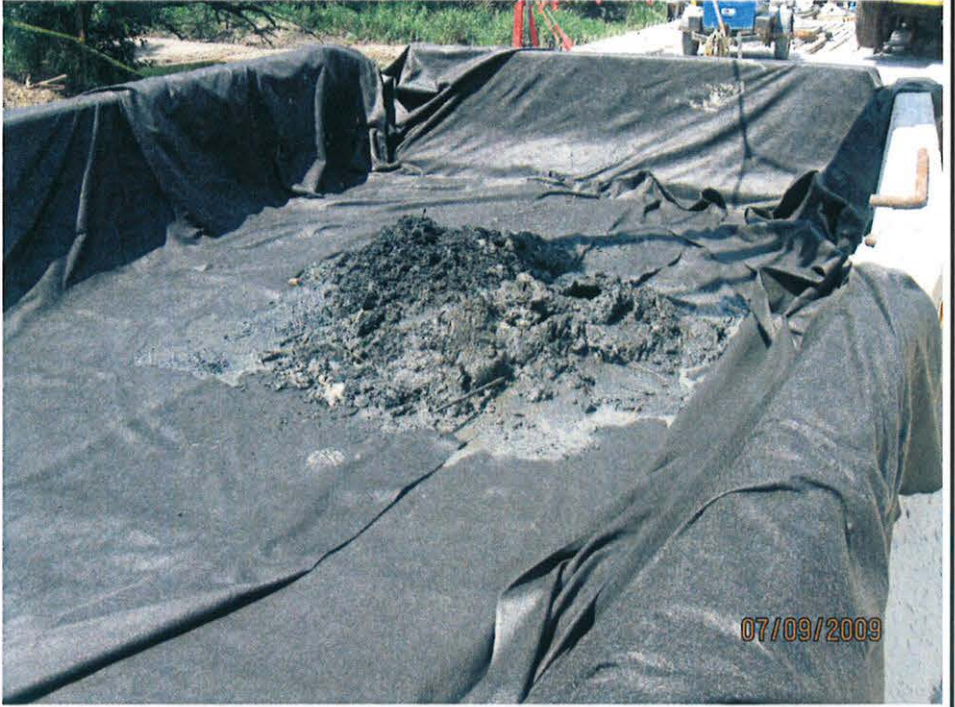
<p>07/09/2009</p>	
5	July 2009		
Description Sediment dewatering box lined with filter fabric, eastern side.			
Photo No.	Date

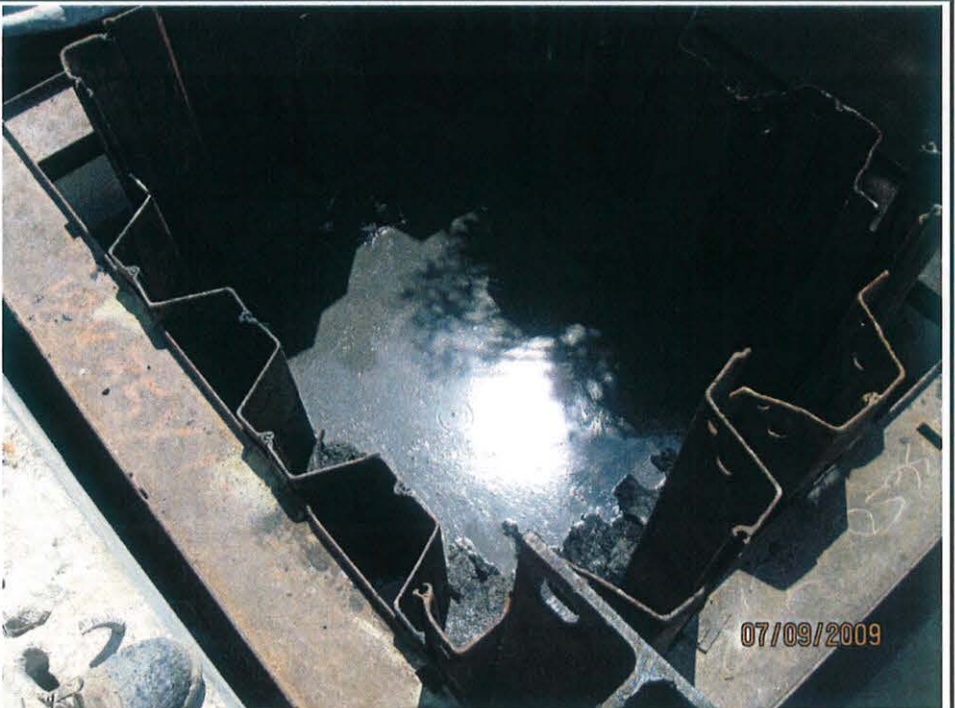
<p>07/09/2009</p>	
6	July 2009		
Description Looking inside eastern coffer dam.

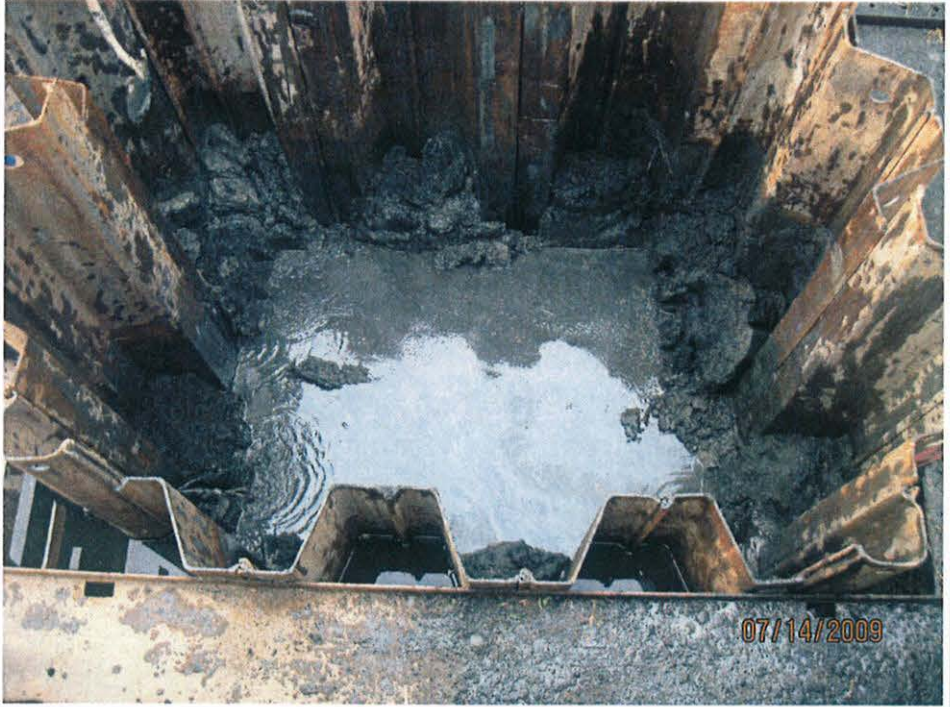
Client Name: Wisconsin Department of Natural Resources		Site Location: W. Silver Spring Drive over Little Menomonee River	Project No.: 00-10909.02
Photo No. 7	Date July 2009

<p>07/14/2009</p>	
Description Looking inside western coffer dam.			
Photo No. 8	Date July 2009

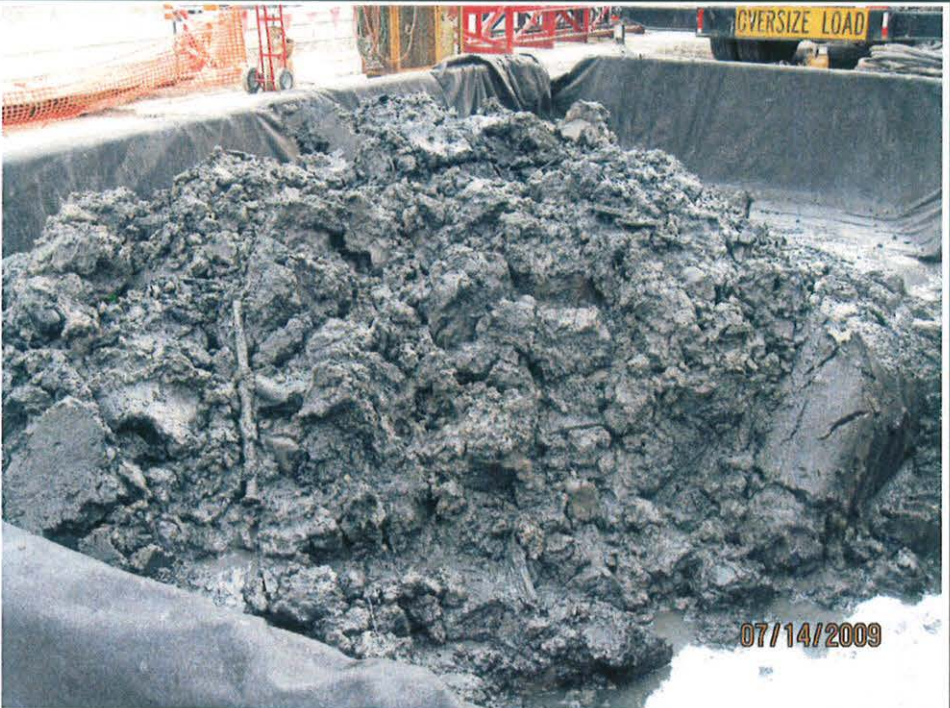
<p>07/14/2009</p>	
Description Sediment dewatering box lined with filter fabric, western side.
