**Subject: Remedial Action Letter Report
Moss American Superfund Site
Milwaukee, Milwaukee County, Wisconsin
Technical Direction Document No. S05-0806-001
START Contract No. EP-S5-06-03**

**Moss American Site
Milwaukee, Wisconsin
Removal Action Letter Report**

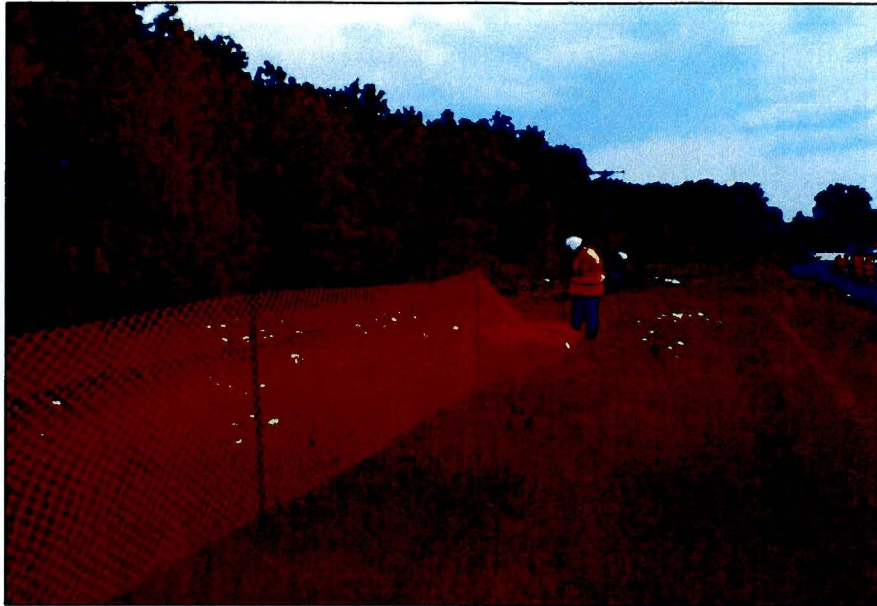
Photograph No.: 1 **Photographer:** Naren Babu **Date:** 8/03/2009
Subject: General view of Snow fence along Silver Spring drive. Silt fence for endangered snake protection can be seen inside the snow fence.

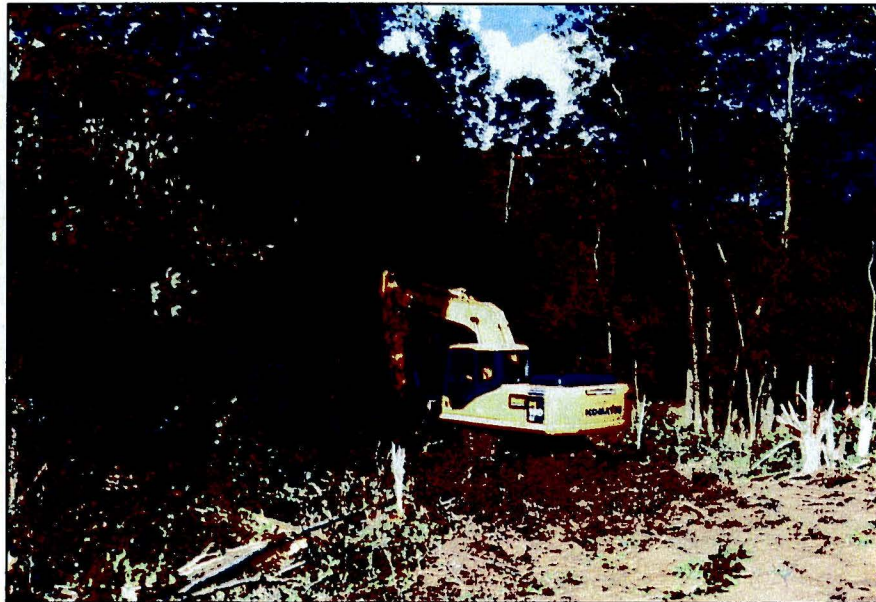
Photograph No.: 2 **Photographer:** Troy Thompson **Date:** 8/10/2009
Subject: ERRS clearing the trees with a back hoe for access roads.

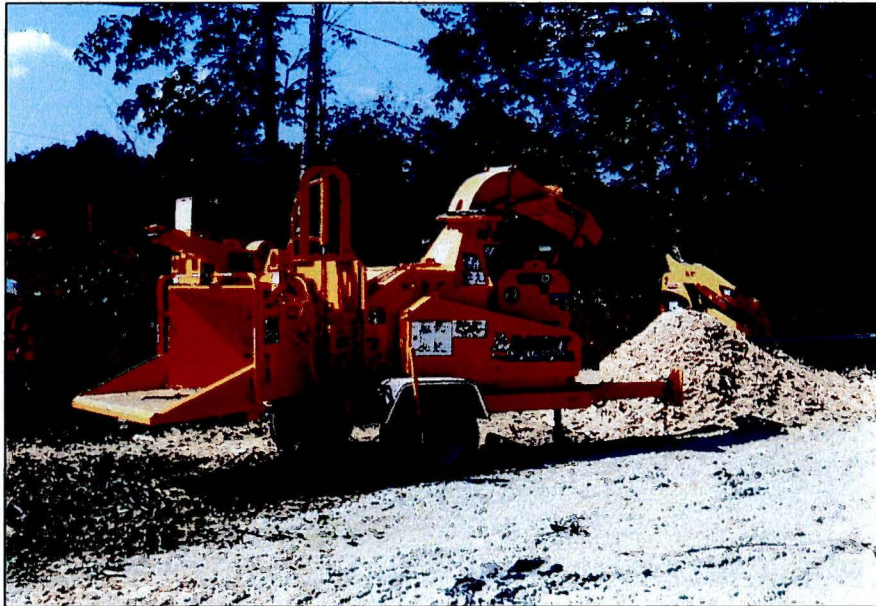
Photograph No.: 3 **Photographer:** Troy Thompson **Date:** 8/13/2009
Subject: General view of the Wood Chipper and Wood chips.

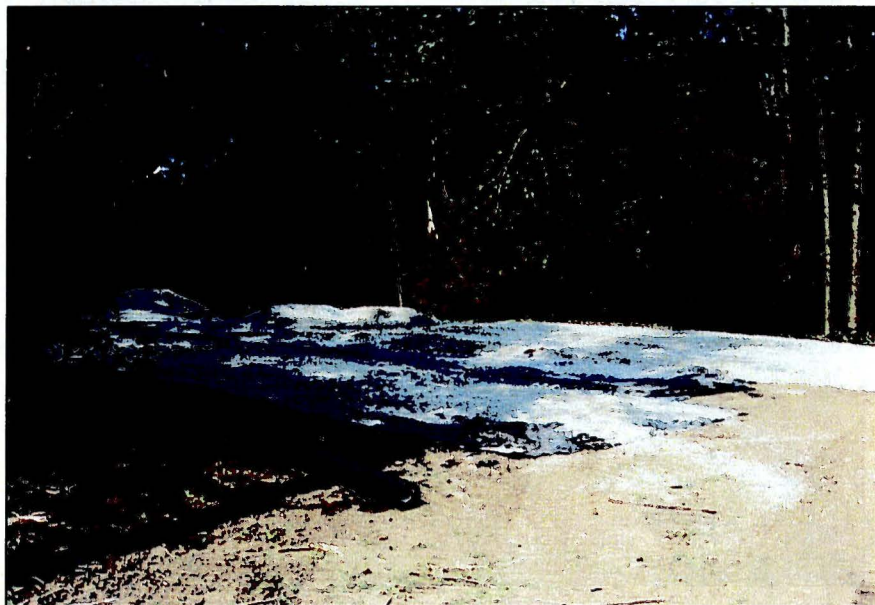
Photograph No.: 4 **Photographer:** Troy Thompson **Date:** 8/15/2009
Subject: for pumps was constructed with soil, gravel and geofabric along the Little
e river at Silver Spring Access area.

without hindering the heavy vehicle traffic along the access road. ERRS constructed two gravel pads adjacent to the access road to stage the frac tanks and water filtration systems (Photo #4 and Photo #5).

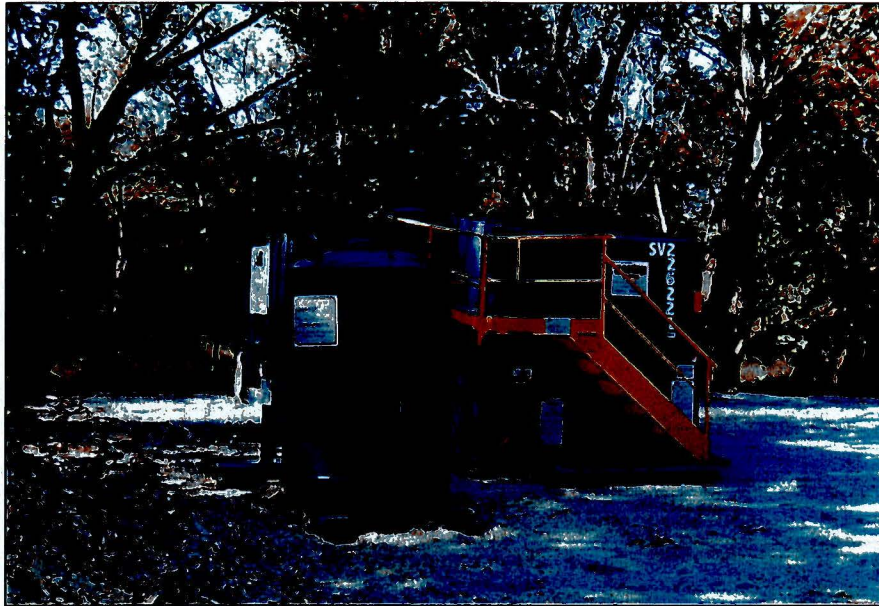
Photograph No.: 5 **Photographer:** Troy Thompson **Date:** 8/24/2009
Subject: General view of Frac tank and water treatment equipment on the staging pad.

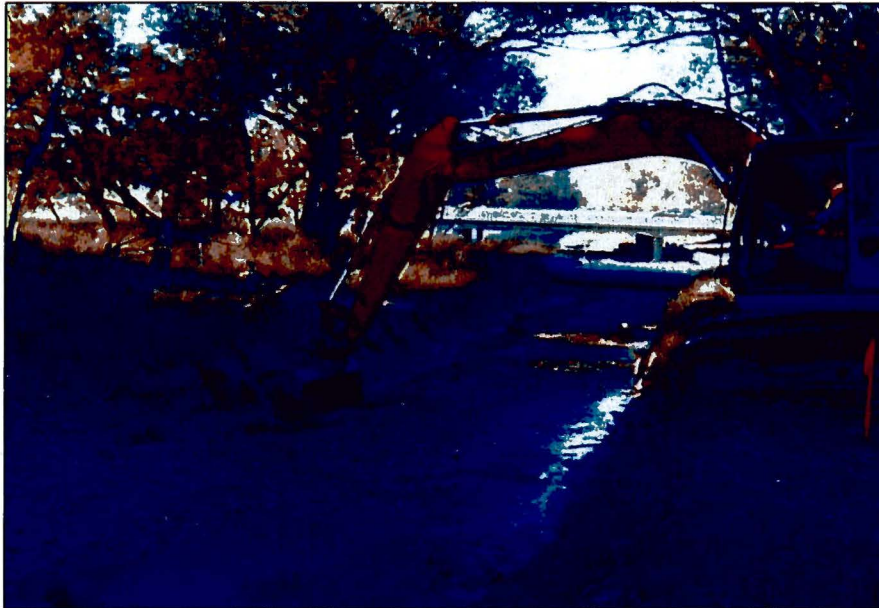
Photograph No.: 7 **Photographer:** Naren Babu **Date:** 09/11/2009
Subject: Excavator removing contaminated sediments from the river at the southern segment of Reach 4/5.

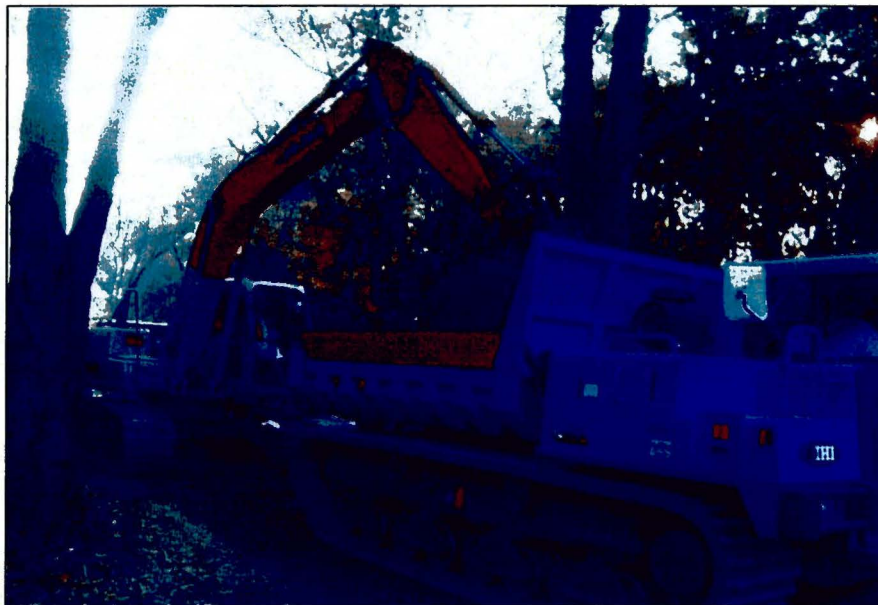
Photograph No.: 8 **Photographer:** Naren Babu **Date:** 9/10/2009
Subject: Back Hoe loading Scubic yard truck with sediments from Work Area #8.

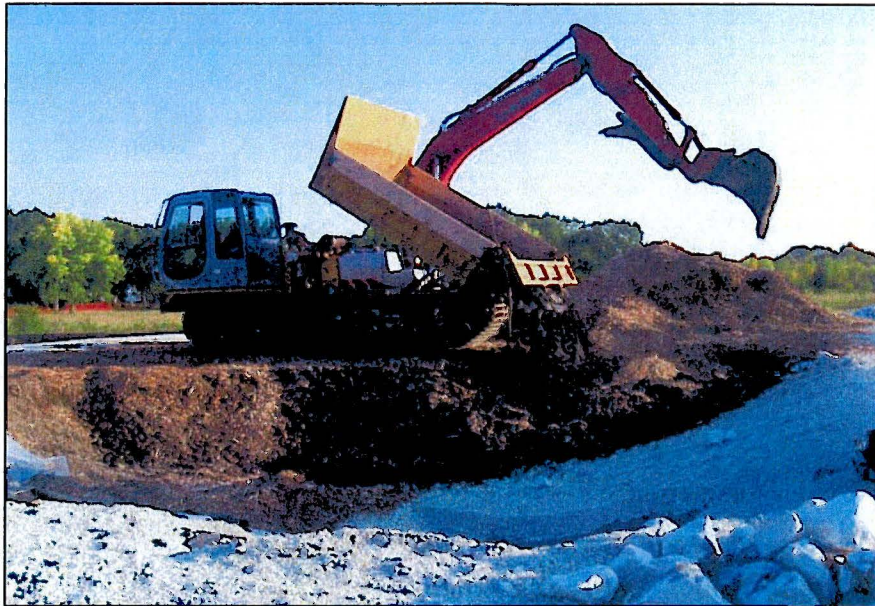
Photograph No.: 9 **Photographer:** Naren Babu **Date:** 9/11/2009
Subject: 5 cubic yard truck unloading sediments at the sediment dewatering pad on 107th Street access area.

U.S. EPA obtained access approval from the City of Milwaukee across the City sidewalk and right-of-way and established an access point-of-entry for site vehicles from North 107th Street to the 107th Street access area. Site set-up activities in 107th Street access area were conducted from August 03, 2009 until September 09, 2009. A snow fence was installed along the 107th Street to discourage unauthorized access into the work area. A silt fence was installed inside the orange snow fence to try to keep the work area free of the endangered Butler Garter Snake. A sediment dewatering pad and staging pad for frac tanks storage was constructed at the 107th Street access area (Photo #9 and Photo #10) with gravel, geofabric

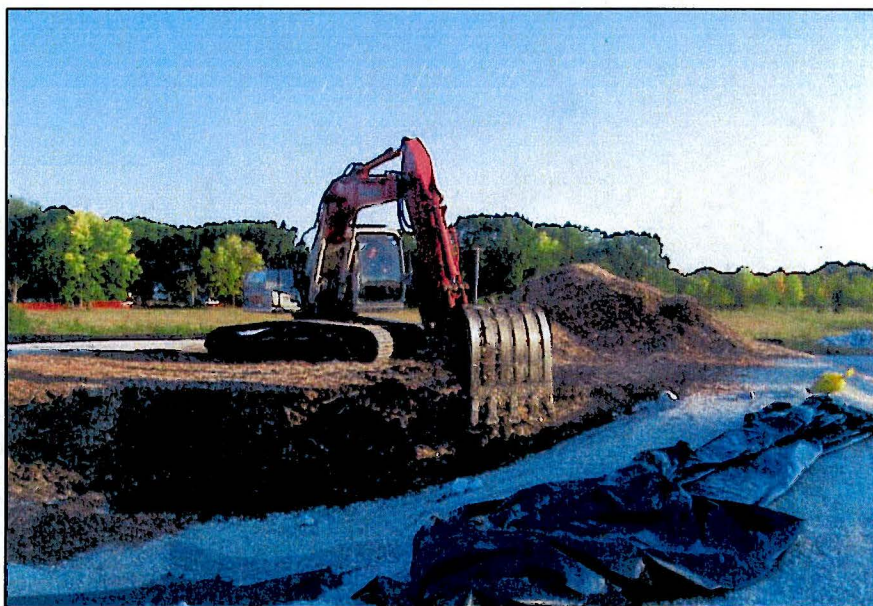
Photograph No.: 10 **Photographer:** Naren Babu **Date:** 9/11/2009
Subject: Back Hoe mixing the sediments with saw dust at the sediment dewatering pad on 107th Street access area.

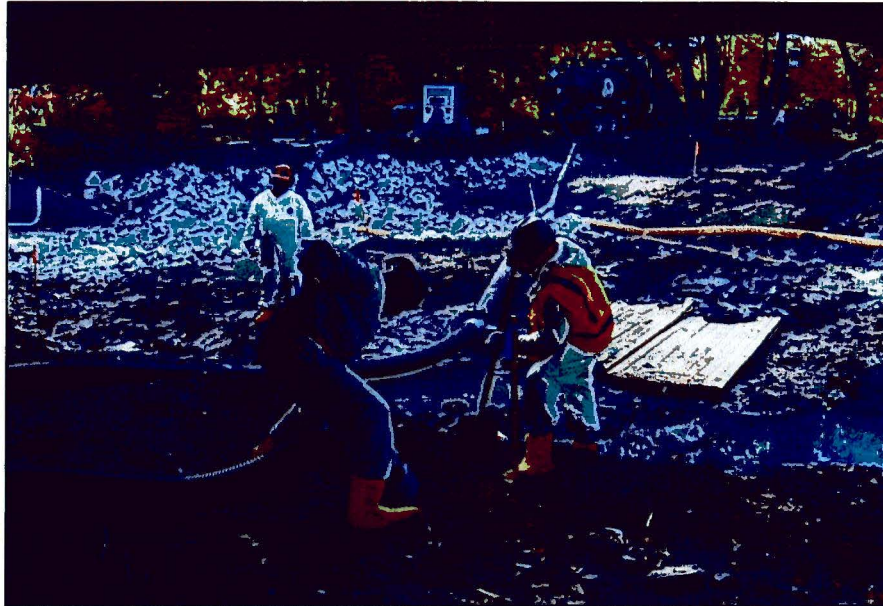
Photograph No.: 11 **Photographer:** Troy Thompson **Date:** 9/17/2009
Subject: ERRS removing sediments with Vacuum hoses at Work Area #13 under Silver Spring Drive Bridge.

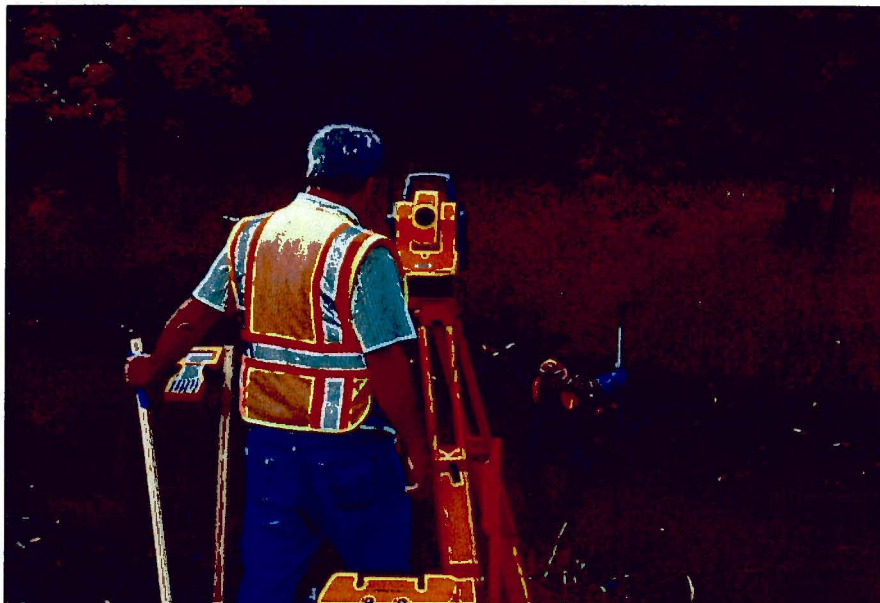
Photograph No.: 12 **Photographer:** Sheila Sullivan **Date:** 9/22/2009
Subject: START conducting confirmation sediment survey at Work Area #17 in 107th Street access area.

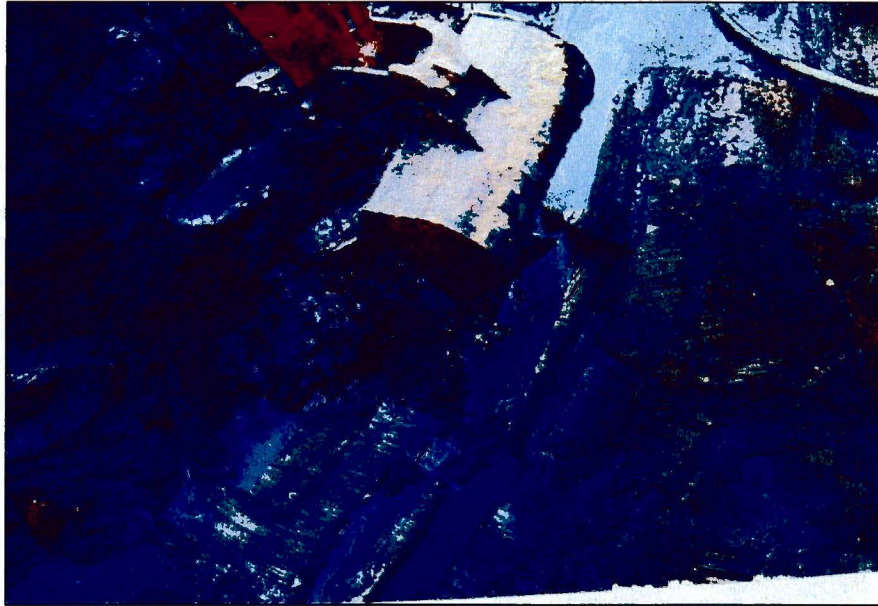
Sediment contaminated with free-product creosote was found south of the Appleton Avenue Bridge out of the boundaries of work area #1. This odorous, dark sediment (Photo #13) was not identified during previous investigations conducted by the PRP, Tronox. These stained sediments were excavated up to 4 feet depths until a layer of natural clay or odorless sediment was exposed. U.S. EPA conducted removal of these contaminated sediments from the channel between work area #1 and work area #4. This additional sediment removal resulted in a significant increase in actual sediment volume removed in work areas #1 and #4 compared to the original estimated volume proposed in the work plan by the PRP.

Photograph No.: 13 **Photographer:** Naren Babu **Date:** 11/13/2009
Subject: View of the dark sediments with oily Sheen and odor found south of the Appleton Avenue Bridge.

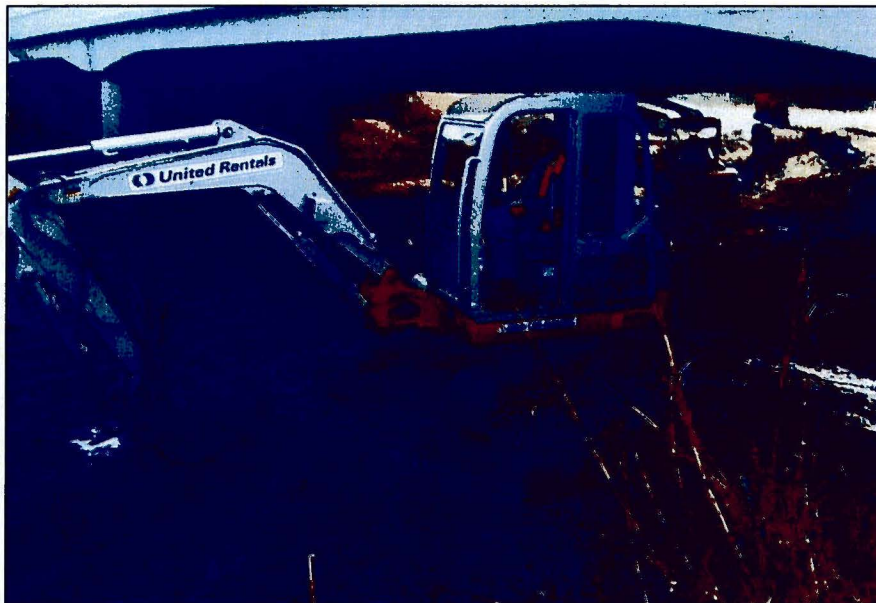
Photograph No.: 14 **Photographer:** Naren Babu **Date:** 11/10/2009
Subject: Excavator removing contaminated sediments underneath Appleton Avenue bridge.

Excavation was conducted using vacuum removal in work areas #2 and #3. At work area #1 underneath the Appleton Avenue Bridge, a regular backhoe excavator was not used due to the low clearance between the bottom of the bridge and the sediment surface. Sediment removal was conducted using a combination of vacuum removal and mini-excavators as was done at work area #13. Excavation was conducted with a backhoe excavator in work area #4. The sediments removed from the Appleton Avenue access area were transported to the sediment dewatering pad at the Silver Spring Access area for drying with wood chips and saw dust prior to transport to the landfill.

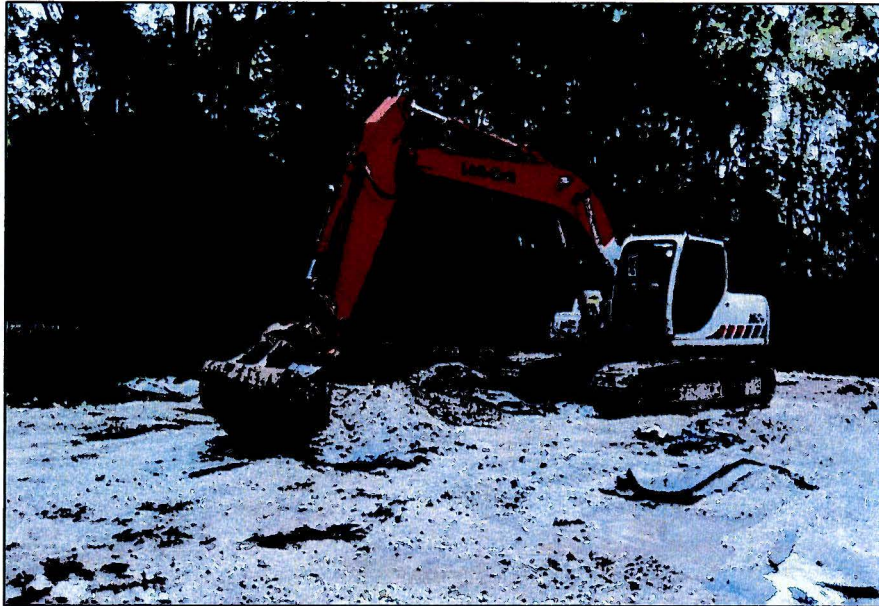
Photograph No.: 15 **Photographer:** Naren Babu **Date:** 9/29/2009
Subject: Back Hoe removing gravel and geofabric liner from access roads.

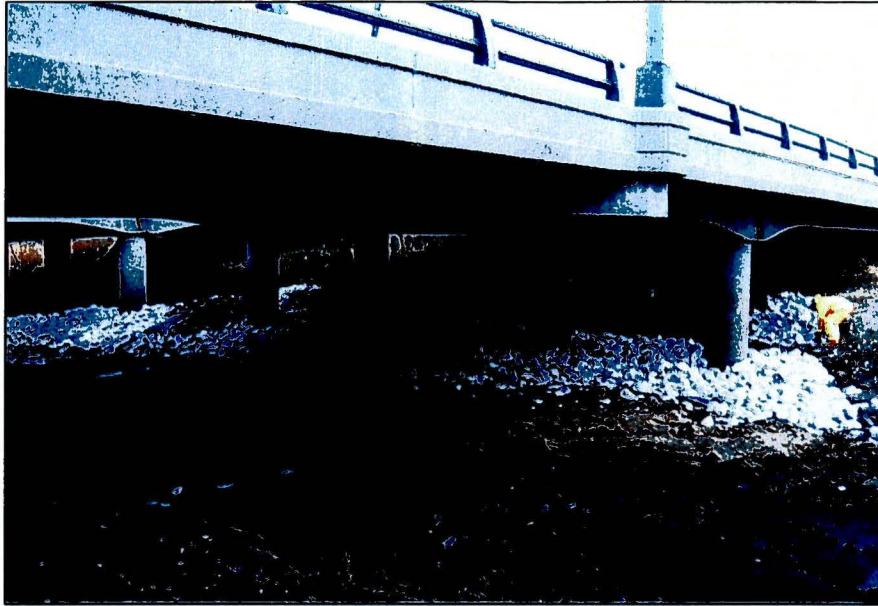
Photograph No.: 17 **Photographer:** Naren Babu **Date:** 11/17/2009
Subject: Rip raps were placed around the footings of the bridges for stabilization and erosion control.

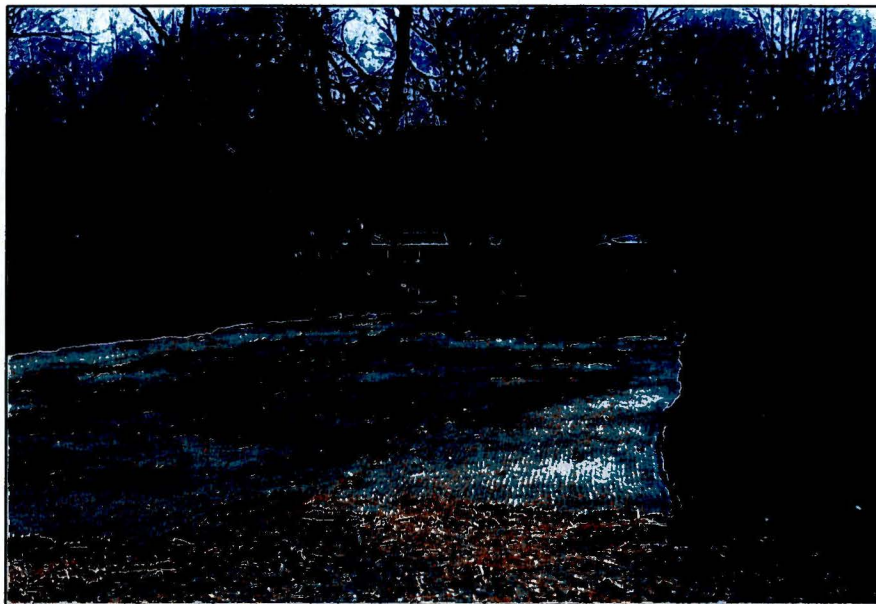
Photograph No.: 18 **Photographer:** Troy Thompson **Date:** 11/20/2009
Subject: View of grass coming up from seeded areas along the river in 107th Street Access area.
