Letter of Transmittal

Re: Limited Phase II Site Assessment Results, Former UST Site
Former Pilsner Ford property, 207 West Street, Juneau, Wisconsin

Presented herein are the results of a limited Phase II Environmental Site Assessment of a former underground storage tank (UST) system at the Former Pilsner Ford property, 207 West Street, Juneau, Wisconsin, referred to as "Project" and "Project Site", respectively. Per documentation filed with the Juneau Fire Department, a 1,000 gallon gasoline UST and dispenser, had been removed in December of 1988. The former tank and dispenser was located on the east side of the building under concrete surfacing. At the time of removal, a site assessment was not conducted. However, due to the pending sale of the property, a tank site assessment has been requested by you and the results are reported below.

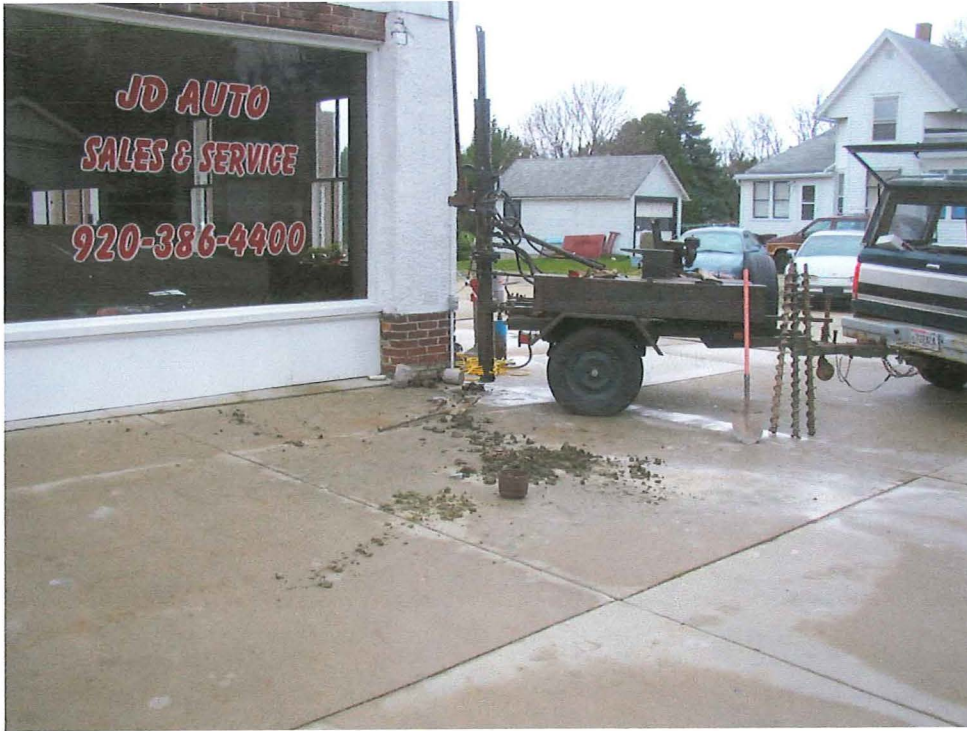
Regarding Pilsner Ford (Former) LUST Site, BRRTS # 03-14-530057, enclosed please find a copy of the Phase II Environmental Site Assessment (ESA) report completed in 2004. Per our discussion, I was not aware the DNR did not receive a copy of the report along with the notification of release. I also enclosed two photos of the sample site, as there is no map of the site in the Phase II ESA report.

View of Bore hole Locations
