Soil and Waste Management Plan - Revised

Eagle Point Senior Living
935 East John Street
Appleton, WI 54911

DNR BRRTS Number 02-45-530084
OMNI Project Number M1445C16

Soil and Waste Management Plan

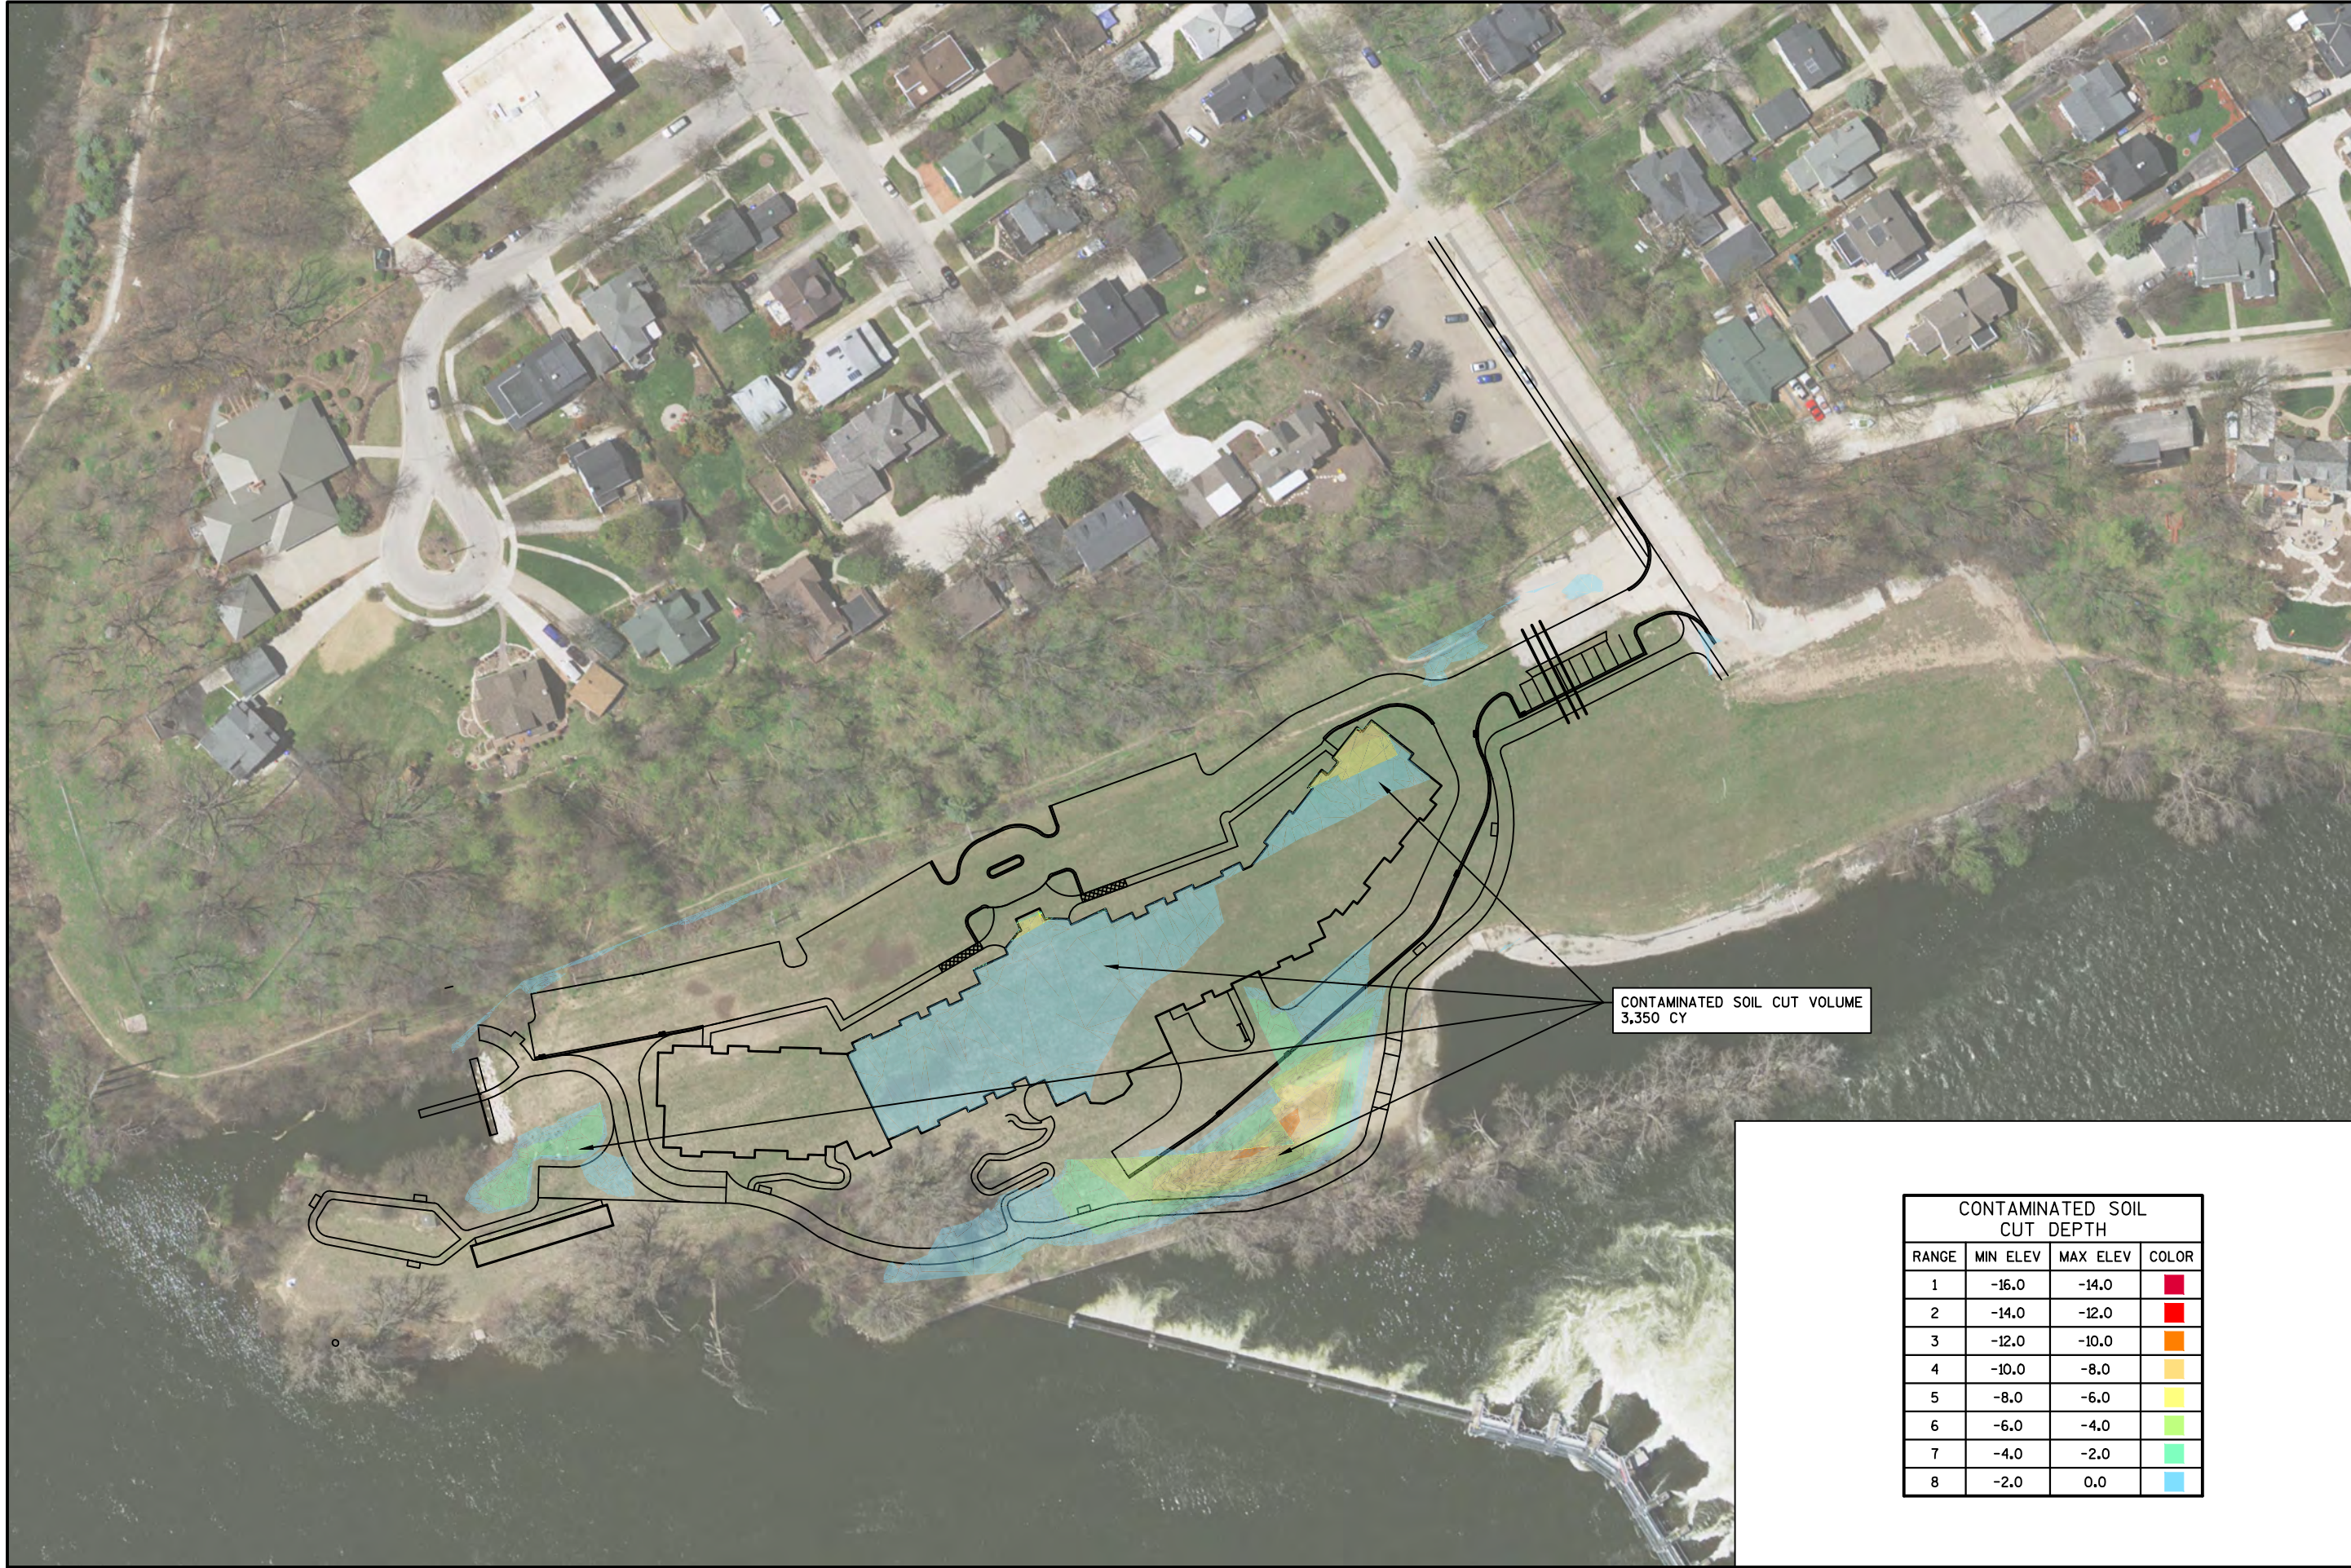
**EAGLE POINT SENIOR LIVING
CONTAMINATED SOIL EXCAVATION**

CONTAMINATED SOIL CUT VOLUME
3,350 CY

CONTAMINATED SOIL CUT DEPTH			
RANGE	MIN ELEV	MAX ELEV	COLOR
1	-16.0	-14.0	Red
2	-14.0	-12.0	Red-Orange
3	-12.0	-10.0	Orange
4	-10.0	-8.0	Yellow-Orange
5	-8.0	-6.0	Yellow
6	-6.0	-4.0	Light Green
7	-4.0	-2.0	Green
8	-2.0	0.0	Blue

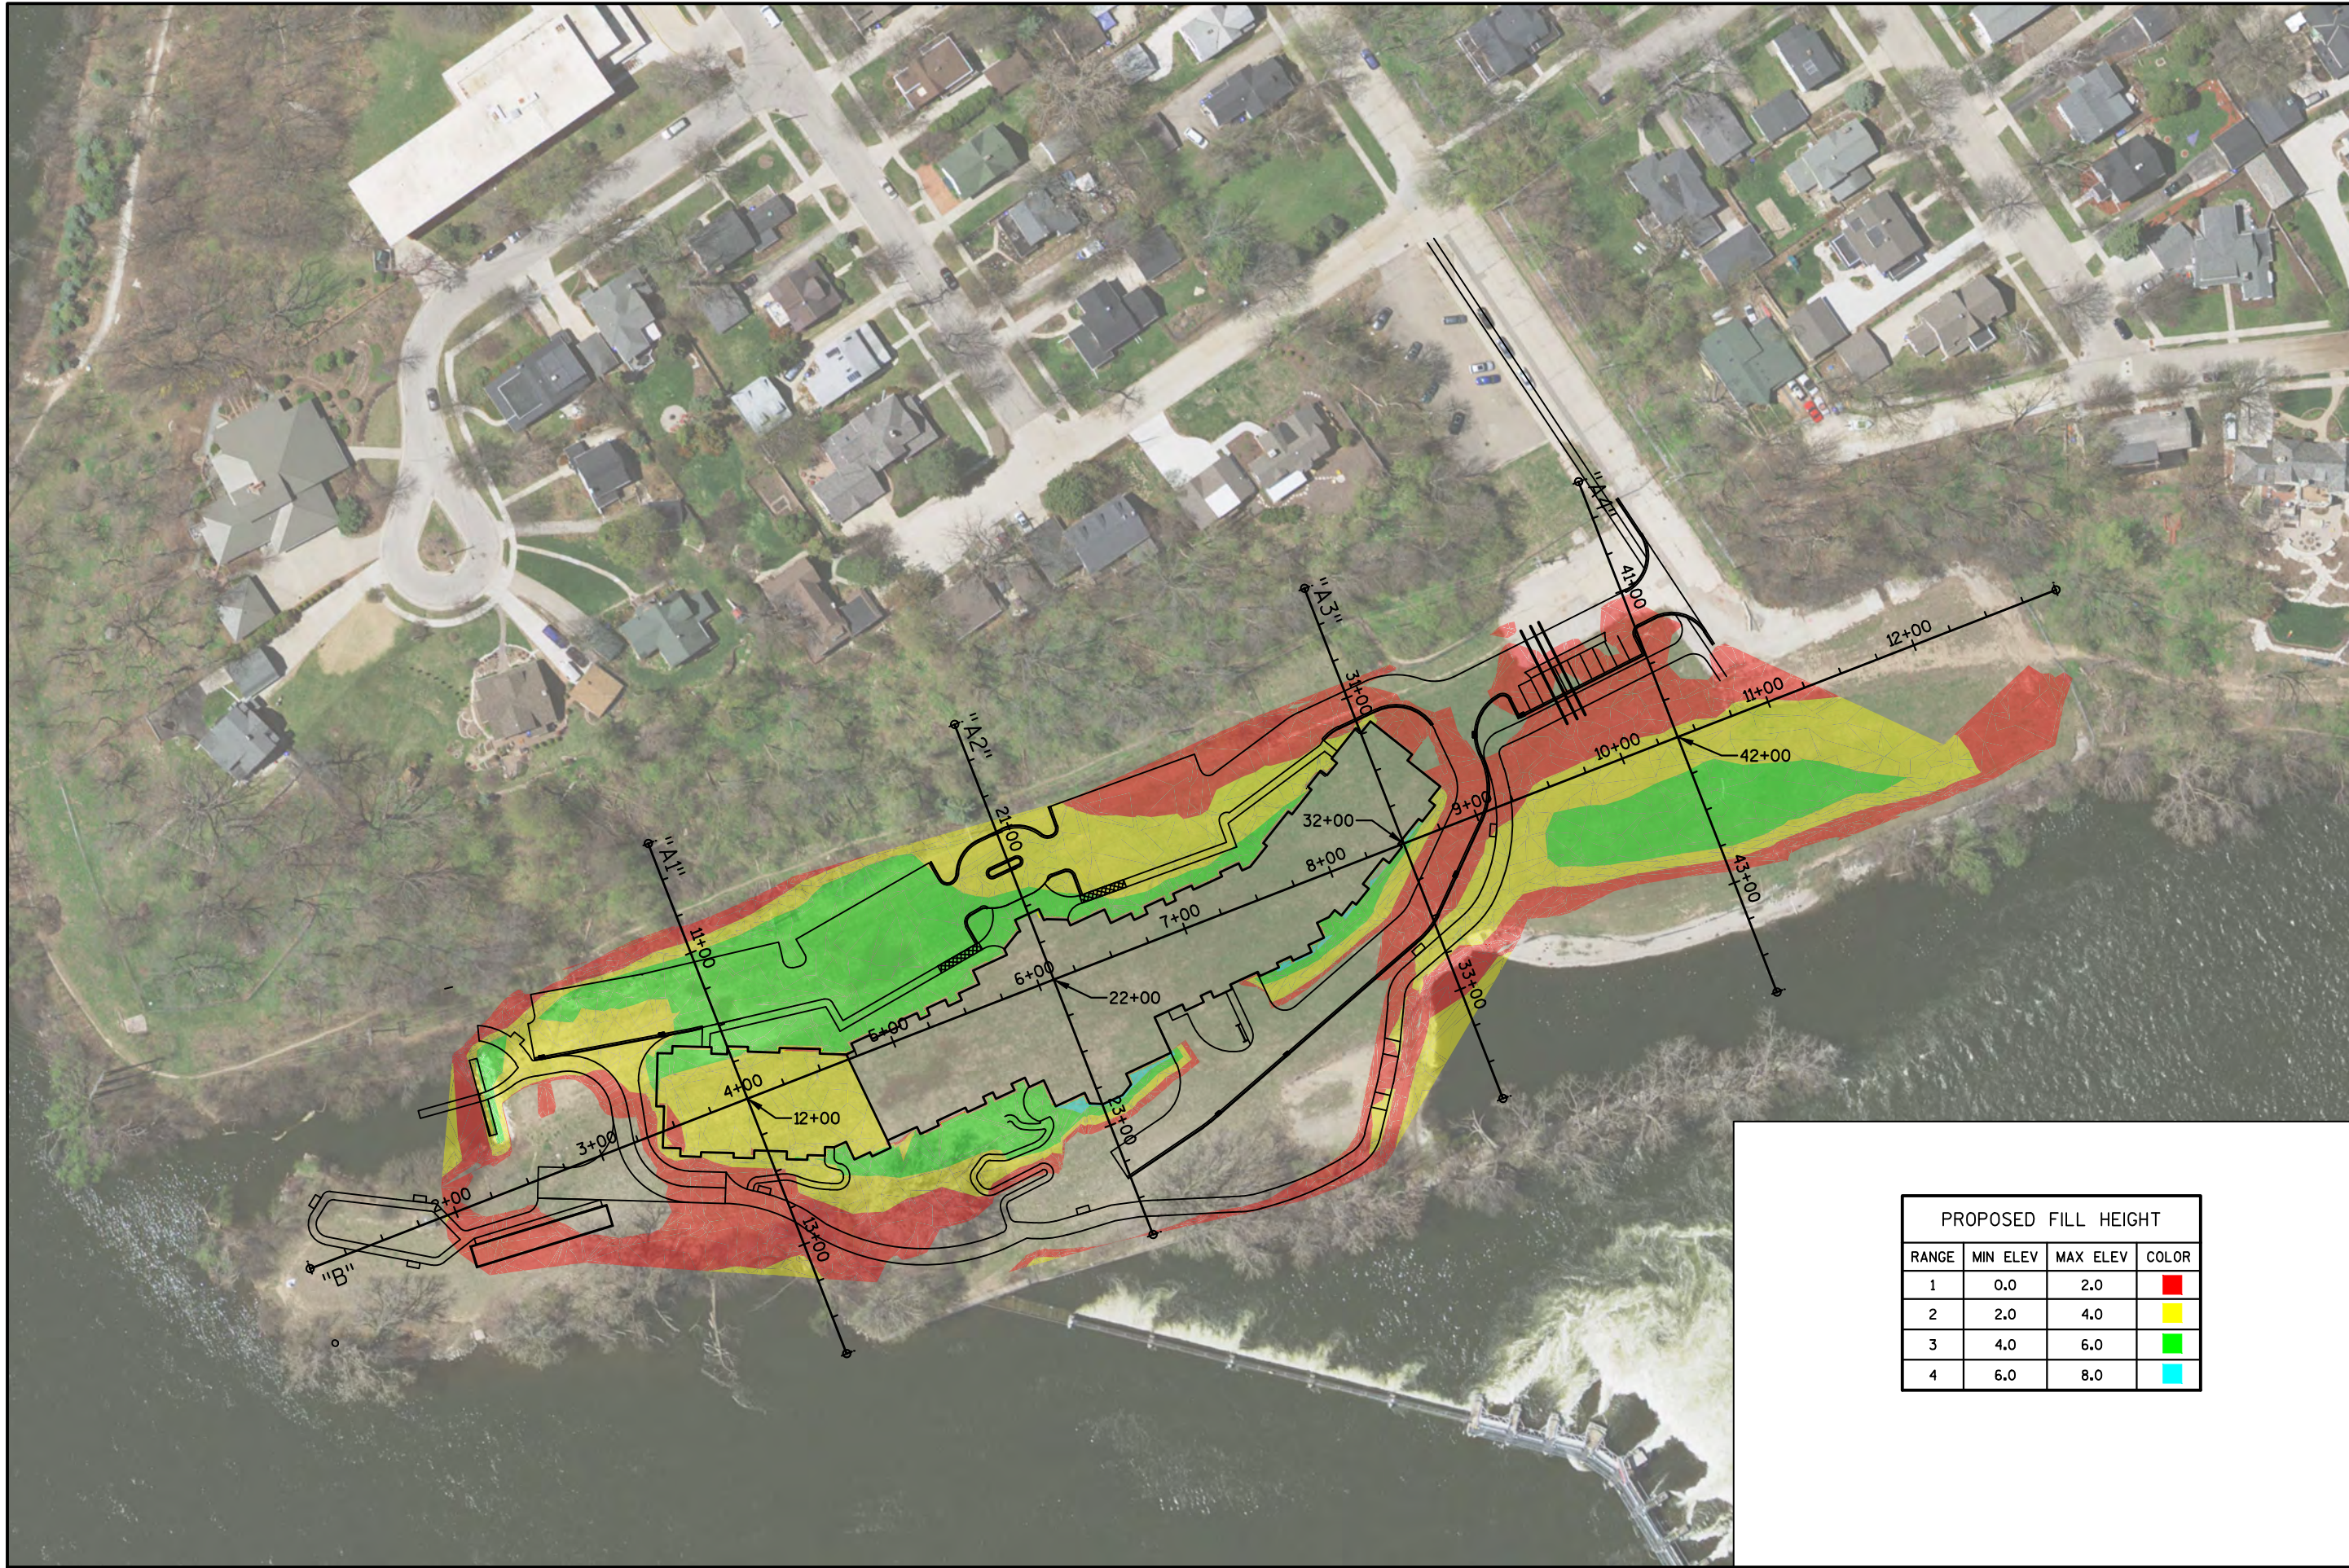
PROJECT NO: M1445C16
DRAWN BY: ADW
DATE: 10/21/2016
SHEET: 1 OF 1

PROPOSED FILL HEIGHT			
RANGE	MIN ELEV	MAX ELEV	COLOR
1	0.0	2.0	Red
2	2.0	4.0	Yellow
3	4.0	6.0	Green
4	6.0	8.0	Cyan

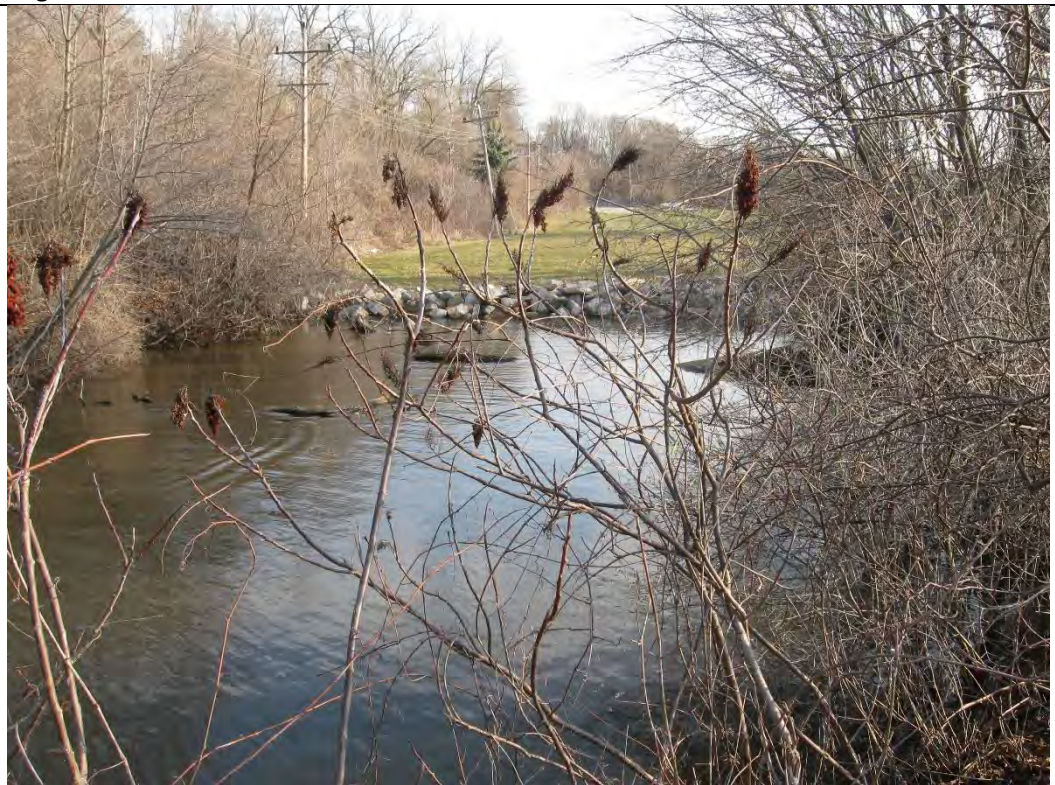
View of remaining portion of former head raceway, looking from the south.

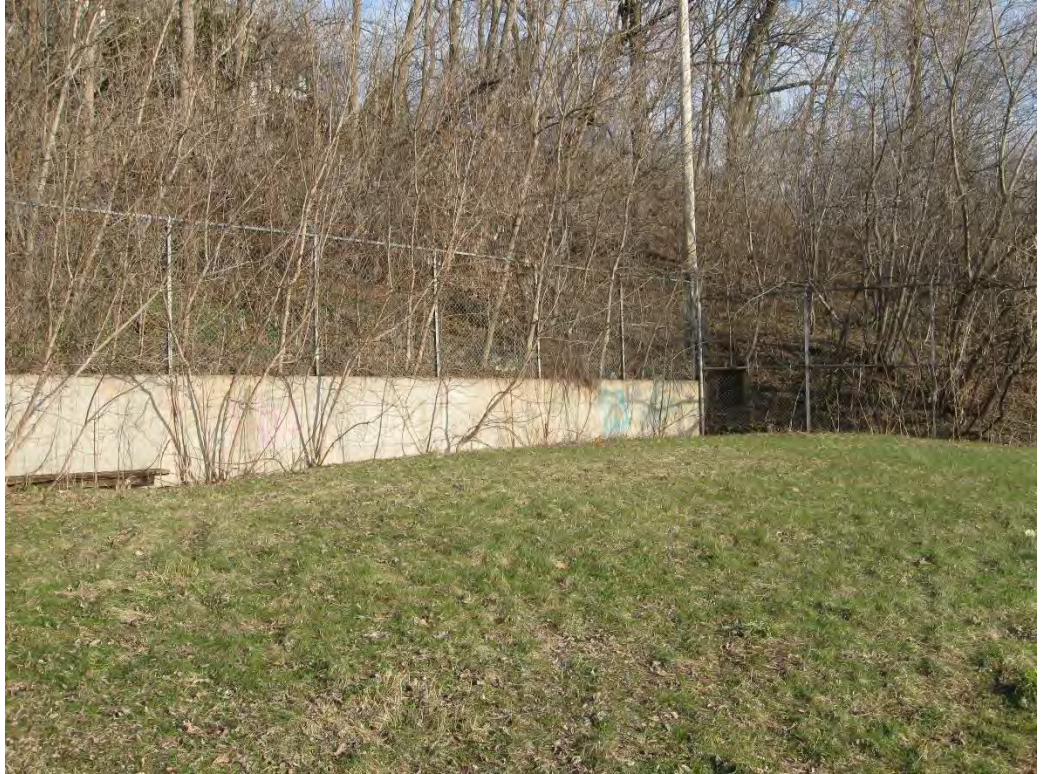
Photo #
5

Description:
View of former electrical transformer area, looking from the southeast.

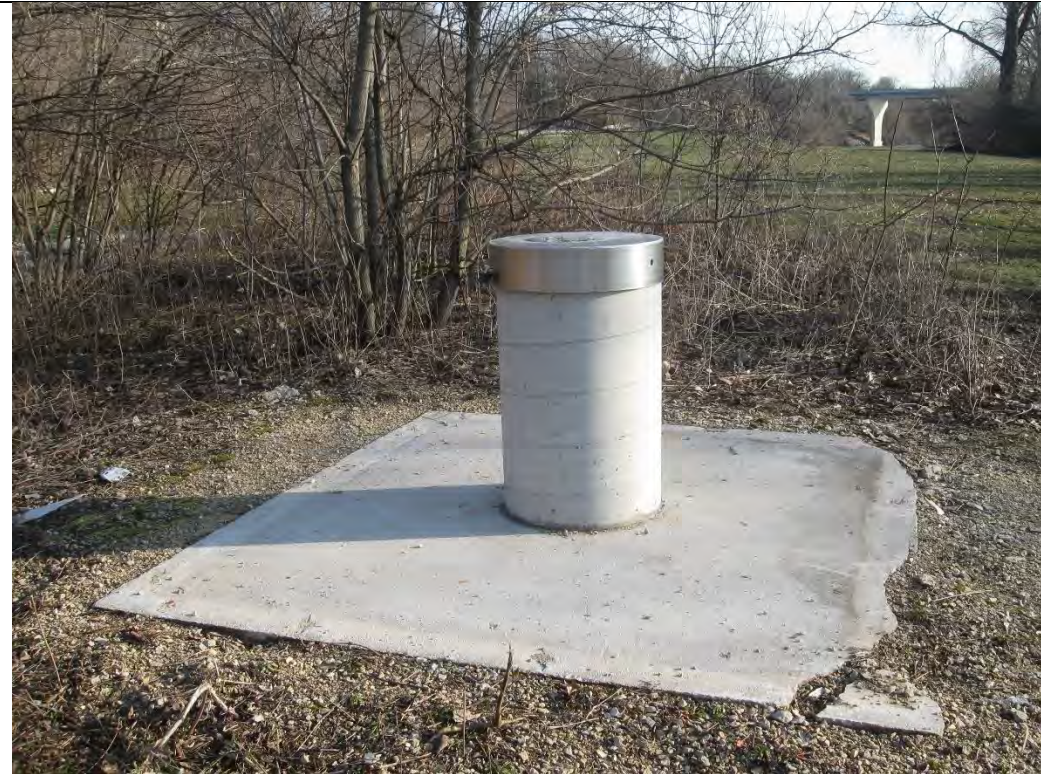
Photo #
6

Description:
View of monitoring well FF-1, looking from the south.

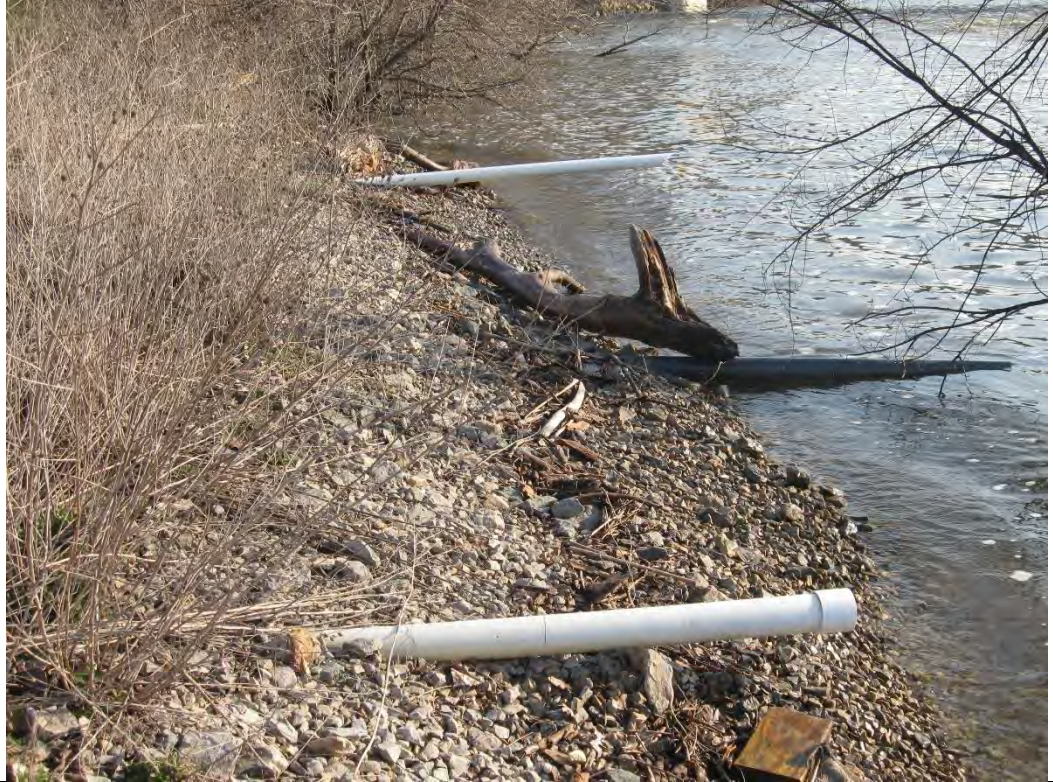
Photo #
7

Description:
View of drain pipes into the Fox River, located east and opposite of the subject property's former parking lot, looking from the south.

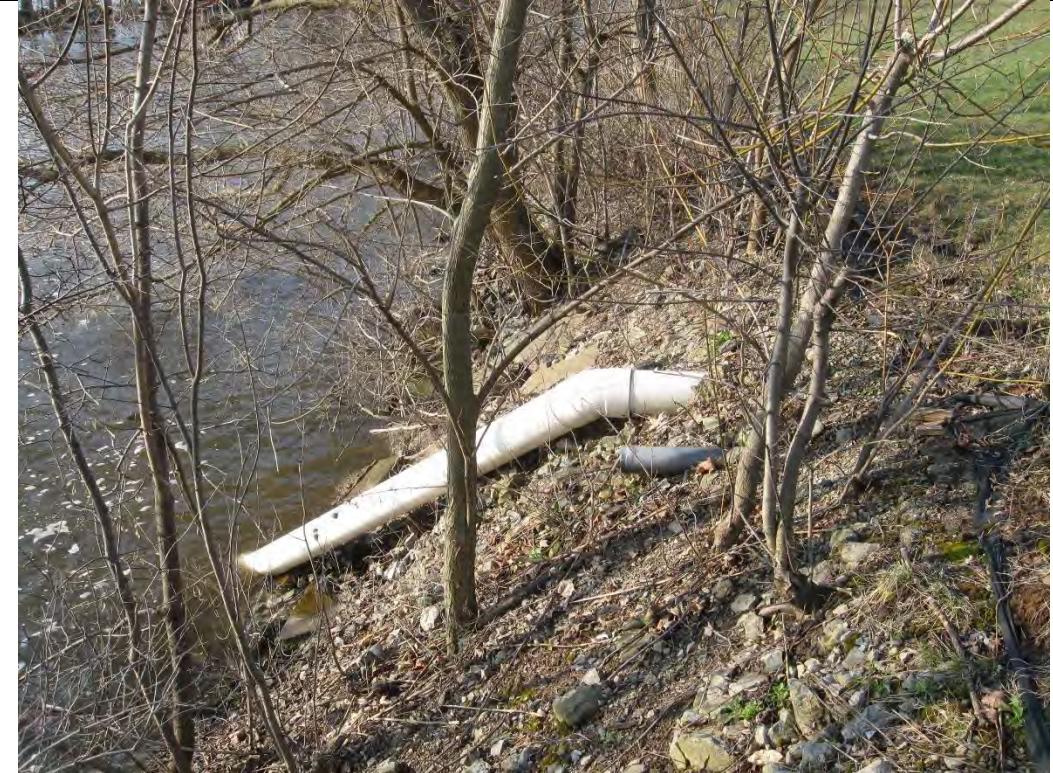
Photo #
8

Description:
View of drain pipe into the Fox River, located east and opposite of John St., looking from the north.
