ST. JOHN - MITTELHAUSER & ASSOCIATES

Re: D&C Partners Response to WDNR's June 3, 2020 Correspondence
5005 S. Packard Avenue
Cudahy, WI

Attachments: Revised Figure 12

CROSS SECTION C-C'
 SUPERIOR HEALTH LINENS
 5005 SOUTH PACKARD AVENUE
 CUDALUP, WISCONSIN

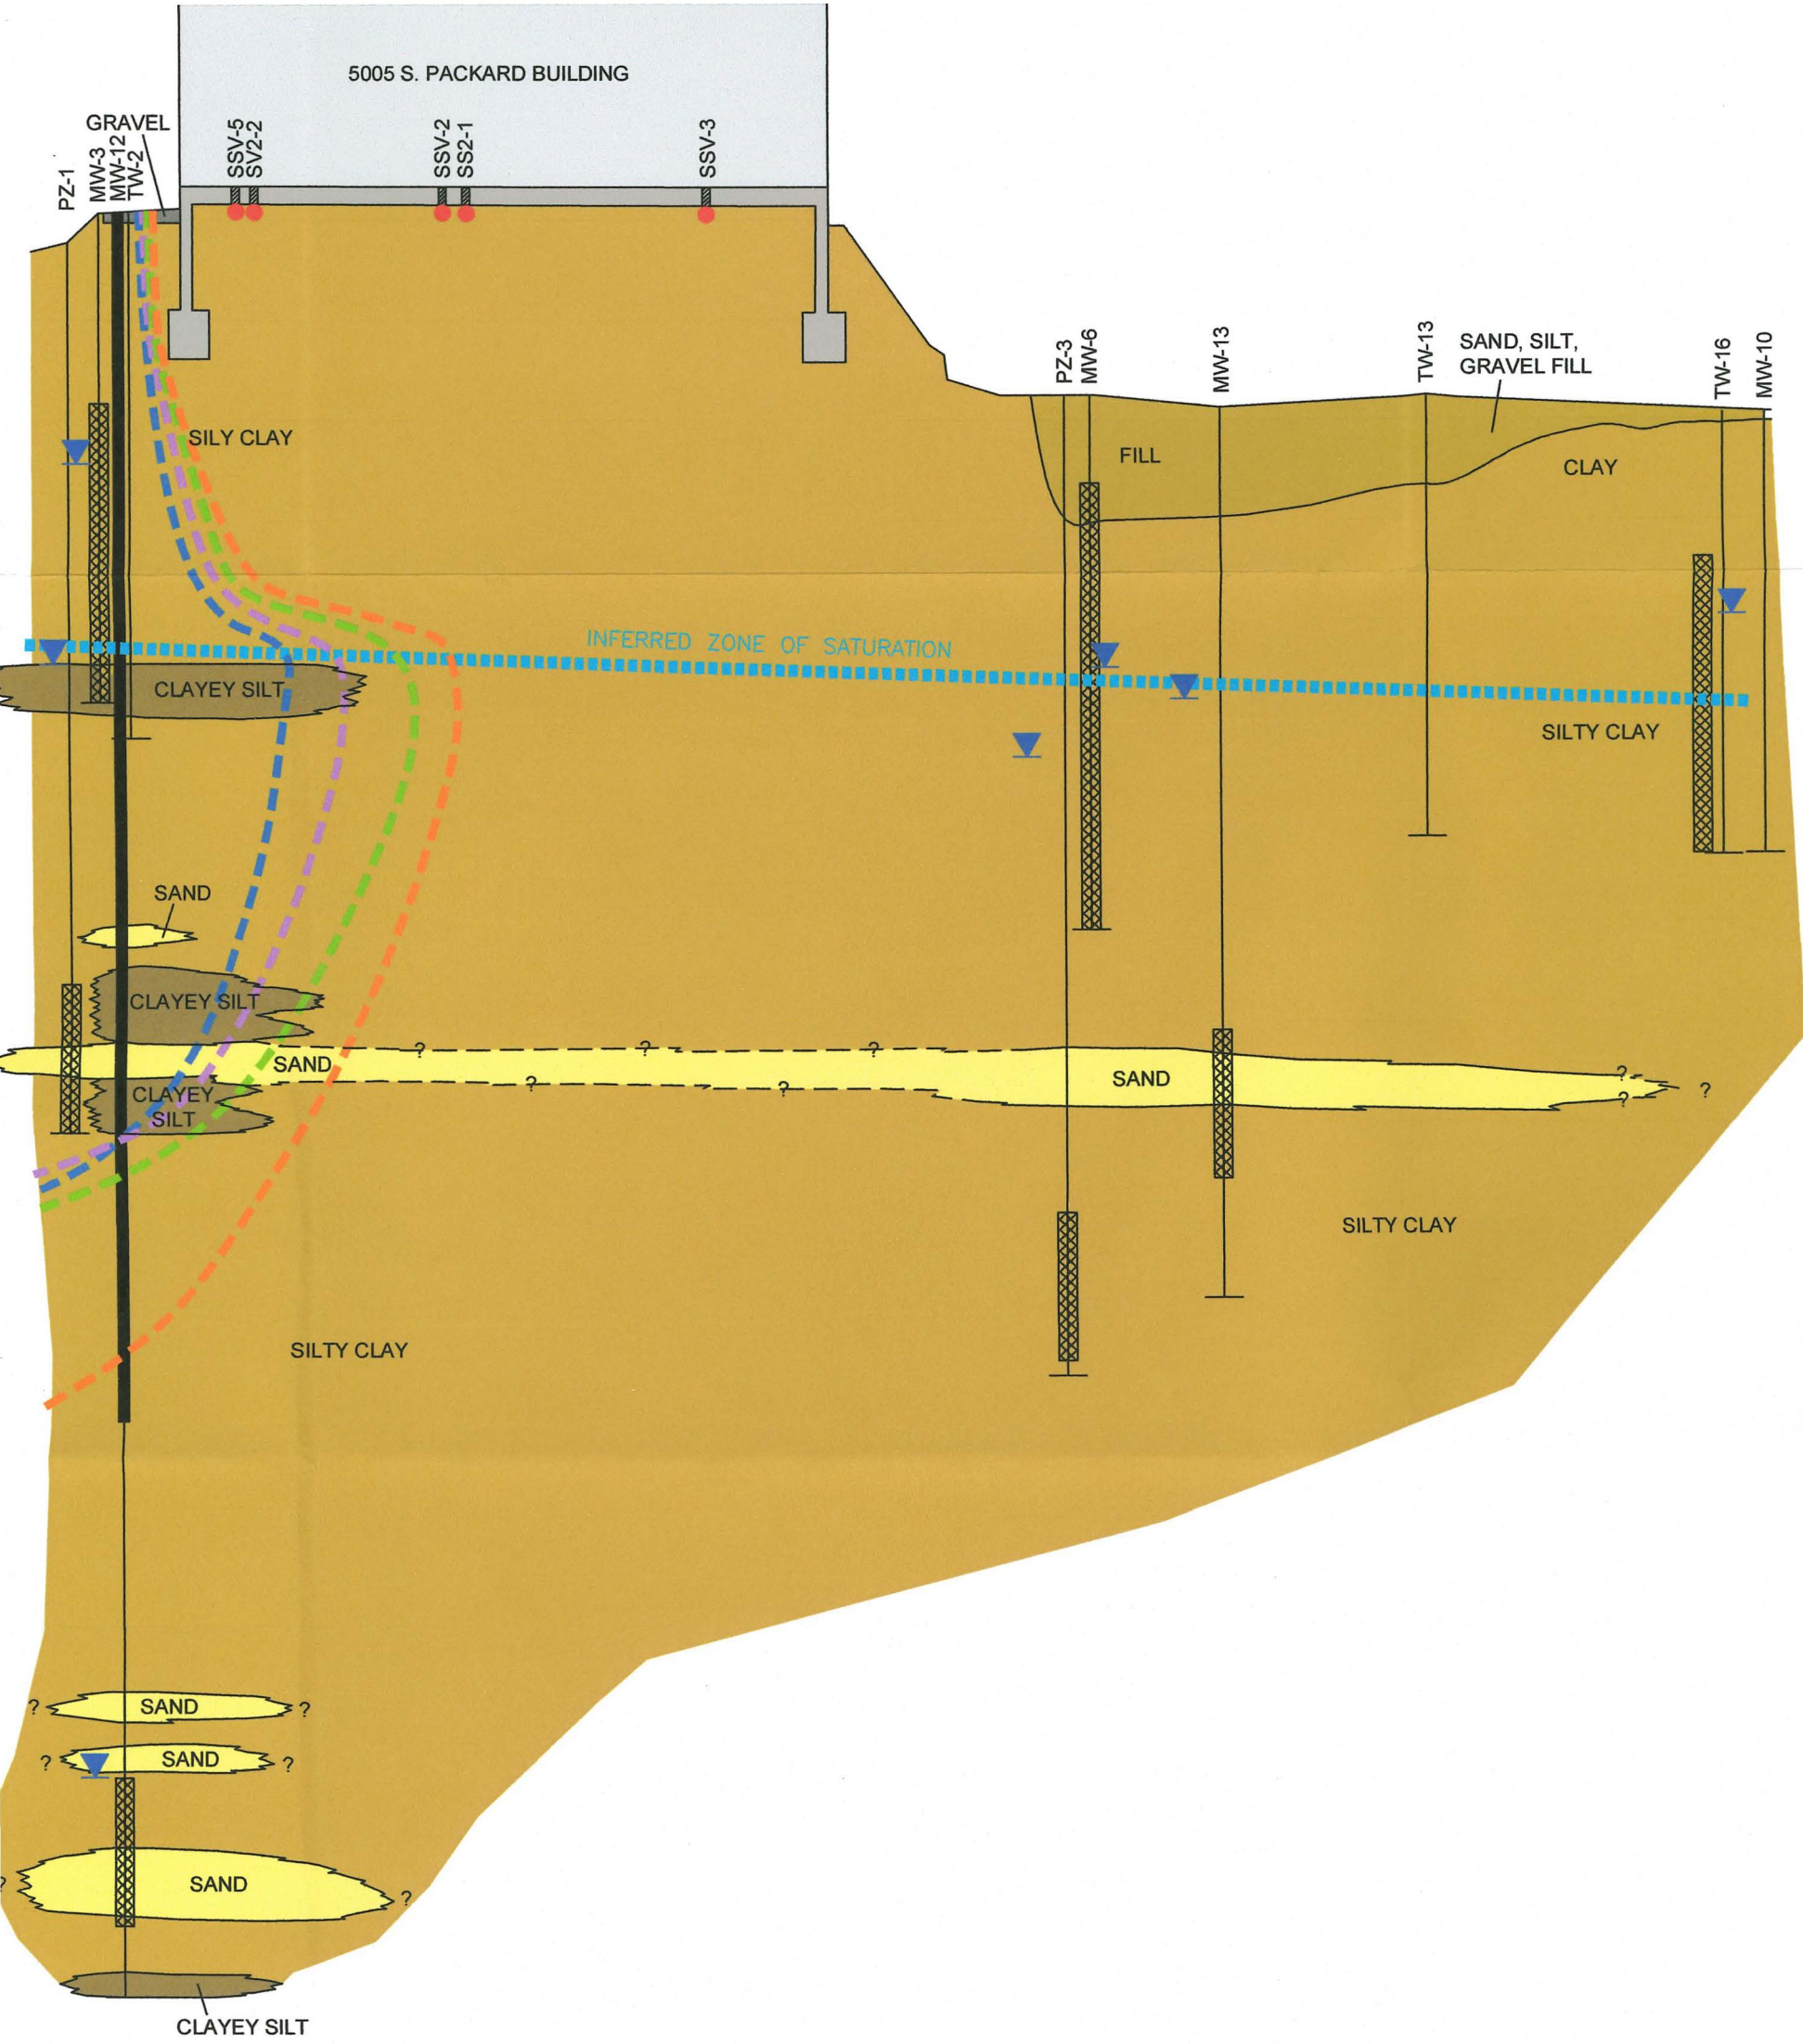
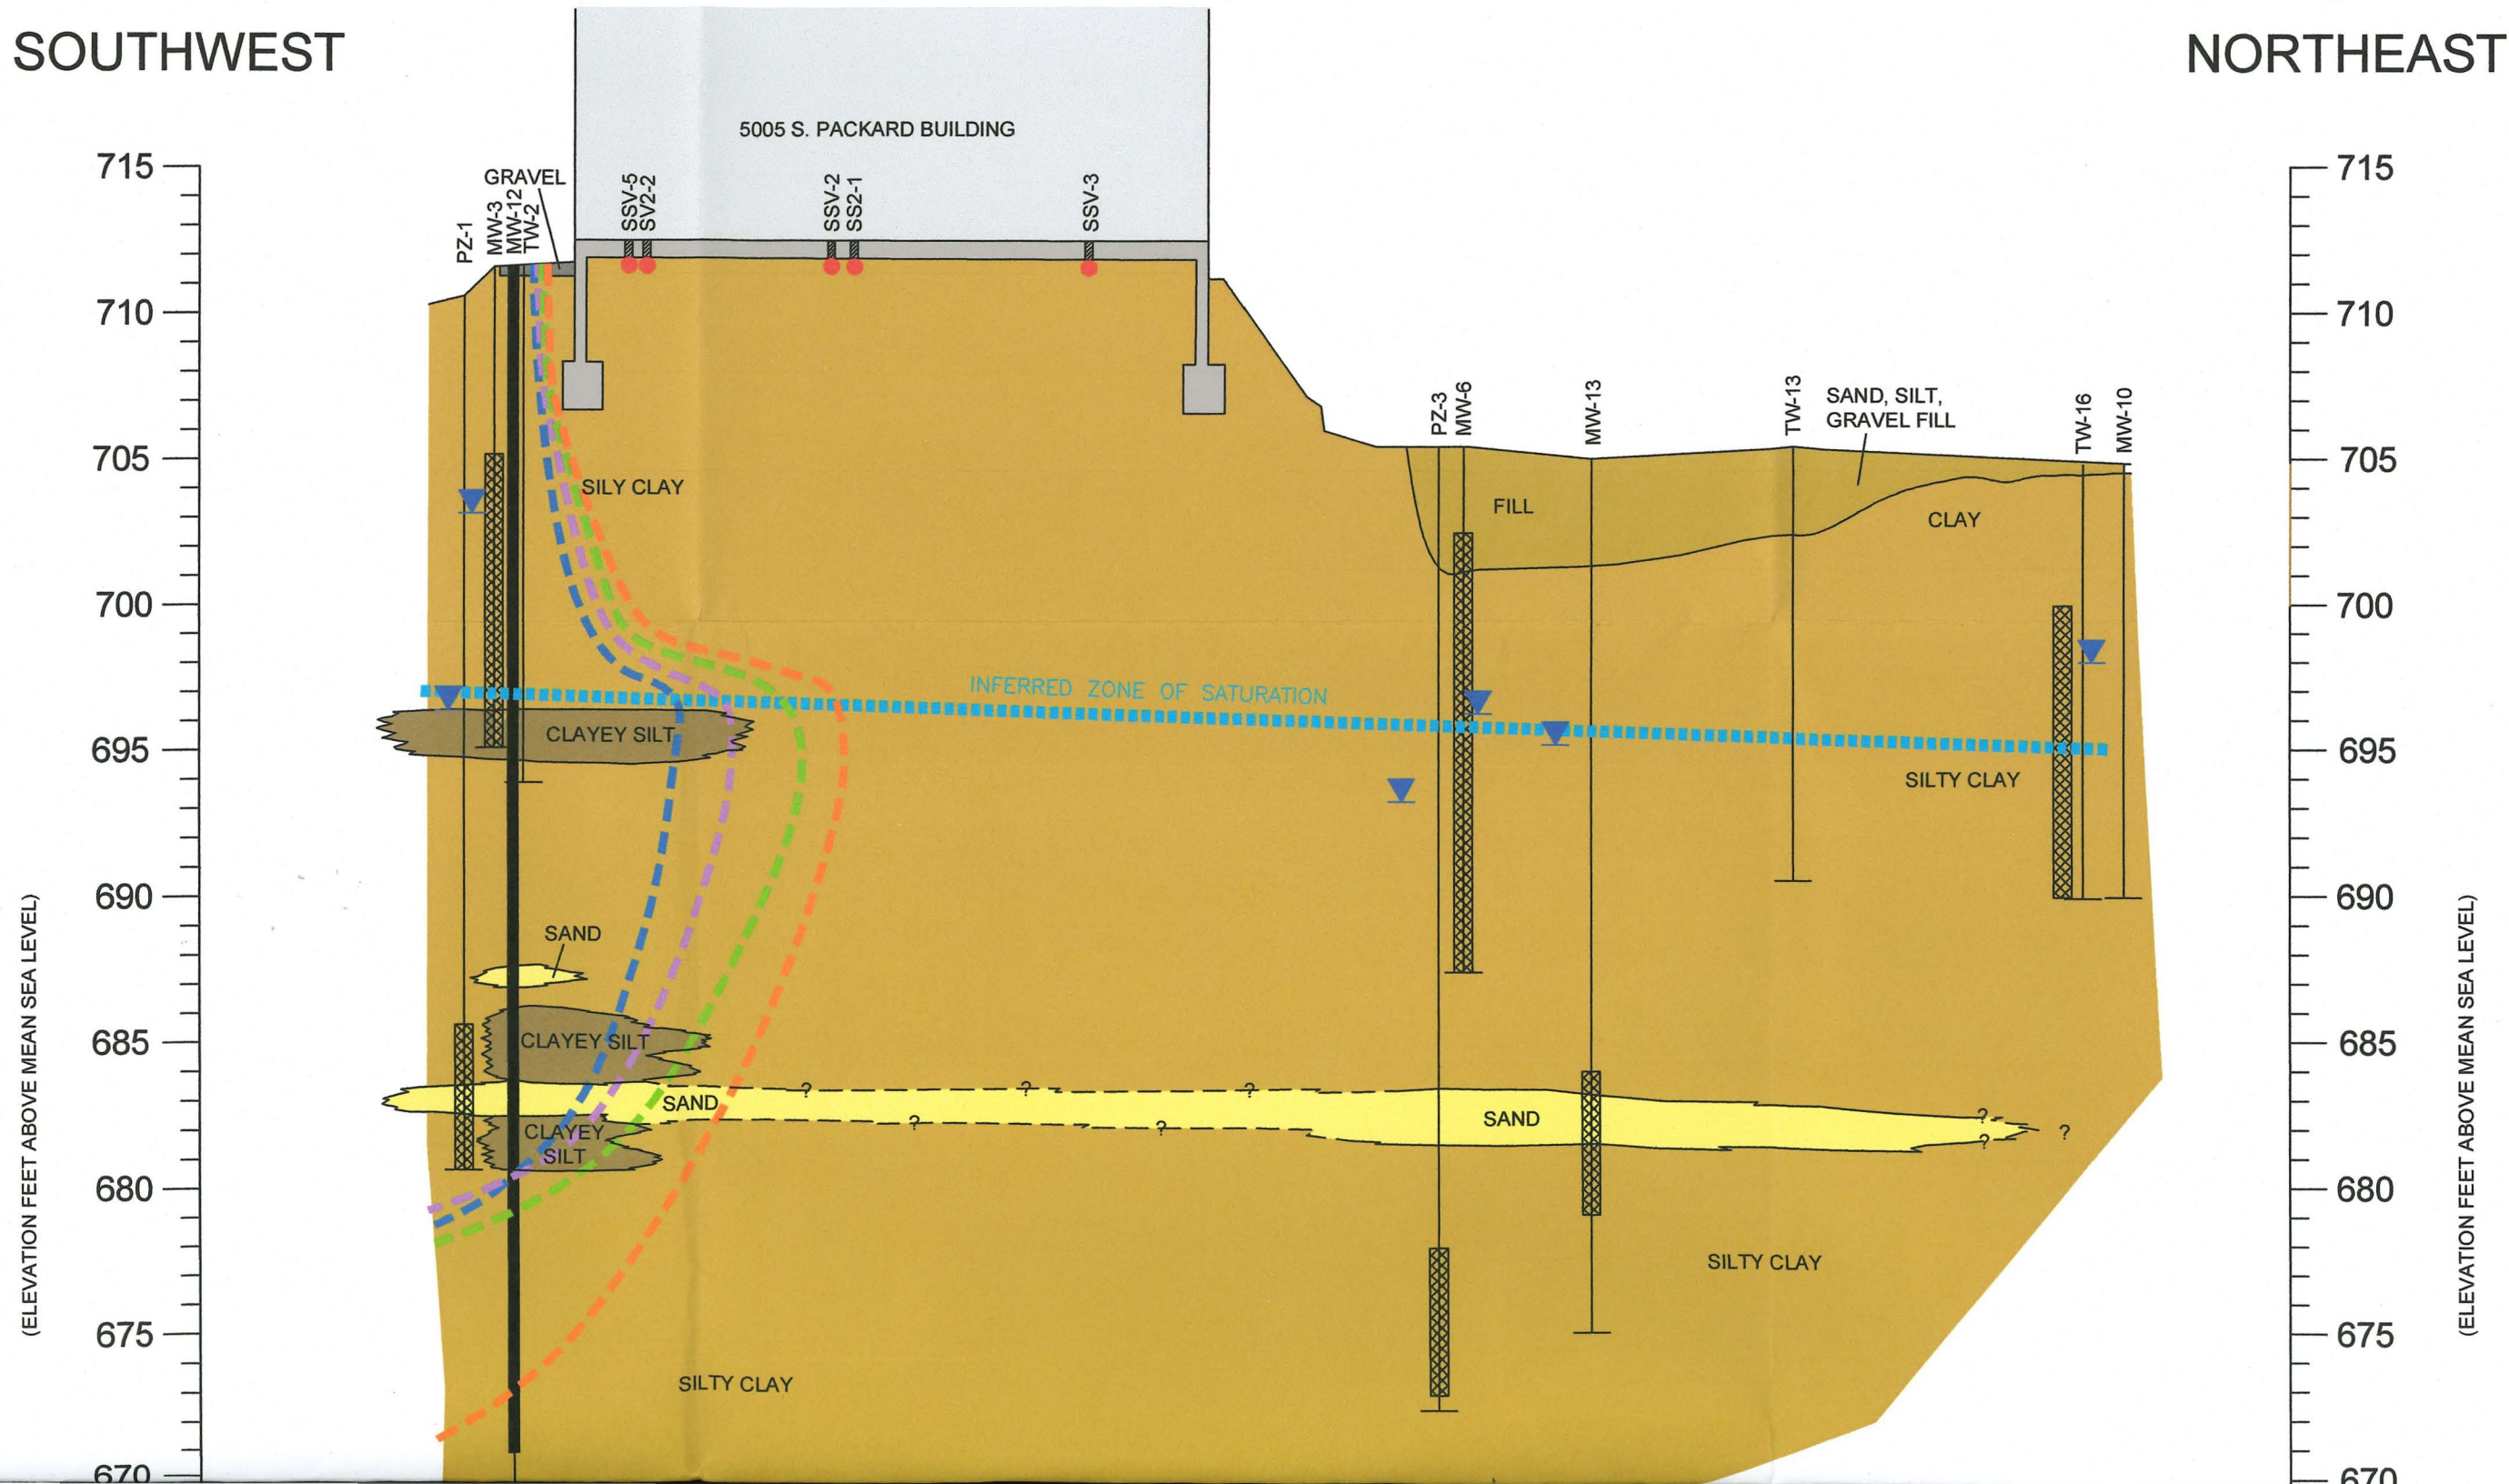
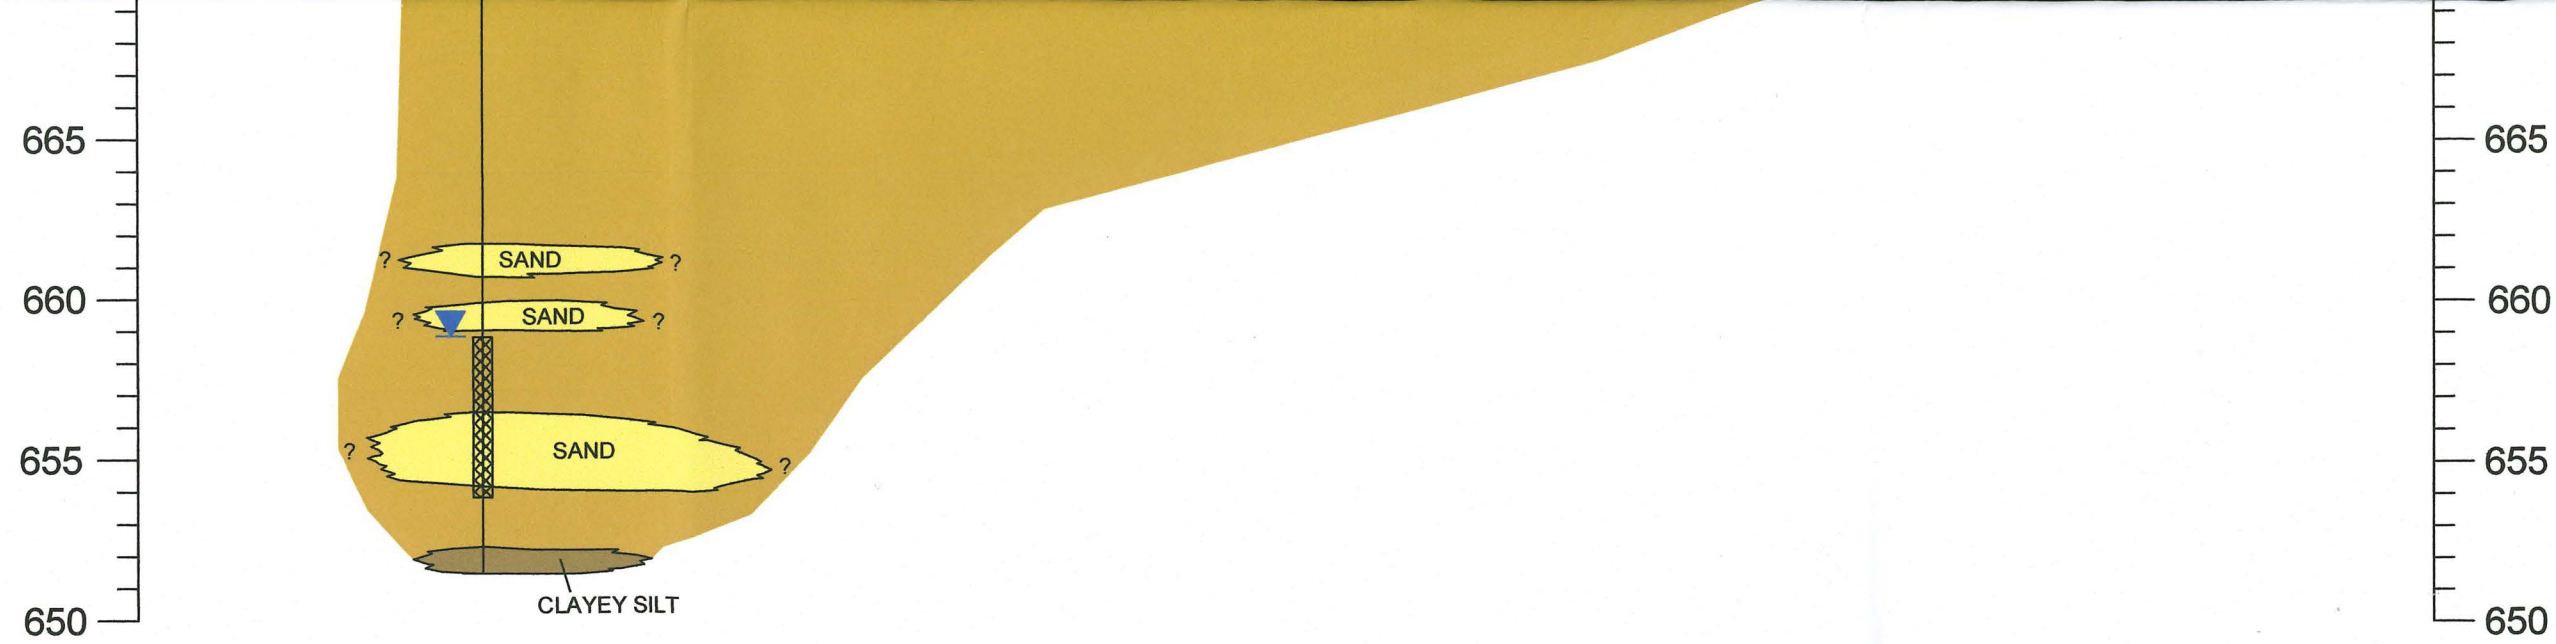
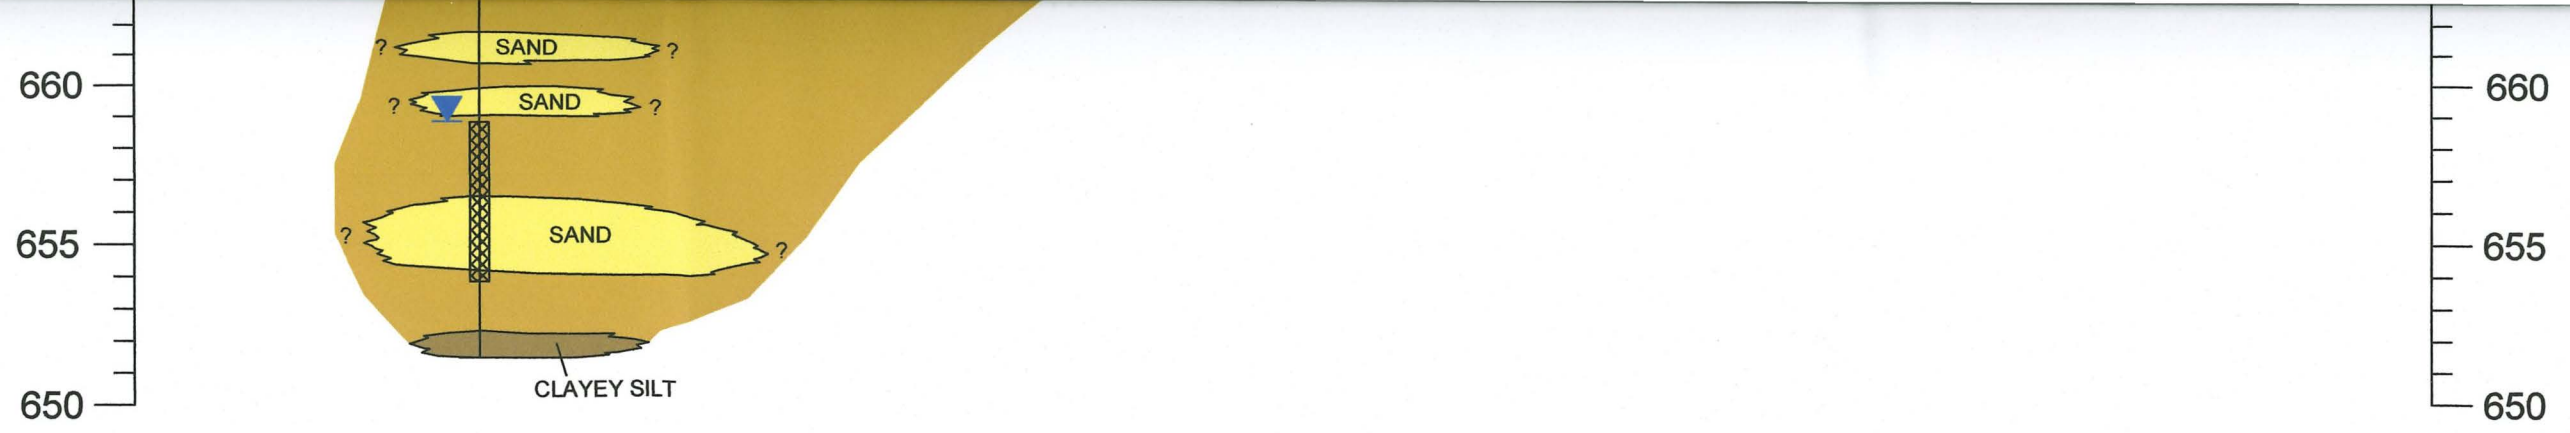
INFERRED EXTENT OF CONTAMINANTS EXCEEDING PROTECTION OF GROUNDWATER RCLs

C
SOUTHWEST

C'
NORTHEAST

As demonstrated on Figure 12 of the SIR/RAODR, piezometer PZ-3 is completed downgradient of the source area and adjacent to MW-6 and MW-13. The piezometer is screened at a depth of 27 – 33 feet bgs and completed in the clay unit underlying the glacial till and the “sand seam.” Groundwater samples collected from PZ-3 between December 2010 and August 2017 (8 sampling events) indicated all CVOCs were below the reporting limits of the laboratory equipment.

indicated 1,1,1-TCA was below the laboratory reporting limits for all five groundwater sampling events. Therefore, there is no plume of 1,1,1-TCA on cross-section C – C' (Figure 12).

The sub slab soil gas analytical results identified that one of the samples had no detectable VOC results and the other samples identified the presence of two (2) VOCs above the reporting limits of the laboratory equipment in one sample (SSV-3). The VOCs included 1,1,1-TCA at a concentration of 79.1 ug/m³ and TCE at a concentration of 1.1 ug/m³. Both were below their respective Target Sub-Slab Vapor Risk Screening Level of 2,200,000 ug/m³ and 880 ug/m³ respectively. Given the concentration of CVOCs within the source area, and its proximity to the western edge of the building footprint, the presence of trace amounts of 1,1,1-TCA and TCE are not surprising. Figure 12 (Cross Section C – C') has been updated to show the projected location of the sub slab soil gas samples and the inferred extent of contaminants exceeding the protection of groundwater RCLs. The updated figure is attached to this correspondence.
