**SUPERIOR LINENS (BRRTS #02-41-532649) REMEDIAL ACTION WORKPLAN – UPRR RIGHT-OF-WAY, PARCEL NO. 6319999000, CUDAHY, WISCONSIN**

PROJECT  
SUPERIOR LINENS REMEDIATION  
UPRR RIGHT-OF-WAY  
CUDAHY, WISCONSIN

TITLE  
**SOIL ANALYTICAL RESULTS**

TITLE  
**EXCAVATION LIMITS**

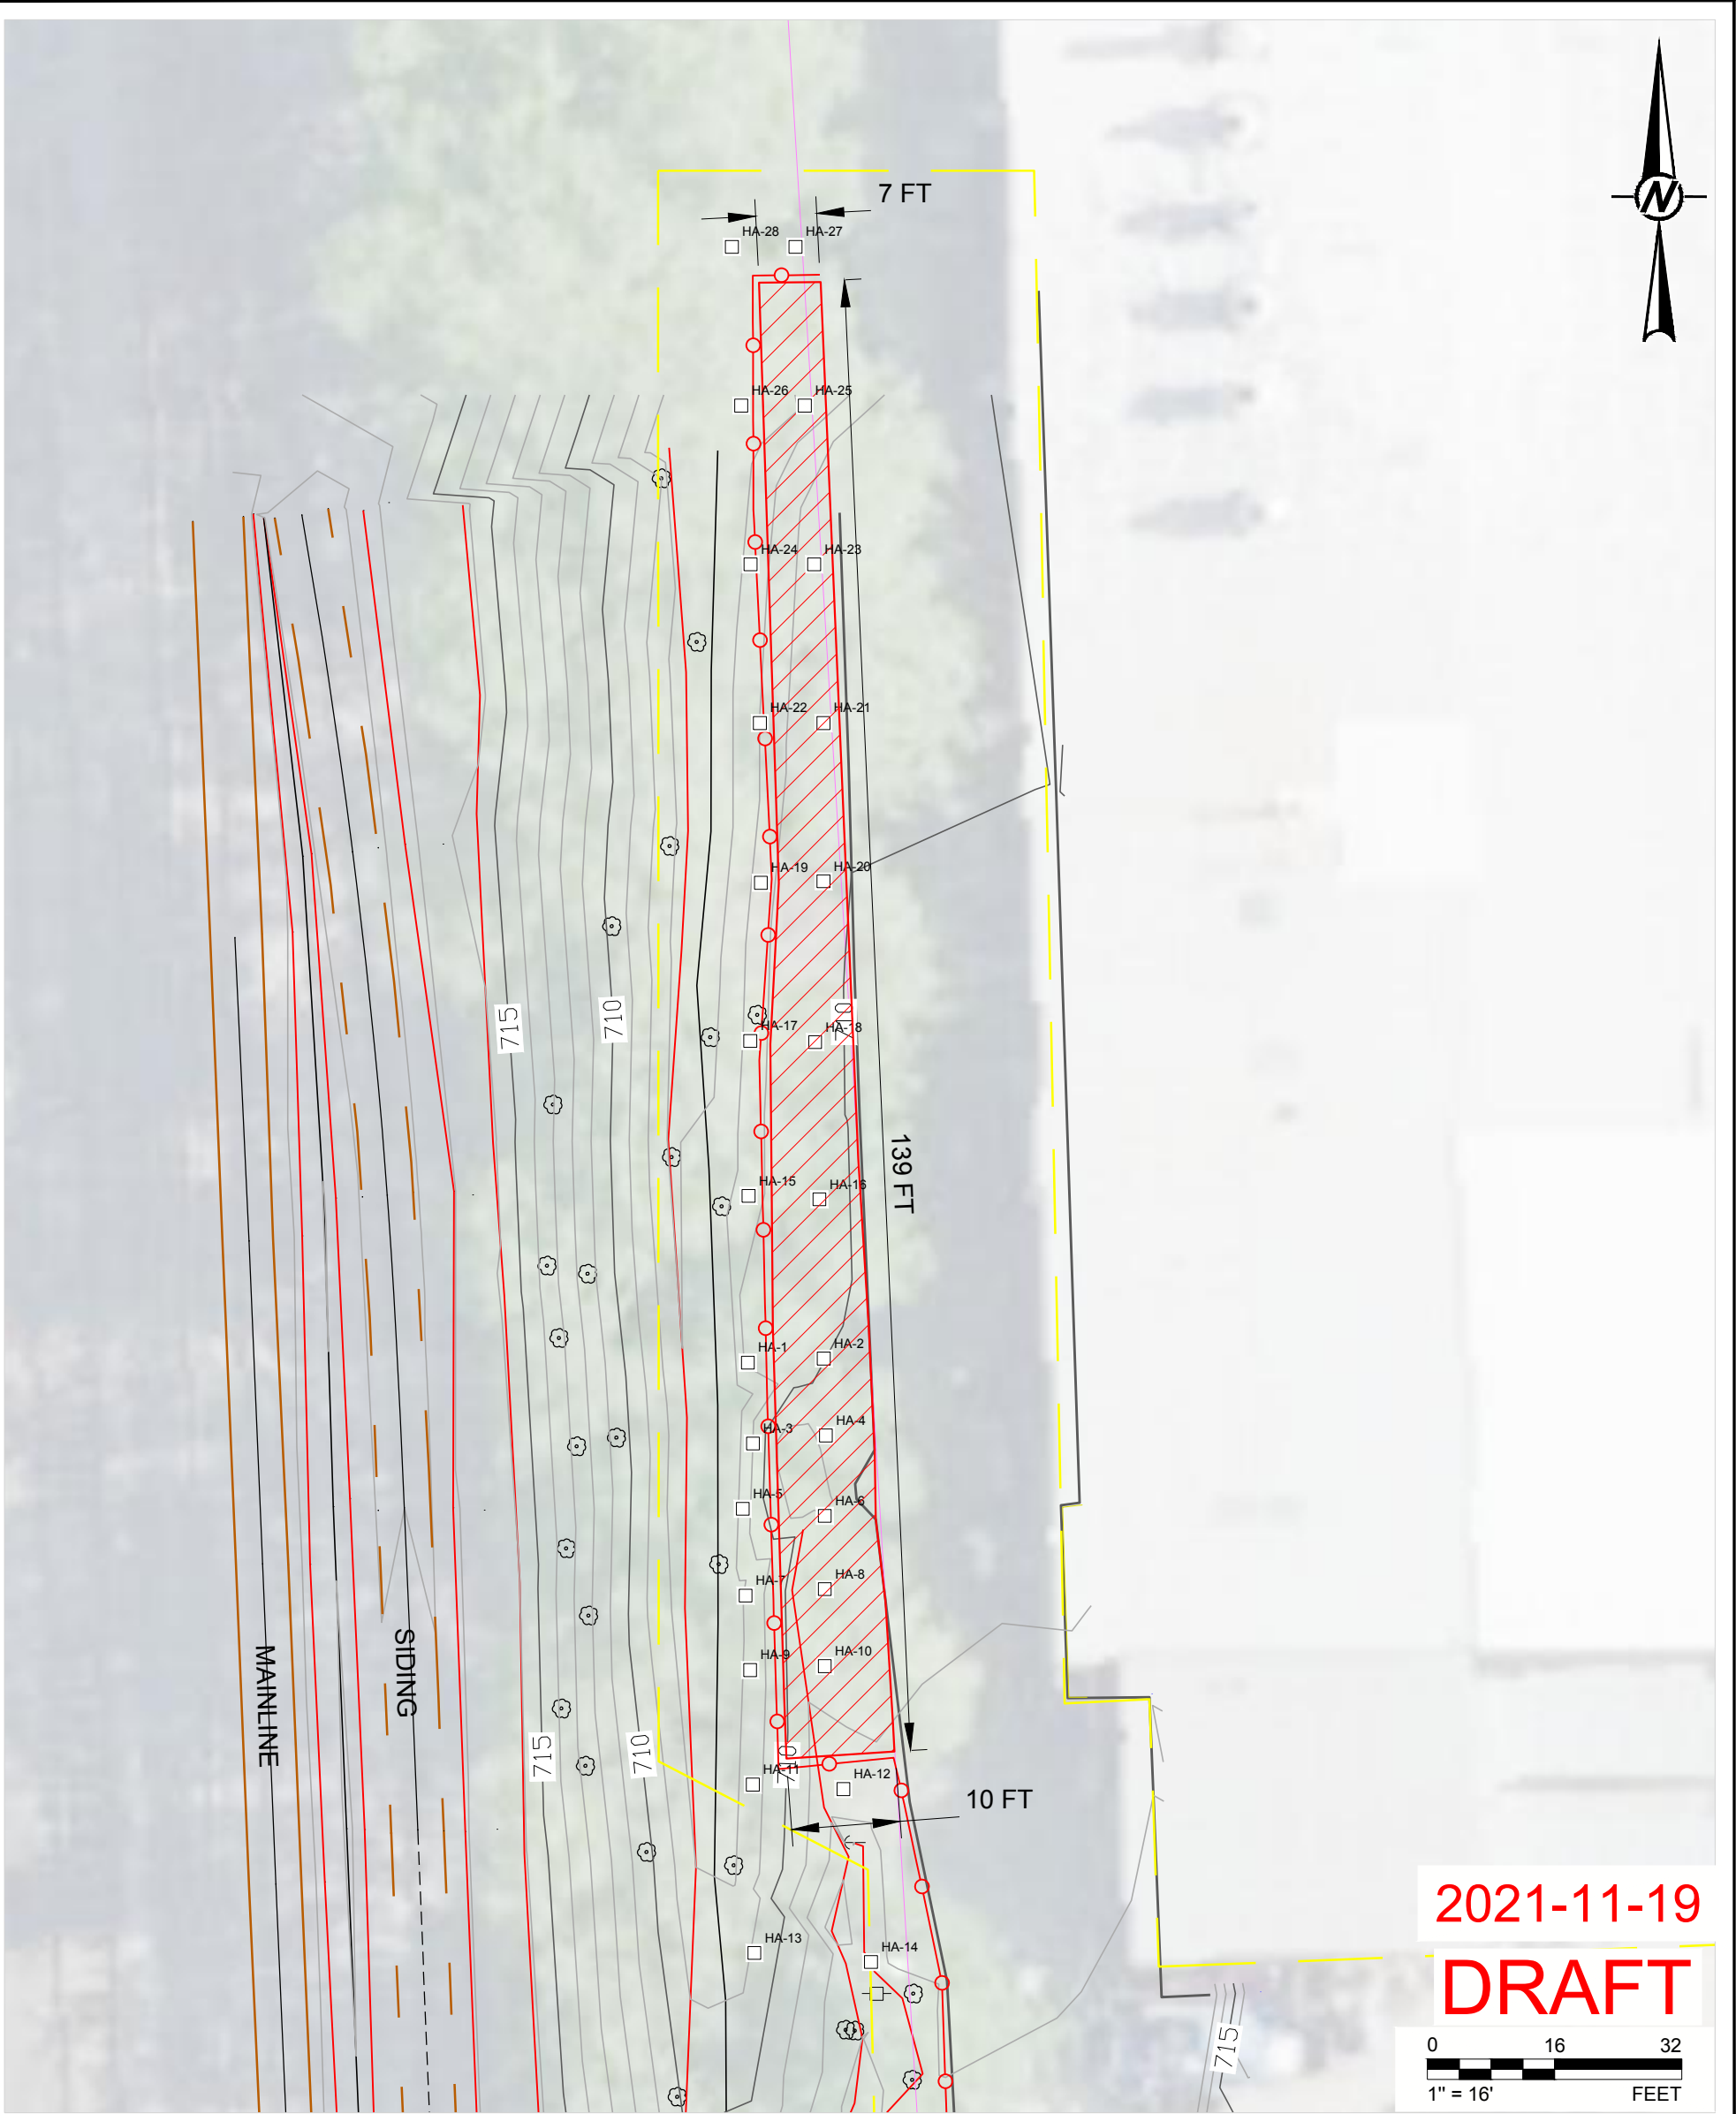
As a basis for the soil excavation limits, Golder will utilize the results of the hand auger samples collected in October and November 2021. The eastern excavation limit will be the existing asphalt surface on the Superior Health Linens property that serves as a cap. The southern excavation limit will be defined by the hand auger samples HA-11, HA-12, HA-13, and HA-14 where no ID-RCL exceedances occurred. The western excavation limit will be defined by the hand auger samples HA-9, HA-7, HA-5, HA-3, HA-1, HA-15, HA-17, and HA-19 where no ID-RCL exceedances occurred. Hand auger locations HA-22 through HA-28 have not been collected to date and will be used to define the excavation limits in the northern portion of the site. The excavation limits will be adjusted to contain the area identified as ID-RCL exceedances. The samples collected to date allow for the western and southern excavation limits to be defined.

Golder conducted a topographic survey of the site on July 20, 2021. From this survey, a shoring review was conducted that determined shoring would be required to support the rail embankment during the excavation. It was determined that excavating within the embankment of the active rail line would present undesired risk and increased project cost. Therefore, to determine if the extent of direct contact standard soil exceedances extends as far west as SM&A initially assumed, Golder collected additional soil samples with a hand auger in October and November 2021 to delineate the extent of soil exceedances. Based on the results obtained, revised excavation limits are being proposed. The additional soil sample locations, analytical results, and proposed new excavation limits are shown in the attached figures.

Figure 2 - Excavation Limits, Golder, 2021-11-19
