CONSTRUCTION DOCUMENTATION REPORT

FORMER KLINKE CLEANERS – FOX RUN
2346 WEST ST. PAUL AVENUE
WAUKESHA, WISCONSIN

ENDPOINT PROJECT No. 525-008-005

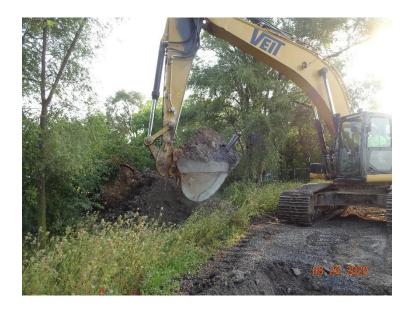
1. Six-inch (6") sanitary sewer pipe removed from west of MH 4 at the northeast corner of the Site.

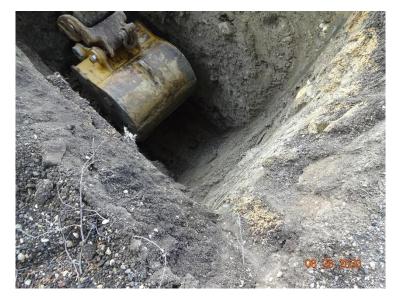
2. Excavating sanitary sewer trench west of MH 4 at the northeast corner of the Site.

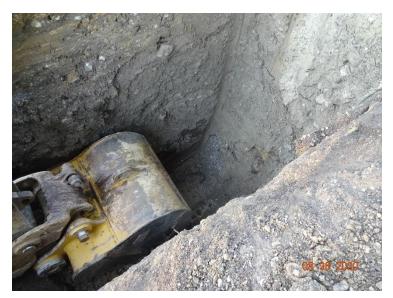
3. Excavating sanitary sewer trench west of MH 4 at the northeast corner of the Site.

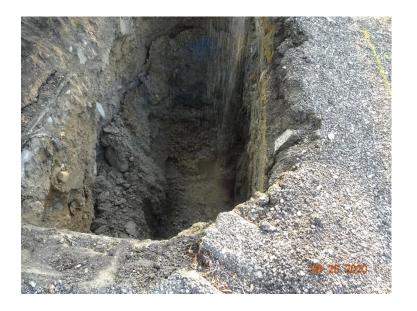
4. Backfilling sanitary sewer trench with compacted clay west of MH 4 at the northeast corner of the Site.

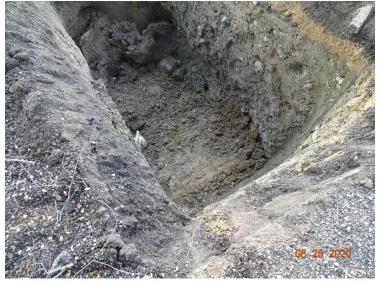
6. Compacted clay within the sanitary sewer trench west of MH 4 at the northeast corner of the Site.

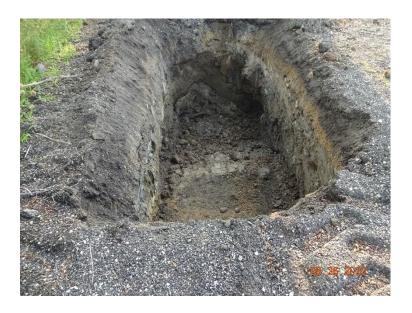
7. Compacted clay within the sanitary sewer trench west of MH 4 at the northeast corner of the Site.

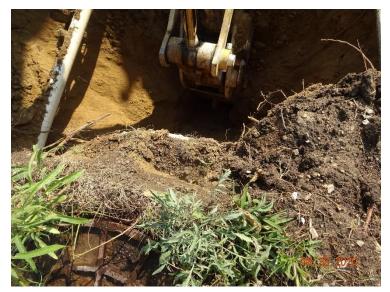
9. Excavating east of MH 2 with one (1) underground fiber optic utility exposed in the northwest corner of the Site.

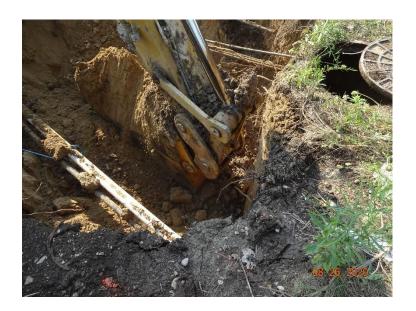
10. Excavating east of MH 2 with two (2) underground fiber optic and one (1) underground electric utility exposed in the northwest corner of the Site.

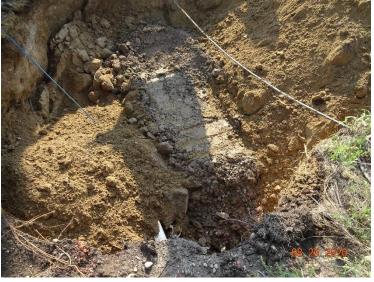
12. Backfilled sanitary sewer trench east of MH 2 with compacted clay.

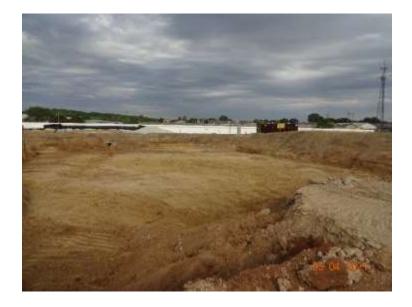
1. 16-unit building excavation viewed from the east.

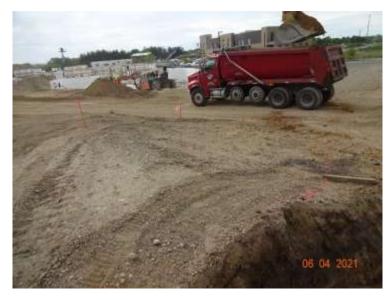
2. Approximate area of contaminated soils marked in northeast building corner.

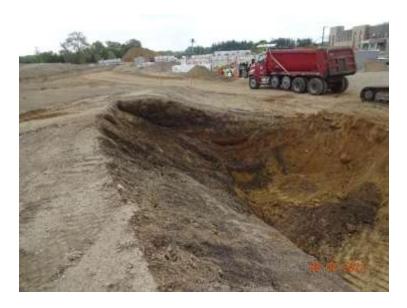
3. View of the excavation profile looking into the area of contaminated soils.

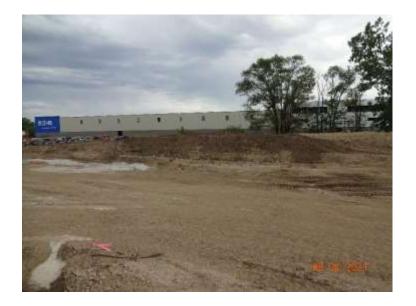
4. Screening berm along north boundary of the Site.

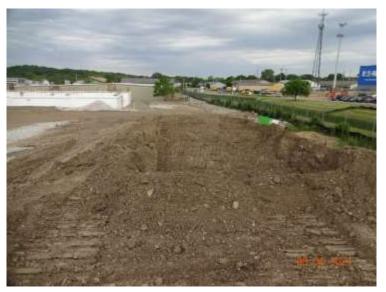
5. Area prepared in screening berm to accept contaminated soils.

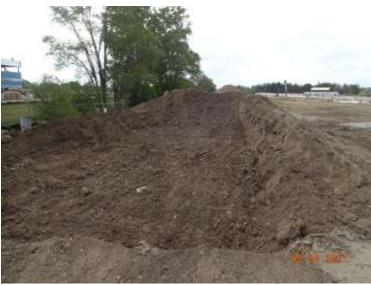
6. Area prepared in screening berm to accept contaminated soils.

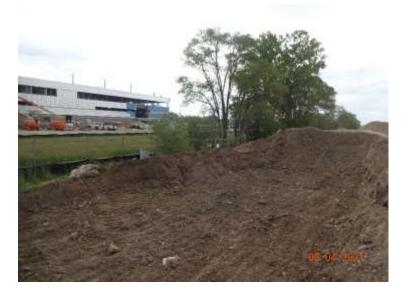
7. Area prepared in screening berm to accept contaminated soils.

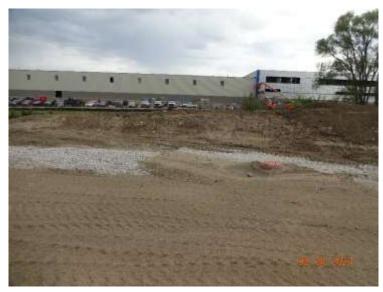
8. Location of prepared area of screening berm viewed from the south.

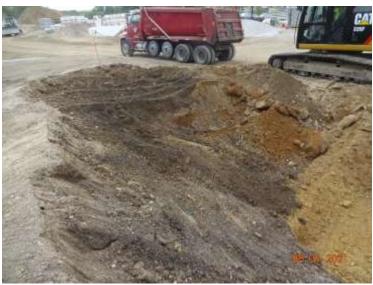
9. Excavation of contaminated soil area in progress.

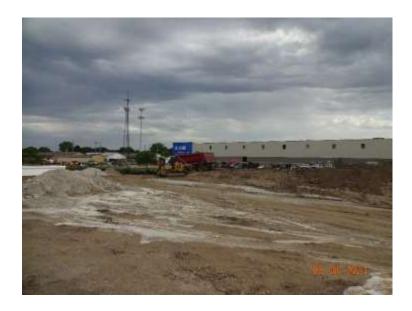
10. First load of contaminated soil being deposited in the screening berm.

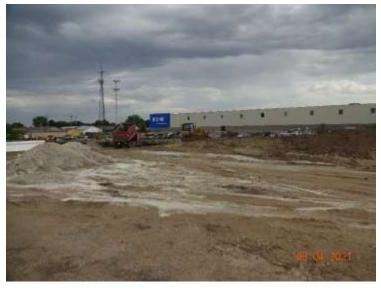
12. Dozer spreading contaminated soil in prepared area of screening berm.

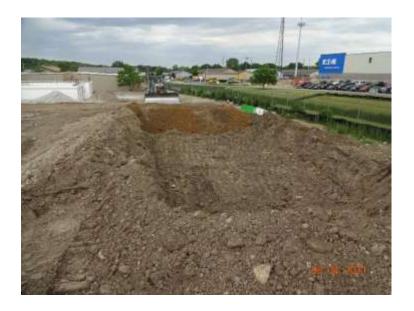
13. First load deposited in screening berm.

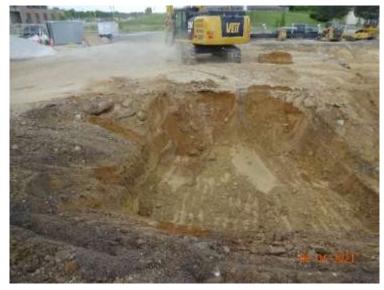
14. Excavation of contaminated soils nearly complete.

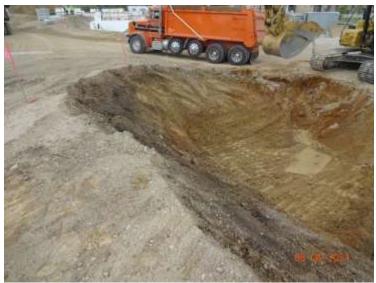
15. Excavation of contaminated soils nearly complete.

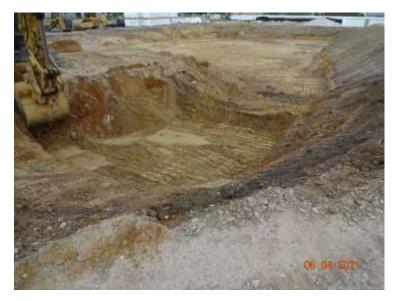
16. Excavation of contaminated soils complete.

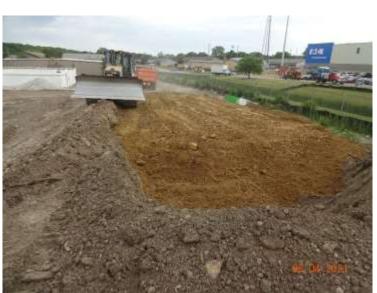
17. Contaminated soils placed in screening berm ready for clean soil cover.
