SUBJECT: Final Case Closure with Continuing Obligations
Busy Bea Dry Cleaners, 1077 Racine Street, Menasha WI
DNR BRRTS Activity #: 02-71-536999

D.3 Former Busy Vapor Mitigation System and Cover Barrier Photographic Record

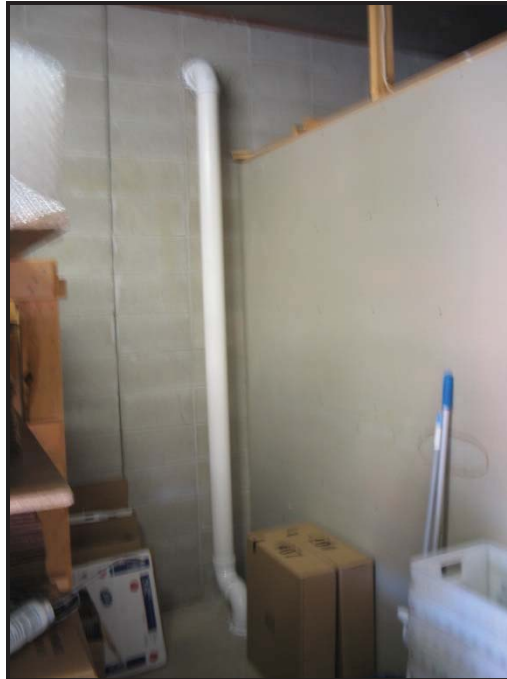
Photo #: 2

View of interior vapor mitigation piping run in the dry cleaner tenant space. Piping proceeds leftward to the northwest corner supply in the tenant space and rightward exit to the exterior fan mechanism.
