SUBJECT: Final Case Closure with Continuing Obligations
Adell Auto Body Shop, 610 Wisconsin Avenue, Village of Adell, WI
DNR BRRTS Activity #: 03-60-537761
DNR FID: 460008560

CAP MAINTENANCE PLAN

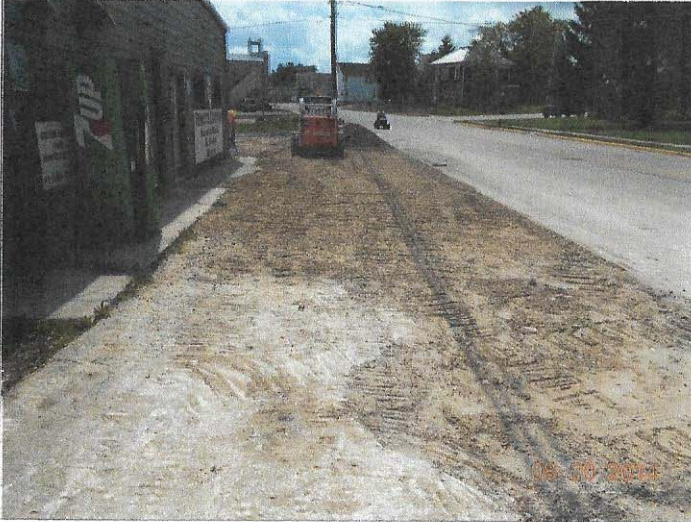
Title: Photo #1: Area of cap to be maintained (west side of on-site building)

The concrete/asphalt/building cap overlying the contaminated soil and groundwater and as depicted in Attachment D.2 will be inspected once a year, normally in the spring after all snow and ice is gone, for deterioration, cracks and other potential problems that can cause exposure to underlying soils or additional infiltration through asphalt or concrete. The inspections will be performed by the property owner or their designated representative. The inspections will be performed to evaluate damage due to settling, exposure to the weather, wear from traffic, increasing age and other factors. Any area where soils have become or are likely to become exposed and where infiltration from the surface will not be effectively minimized will be documented. A log of the inspections and any repairs will be maintained by the property owner and is included as Form 4400-305 Continuing Obligations and Maintenance Log. The log will include recommendations for necessary repair of any areas where underlying soils are exposed and where infiltration from the surface will not be effectively minimized. Once repairs are completed, they will be documented in the inspection log. A copy of the inspection log will be kept at the address of the property owner and available for submittal or inspection by Wisconsin Department of Natural Resources ("WDNR") representatives upon their request.

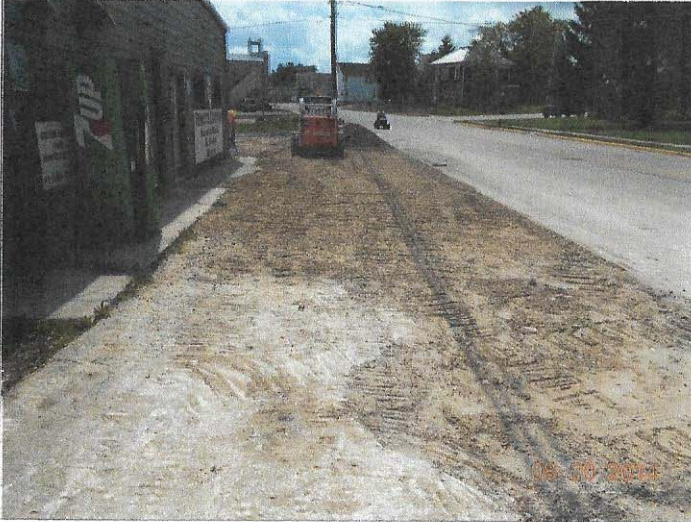
Title: Photo #1: Area of cap to be maintained (west side of on-site building)

The concrete/asphalt/building cap overlying the contaminated soil and groundwater and as depicted in Attachment D.2 will be inspected once a year, normally in the spring after all snow and ice is gone, for deterioration, cracks and other potential problems that can cause exposure to underlying soils or additional infiltration through asphalt or concrete. The inspections will be performed by the property owner or their designated representative. The inspections will be performed to evaluate damage due to settling, exposure to the weather, wear from traffic, increasing age and other factors. Any area where soils have become or are likely to become exposed and where infiltration from the surface will not be effectively minimized will be documented. A log of the inspections and any repairs will be maintained by the property owner and is included as Form 4400-305 Continuing Obligations and Maintenance Log. The log will include recommendations for necessary repair of any areas where underlying soils are exposed and where infiltration from the surface will not be effectively minimized. Once repairs are completed, they will be documented in the inspection log. A copy of the inspection log will be kept at the address of the property owner and available for submittal or inspection by Wisconsin Department of Natural Resources ("WDNR") representatives upon their request.
