Activity (Site) Name One Hour Martinizing	BRRTS No. 02-68-539238
---	----------------------------------

Sub-Slab Depressurization Systems -- Annual O&M Inspection Form

Address: 12527 W. Hampton, Butler
 Property Identification Number: 12527 W. Hampton Temperature (Ambient): 85° °F
 Tenant's Name: Thomas Grimm Temperature (House): _____ °F
 Owner's Name: _____ Barometric Pressure: _____ °Hg
 Owners Address (If Different from Property): _____ Weather Conditions: Sunny
W204 N9126 Lannon Rd. Menomonee Falls, WI 53051
 Inspector Name: Tiffany Ryan / Tom Wentland, DNIC, Thomas Grimm
 Date: 7/12/16
 Time: 10:00 a.m.

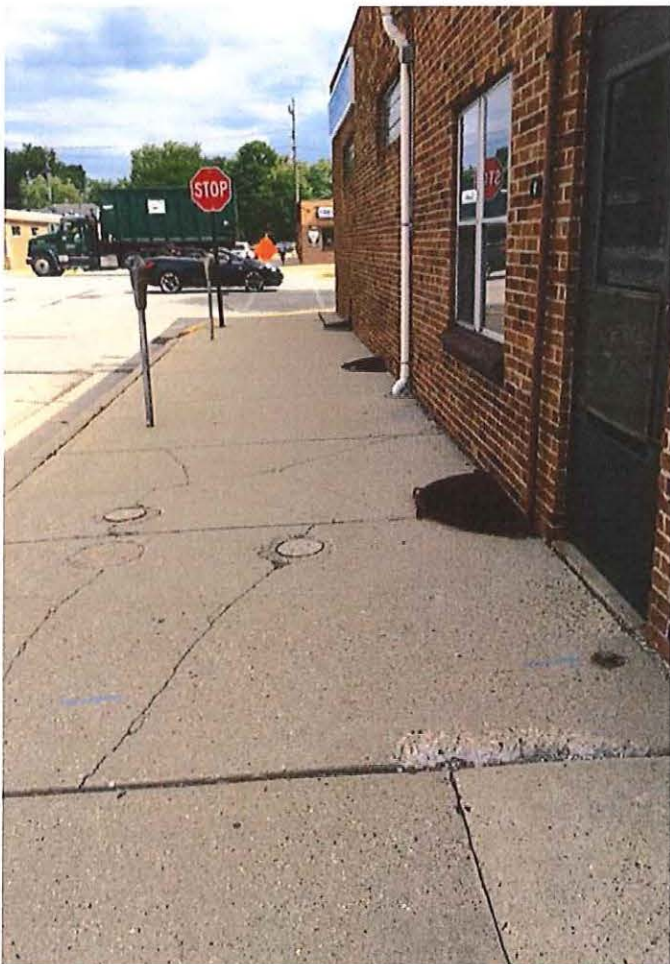
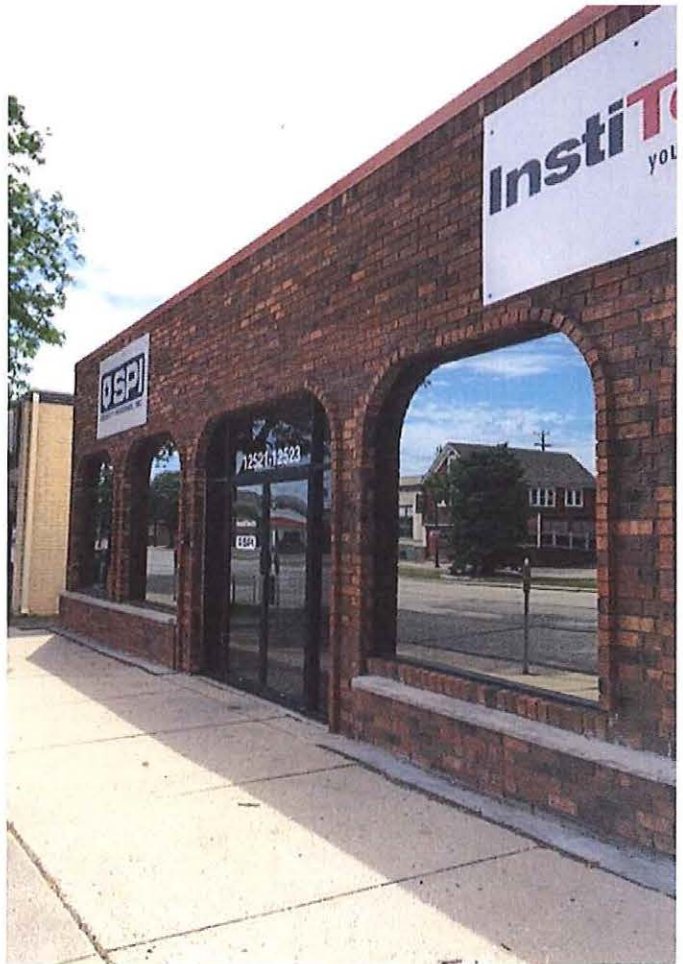
Sample Point ID	Minimum Vacuum (in w.c.)	Inspection			Post Repair (If Necessary)		
		Date	Time	Pressure (in w.c.)	Date	Time	Pressure (in w.c.)
Manometer - Q1	0.50	7/12/16	10:00am	.75			
Manometer - Q2	0.50						
Manometer - Q3	0.50						
Manometer - Q4	0.50

Repair should be made to exterior opening to grade at sidewalk.
