SUBJECT: Final Case Closure with Continuing Obligations
Kipp's Auto & Towing Service, 5507 W Hampton Ave, Milwaukee, WI
DNR BRRTS Activity #: 03-41-543343
FID #: 241199530 PECFA # 53218-5041-07-A

B.2.b. RESIDUAL SOIL CONTAMINATION
KIPP'S AUTO & TOWING SERVICE

B.3.a. GEOLOGIC CROSS-SECTION FIGURE
KIPP'S AUTO & TOWING SERVICE

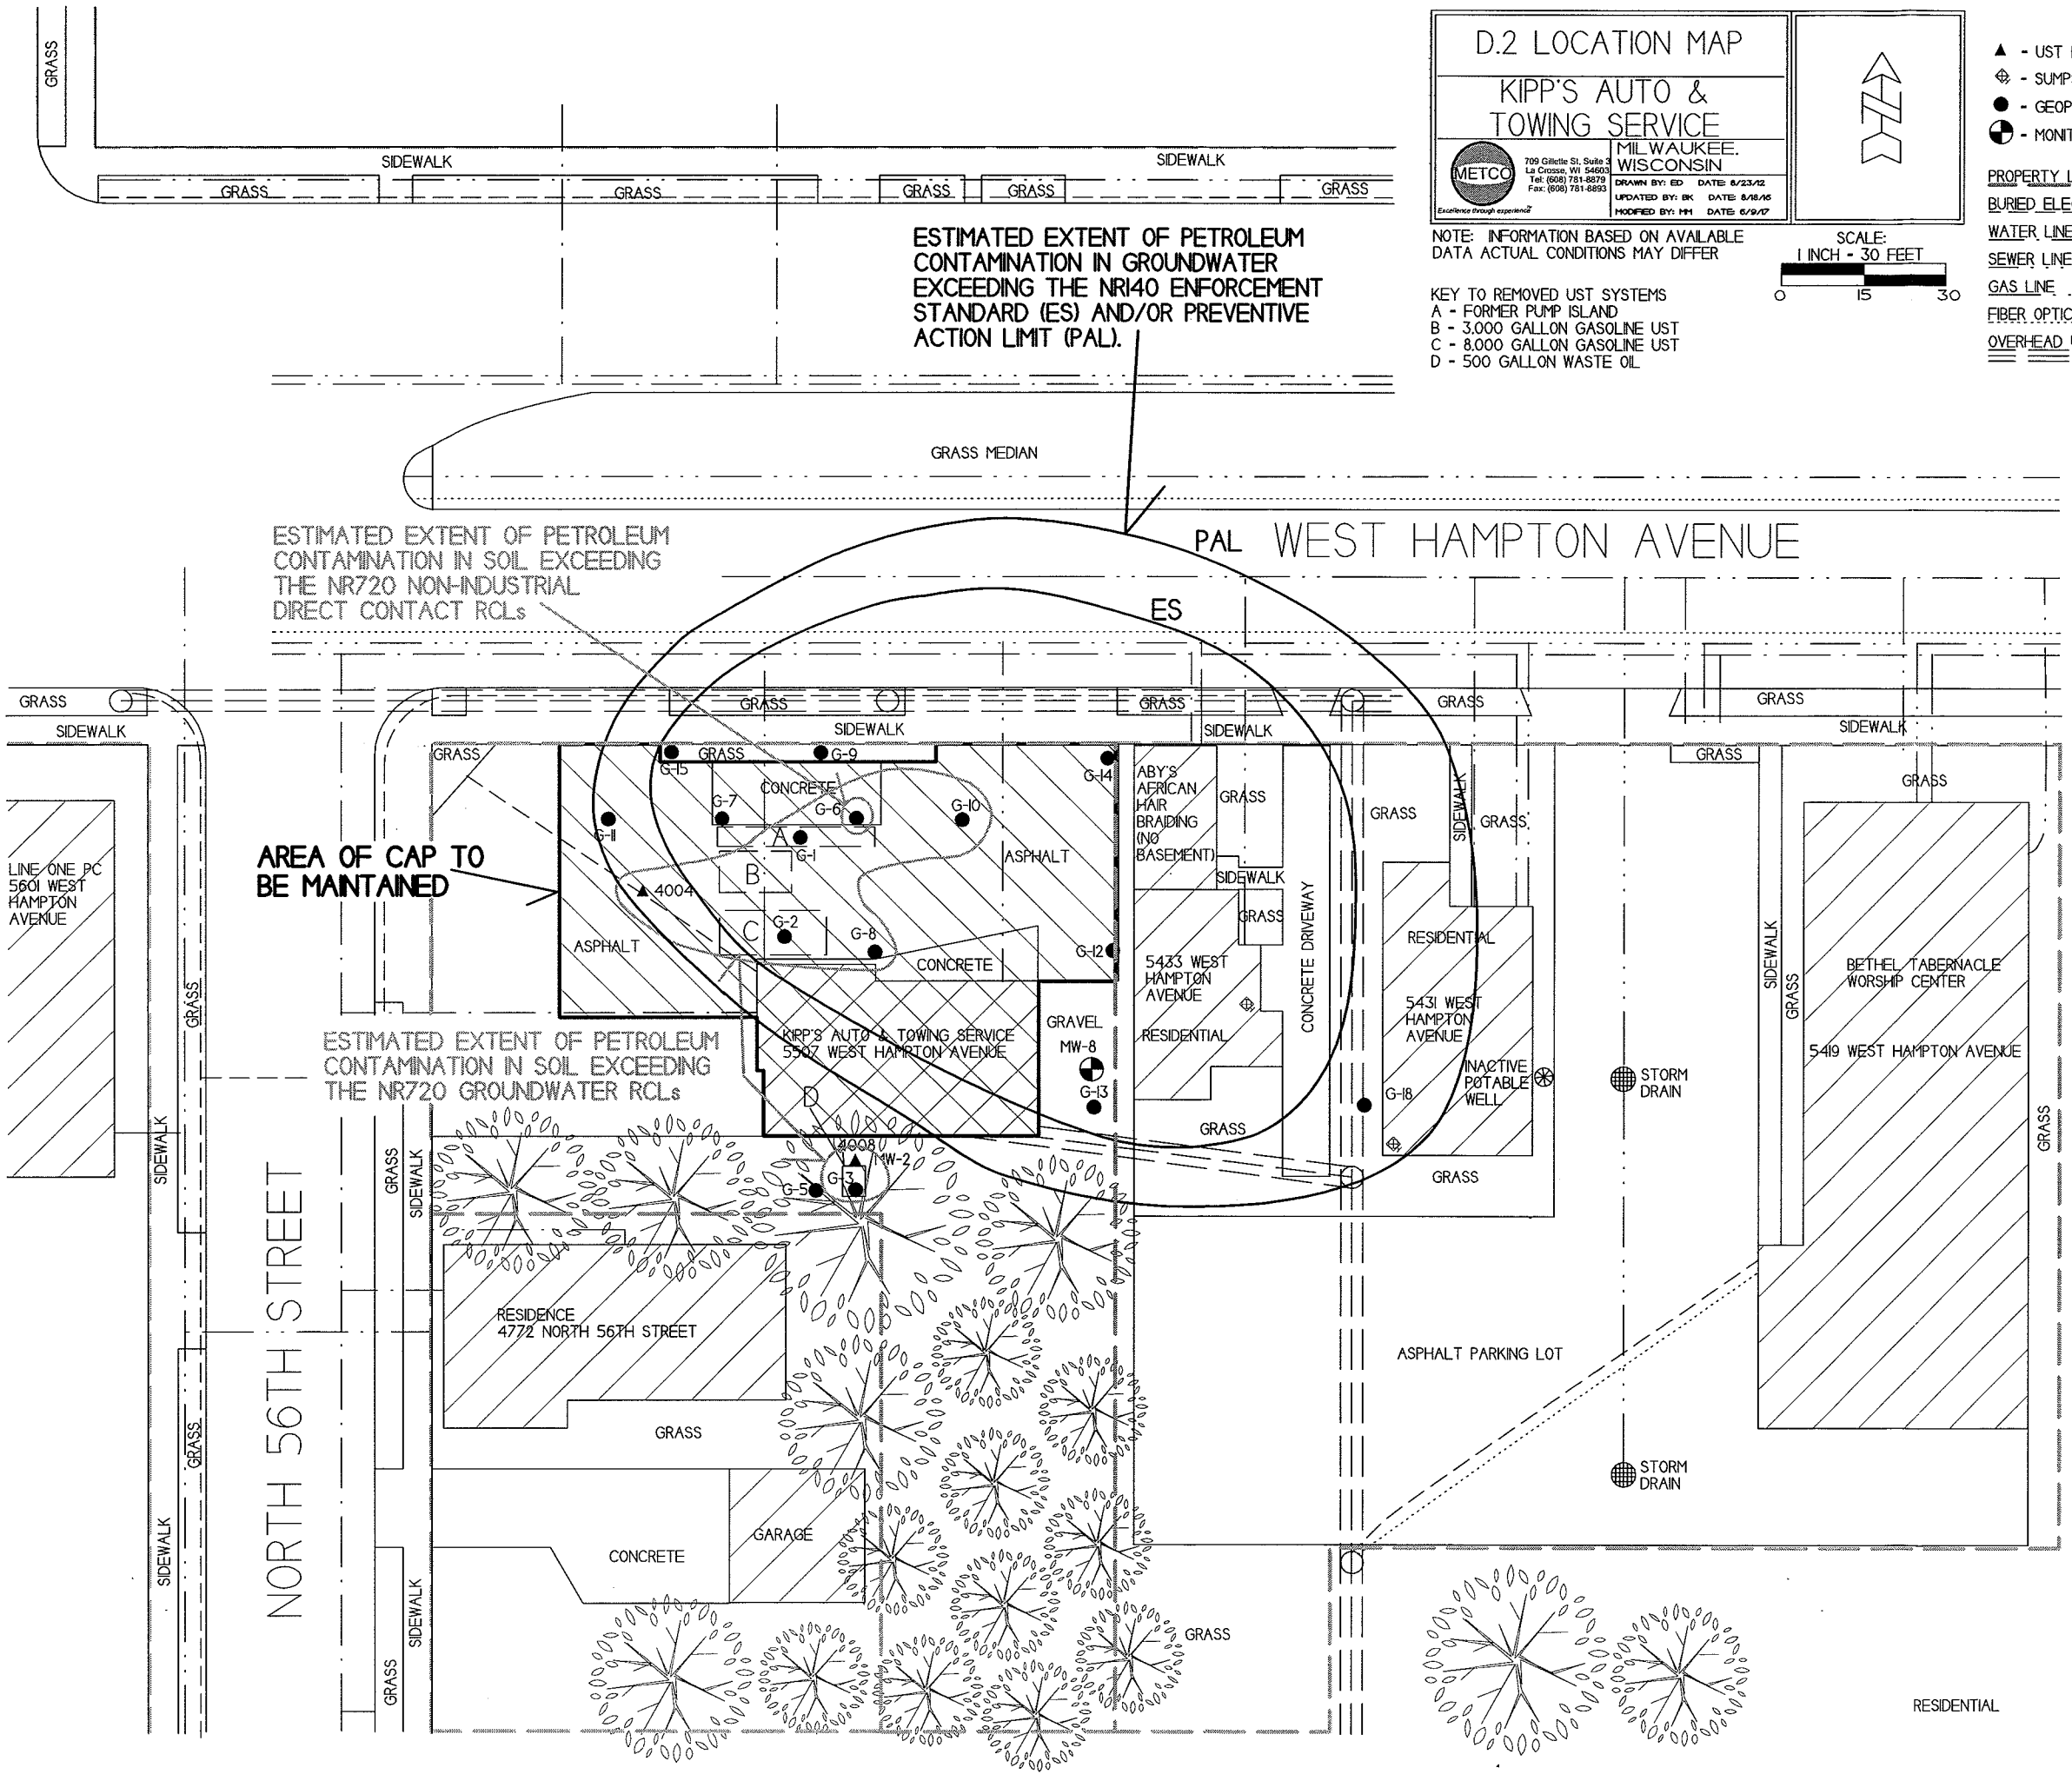
- KEY TO REMOVED UST SYSTEMS
- A - FORMER PUMP ISLAND
 - B - 3,000 GALLON GASOLINE UST
 - C - 8,000 GALLON GASOLINE UST
 - D - 500 GALLON WASTE OIL

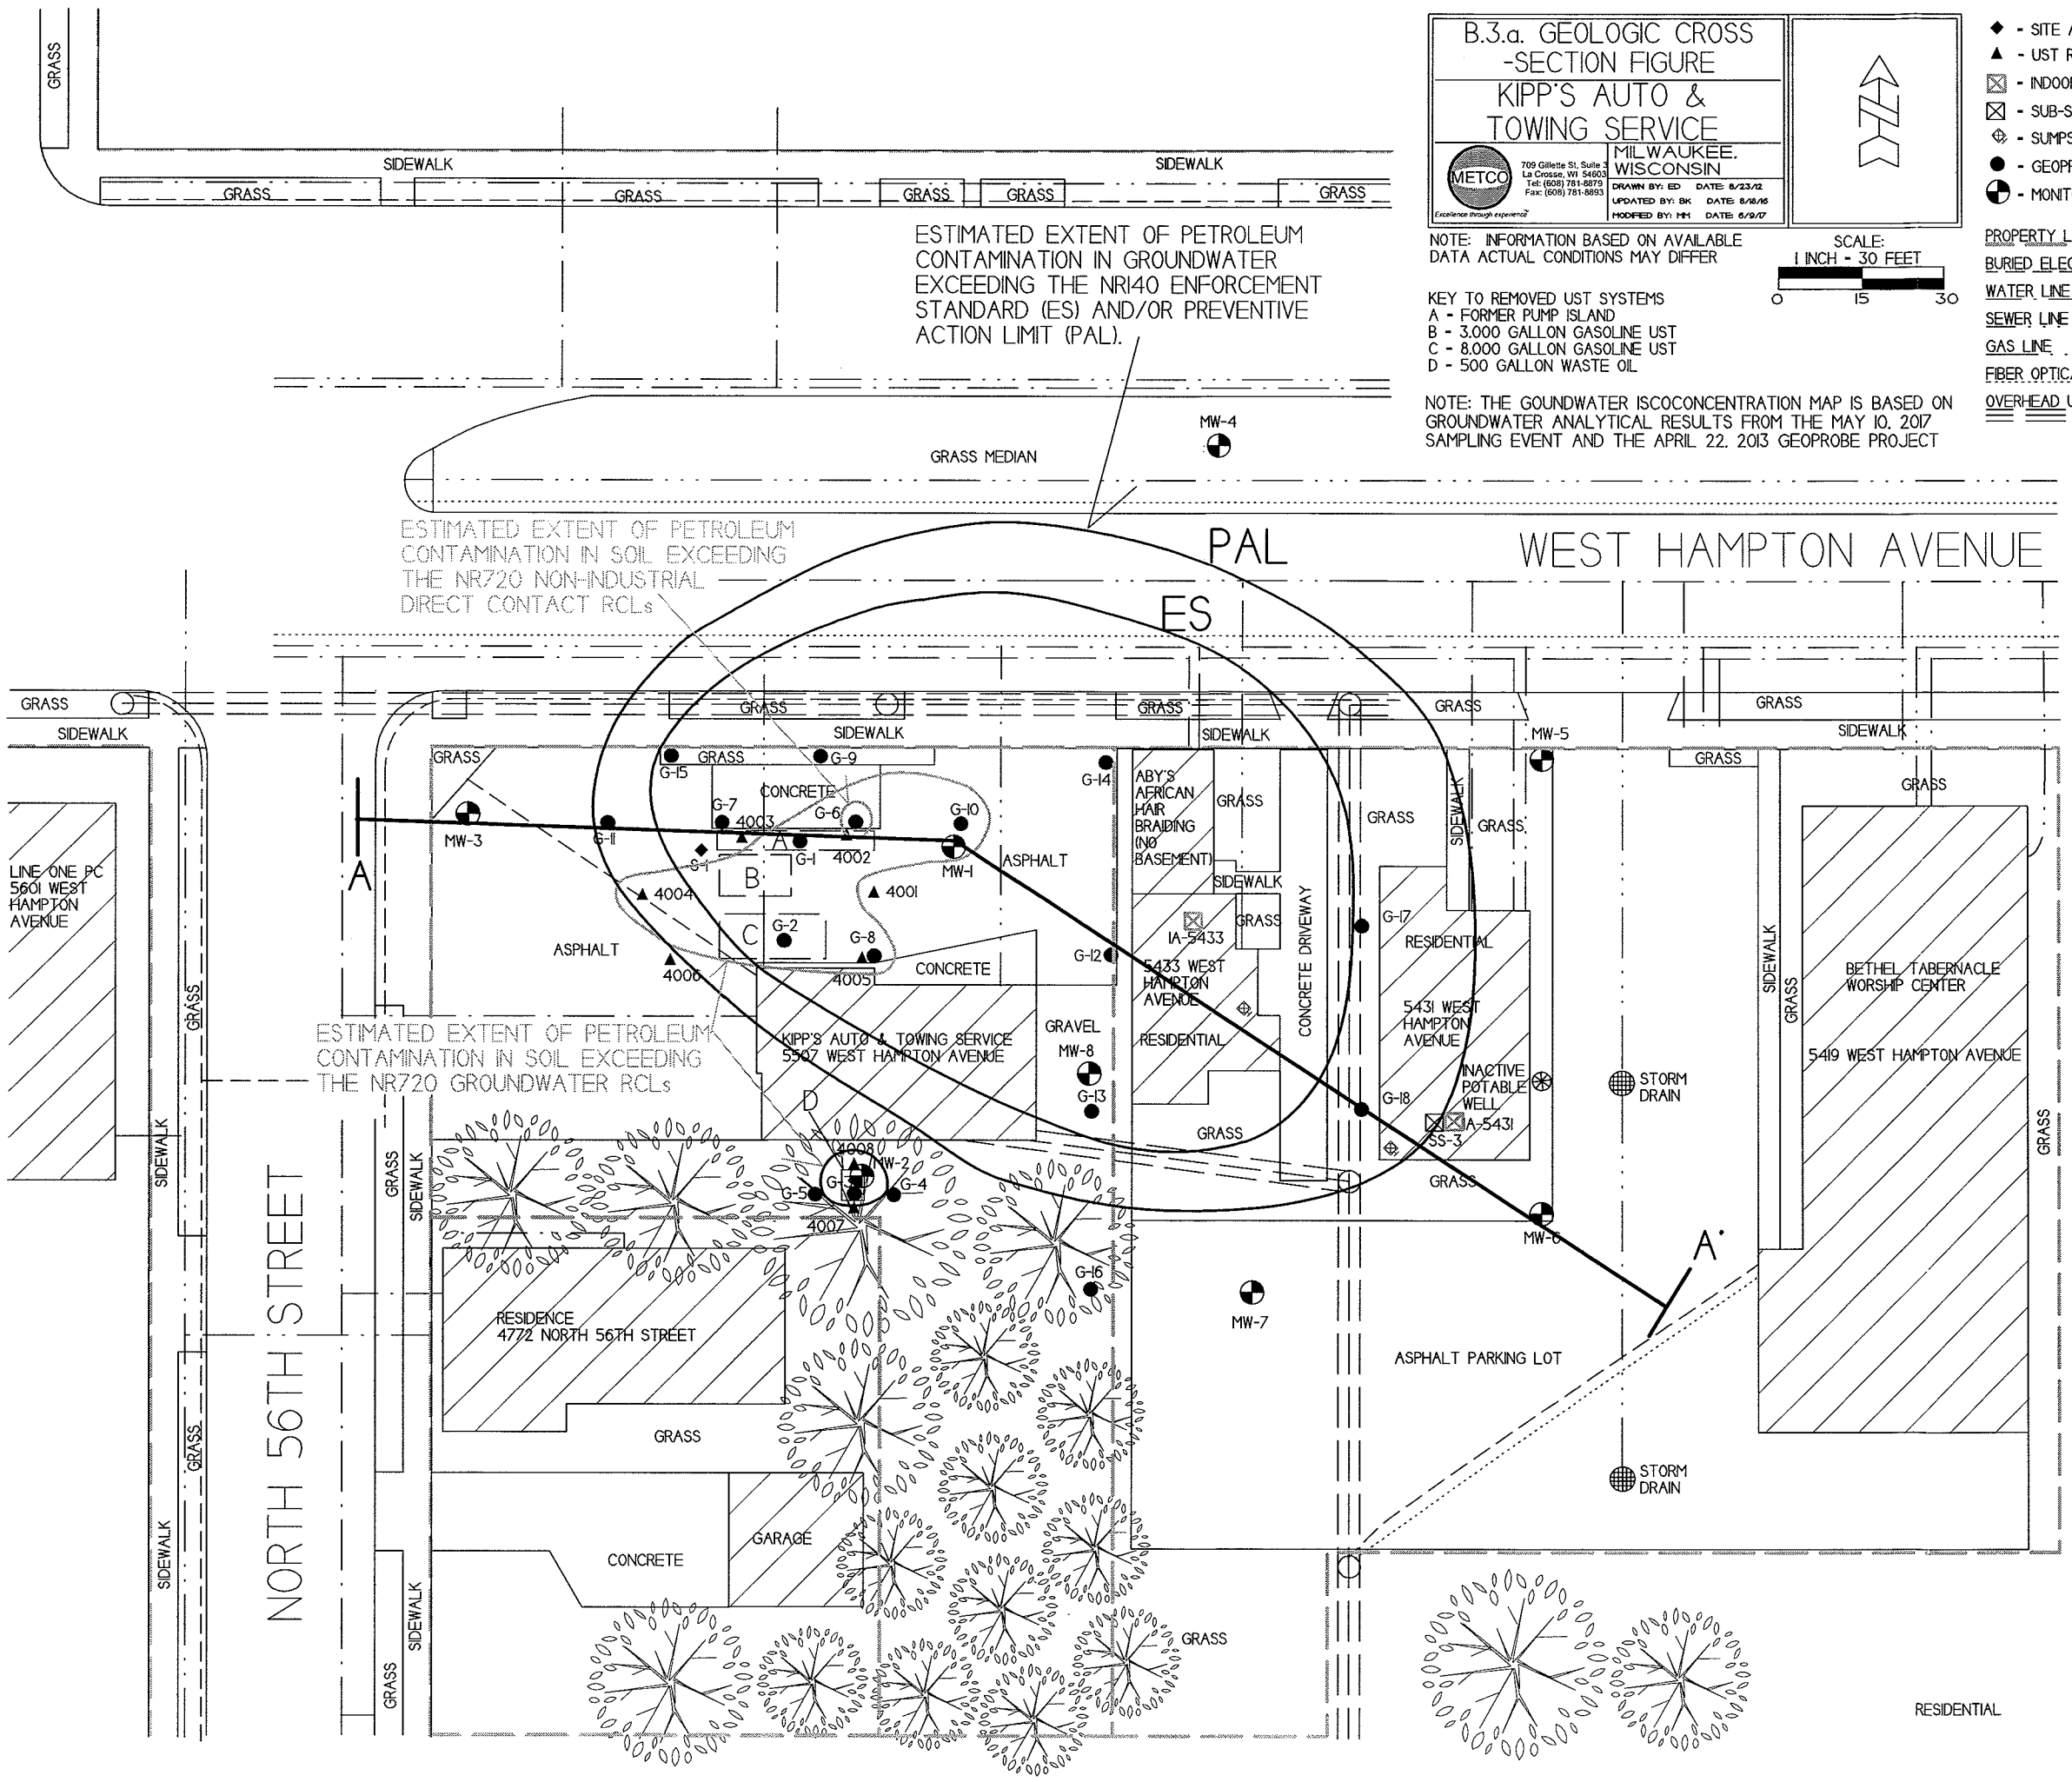
NOTE: THE GROUNDWATER ISOCOCONCENTRATION MAP IS BASED ON GROUNDWATER ANALYTICAL RESULTS FROM THE MAY 10, 2017 SAMPLING EVENT AND THE APRIL 22, 2013 GEOPROBE PROJECT

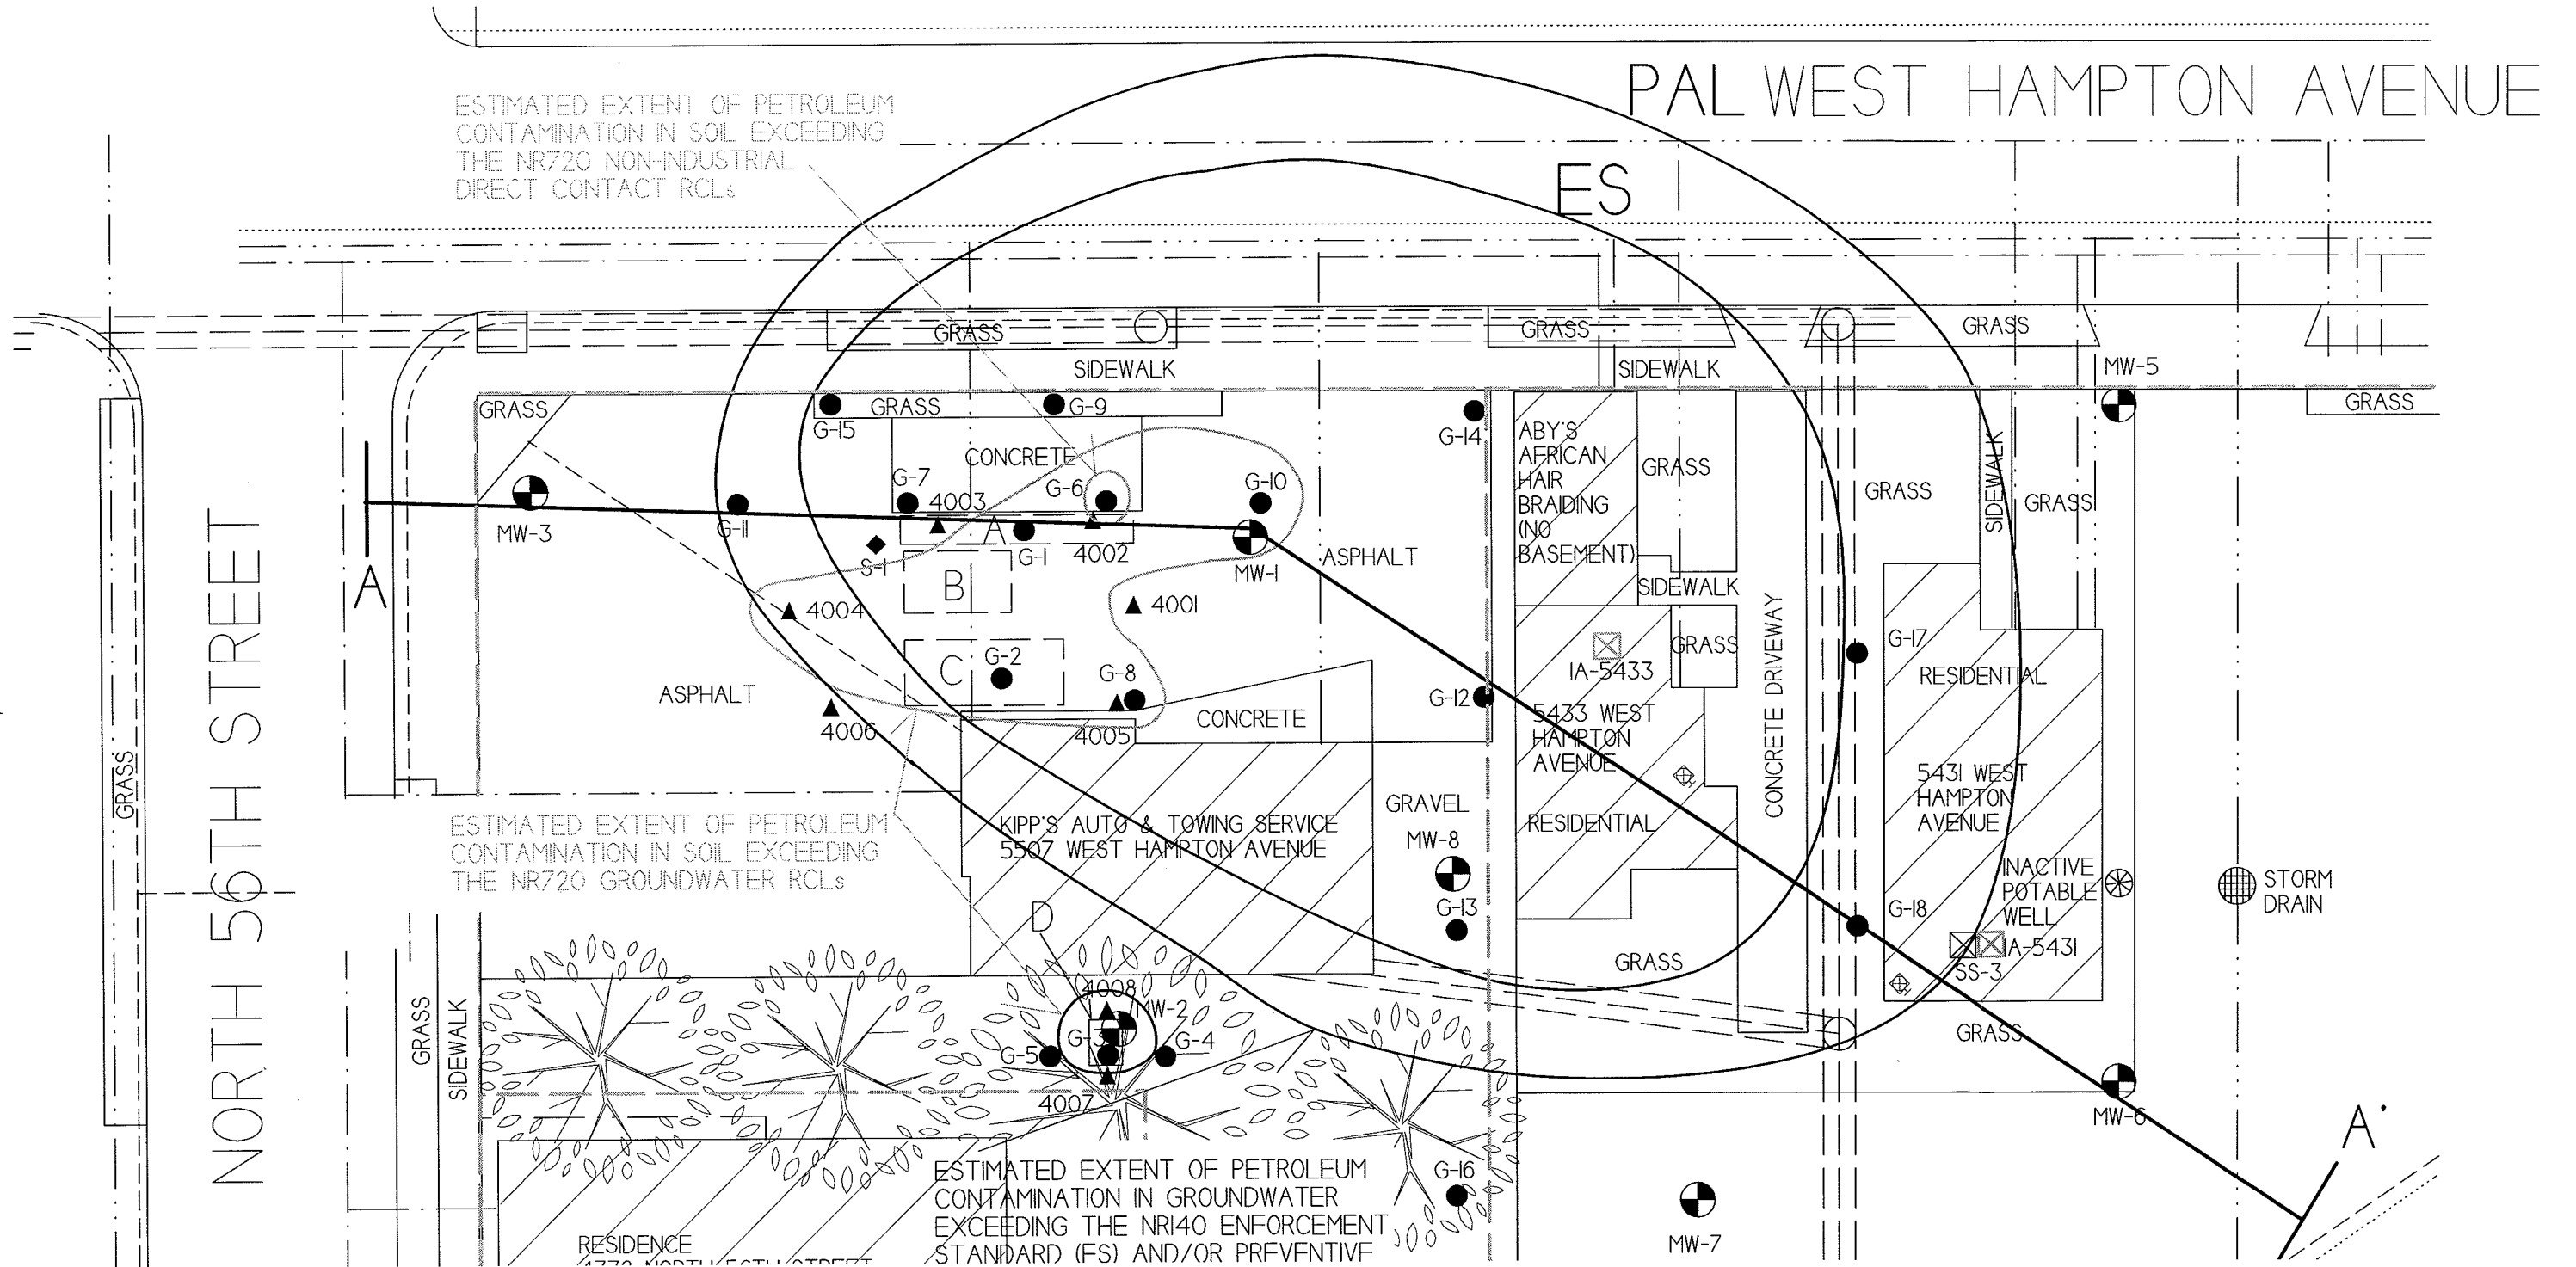
B.3.a.3 GEOLOGIC CROSS SECTION FIGURE

- TAN SAND AND PEA GRAVEL (FILL MATERIAL)
- TAN TO GRAY TO GREEN TO BROWN SANDY CLAY TO CLAY
- TAN TO GRAY TO GREEN TO BROWN SANDY CLAY TO CLAY WITH GRAVEL
- TAN TO GRAY CLAY

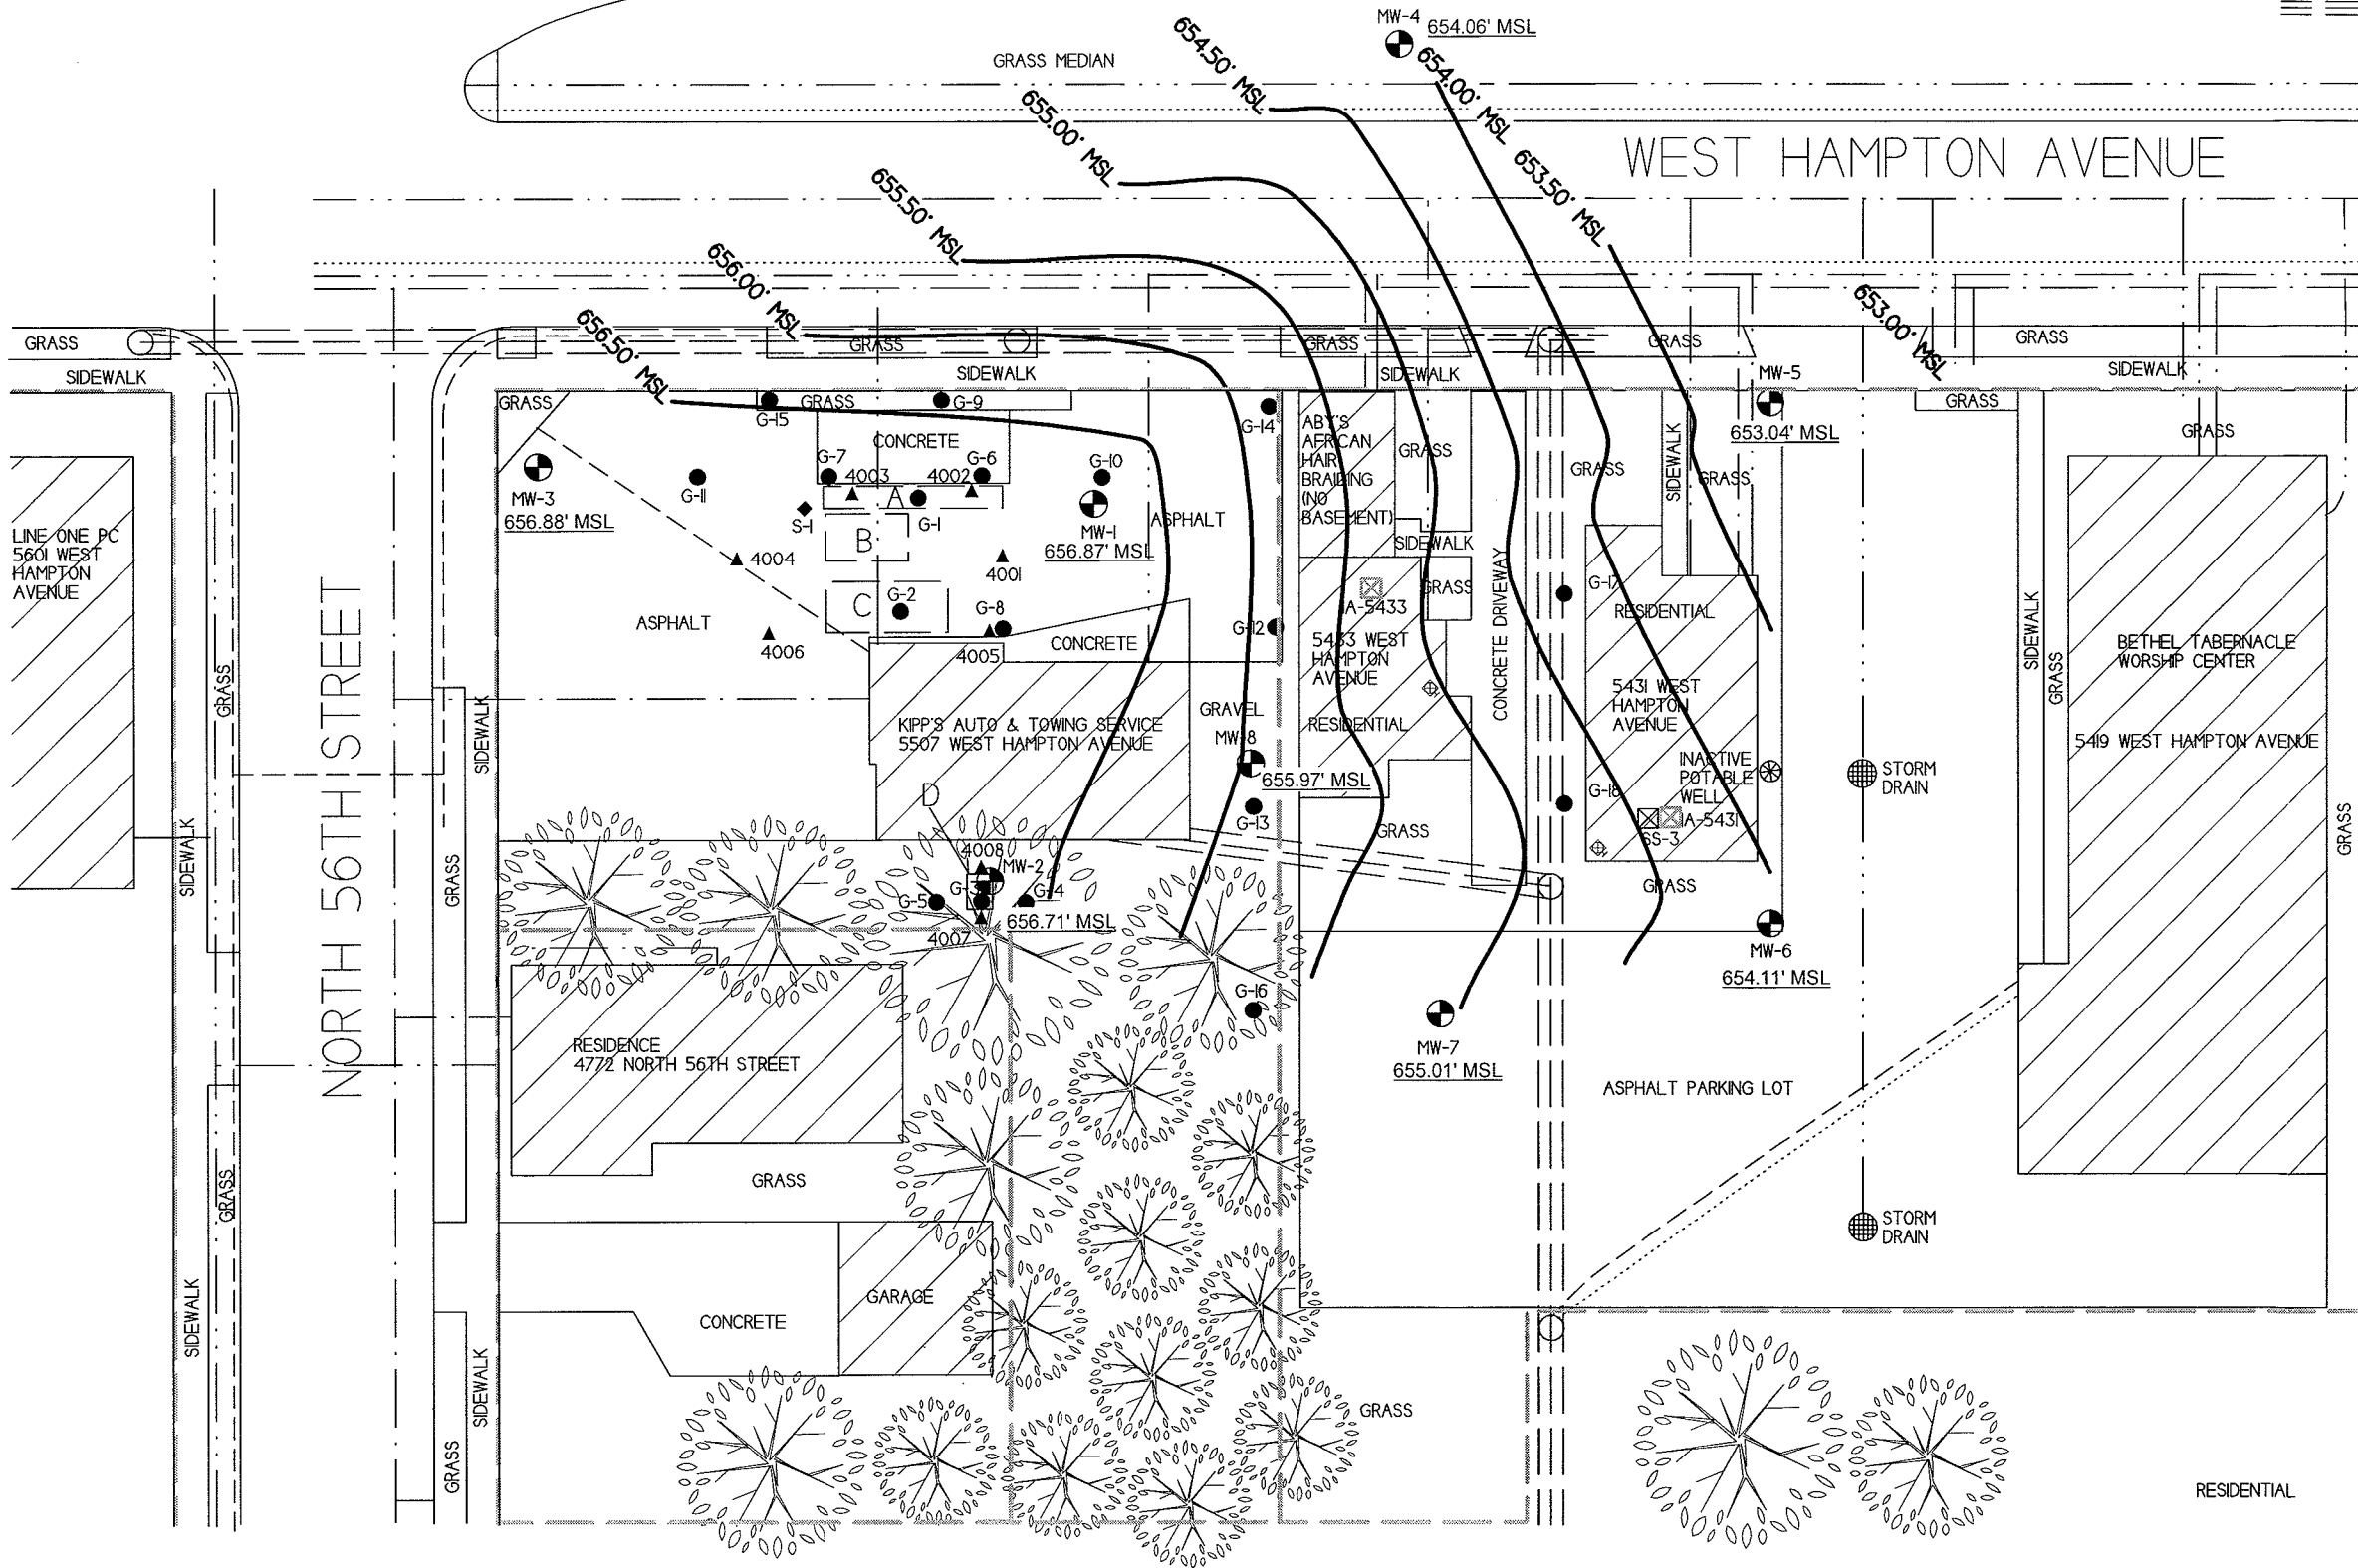
NOTES:
 1) THE GROUNDWATER FLOW DIRECTION MAP IS BASED ON GROUNDWATER ELEVATION DATA COLLECTED DURING THE MAY 10, 2017 SAMPLING EVENT.
 2) ELEVATION DATA IS PRESENTED IN FEET MEAN SEA LEVEL (MSL).

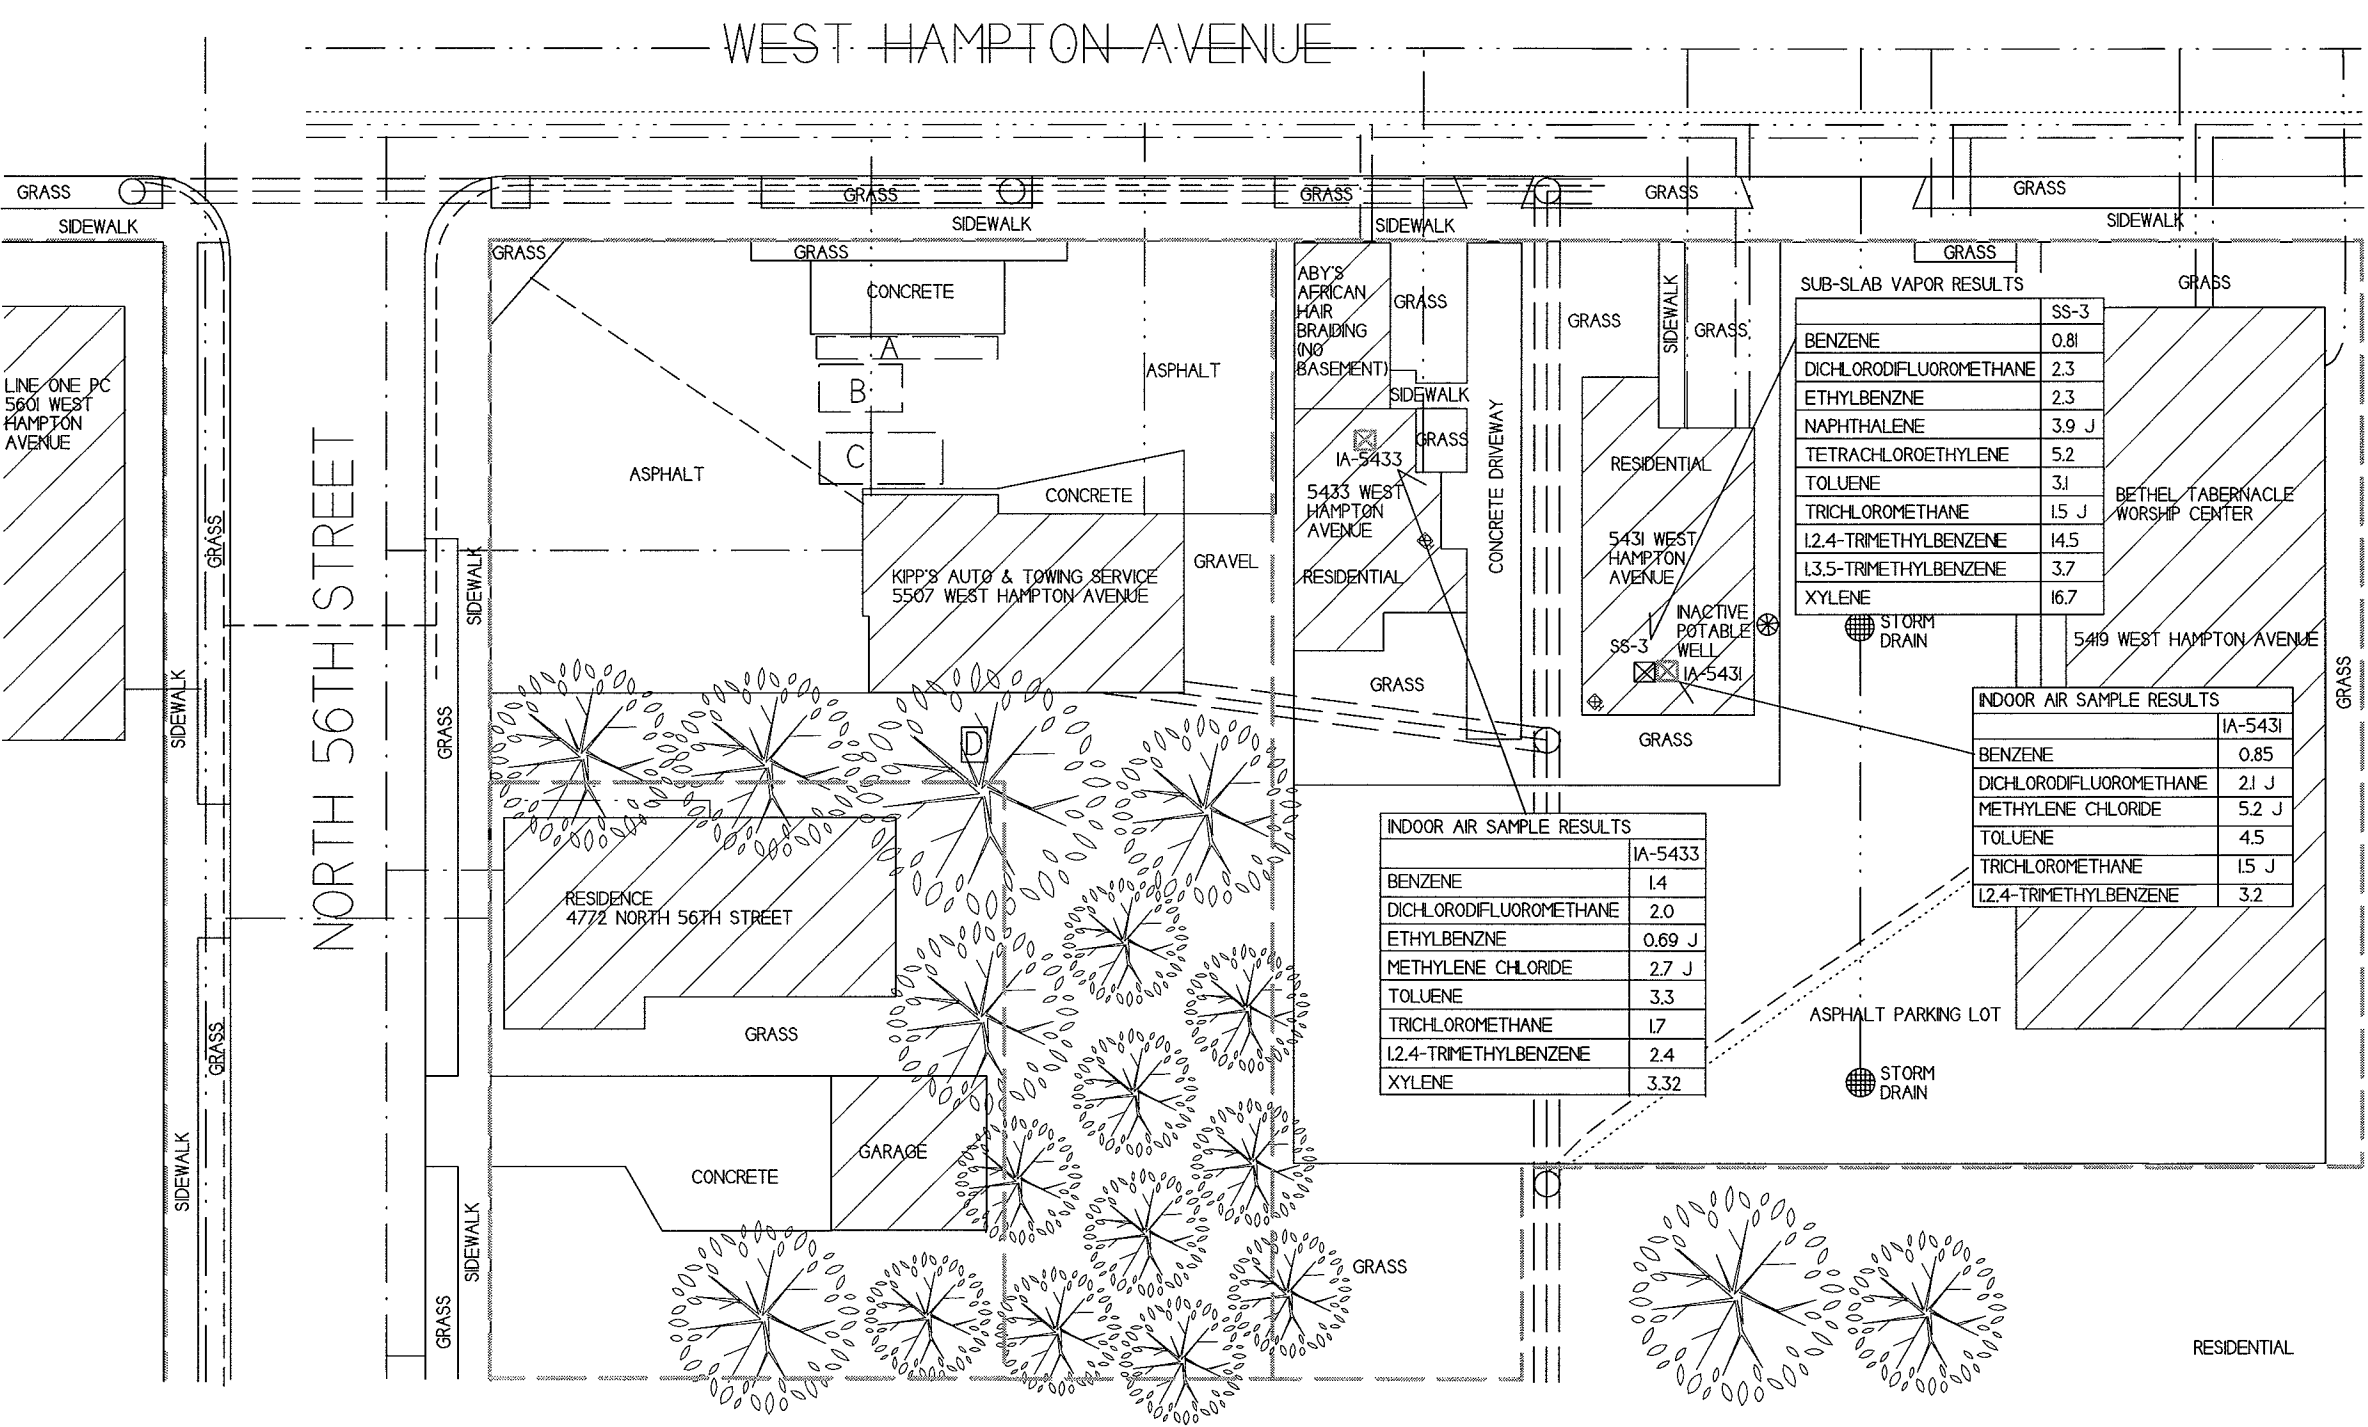
B.4.a. VAPOR INTRUSION MAP
KIPP'S AUTO & TOWING SERVICE

SUB-SLAB VAPOR RESULTS

SS-3
BENZENE	0.81
DICHLORODIFLUOROMETHANE	2.3
ETHYLBENZENE	2.3
NAPHTHALENE	3.9 J
TETRACHLOROETHYLENE	5.2
TOLUENE	3.1
TRICHLOROMETHANE	1.5 J
1,2,4-TRIMETHYLBENZENE	14.5
1,3,5-TRIMETHYLBENZENE	3.7
XYLENE	16.7

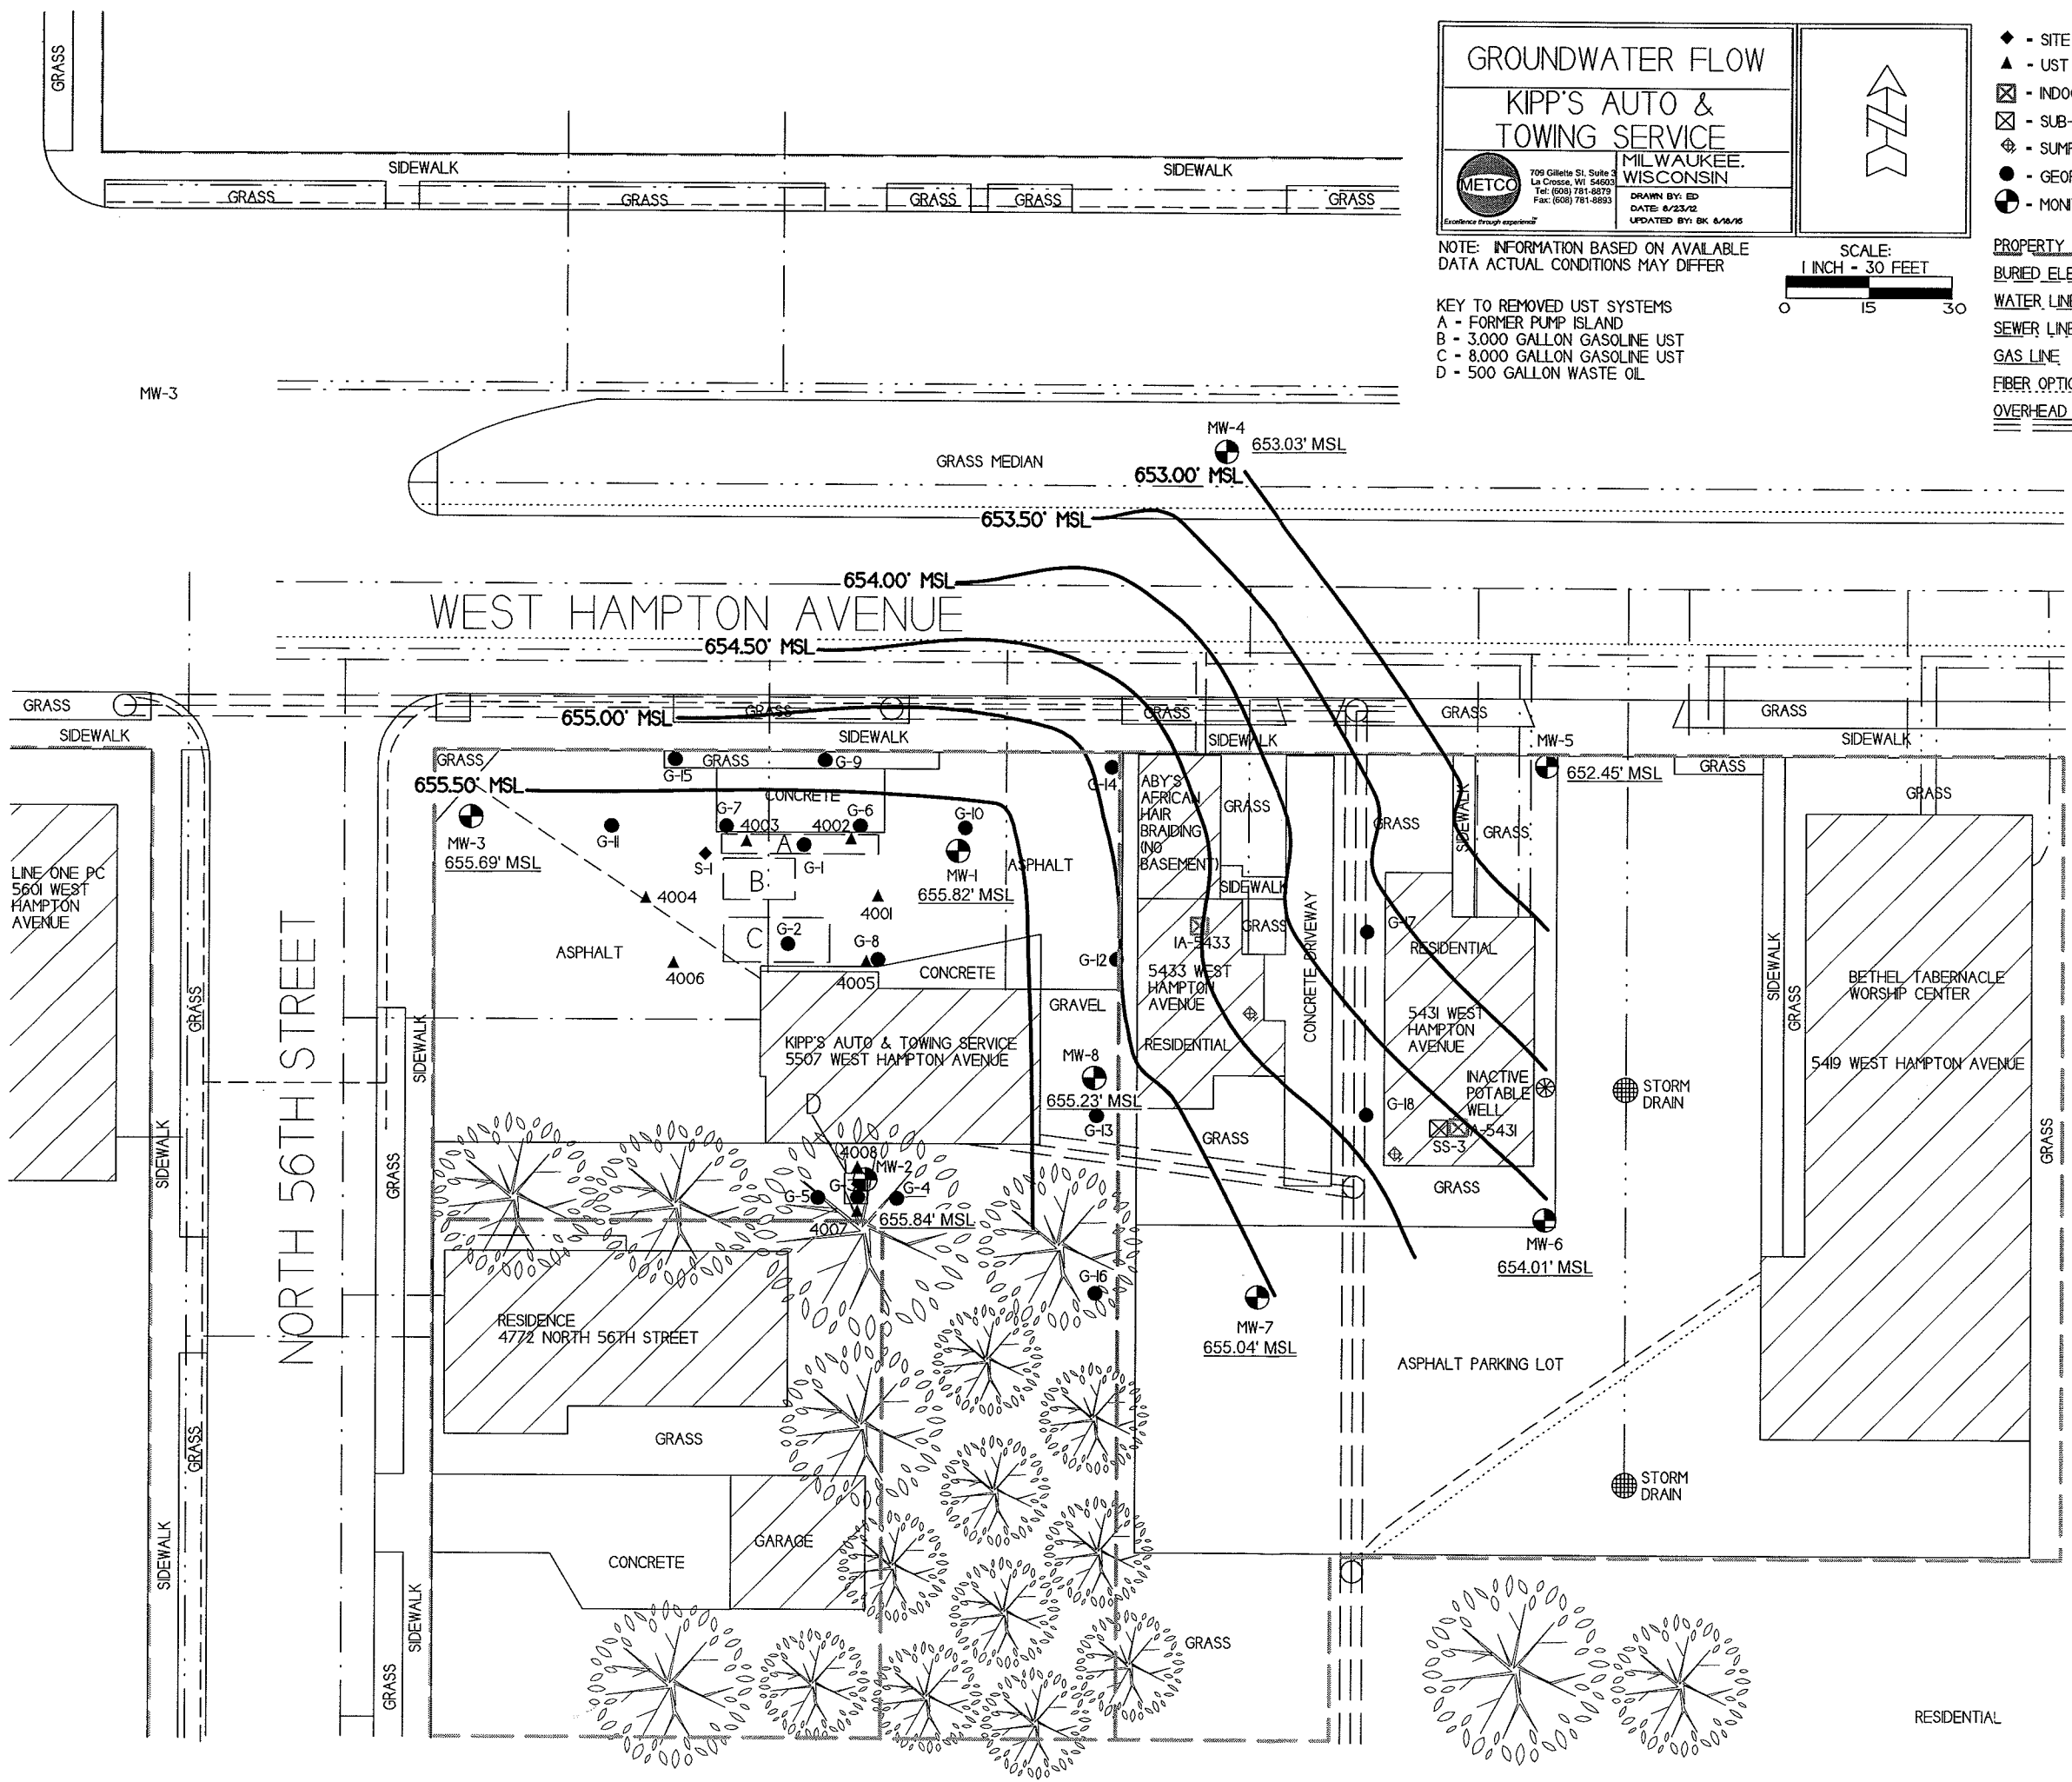
- 1) THE GROUNDWATER FLOW DIRECTION MAP IS BASED ON GROUNDWATER ELEVATION DATA COLLECTED DURING THE FEBRUARY 16, 2017 SAMPLING EVENT.
- 2) ELEVATION DATA IS PRESENTED IN FEET MEAN SEA LEVEL (MSL).
