SUBJECT: Final Case Closure with Continuing Obligations
Kipp's Auto & Towing Service, 5507 W Hampton Ave, Milwaukee, WI
DNR BRRTS Activity #: 03-41-543343
FID #: 241199530 PECFA # 53218-5041-07-A

B.2.b. RESIDUAL SOIL CONTAMINATION
KIPP'S AUTO & TOWING SERVICE

B.3.a. GEOLOGIC CROSS-SECTION FIGURE
KIPP'S AUTO & TOWING SERVICE

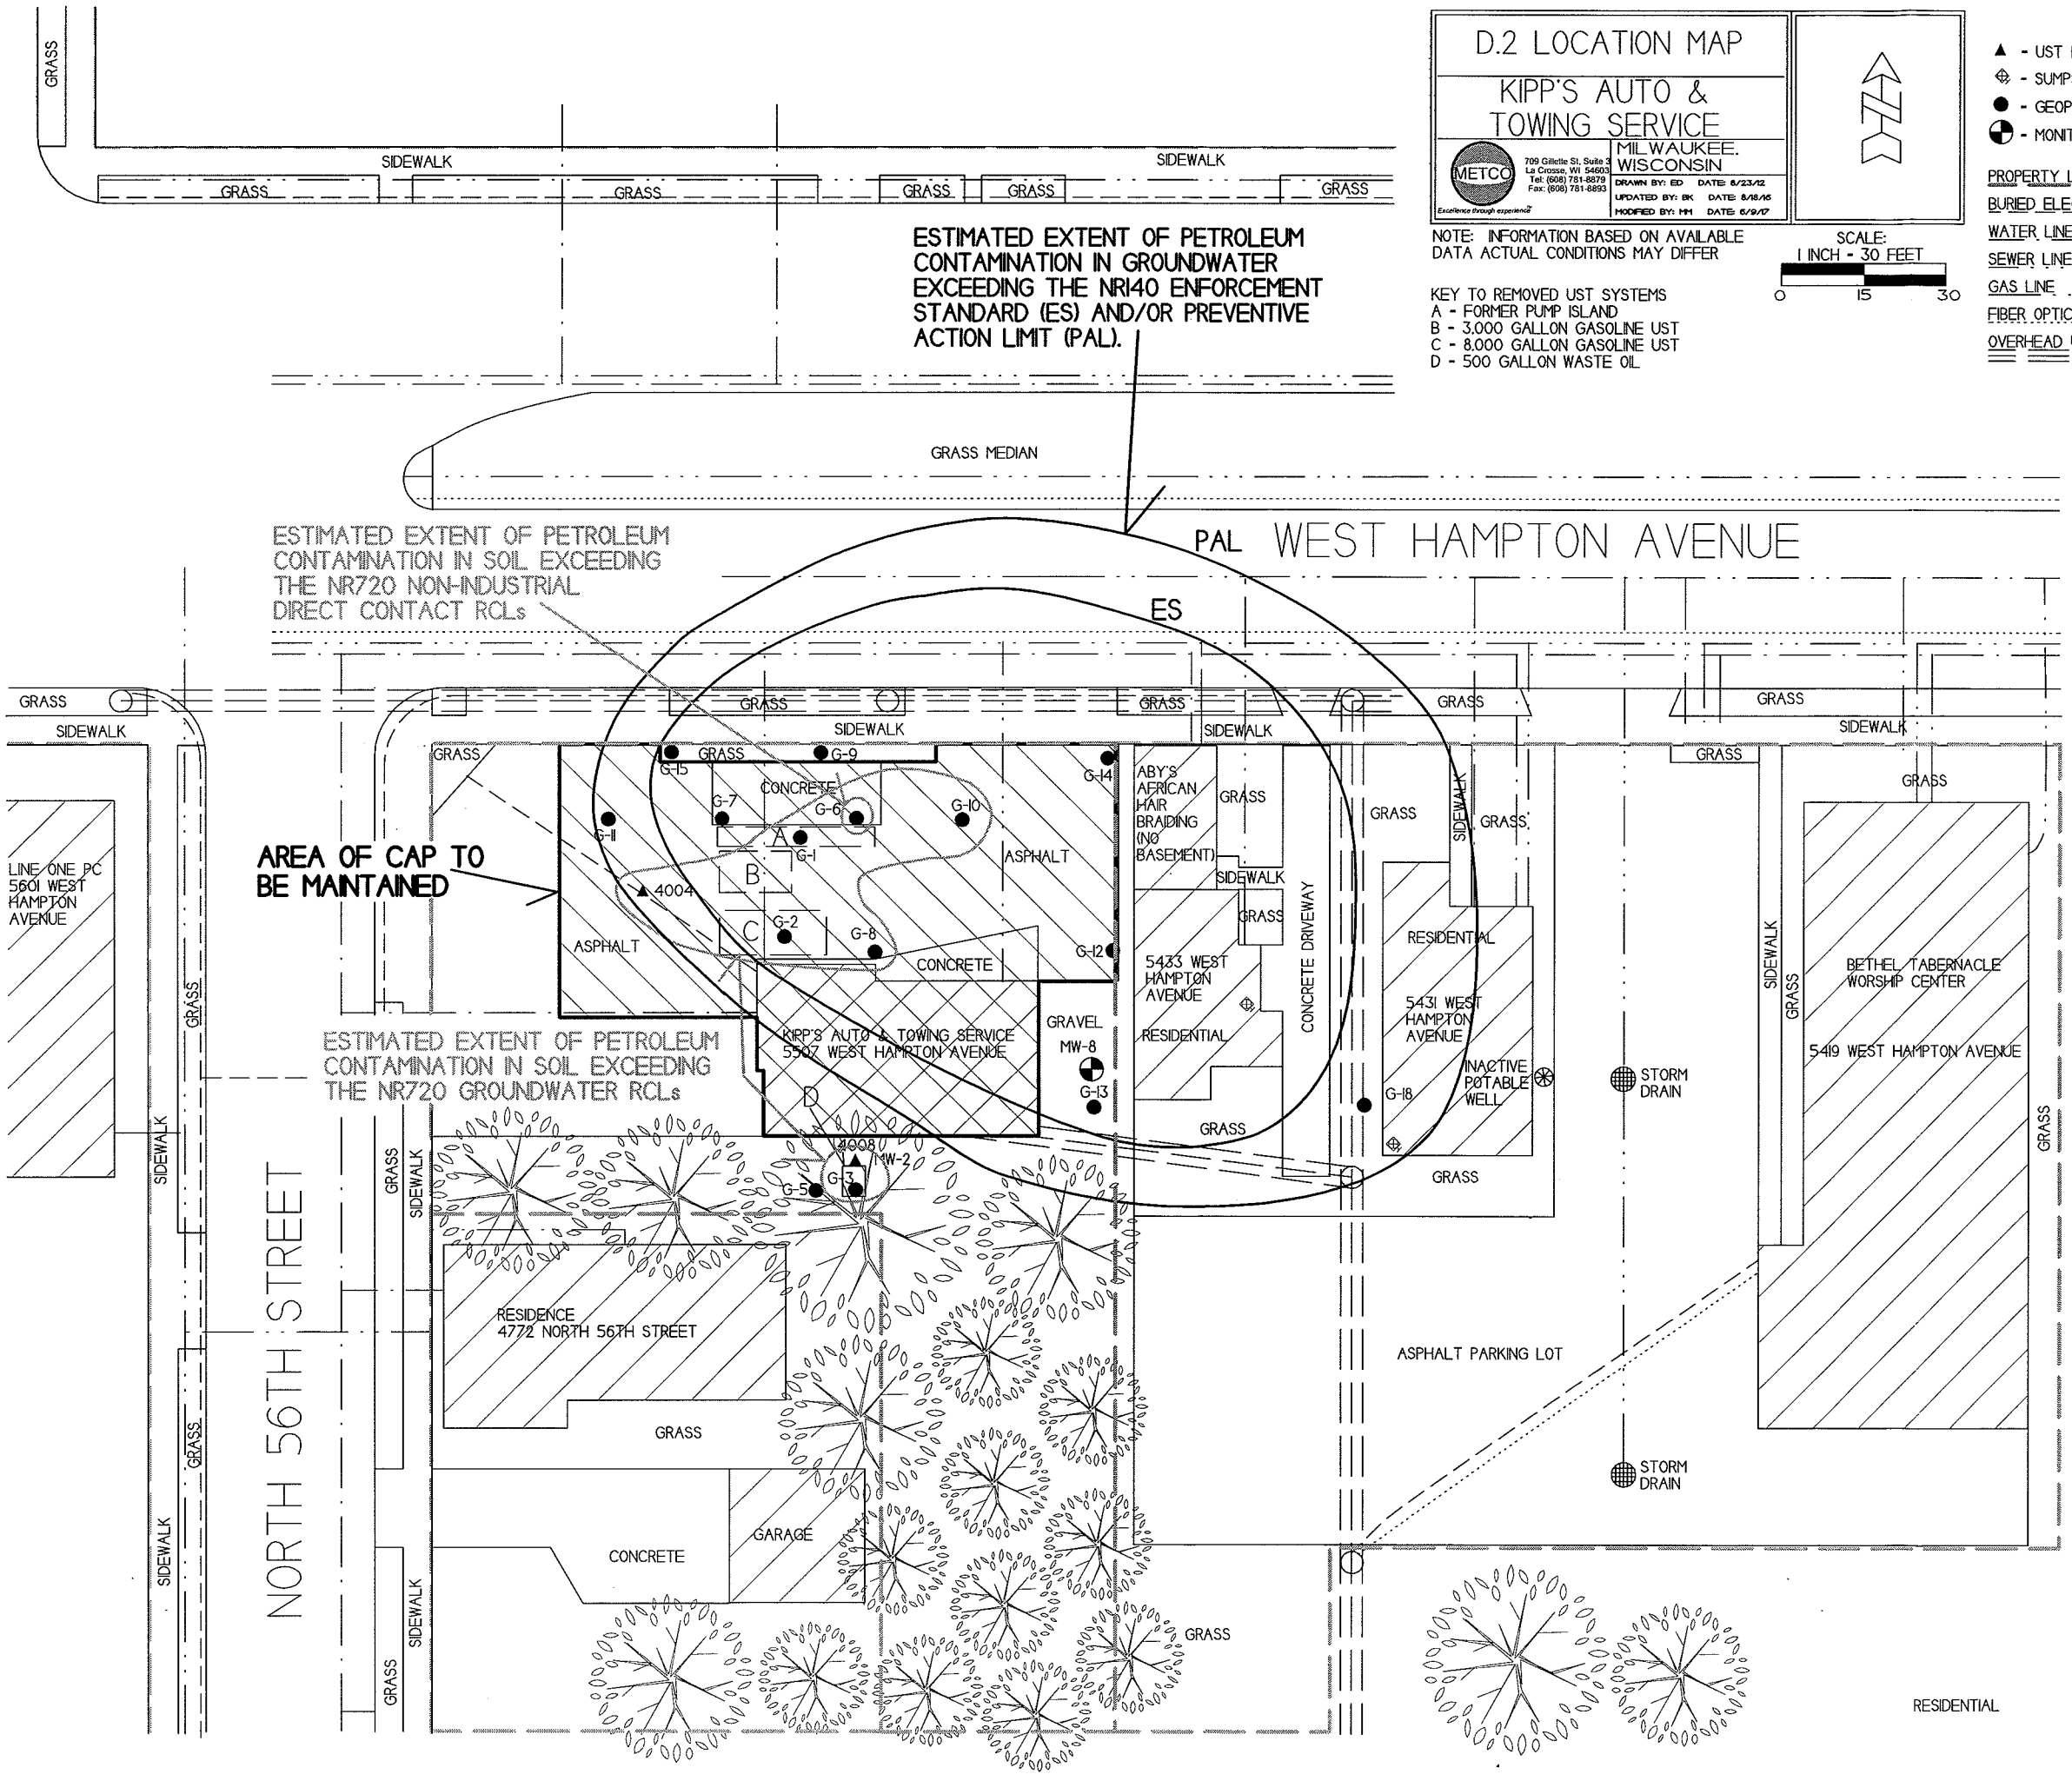
The pavement cover that exists in the location shown on the attached map Figure D.2 Location Map, dated June 9, 2017 shall be maintained in compliance with the attached maintenance plan in order to minimize the infiltration of water and prevent additional groundwater contamination that would violate the groundwater quality standards in ch. NR 140, Wis. Adm. Code, and to prevent direct contact with residual soil contamination that might otherwise pose a threat to human health.

The cap/barrier consists of the asphalt (2-3 inches thick), concrete (4 inches thick), and the foundation of the on-site building (6 inches thick) covering the area of soil contamination and groundwater contamination, as shown on Attachment D.2.

The asphalt, concrete, and foundation cap/barrier overlying the contaminated soil and groundwater, as depicted in Attachment D.2, will be inspected once a year, normally in the spring after all snow and ice is gone, for deterioration and other potential problems that can cause additional infiltration into or exposure to underlying soils. The inspections will be performed by the property owner or their designated representative. The inspections will be performed to evaluate damage due to settling, exposure to the weather, wear from traffic, increasing age and other factors. Any area where soils have become or are likely to become exposed or where infiltration from the surface will not be effectively minimized will be documented.

If problems are noted during the annual inspections or at any other time during the year, repairs will be scheduled as soon as practical. Repairs can include patching and filling or larger resurfacing or construction operations. In the event that necessary maintenance activities expose the underlying soil, the owner must inform maintenance workers of the direct contact exposure hazard and provide them with appropriate personal protection equipment ("PPE"). The owner must also sample any soil that is excavated from the site prior to disposal to ascertain if contamination remains. The soil must be treated, stored and disposed of by the owner in accordance with applicable local, state and federal law.

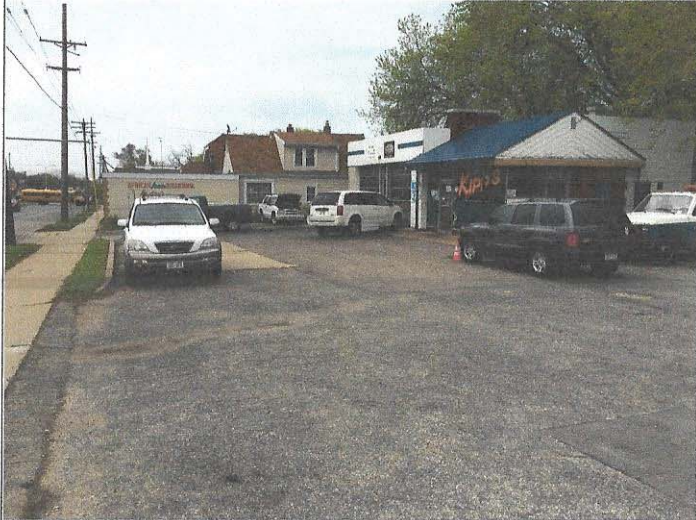
Title: Area of Cap to be Maintained, looking east.

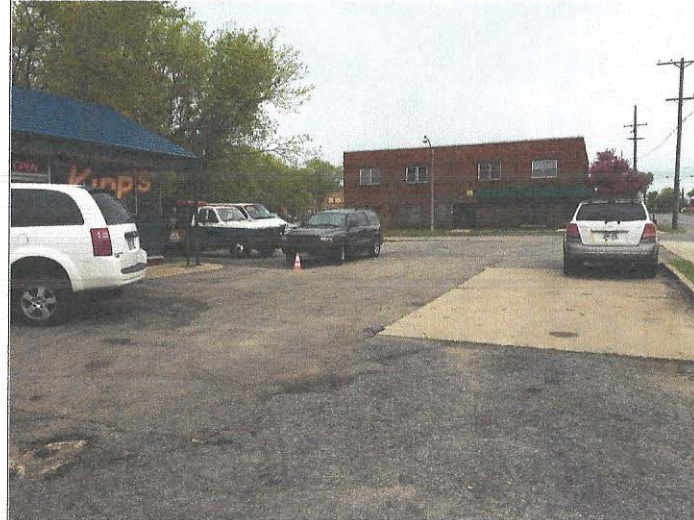
Title: Area of Cap to be Maintained, looking west.

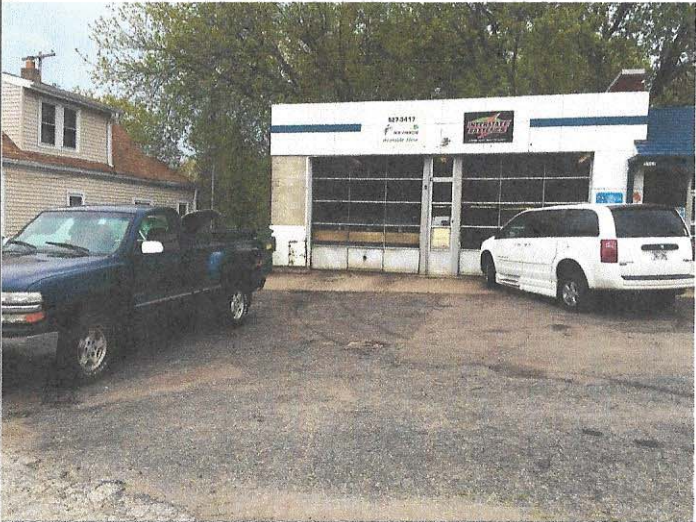
Title: Area of Cap to be Maintained, looking south.

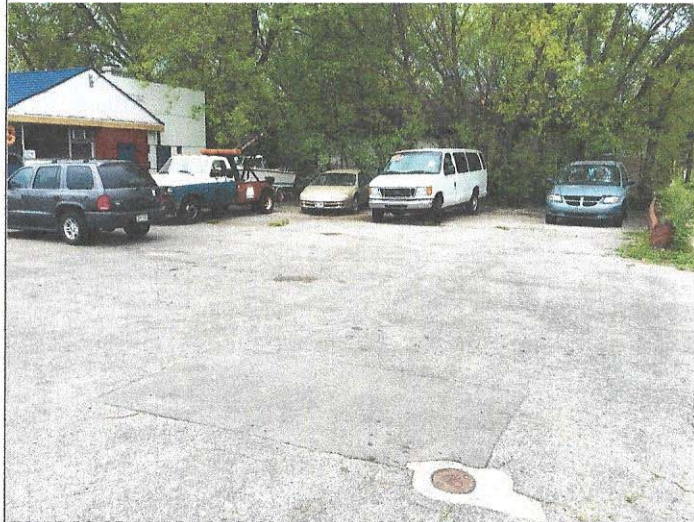
Title: Area of Cap to be Maintained, looking southeast.
