# **Endpoint Solutions**

**Subject: Results of Additional Investigation**

Eva Manor, 2103-2133 91<sup>st</sup> Street, Pleasant Prairie, Wisconsin  
BRRTS #: 02-30-543562 / FID #: 230115930

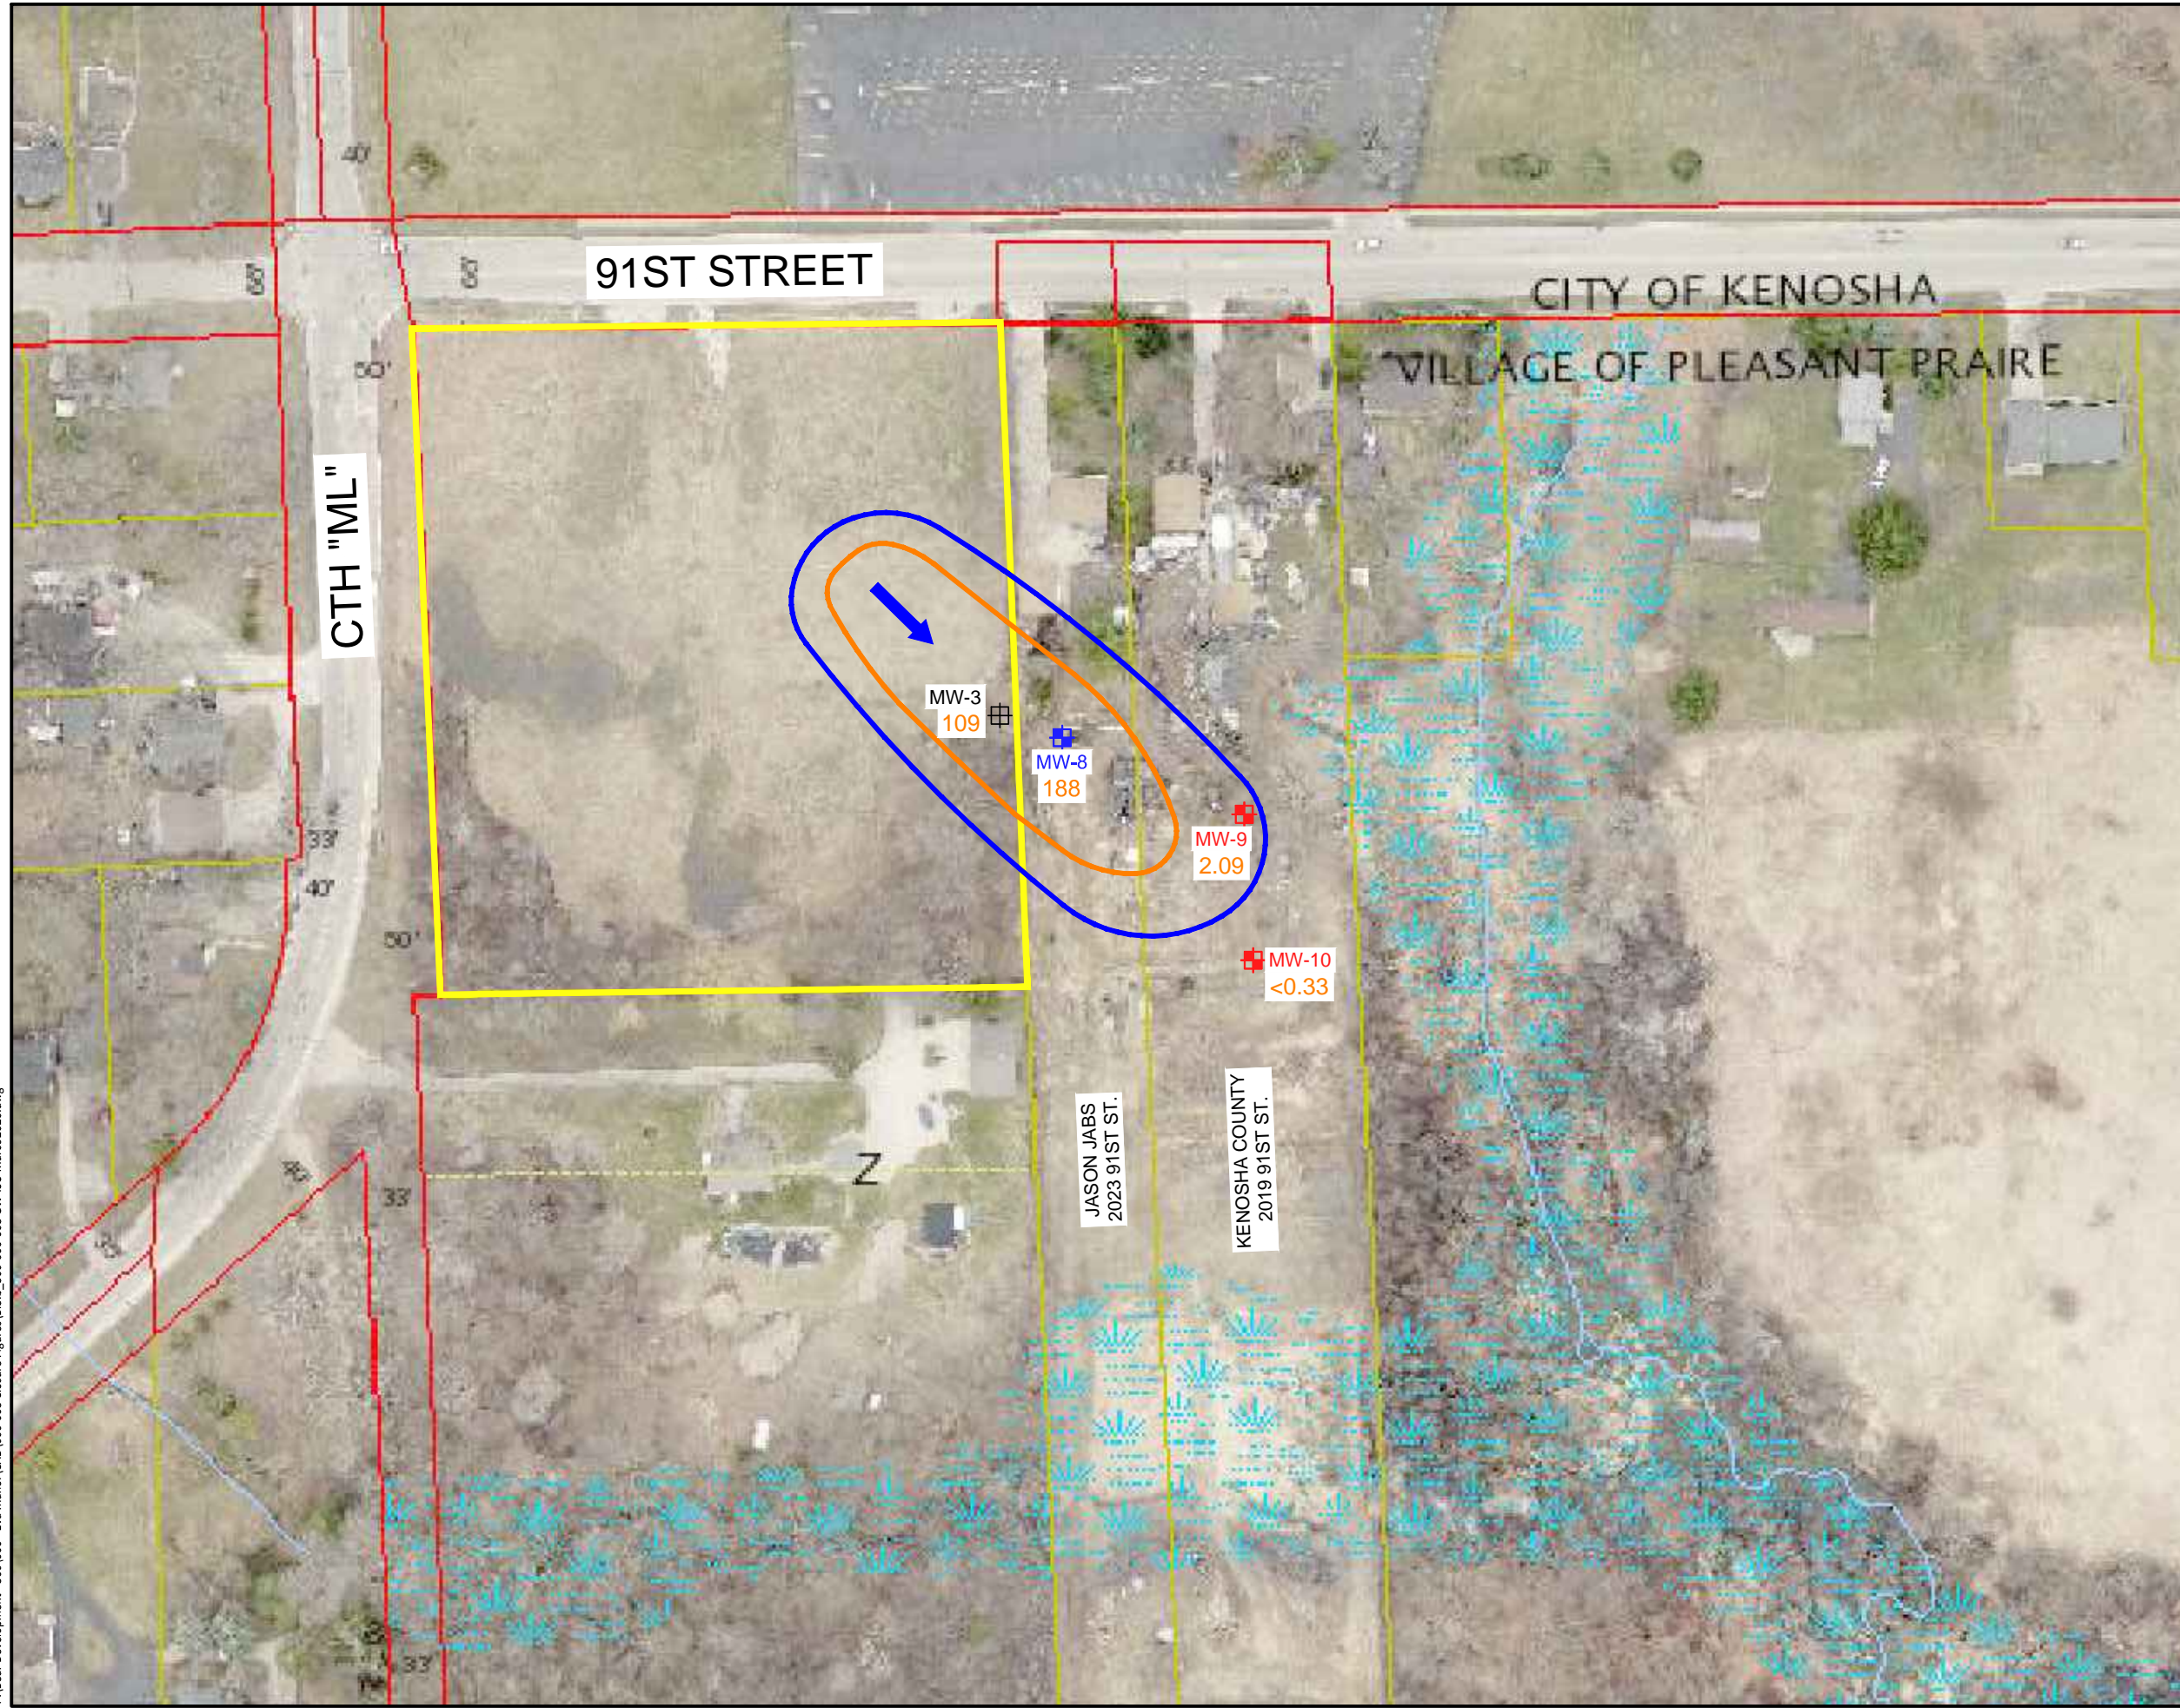
- ▬ SUBJECT PROPERTY
- ⊕ MONITORING WELL LOCATION (DRAKE 2008)
- ⊕ MONITORING WELL LOCATION (ENDPOINT NOVEMBER 2017)
- ⊕ MONITORING WELL LOCATION (ENDPOINT FEBRUARY 2020)
- ← GROUNDWATER FLOW DIRECTION
- <0.33 PCE VALUE
- ▬ APPROXIMATE EXTENT OF ES EXCEEDANCE (5 ug/L)
- ▬ APPROXIMATE EXTENT OF PAL EXCEEDANCE (0.5 ug/L)

**GROUNDWATER ISOCONCENTRATION - 3/09/2020**

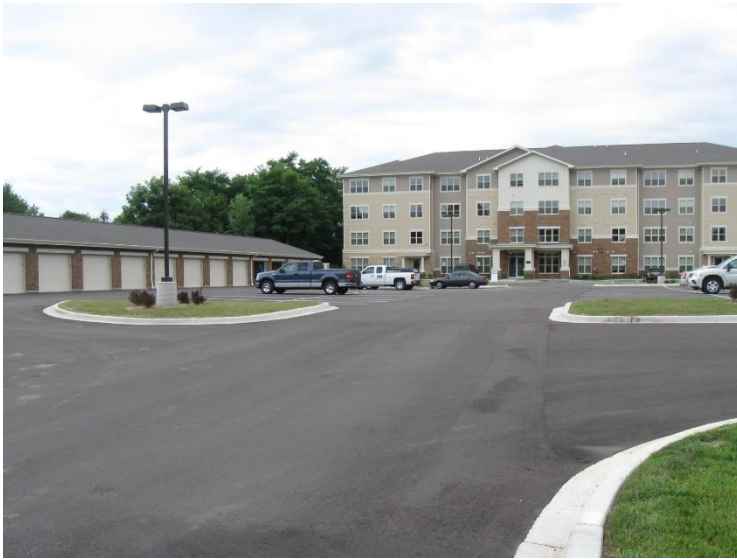
1. View southeasterly of site from entrance along 91<sup>st</sup> Street.

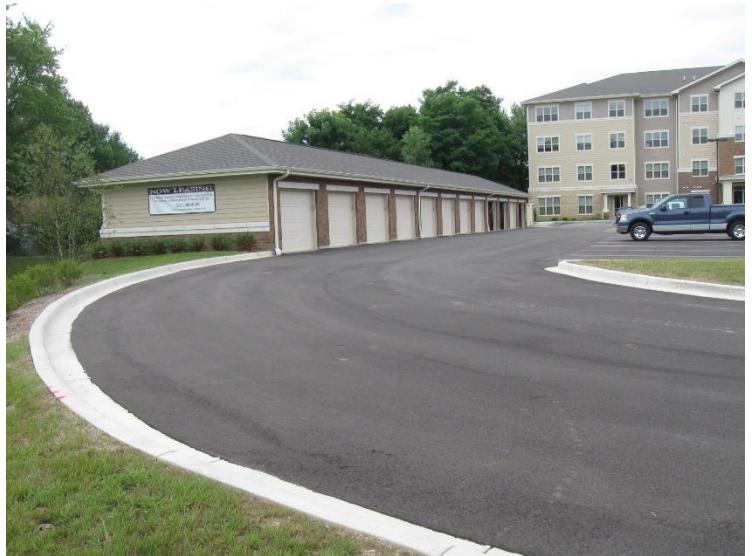
2. View southeasterly of paved parking area and garage structure over the area of residual soil

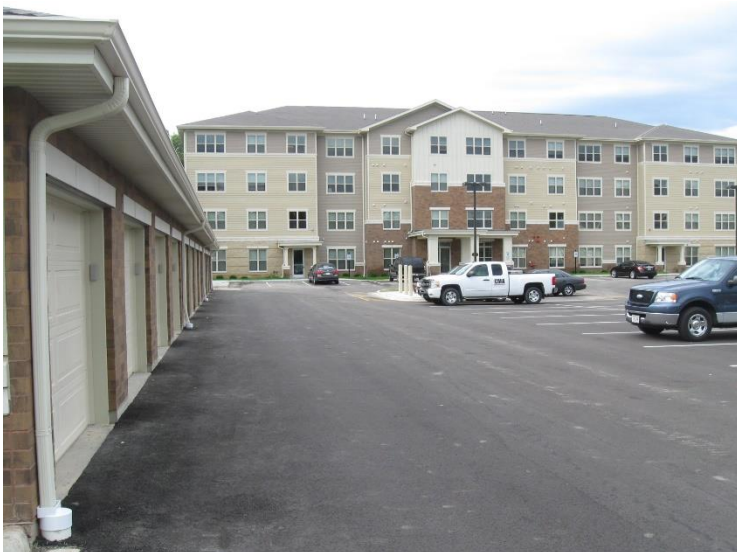
3. View southerly along garage structure and entrances.

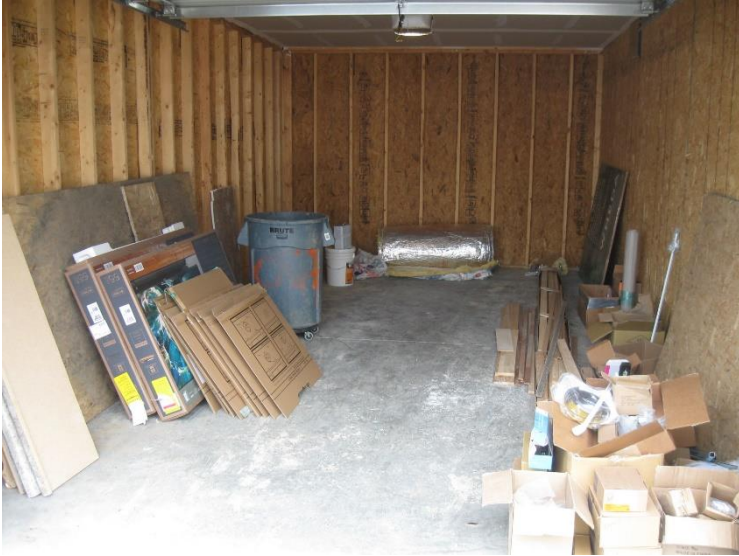
4. View of garage interiors and concrete floors.

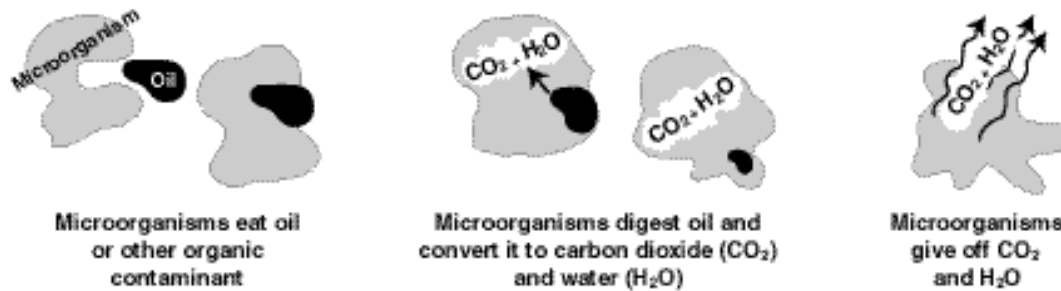
**Figure 1. Schematic Diagram of Aerobic Biodegradation in Soil**

Biodegradation is a process in which micro-organisms that naturally occur in soil and groundwater (e.g. yeast, fungi, or bacteria), break down, or degrade hazardous substances to less toxic or non-toxic substances. Microorganisms, like humans, eat and digest organic compounds for nutrition and energy (organic compounds contain carbon and hydrogen atoms).

Some types of microorganisms can digest organic substances such as fuels or solvents that are hazardous to humans. Microorganisms break down the organic contaminants into harmless products – mainly carbon dioxide and water. Once the contaminants are degraded, the microorganism populations decline because they have used their food sources. These small populations of microorganisms pose no contaminant or health risk.
