SUBJECT: Final Case Closure with Continuing Obligations  
Mags Auto Service  
2101 E 5<sup>th</sup> Street  
Superior, WI  
DNR BRRTS Activity # 03-16-543960

| B.1.a LOCATION MAP – CONTOUR INTERVAL 10 FEET |

B.I.b. DETAILED SITE MAP

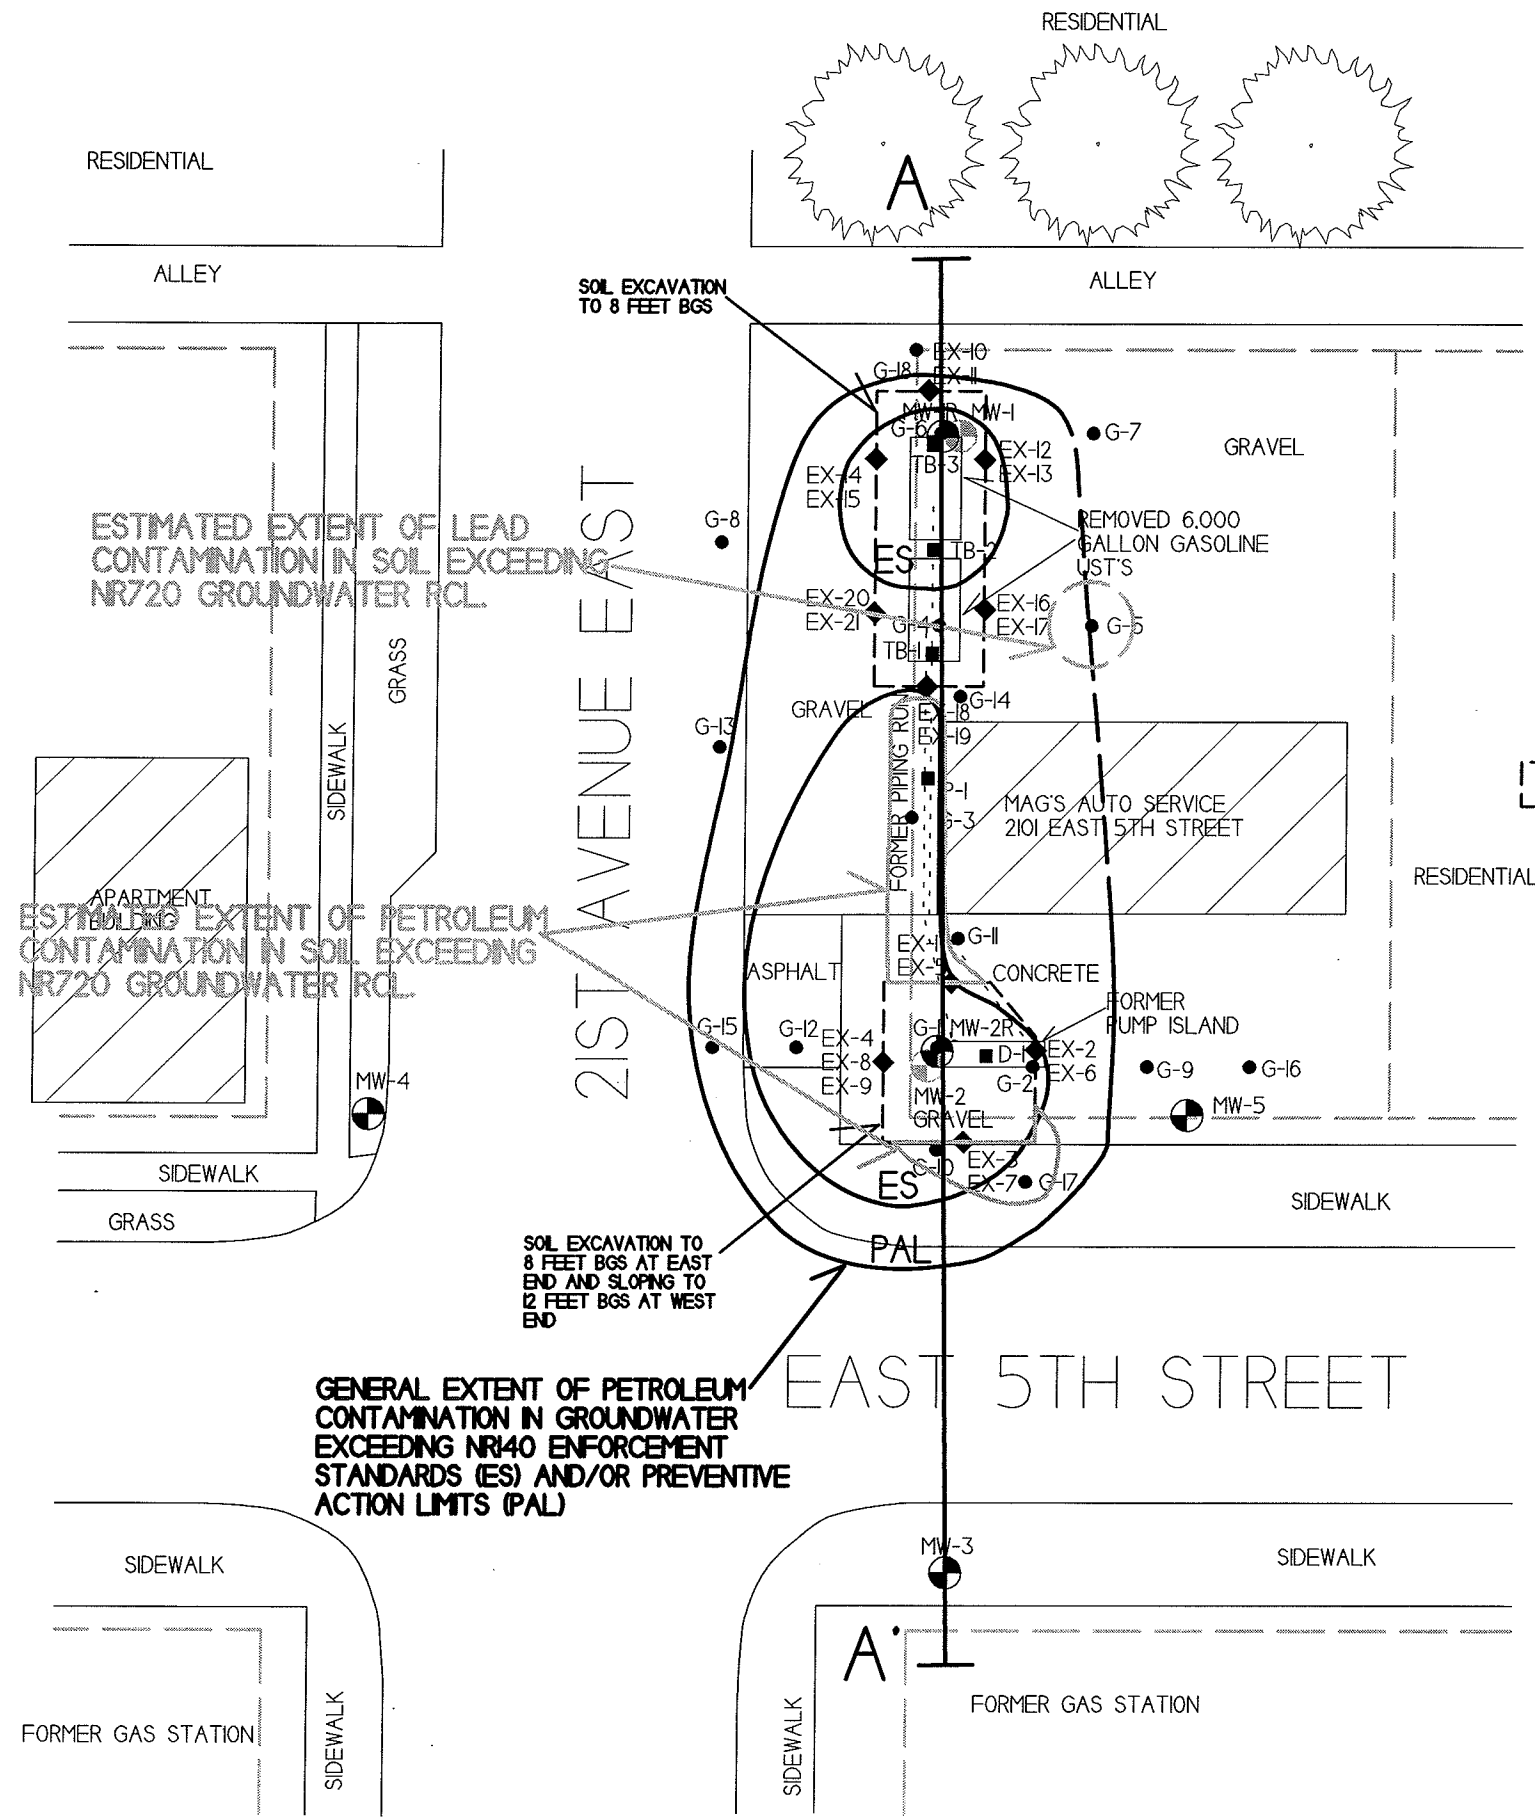
B.3.a.l. GEOLOGIC CROSS SECTION MAP

SOIL EXCAVATION TO 8 FEET BGS

- ii. Describe the composition, location and lateral extent, and depth of fill or waste deposits on the site.  
Fill material was found in the area of the removed UST's and consisted of sand to sandy clay from surface to approximately 14 feet bgs.
