Technical Assistance, Environmental Liability Clarification or Post-Closure Modification Request

Property Name 700 Series Properties		FID No. (if known) 341117040	
BRRTS No. (if known) 02-41-544080	Parcel Identification Number 454-0648, 454-0649, and 454-0650-000		
Street Address 6633-6709 West National Avenue	City West Allis	State WI	ZIP Code 53214
County Milwaukee	Municipality where the Property is located <input checked="" type="radio"/> City <input type="radio"/> Town <input type="radio"/> Village of West Allis	Property is composed of: <input type="radio"/> Single tax parcel <input checked="" type="radio"/> Multiple tax parcels	Property Size Acres 7

Other report(s) or information - Describe: RAP dated November 19, 2021; BRRTS # 02-41-560505

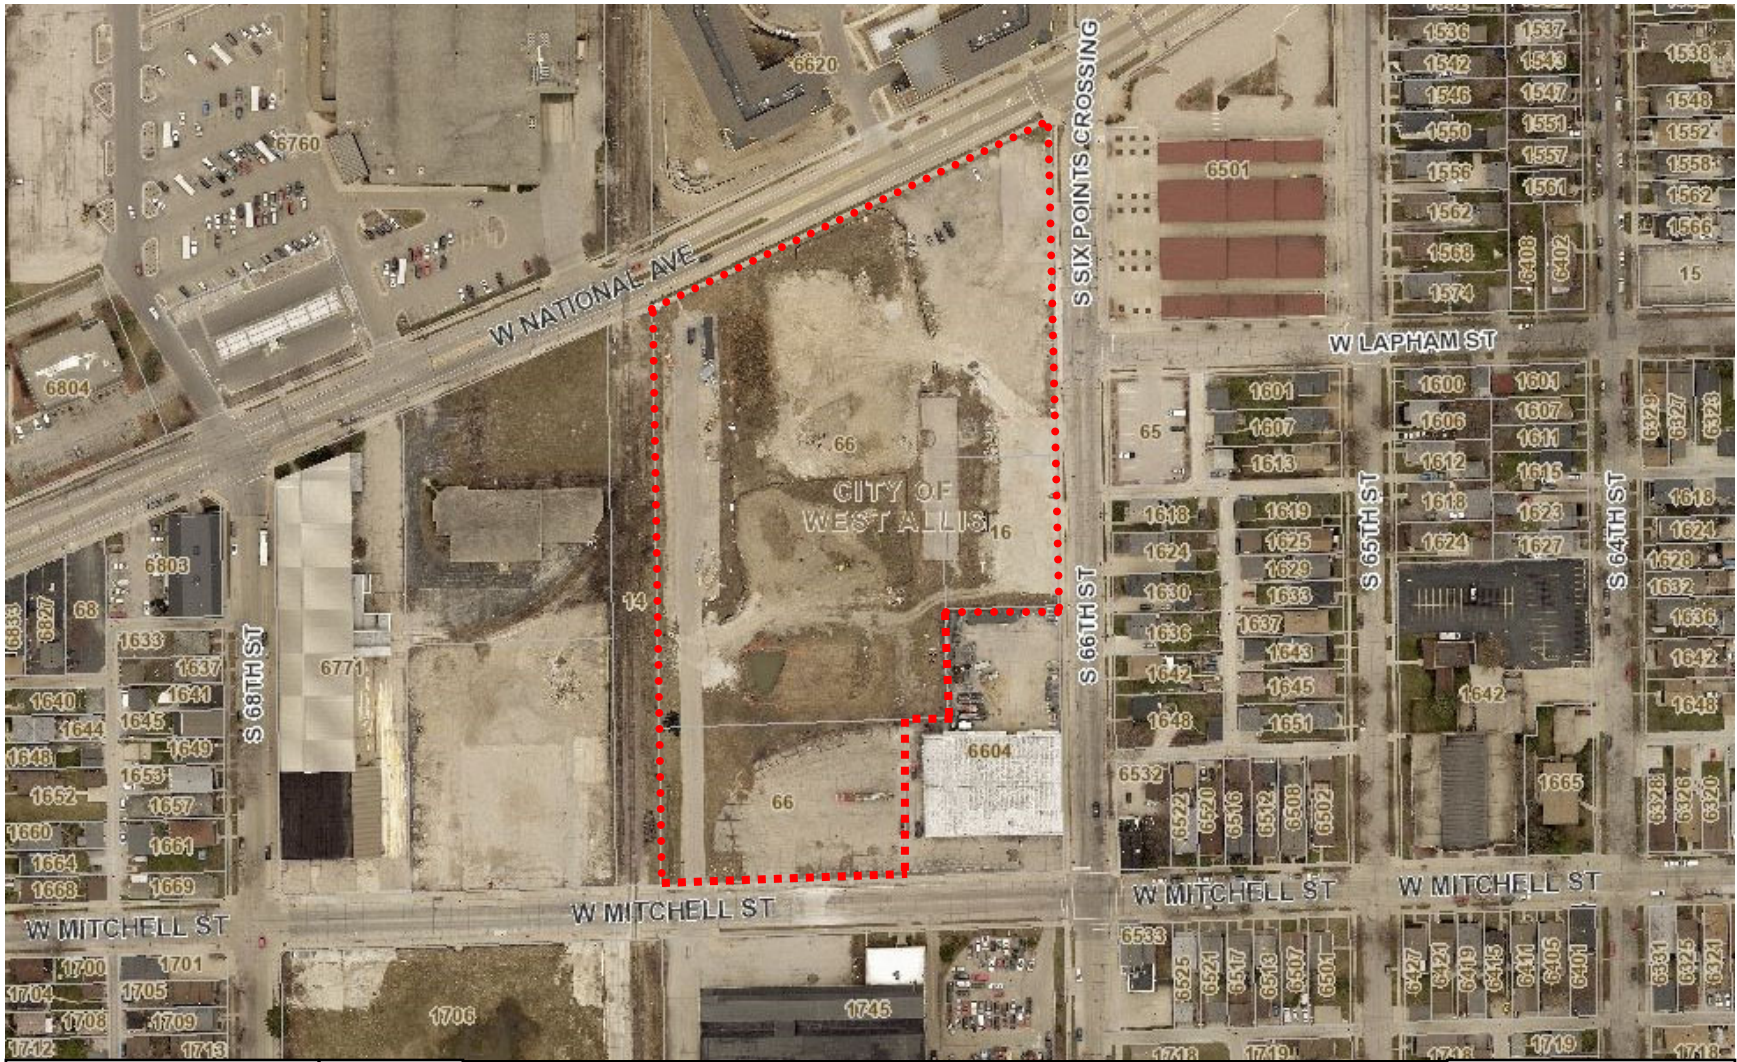
Figure
 2

2020 Site Aerial Diagram
 South of National Avenue (SoNA) Property
 West Allis, WI

The Site is situated at the southwest corner of the intersection of West National Avenue and South 66th Street in the City of West Allis. The Site is approximately 6.53-acres and currently vacant with asphalt paved areas on the northeast, northwest, and southeast portions of the Site. The remainder of the Site consists of vacant grass covered land with fill piles on the north-central portion of the Site. Storm sewer manholes were observed on the southern portion of the Site. The grade of the subject property slopes downwards from the north to the south with the asphalt areas being of higher elevation. The Site is illustrated on Figures 1 and 2.

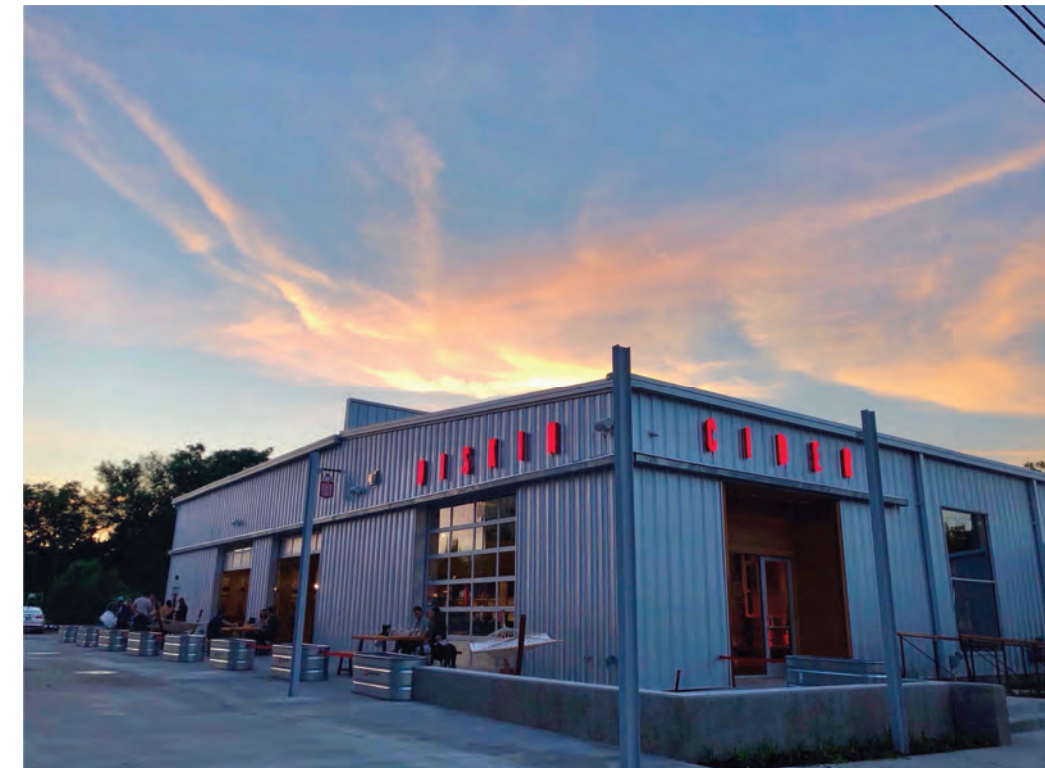
The photo above is of a repurposed industrial service building in Nashville, TN. The conversion now houses Diskin Cider’s production operations, tasting room and events space. The interior reflects the industrial character of the original steel-framed building while the exterior has been reskinned with a sharp-looking, tasteful palette of materials together with carefully selected glazing, signage and lighting. This project was visited by Mandel Group in April 2019 as part of our conceptualization for Makers Row, the food-centric commercial component of the SoNa development.

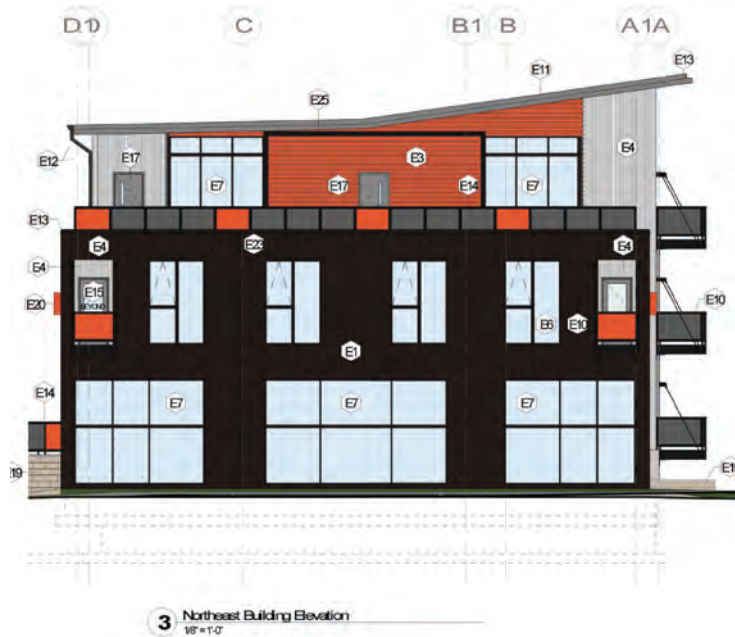
The architectural drawing above is a study of materials and window fenestration. A masonry brick base supports a rooftop terrace amenity space. The upper floor is sheathed in a combination of vertical ribbed metal panel and horizontally laid deep-profile metal panel with a burnt orange accent color.

The SoNa Lofts apartment building takes its inspiration from historic loft structures and borrows certain exterior palette materials from Makers Row. The masonry base of the building is complemented with ribbed metal skin and pops of color to make the finished product a contemporary, memorable design statement. The overall form of the building is unique and will present a high-quality design statement along National Avenue.

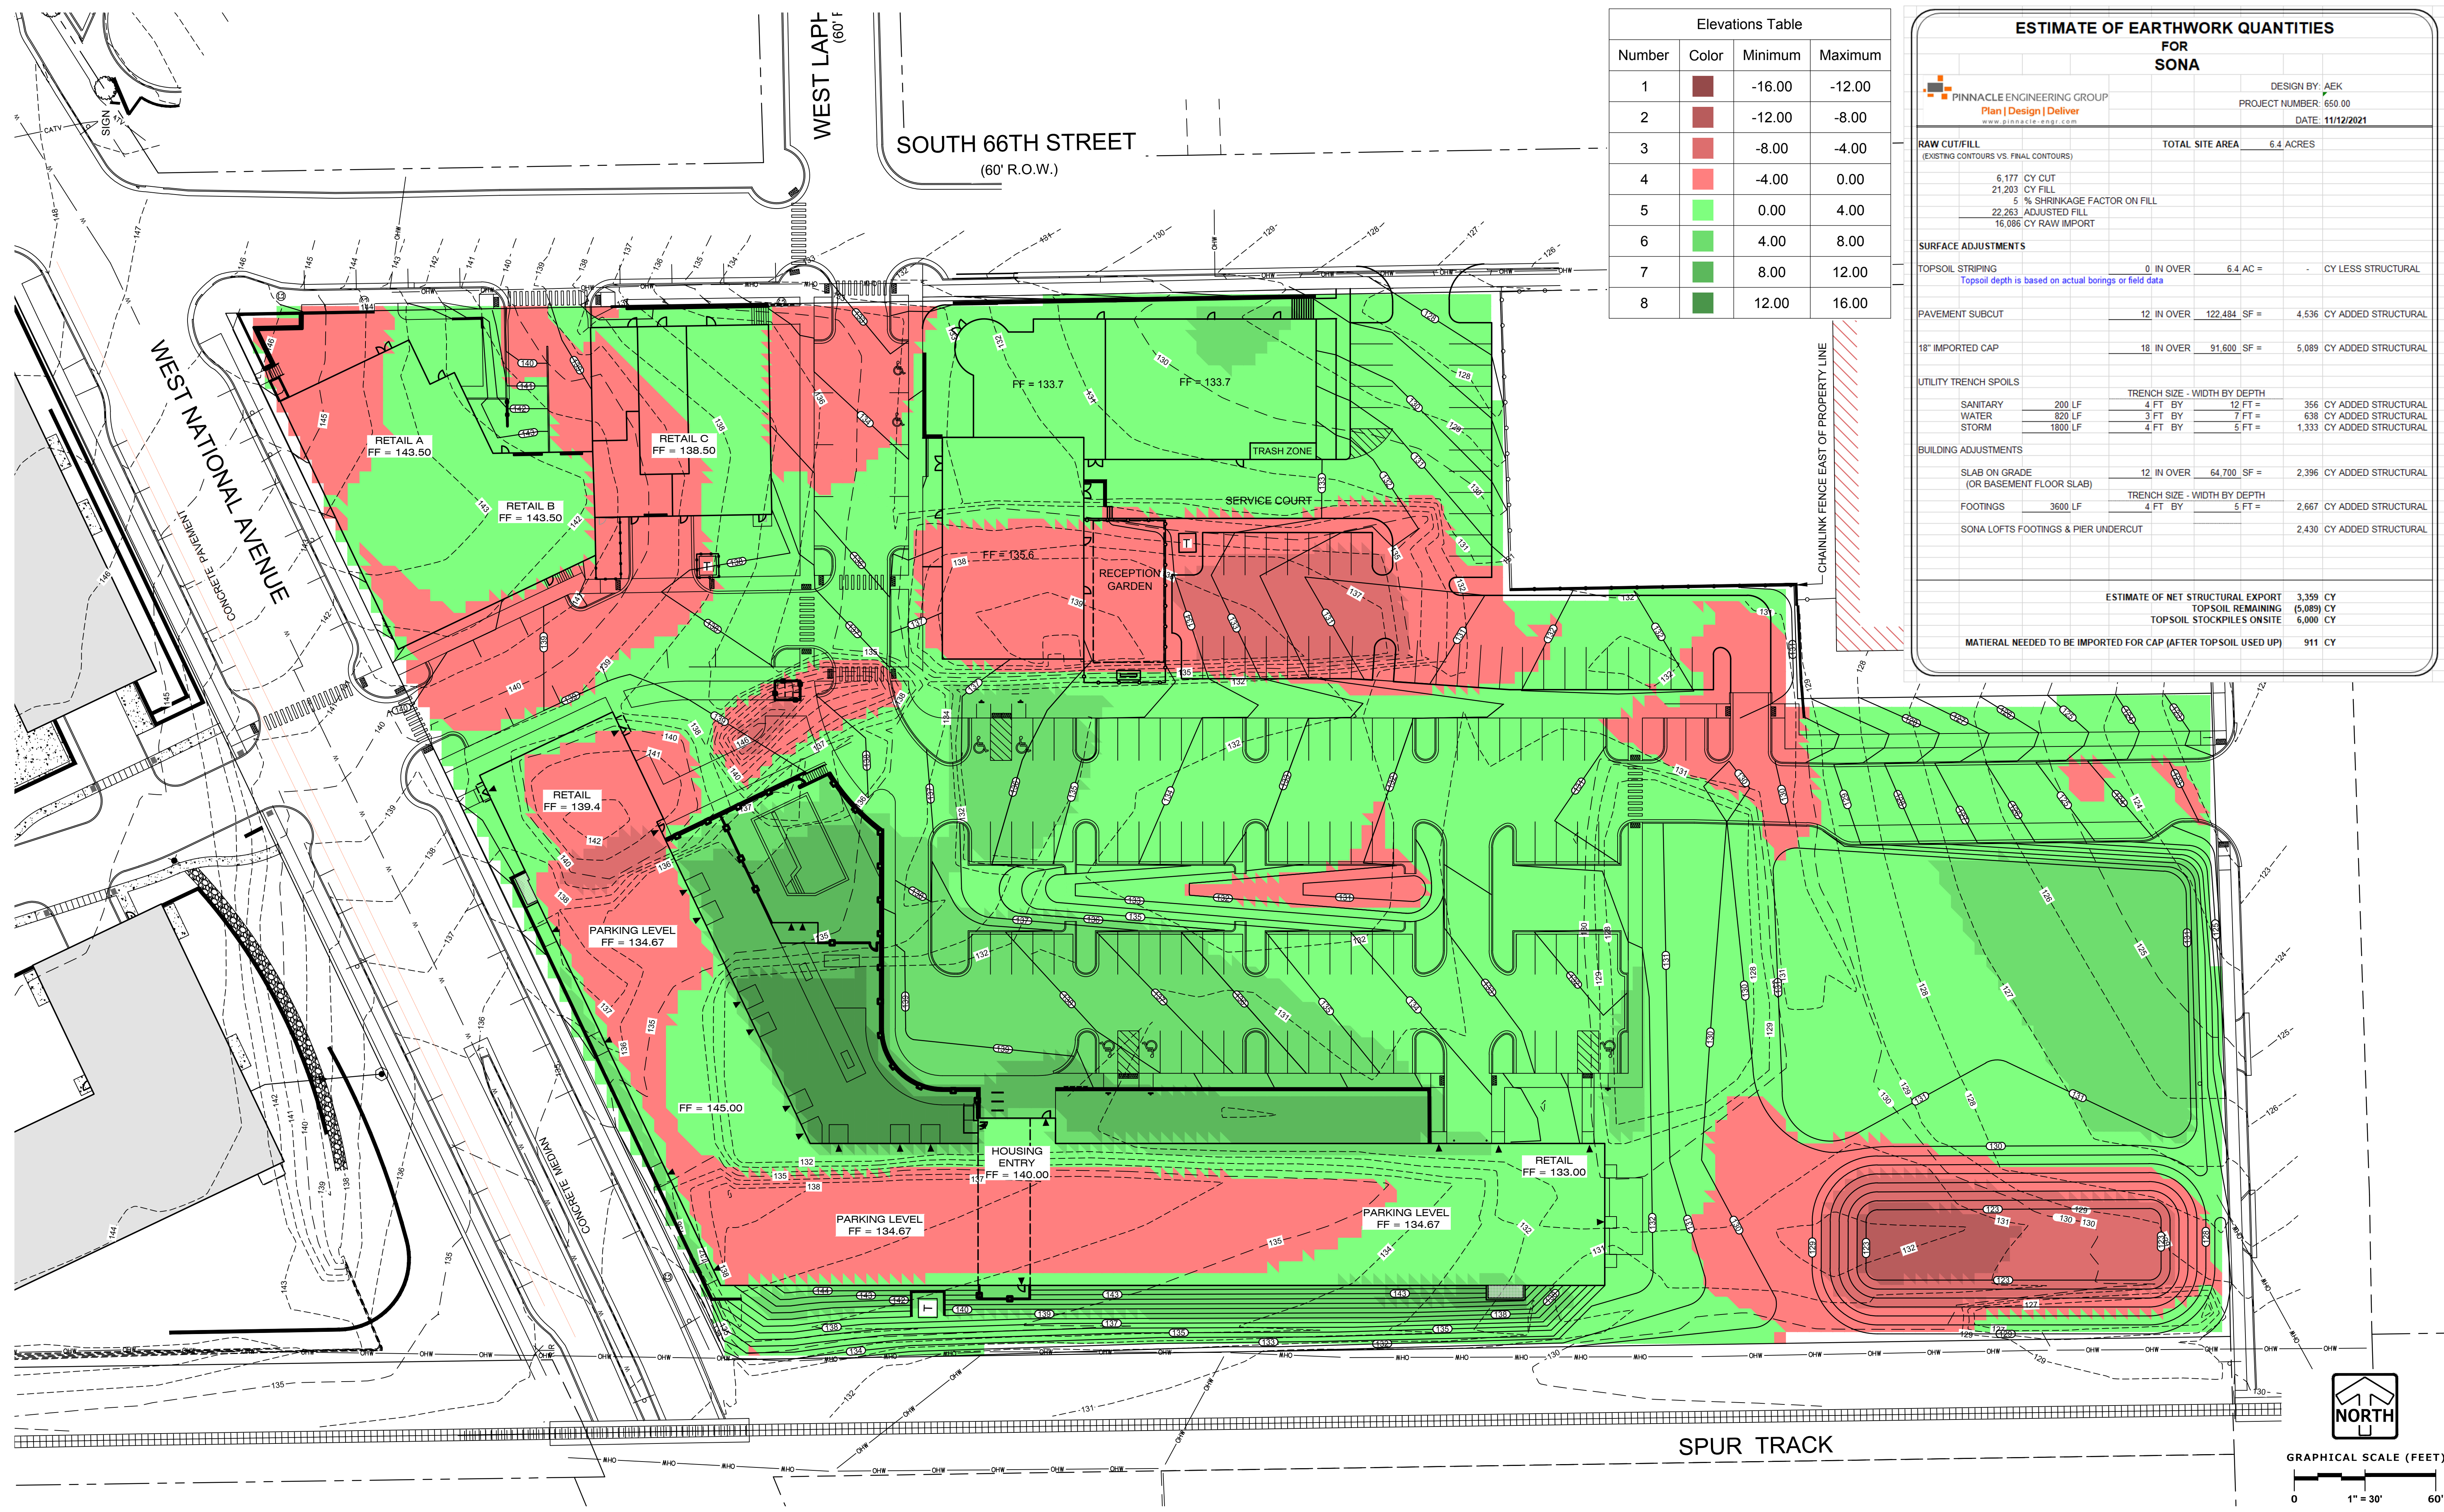
Elevations Table			
Number	Color	Minimum	Maximum
1	Dark Red	-16.00	-12.00
2	Red	-12.00	-8.00
3	Light Red	-8.00	-4.00
4	Red-Orange	-4.00	0.00
5	Light Green	0.00	4.00
6	Green	4.00	8.00
7	Dark Green	8.00	12.00
8	Very Dark Green	12.00	16.00

ESTIMATE OF EARTHWORK QUANTITIES FOR SONA			
RAW CUT/FILL (EXISTING CONTOURS VS. FINAL CONTOURS) 6,177 CY CUT 21,203 CY FILL 5% SHRINKAGE FACTOR ON FILL 22,263 ADJUSTED FILL 16,086 CY RAW IMPORT		TOTAL SITE AREA 6.4 ACRES	
SURFACE ADJUSTMENTS			
TOPSOIL STRIPING	0 IN OVER	6.4 AC =	- CY LESS STRUCTURAL
<i>Topsoil depth is based on actual borings or field data</i>			
PAVEMENT SUBCUT	12 IN OVER	122,484 SF =	4,536 CY ADDED STRUCTURAL
18" IMPORTED CAP	18 IN OVER	91,600 SF =	5,089 CY ADDED STRUCTURAL
UTILITY TRENCH SPOILS			
		TRENCH SIZE - WIDTH BY DEPTH	
SANITARY	200 LF	4 FT BY 12 FT =	356 CY ADDED STRUCTURAL
WATER	820 LF	3 FT BY 7 FT =	638 CY ADDED STRUCTURAL
STORM	1800 LF	4 FT BY 5 FT =	1,333 CY ADDED STRUCTURAL
BUILDING ADJUSTMENTS			
SLAB ON GRADE (OR BASEMENT FLOOR SLAB)	12 IN OVER	64,700 SF =	2,396 CY ADDED STRUCTURAL
		TRENCH SIZE - WIDTH BY DEPTH	
FOOTINGS	3600 LF	4 FT BY 5 FT =	2,667 CY ADDED STRUCTURAL

SONA LOFTS FOOTINGS & PIER UNDERCUT		2,430 CY ADDED STRUCTURAL	
ESTIMATE OF NET STRUCTURAL EXPORT		3,359 CY	
TOPSOIL REMAINING		(5,089) CY	
TOPSOIL STOCKPILES ONSITE		6,000 CY	
MATERIAL NEEDED TO BE IMPORTED FOR CAP (AFTER TOPSOIL USED UP)		911 CY
