SUBJECT: Final Case Closure with Continuing Obligations  
Capitol Auto Sales/BV's Automotive (Former), 7210 W. Capitol Drive, Milwaukee, WI  
DNR BRRTS Activity #: 03-41-545023  
FID #: 341124630

**B.2.b RESIDUAL SOIL CONTAMINATION**  
**CAPITOL AUTO SALES- BV'S AUTOMOTIVE**

**MILWAUKEE, WISCONSIN**

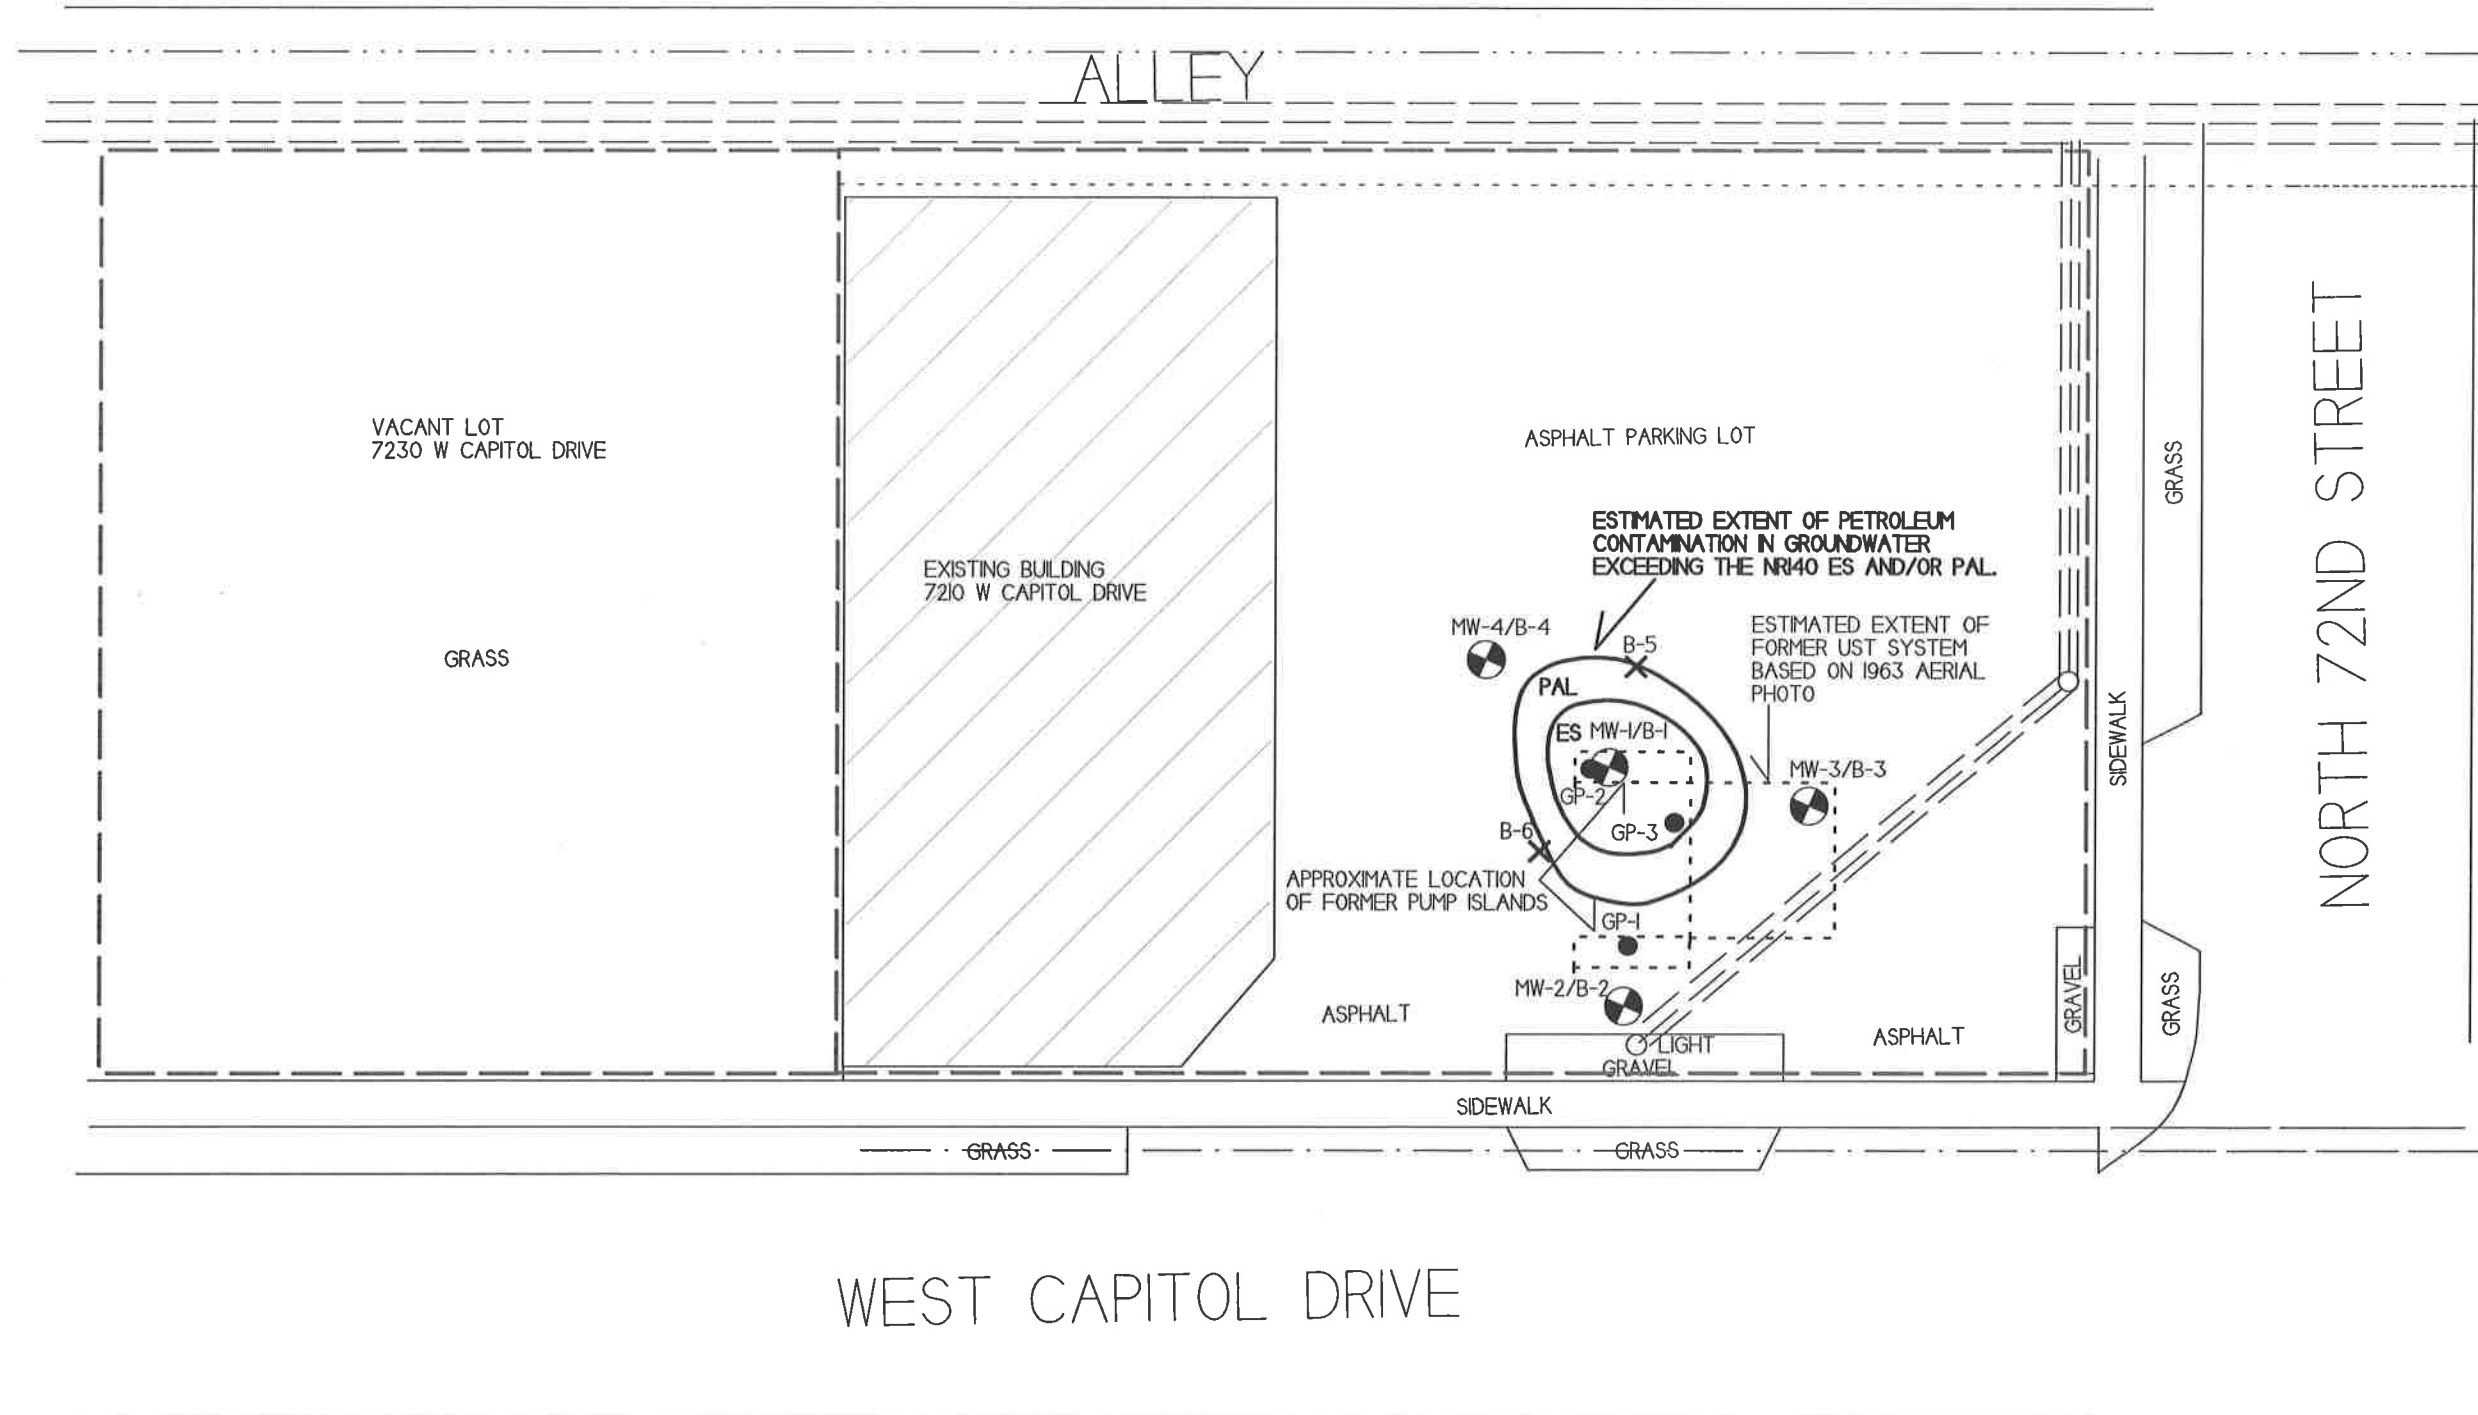
Soil contamination remains in the south-central portion of the parking lot as indicated on the attached map **Residual Soil Contamination**, Attachment B.2.b, 8/10/18. If soil in the specific locations described above is excavated in the future, the property owner or right-of-way holder at the time of excavation must sample and analyze the excavated soil to determine if contamination remains. If sampling confirms that contamination is present, the property owner or right-of-way holder at the time of excavation will need to determine whether the material is considered solid or hazardous waste and ensure that any storage, treatment or disposal is in compliance with applicable standards and rules. Contaminated soil may be managed in accordance with ch. NR 718, Wis. Adm. Code, with prior DNR approval.

Future Concern: petroleum volatile organic compounds remain in soil and groundwater in the south-central portion of the parking lot, as shown on the attached map **Residual Soil Contamination**, Attachment B.2.b, 8/10/18, at levels that may be of concern for vapor intrusion in the future, depending on construction and occupancy of a building. The site is currently operating as an auto repair shop and used auto sales facility. Therefore, before a building is

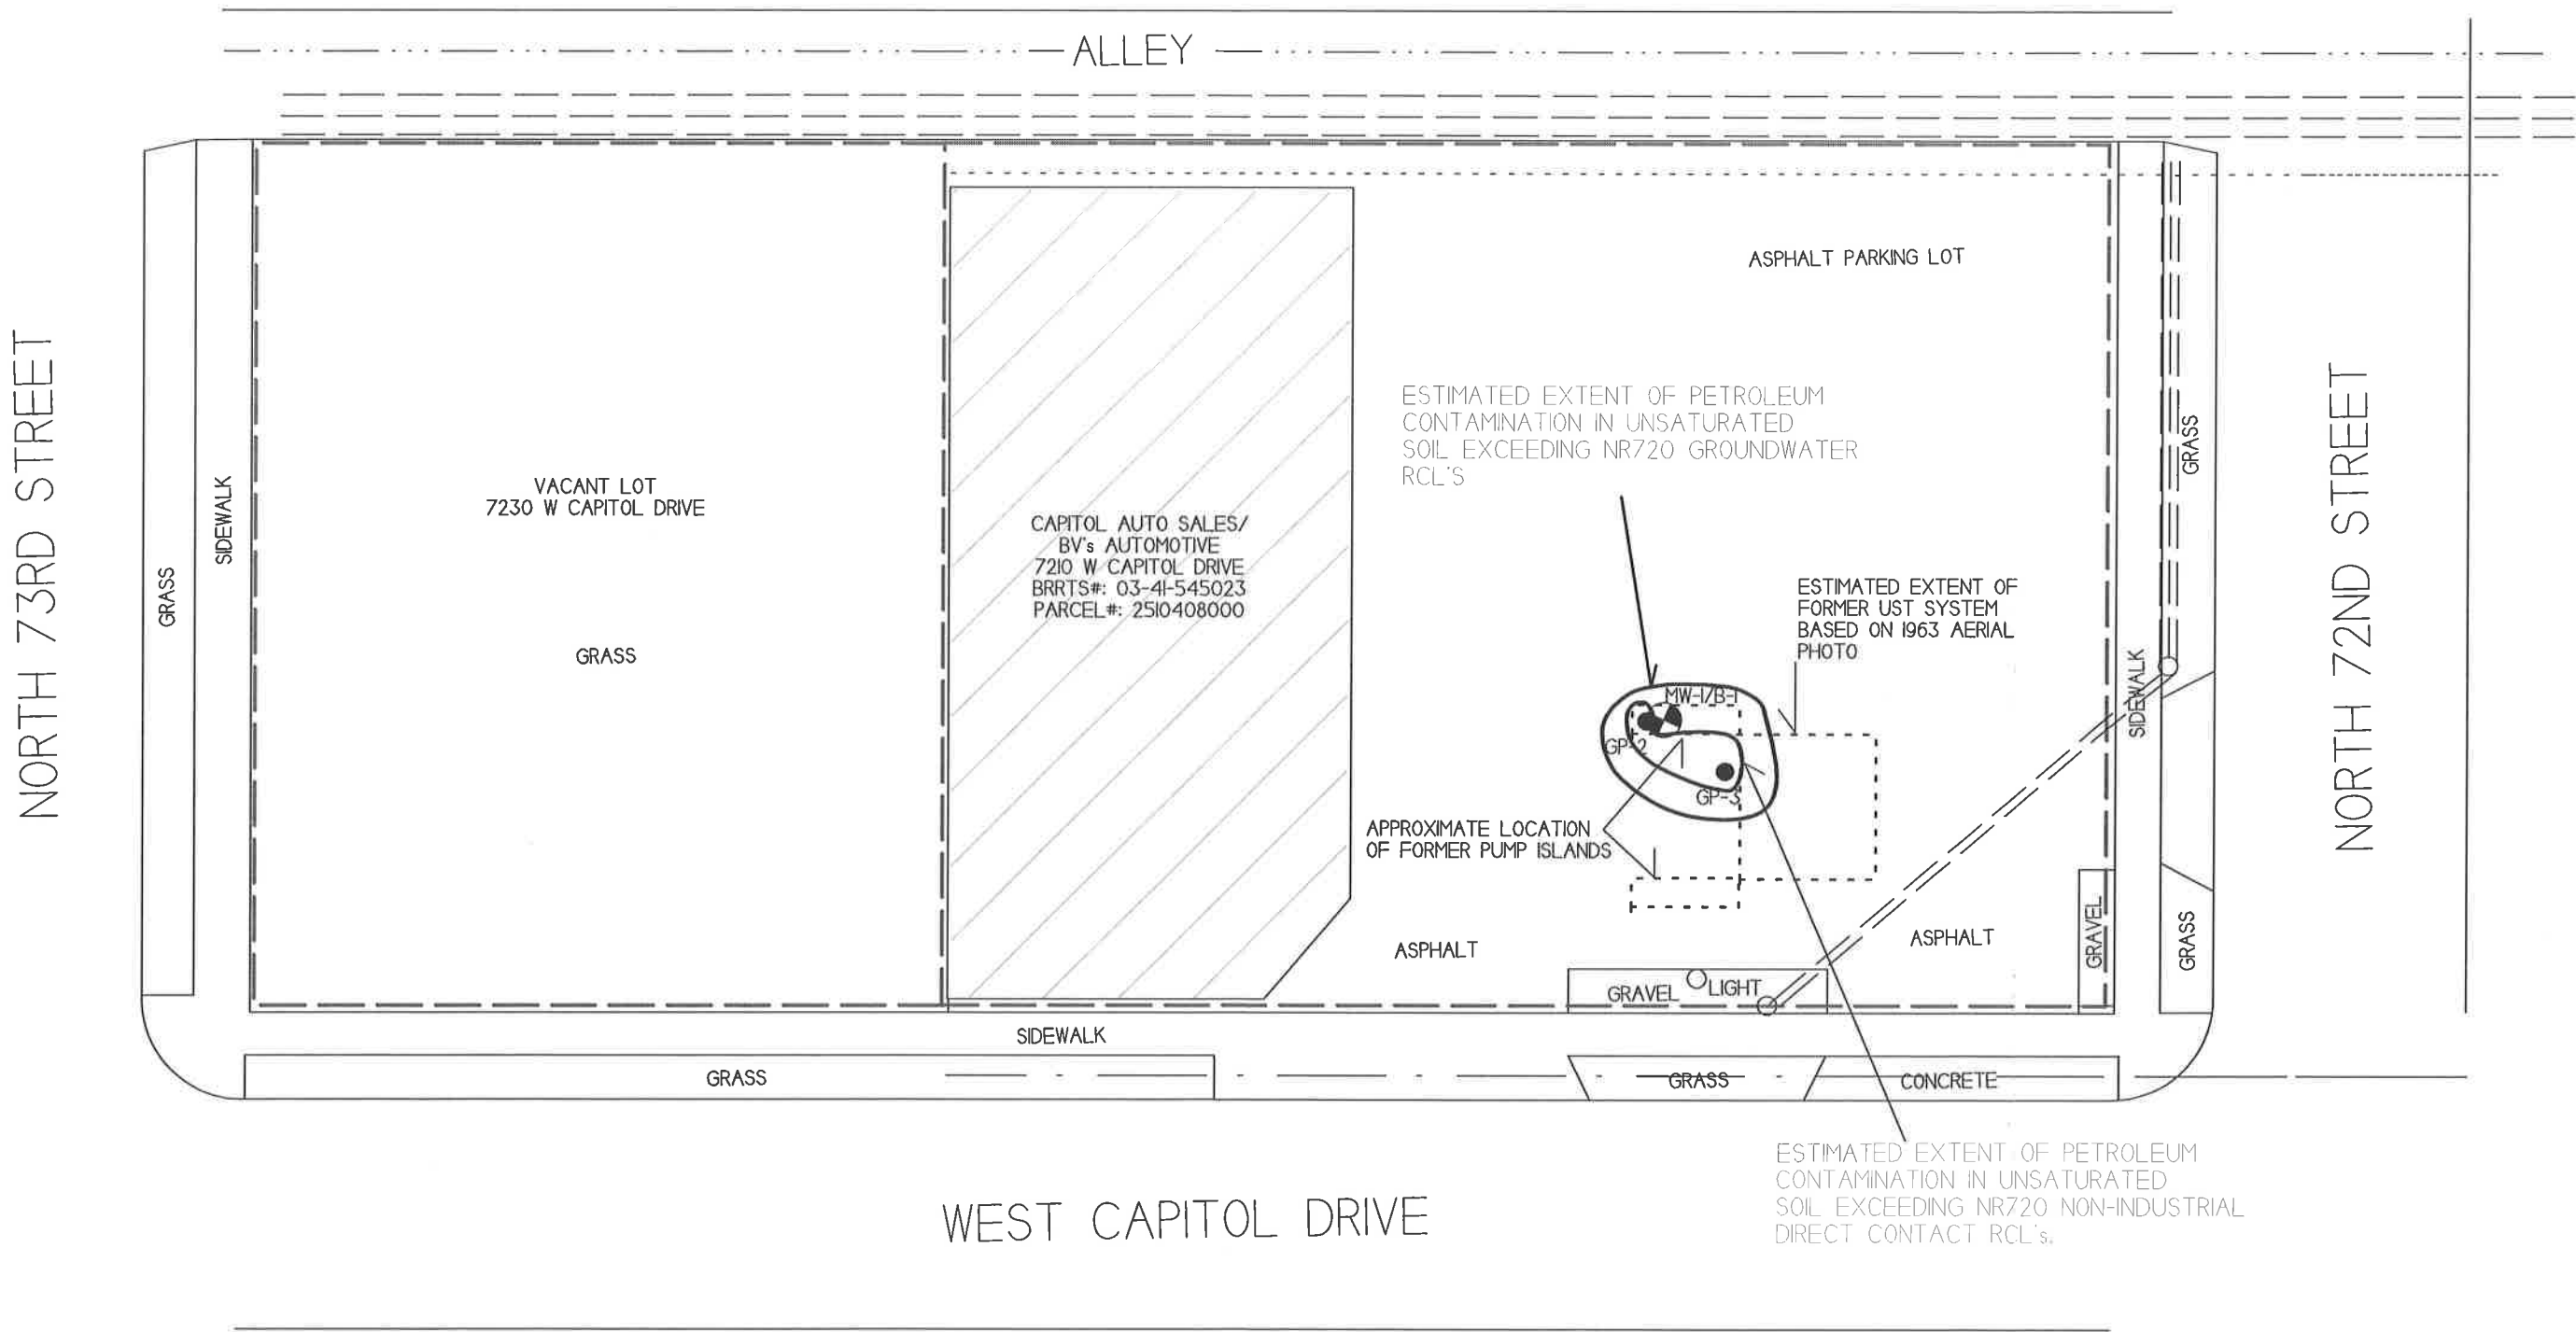
D.2. LOCATION MAP

The pavement that exists in the location shown on the attached **Location Map**, Attachment D.2, 3/28/18 shall be maintained in compliance with the attached maintenance plan in order to minimize the infiltration of water and prevent additional groundwater contamination that would violate the groundwater quality standards in ch. NR 140, Wis. Adm. Code, and to prevent direct contact with residual soil contamination that might otherwise pose a threat to human health.

The asphalt cap overlying the contaminated soil and as depicted in Attachment D.2 will be inspected once a year, normally in the spring after all snow and ice is gone, for deterioration, cracks and other potential problems that can cause exposure to underlying soils or additional infiltration through asphalt. The inspections will be performed by the property owner or their designated representative. The inspections will be performed to evaluate damage due to settling, exposure to the weather, wear from traffic, increasing age and other factors. Any area where soils have become or are likely to become exposed and where infiltration from the surface will not be effectively minimized will be documented. A log of the inspections and any repairs will be maintained by the property owner and is included as Form 4400-305 Continuing Obligations and Maintenance Log. The log will include recommendations for necessary repair of any areas where underlying soils are exposed and where infiltration from the surface will not be effectively minimized. Once repairs are completed, they will be documented in the inspection log. A copy of the inspection log will be kept at the address of the property owner and available for submittal or inspection by Wisconsin Department of Natural Resources ("WDNR") representatives upon their request.

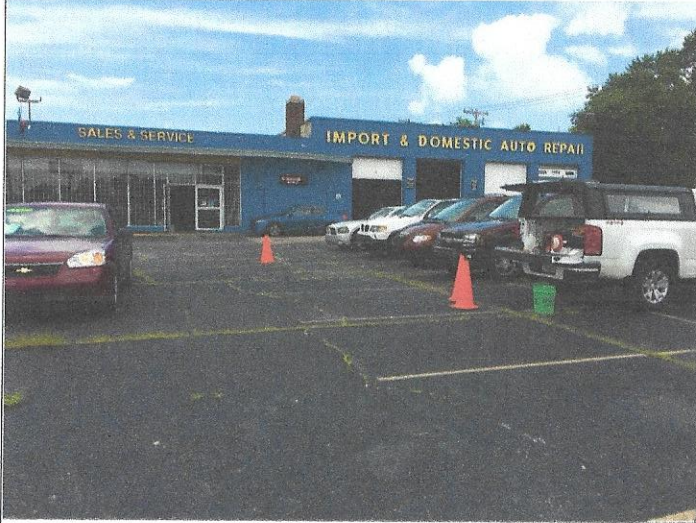
Title: Looking west at area of asphalt cap.

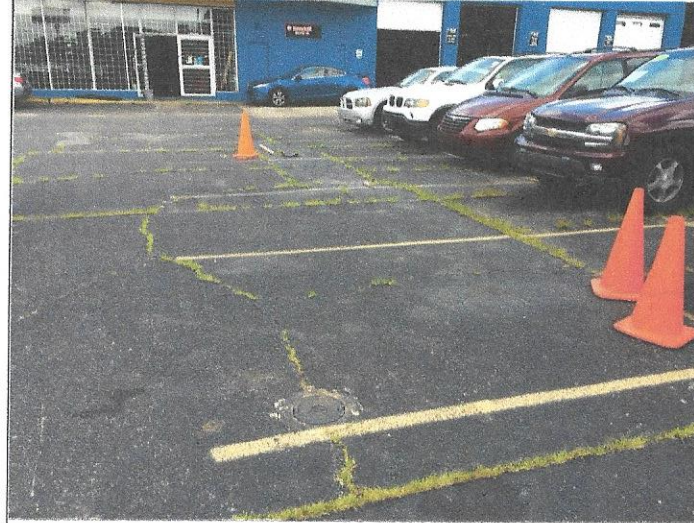
Title: Looking west at area of asphalt cap.

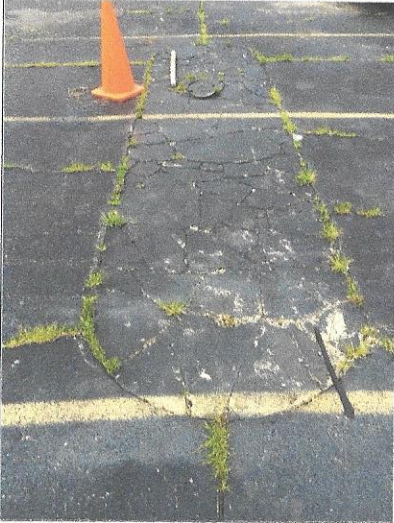
Title: Former pump island - area of asphalt cap.
