**Subject:       Site Assessment Report  
                  Mirro-Spirtas Site  
                  Manitowoc, Manitowoc County, Wisconsin  
                  Technical Direction Document No. TO-05-10-12-0002  
                  OTIE Contract No. EP-S5-10-10**

**SITE ASSESSMENT REPORT  
MIRRO-SPIRTAS SITE  
MANITOWOC, MANITOWOC COUNTY, WISCONSIN**

TDD No.:	TO-05-10-12-0002
Date Prepared:	March 15, 2011
Contract No.:	EP-S5-10-10
Prepared by:	OTIE
START Project Manager:	Naren Babu
Telephone No.:	(312) 220-7000
U.S. EPA On-Scene Coordinator:	Kathy Halbur
Telephone No.:	(920) 662-5424

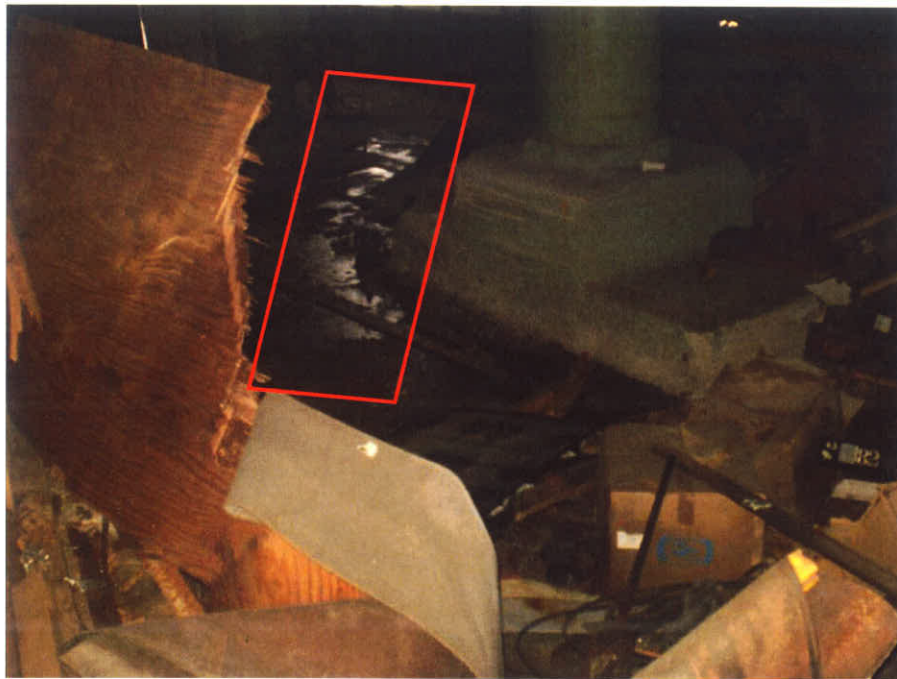
**Photograph No.:** 1                      **Photographer:** Caitlin Ruza                      **Area:** Bldg K-Loading Dock  
**TDD Number:** TO-05-10-12-0002                      **Contract:** EP-S5-10-10, OTIE                      **Date:** January 24, 2011  
**Site Name & Location:** Mirro-Spirtas Site, Manitowoc, Manitowoc County, Wisconsin  
**Photograph Subject:** Dumped material and oil sheen leading to the drain inside the loading dock in Building K

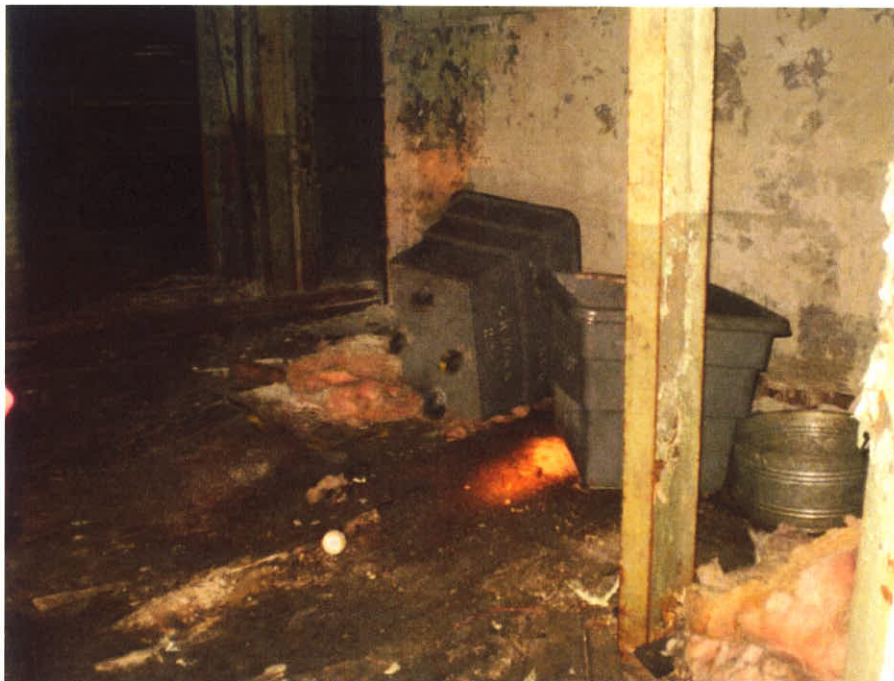
**Photograph No.:** 2                      **Photographer:** Caitlin Ruza                      **Area:** Bldg K-Loading Dock  
**TDD Number:** TO-05-10-12-0002                      **Contract:** EP-S5-10-10, OTIE                      **Date:** January 24, 2011  
**Site Name & Location:** Mirro-Spirtas Site, Manitowoc, Manitowoc County, Wisconsin  
**Photograph Subject:** Two wheeled bins in the loading dock area of Building K. One bin is tipped over and one contains the contents which has been drained from the transformer on the second floor above

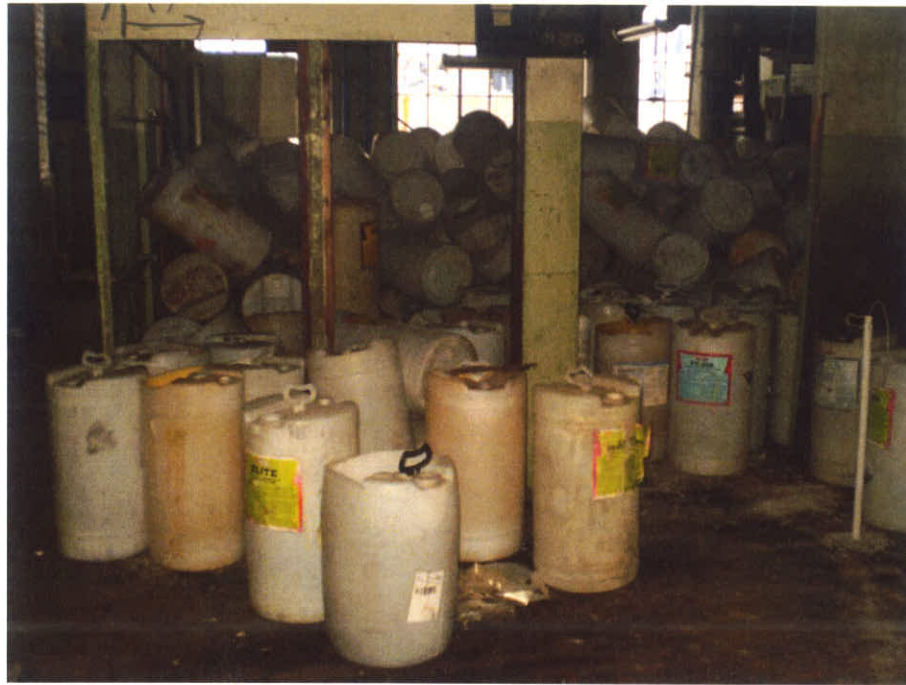
The last investigation area during site reconnaissance was the basement area of Building V. On the walk down to the basement, the OSC and START observed a large pile of empty and nearly-empty 15 gallon drums near the basement stairwell of Building V (Photo 2). Some of the drums were labeled “LIQUID-COUNTDOWN”, “FC-350”, and “Elite”. Once in the basement area of Building V, OSC and START observed six-15 gallon white drums that were stored in a corridor behind the stairwell (Figure 2 – Site

**Photograph No.:** 3      **Photographer:** Caitlin Ruza      **Area:** Building V  
**TDD Number:** TO-05-10-12-0002      **Contract:** EP-S5-10-10, OTIE      **Date:** January 24, 2011  
**Site Name & Location:** Mirro-Spirtas Site, Manitowoc, Manitowoc County, Wisconsin  
**Photograph Subject:** Stack of empty and nearly-empty drums near the basement stairwell in Building V

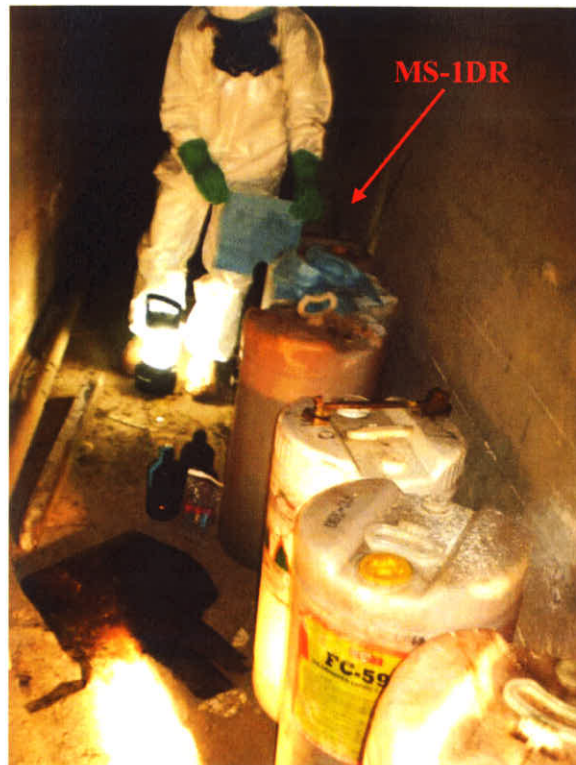
**Photograph No.:** 4      **Photographer:** Caitlin Ruza      **Area:** Bldg V-Basement  
**TDD Number:** TO-05-10-12-0002      **Contract:** EP-S5-10-10, OTIE      **Date:** January 24, 2011  
**Site Name & Location:** Mirro-Spirtas Site, Manitowoc, Manitowoc County, Wisconsin  
**Photograph Subject:** View of all 6 basement drums MS-1DR and MS-1DR-D were both collected from the last drum in the line of drums shown above

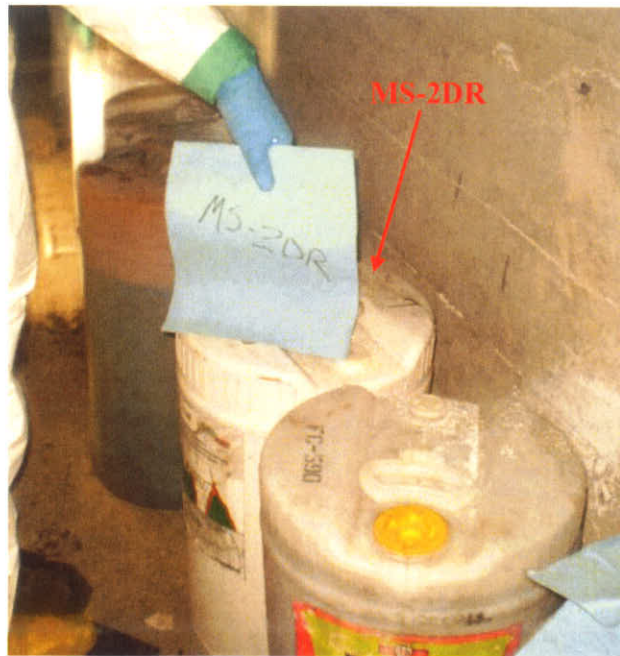
**Photograph No.:** 5      **Photographer:** Caitlin Ruza      **Area:** Bldg V-Basement  
**TDD Number:** TO-05-10-12-0002      **Contract:** EP-S5-10-10, OTIE      **Date:** January 24, 2011  
**Site Name & Location:** Mirro-Spirtas Site, Manitowoc, Manitowoc County, Wisconsin  
**Photograph Subject:** MS-2DR was collected from the second drum back in the line of 6 drums on the basement level of Building V

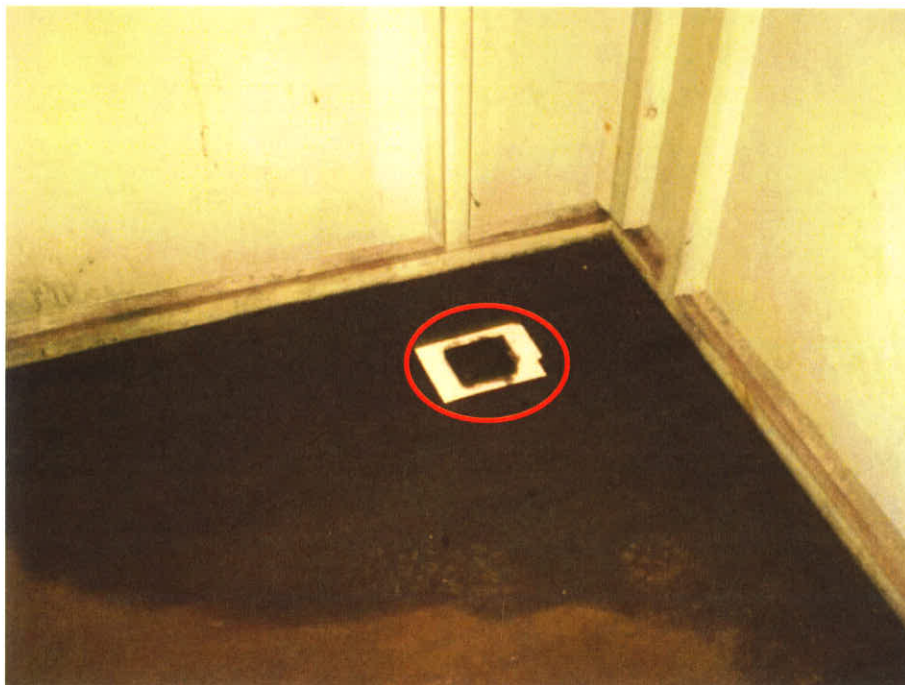
**Photograph No.:** 6      **Photographer:** Caitlin Ruza      **Area:** Building I-Transformer  
**TDD Number:** TO-05-10-12-0002      **Contract:** EP-S5-10-10, OTIE      **Date:** January 24, 2011  
**Site Name & Location:** Mirro-Spirtas Site, Manitowoc, Manitowoc County, Wisconsin  
**Photograph Subject:** MS-WP-1 collected from stained area of small room adjacent to the transformer room in Building I (template area shown)

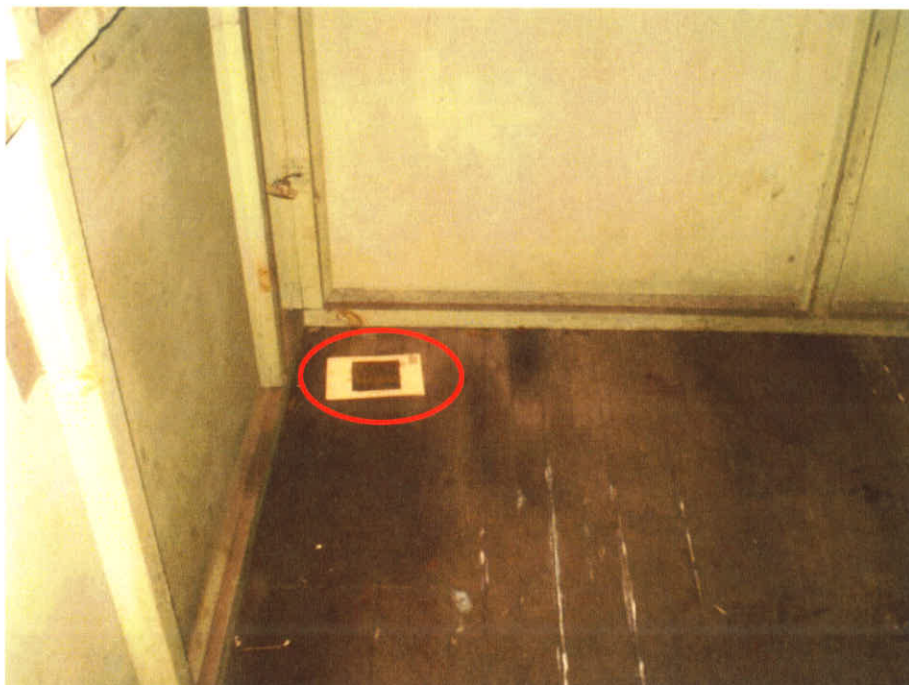
**Photograph No.:** 7      **Photographer:** Caitlin Ruza      **Area:** Building I-Transformer  
**TDD Number:** TO-05-10-12-0002      **Contract:** EP-S5-10-10, OTIE      **Date:** January 24, 2011  
**Site Name & Location:** Mirro-Spirtas Site, Manitowoc, Manitowoc County, Wisconsin  
**Photograph Subject:** MS-WP-2 collected from unstained area of small room adjacent to the transformer room in Building I (template area shown)

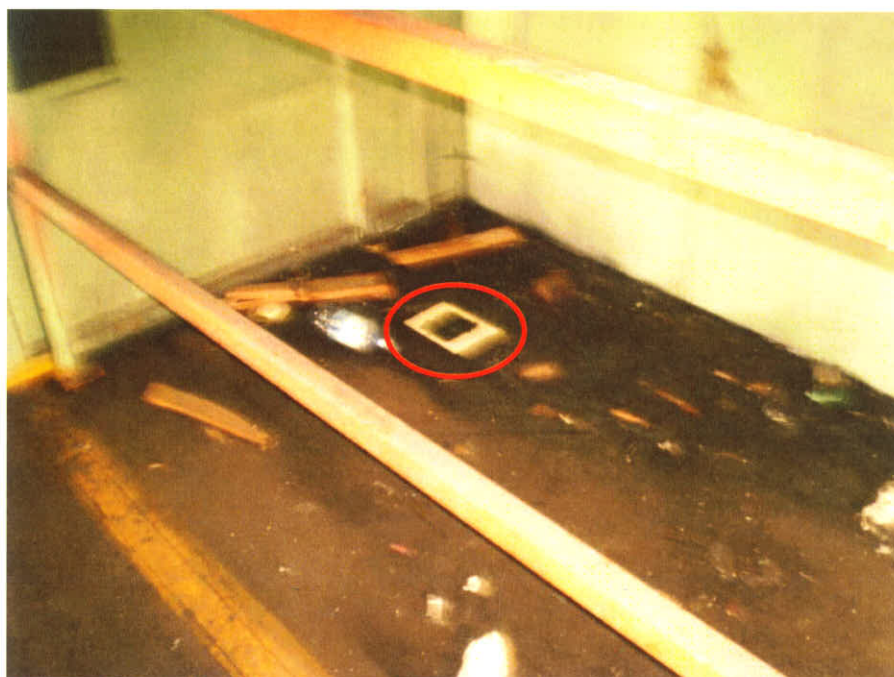
**Photograph No.:** 8      **Photographer:** Caitlin Ruza      **Area:** Building I-Transformer  
**TDD Number:** TO-05-10-12-0002      **Contract:** EP-S5-10-10, OTIE      **Date:** January 24, 2011  
**Site Name & Location:** Mirro-Spirtas Site, Manitowoc, Manitowoc County, Wisconsin  
**Photograph Subject:** MS-WP-3 collected from stained area of small railed in section adjacent to the transformer room in Building I (template area shown)

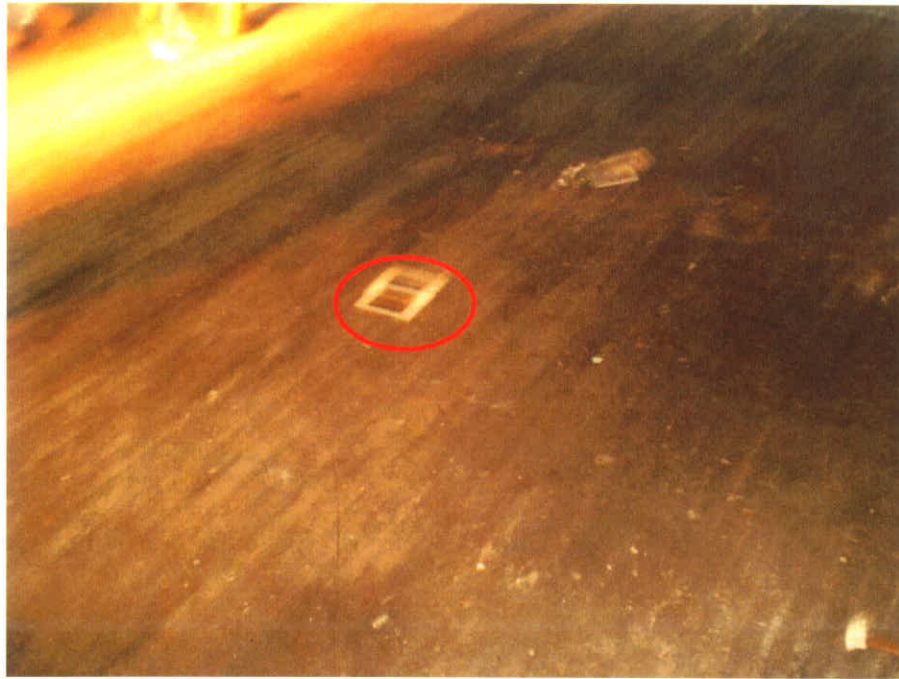
**Photograph No.:** 9                      **Photographer:** Caitlin Ruza                      **Area:** Building I-Transformer  
**TDD Number:** TO-05-10-12-0002                      **Contract:** EP-S5-10-10, OTIE                      **Date:** January 24, 2011  
**Site Name & Location:** Mirro-Spirtas Site, Manitowoc, Manitowoc County, Wisconsin  
**Photograph Subject:** MS-WP-4 collected from edge of saturation staining on flooring outside of the transformer room in Building I (template area shown)

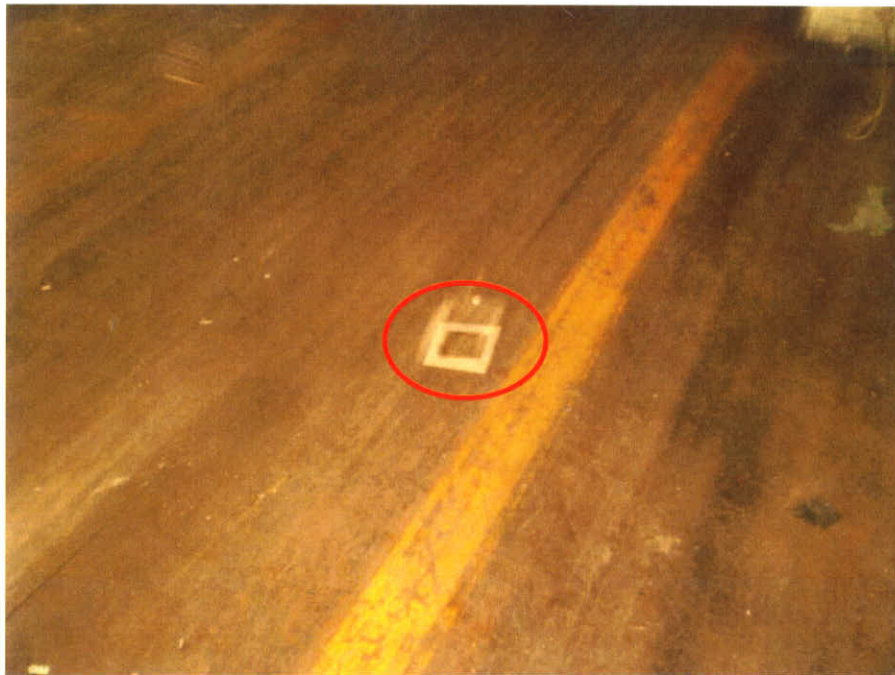
**Photograph No.:** 10                      **Photographer:** Caitlin Ruza                      **Area:** Bldg I-Transformer  
**TDD Number:** TO-05-10-12-0002                      **Contract:** EP-S5-10-10, OTIE                      **Date:** January 24, 2011  
**Site Name & Location:** Mirro-Spirtas Site, Manitowoc, Manitowoc County, Wisconsin  
**Photograph Subject:** MS-WP-5 collected from outside of saturation staining on flooring outside of the transformer room in Building I (template area shown)

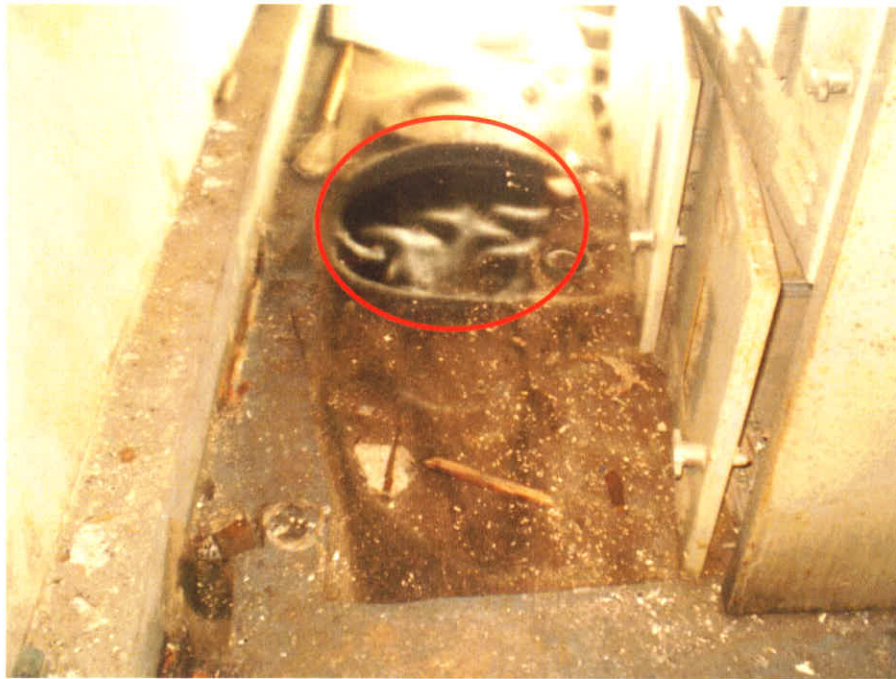
**Photograph No.:** 11      **Photographer:** Caitlin Ruza      **Area:** Bldg I-Transformer  
**TDD Number:** TO-05-10-12-0002      **Contract:** EP-S5-10-10, OTIE      **Date:** January 24, 2011  
**Site Name & Location:** Mirro-Spirtas Site, Manitowoc, Manitowoc County, Wisconsin  
**Photograph Subject:** MS-WP-6 collected from puddle on plastic matting in the transformer room in Building I (approximate sample area shown)

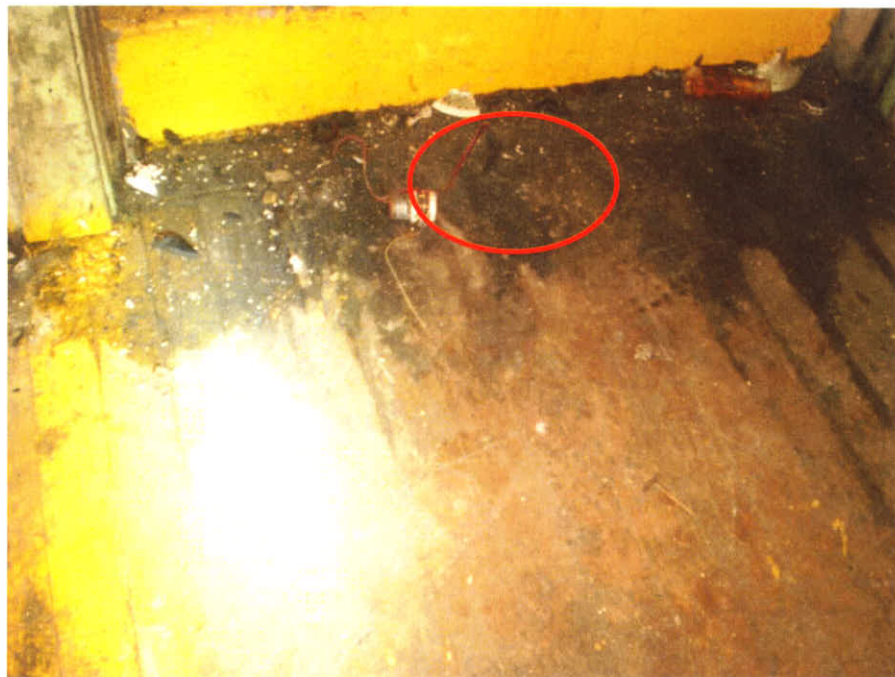
**Photograph No.:** 12      **Photographer:** Caitlin Ruza      **Area:** Bldg I-Transformer  
**TDD Number:** TO-05-10-12-0002      **Contract:** EP-S5-10-10, OTIE      **Date:** January 24, 2011  
**Site Name & Location:** Mirro-Spirtas Site, Manitowoc, Manitowoc County, Wisconsin  
**Photograph Subject:** MS-WP-7 collected from stained area outside of entranceway to the transformer room in Building I (approximate sample area shown)

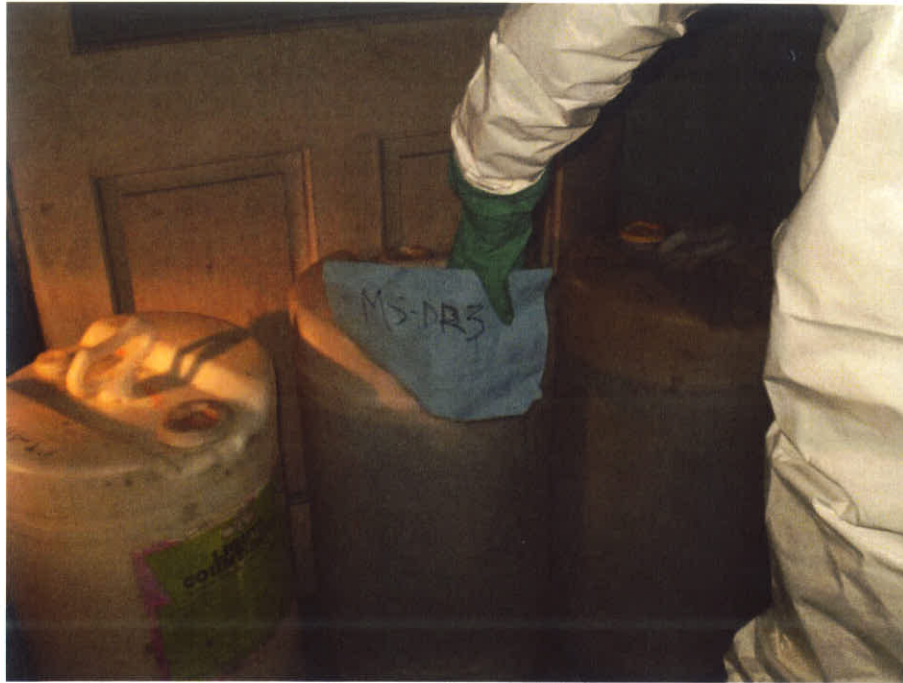
**Photograph No.:** 13      **Photographer:** Caitlin Ruza      **Area:** Bldg I-Transformer  
**TDD Number:** TO-05-10-12-0002      **Contract:** EP-S5-10-10, OTIE      **Date:** January 24, 2011  
**Site Name & Location:** Mirro-Spirtas Site, Manitowoc, Manitowoc County, Wisconsin  
**Photograph Subject:** MS-DR-3 was collected from the middle drum of three drums located to the right of the entranceway of the room containing the transformer in Building I

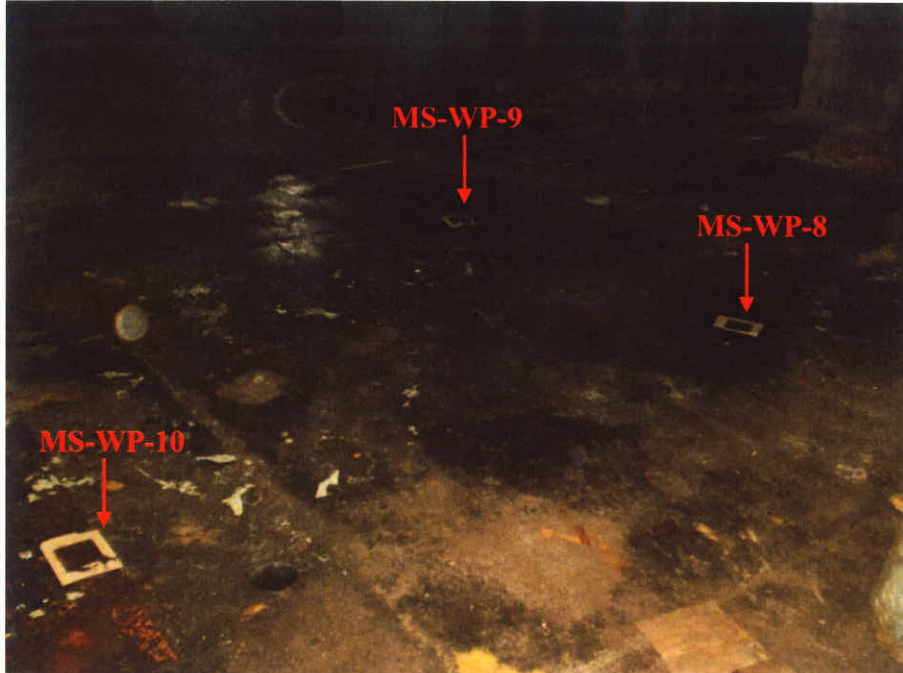
**Photograph No.:** 14      **Photographer:** Caitlin Ruza      **Area:** Bldg K-Loading Dock  
**TDD Number:** TO-05-10-12-0002      **Contract:** EP-S5-10-10, OTIE      **Date:** January 24, 2011  
**Site Name & Location:** Mirro-Spirtas Site, Manitowoc, Manitowoc County, Wisconsin  
**Photograph Subject:** MS-WP-8 was taken directly in front of the bins in the loading dock in Building K. MS-WP-9 was taken adjacent to MS-WP-8. MS-WP-10 was taken in front of Door #7 of the loading dock in Building K (template areas shown)

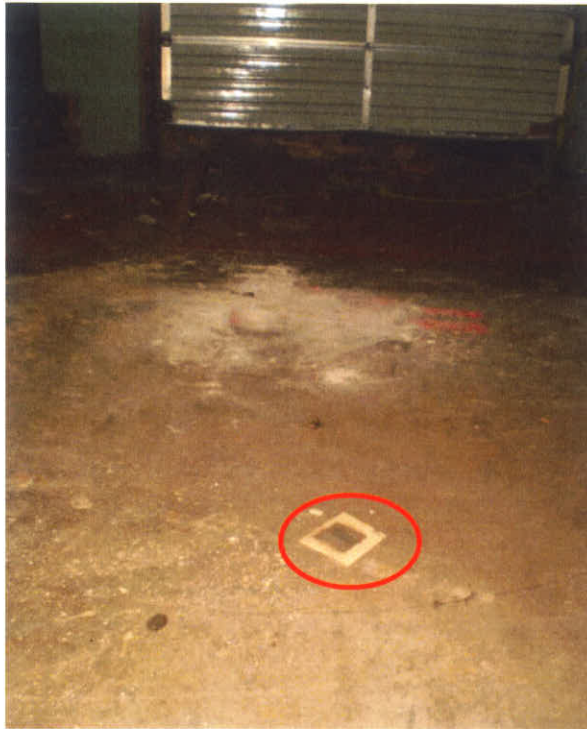
**Photograph No.:** 15 **Photographer:** Caitlin Ruza **Area:** Bldg K-Loading Dock  
**TDD Number:** TO-05-10-12-0002 **Contract:** EP-S5-10-10, OTIE **Date:** January 24, 2011  
**Site Name & Location:** Mirro-Spirtas Site, Manitowoc, Manitowoc County, Wisconsin  
**Photograph Subject:** MS-WP-11 was collected from in front of Door #6 (shown in the background) of the loading dock in Building K (template area shown)

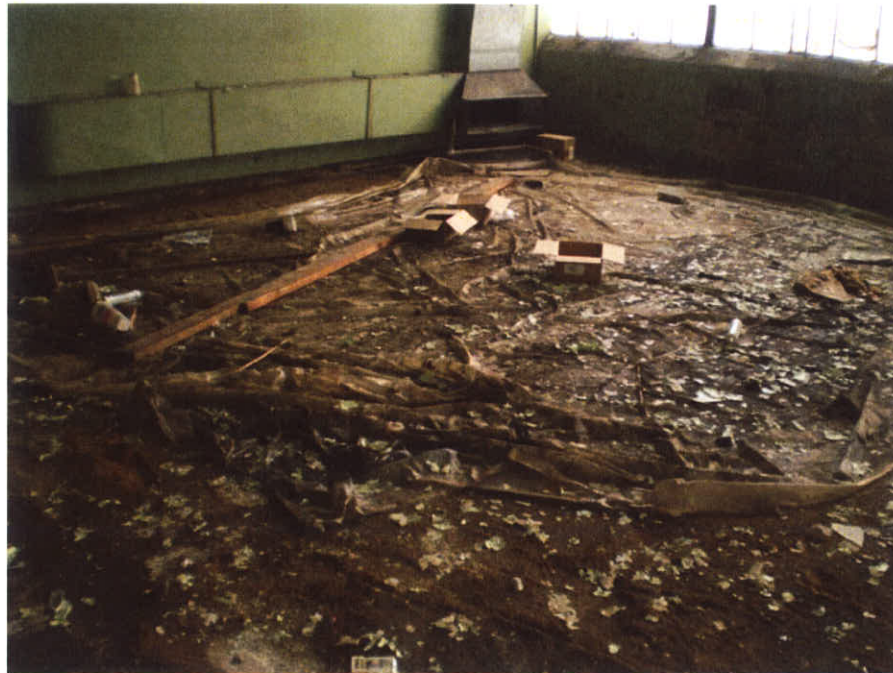
An open sand pit in Building L was the next area observed (Figure 2 – Site Layout Map). The sand pit is located in the northwest corner of Building L. Former Mirro employees suggested that the pit was used to collect runoff oil from machinery during operation.

**Photograph No.:** 16 **Photographer:** Caitlin Ruza **Area:** Building L-Sand Pit  
**TDD Number:** TO-05-10-12-0002 **Contract:** EP-S5-10-10, OTIE **Date:** January 24, 2011  
**Site Name & Location:** Mirro-Spirtas Site, Manitowoc, Manitowoc County, Wisconsin  
**Photograph Subject:** MS-SAND-1 was collected as a 5-point composite sample from the sand material area in Building L

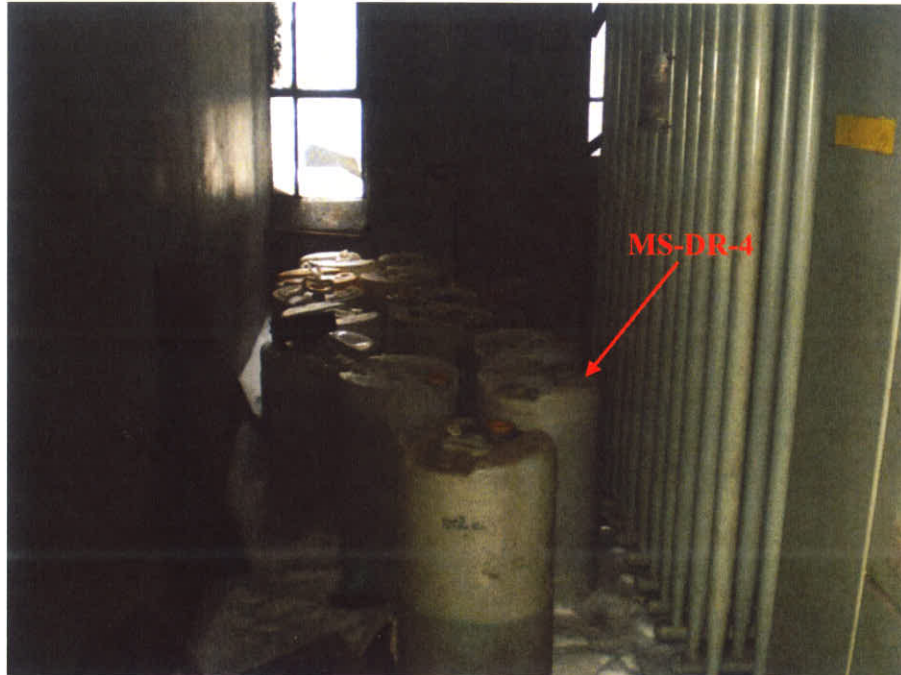
**Photograph No.:** 17      **Photographer:** Caitlin Ruza      **Area:** Building K-Transformer  
**TDD Number:** TO-05-10-12-0002      **Contract:** EP-S5-10-10, OTIE      **Date:** January 24, 2011  
**Site Name & Location:** Mirro-Spirtas Site, Manitowoc, Manitowoc County, Wisconsin  
**Photograph Subject:** MS-DR-4 was collected from the second drum back from the front of the photo on the right.  
These 14 drums are located inside the transformer room in Building K
