SUBJECT: Review of the Site Investigation – Additional Investigation Needed
Mirro Plt 9 (Former) – LGU, 1512 Washington Street, Manitowoc, WI
BRRTS #: 02-36-545108, FID #: 436033730

Review

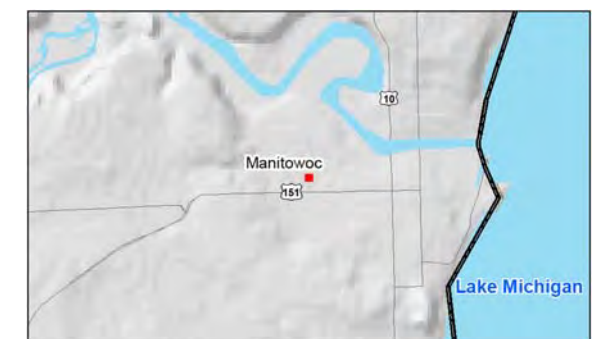
Figure No. **2**
 Title
Potential Source Areas and Historic Sampling Locations
 Client/Project
 City of Manitowoc
 USEPA Brownfield Assessment Grant
 Hazardous Substances
 0 45 90 Feet
 193703931
 Prepared by HLB on 5-22-18

Source ID	Potential Source
1	Pit
2	Compressor Pits
3	Boiler Room
4	Steam Outlet
5	Etching Room
6	Anodizing Room
7	Basement Sump
8	Former Tannery
9	Drainage Channels
10	Coal Boiler Room
11	Heat Treat Pit
12	Paint Mixing

characterized as a mixture of acetone and polyvinyl fluoride, but also contained high concentrations of PFBA and PFOA. Historically, another NAPL area was found under Building C from a sample from TW-108, which consisted of diesel fuel and/or motor oil but was not confirmed in more recent sampling (see attached Figure 2, Potential Source Areas and Historic Sampling Locations, dated February 2, 2020).

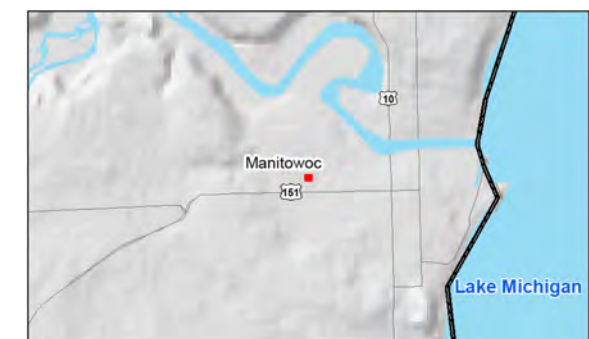
Historic Soil Impacts

- As > BTV
- As and Pb > BTV
- As > IDCL RCL
- PAH > IDC RCL and GW RCL
- PAH > GW RCL
- PCB = 210 mg/kg
- PCB = 0.5 mg/kg
- PCB = 6 mg/kg
- PCB = 0.2 mg/kg
- Benzene > GW RCL
- cVOC > GW RCL

Notes:
 BTV = ch. NR 720 WAC Background Threshold Value
 * IDC RCL = Ch. NR 720 WAC Residual Contaminant Level for Direct Contact at Industrial Properties
 * GW = ch. NR 720 WAC Residual Contaminant Level for the Soil to Groundwater Pathway
 PAH = Polycyclic Aromatic Hydrocarbon
 PCB = Polychlorinated Biphenyl
 cVOC = Chlorinated Volatile Organic Compounds
 * Note the plumes illustrated herein are based on 2015 RCLs

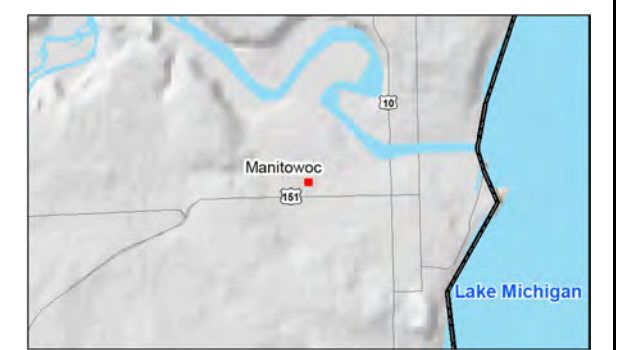
- LNAPL
- Target Parcel
- Former Building Walls
- Parcels

- NAPL under former Building K was found in multiple monitoring points and a sample collected from MW-12. The NAPL had no PCBs and is not likely petroleum based. The NAPL has been

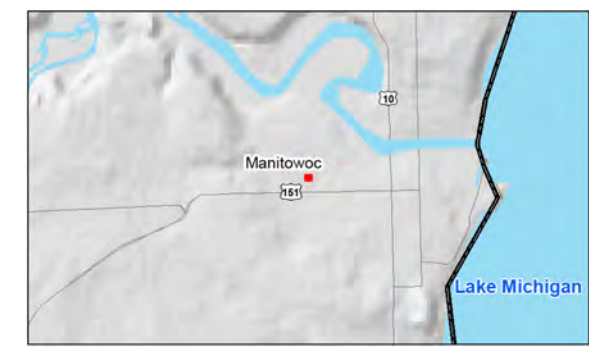
- Legend**
- Symbiont Soil Borings/Temp Wells
 - Monitoring Wells
 - Historic Sampling Locations
 - LNAPL (AES, 2010)

- Historic Groundwater Impacts**
- PAH > ES
 - PAH > PAL
 - Misc. Metals > ES
 - As, Se, or Cr > ES
 - Cr > ES
 - cVOC > ES
 - cVOC > PAL
 - Pet VOC > ES
 - Benzene > PAL
 - Former Building Layout
 - Target Parcel
 - Parcels
