Remedial Investigation/ Feasibility Study

Lincoln Park /Blatz Pavilion Site

March 29, 2007

Project 1845

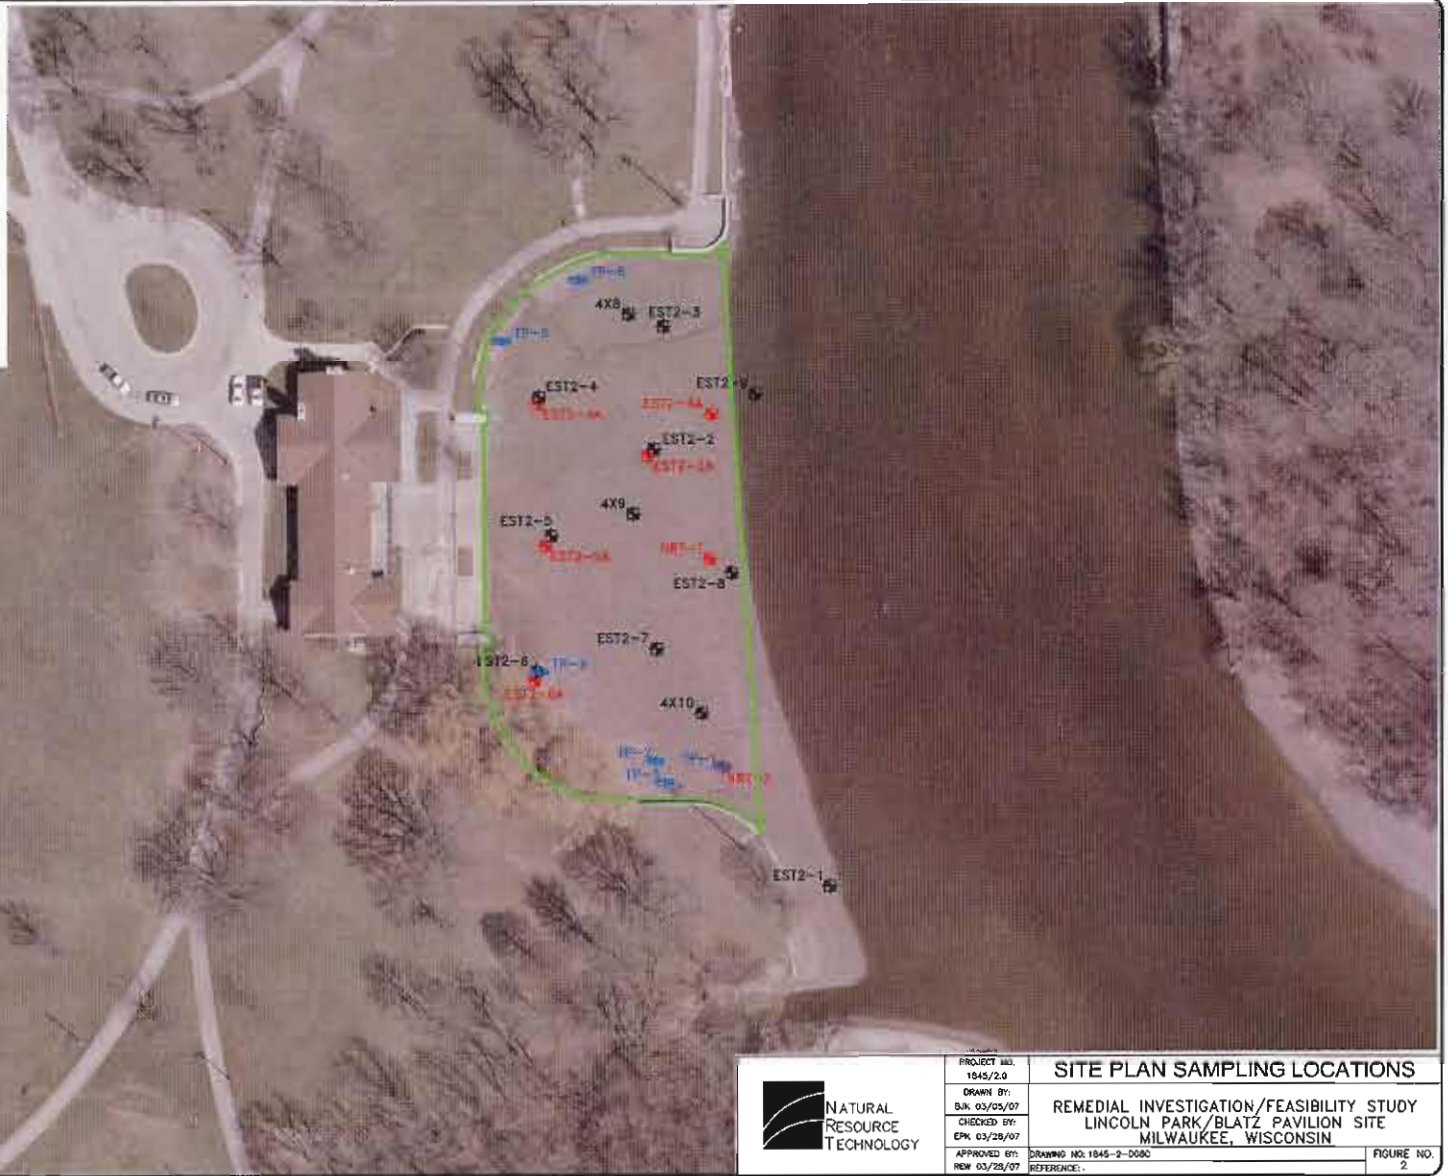
FIGURE NO.
2

SOURCE: AERIAL PHOTO COURTESY OF MILWAUKEE COUNTY PARK SYSTEM. THIS SITE PLAN AND CORE LOCATIONS SUBMITTED BY NRT OCTOBER 2006.

NRT also completed six test pits (TP-1 through TP-6) to evaluate the base of the retaining wall as well as verify the sediment thickness and lithology near a few of the sampling locations (Figure 2). The test pits were completed at depths ranging from two feet to six feet. Grab samples were collected from the lower clay layer for PCB testing from test pits TP-1, TP-2 and TP-5. In general, test pits were backfilled immediately with the exception of TP-1 which was allowed to remain open for approximately two hours to further assess surface water infiltration. A qualitative structural evaluation of the embayment wall was also completed through visual observations that focused on assessing the wall foundation and other factors that require consideration to minimize potential damage during remediation. NRT staff returned to the site on December 28, 2006 and completed a survey of the surface elevation at all of the boring and test pit locations. The laboratory analytical report for the PCB results is included in Appendix B.

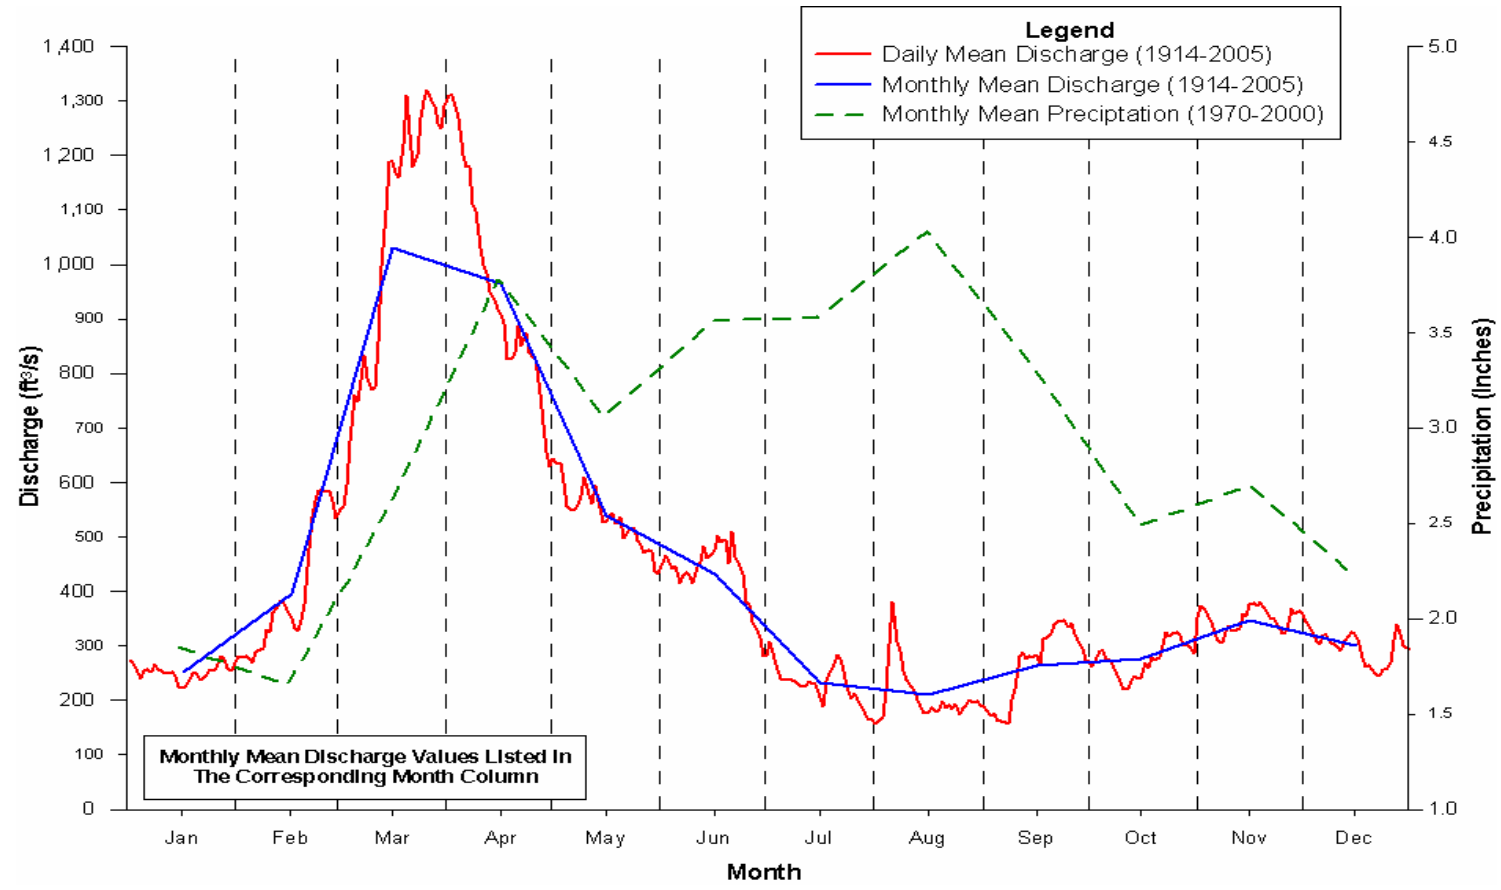
MILWAUKEE RIVER HYDROGRAPH AND
PRECIPITATION PLOT
REMEDIAL INVESTIGATION/FEASIBILITY STUDY
LINCOLN PARK/BLATZ PAVILION
MILWAUKEE, WISCONSIN

Flow within this segment of the river is regulated by the Estabrook Dam as discussed in Section 1.3. The MCPD typically opens the dam (allowing unrestricted water flow) around October 1 and closes it around May 1. The target dates are sometimes shifted slightly to accommodate repairs, construction, or other events. The dam is closed in summer to fill the impoundment to a target elevation of 616 feet above msl. The Estabrook Impoundment has also been lowered in anticipation of high flow events. Opening the dam dewateres the embayment sediments which may induce some compaction due to dewatering.

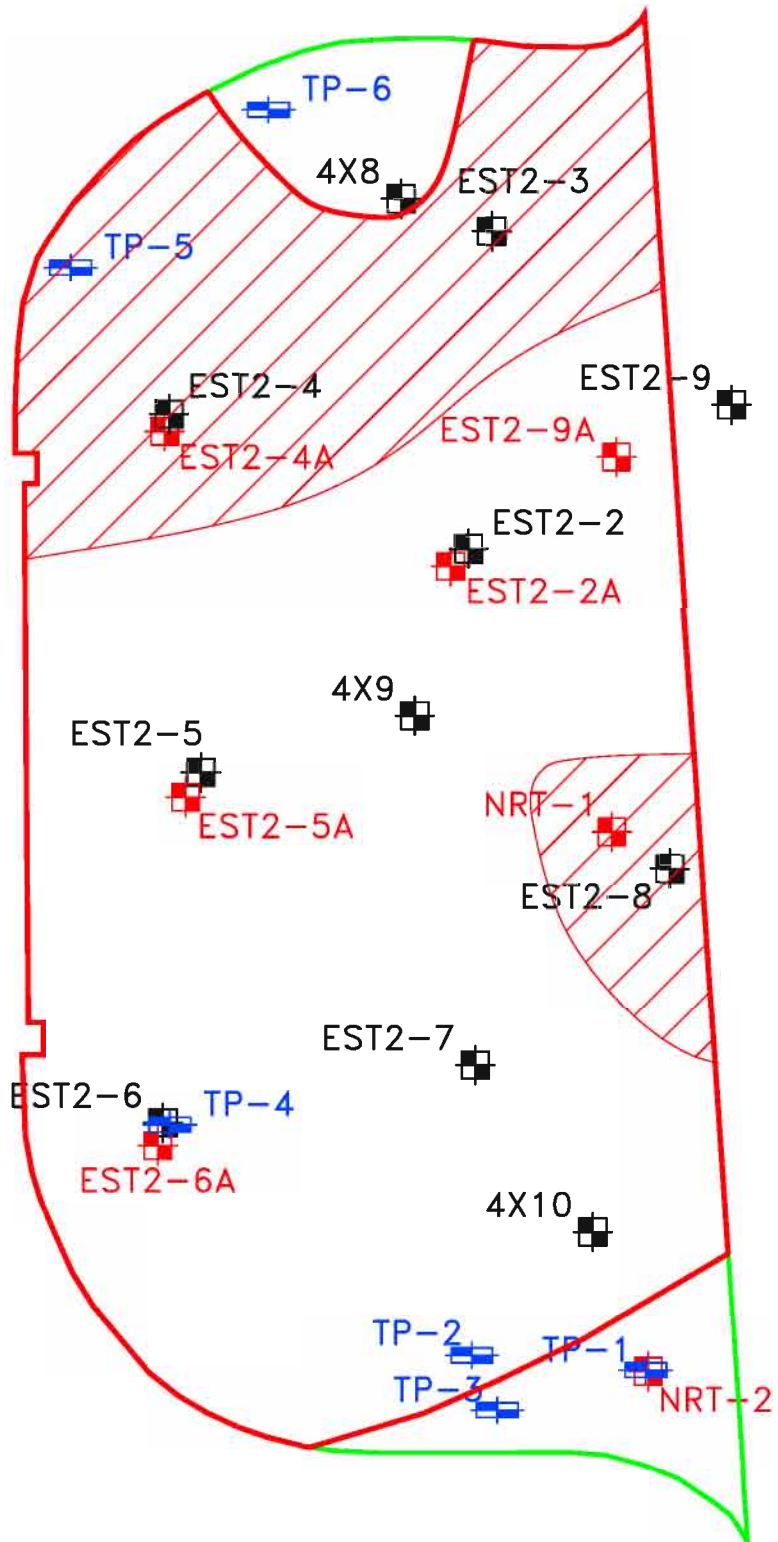
FIGURE NO.
5

>50 mg/kg AT OR BELOW SURFACE

**LATERAL EXTENT OF SEDIMENT
GREATER THAN 50 mg/kg**

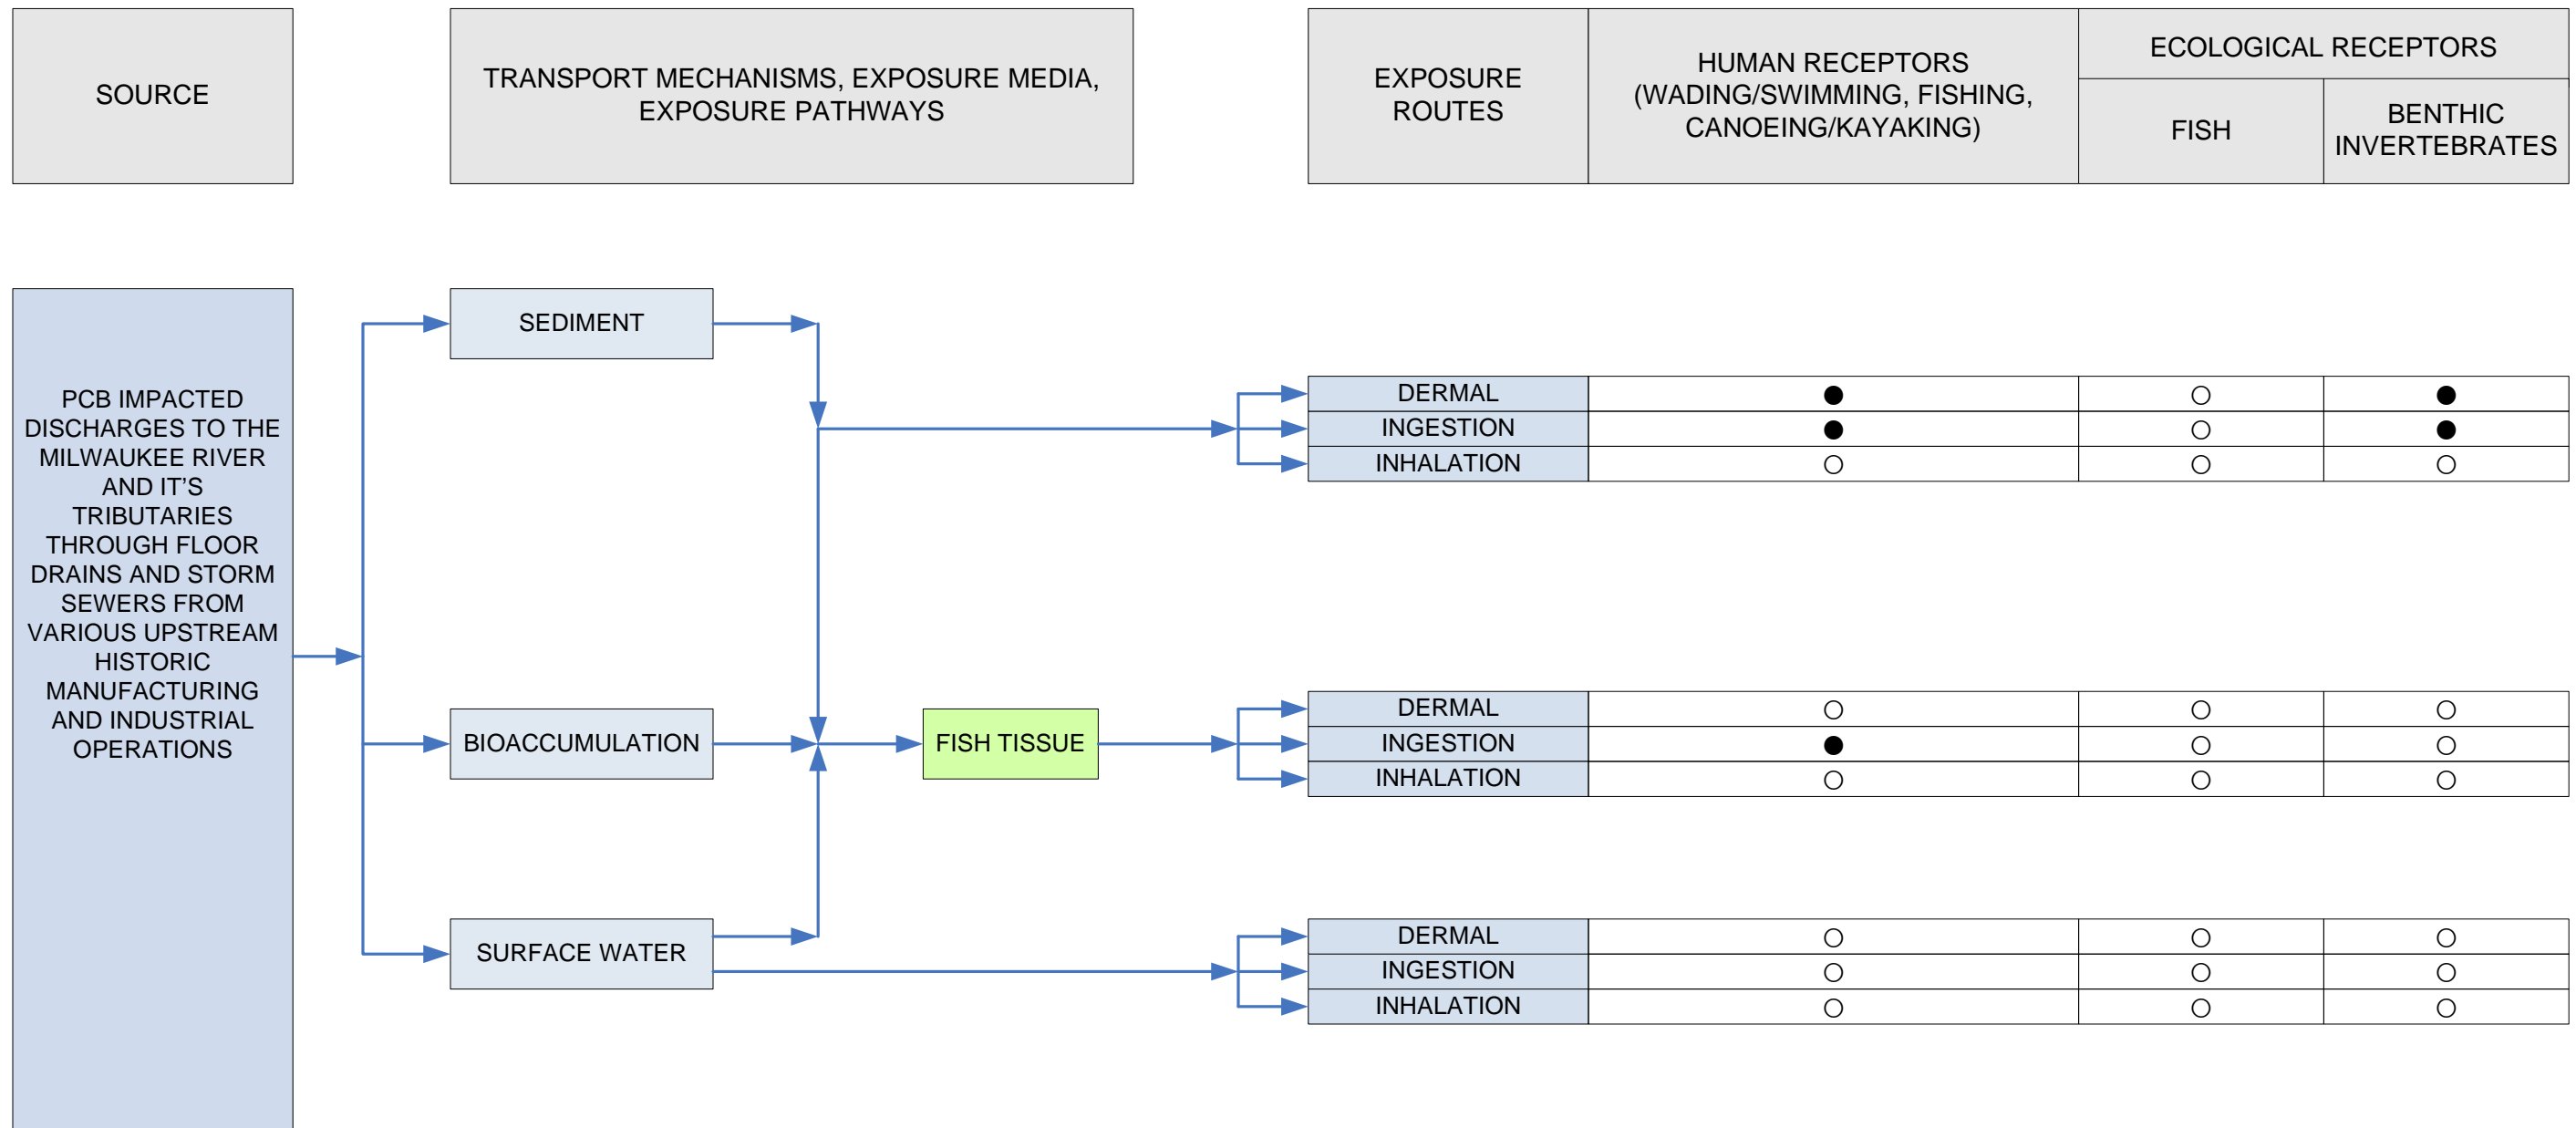
LEGEND:
 ● Complete or possibly complete exposure route.
 ○ Pathway not complete or considered less significant.

PROJECT No. 1845		CONCEPTUAL SITE MODEL REMEDIAL INVESTIGATION / FEASIBILITY STUDY LINCOLN PARK / BLATZ PAVILION MILWAUKEE, WISCONSIN	Drawn By: JTB	Date 01/19/2007
			Checked: EPK	Date 01/22/2007
Figure 6			Approved: REW	Date 01/22/2007

- **Ecological Receptors:** Exposure pathways for ecological receptors affect primarily benthic invertebrates and are complete with respect to the dermal and ingestion routes for sediment. Although this pathway is considered complete, it is somewhat limited based on the fact that annual dewatering of the sediments exposes the benthic community to desiccating conditions and freezing. These seasonal conditions likely severely reduce the benthic population. The fish exposure is considered an incomplete pathway because the fish are completely absent during dewatered periods and have a large foraging range during summer, which limits their overall exposure to PCBs in the embayment sediments.

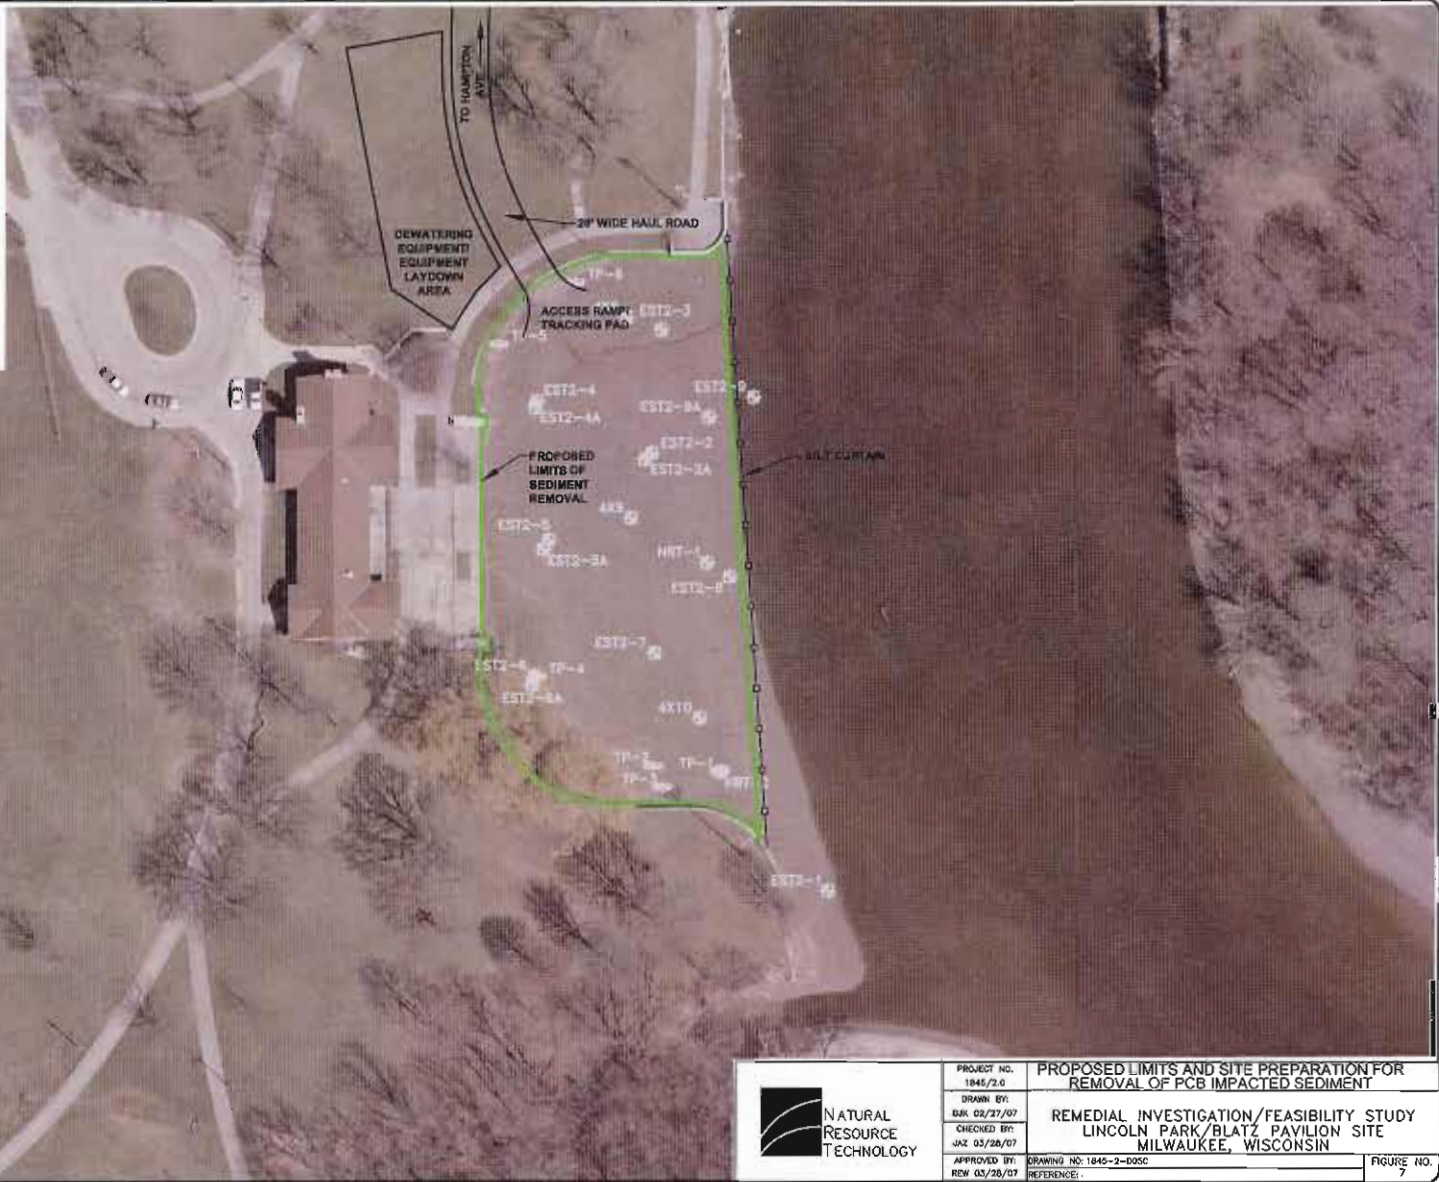
PROJECT NO. 1845/2.0	PROPOSED LIMITS AND SITE PREPARATION FOR REMOVAL OF PCB IMPACTED SEDIMENT
DRAWN BY: BAR 02/27/07	REMEDIAL INVESTIGATION/FEASIBILITY STUDY LINCOLN PARK/BLATZ PAVILION SITE MILWAUKEE, WISCONSIN
CHECKED BY: JAZ 03/28/07	
APPROVED BY: REW 03/28/07	DRAWING NO: 1845-3-005C REFERENCE:
	FIGURE NO. 7

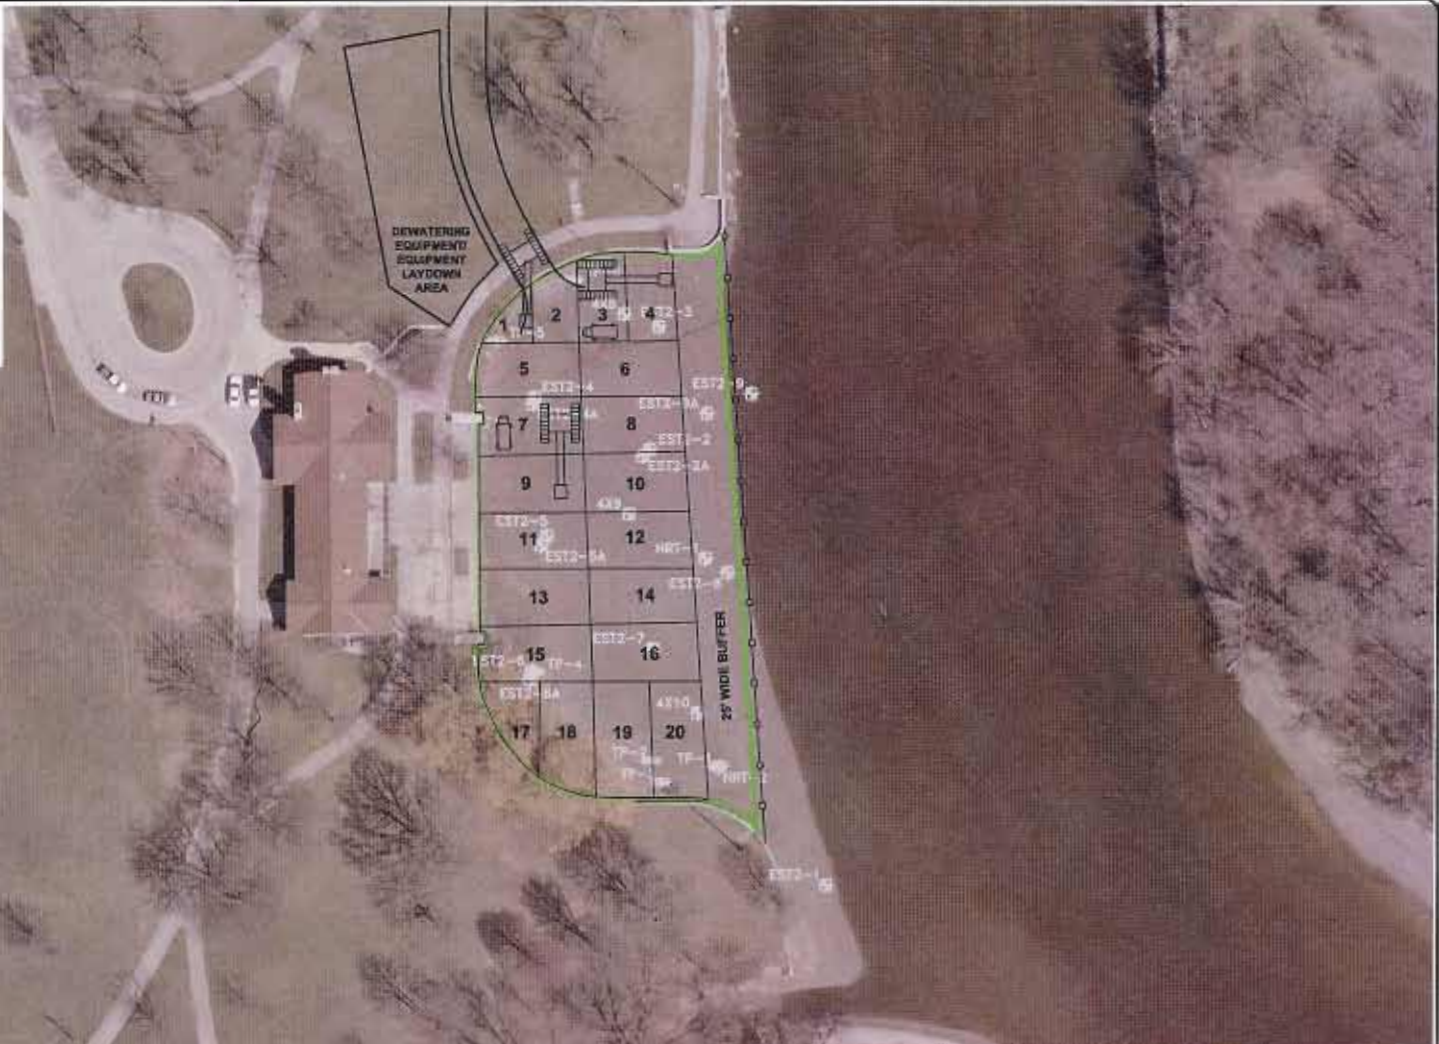
PROJECT NO: 1845/2.0	PHASE I CONCEPT PLAN FOR REMOVAL OF PCB IMPACTED SEDIMENT
DRAWN BY: BAK 02/27/07	REMEDIAL INVESTIGATION/FEASIBILITY STUDY LINCOLN PARK/BLATZ PAVILION SITE MILWAUKEE, WISCONSIN
CHECKED BY: JAZ 03/28/07	
APPROVED BY: REW 03/30/07	DRAWING NO: 1845-2-005C
REFERENCE:	FIGURE NO. 8

A two-phased approach for the sediment removal is planned. Also, each phase is further divided into a "cell" approach. Phase I consists of sediment removal from approximately twenty cells, each approximately 30 feet by 60 feet (Figure 8). The cell dimensions may be modified during field operations as recommended by the excavation contractor. Phase II consists of removal of the final five cells near the river, including proposed shoring along the eastern boundary (Figure 9). Based on the test pit observations, it is anticipated that sediment located within approximately 25 feet of the eastern boundary (near the river edge) will require dewatering. Limited dewatering may also be needed within the Phase I cells. Dewatering procedures will be discussed further below.

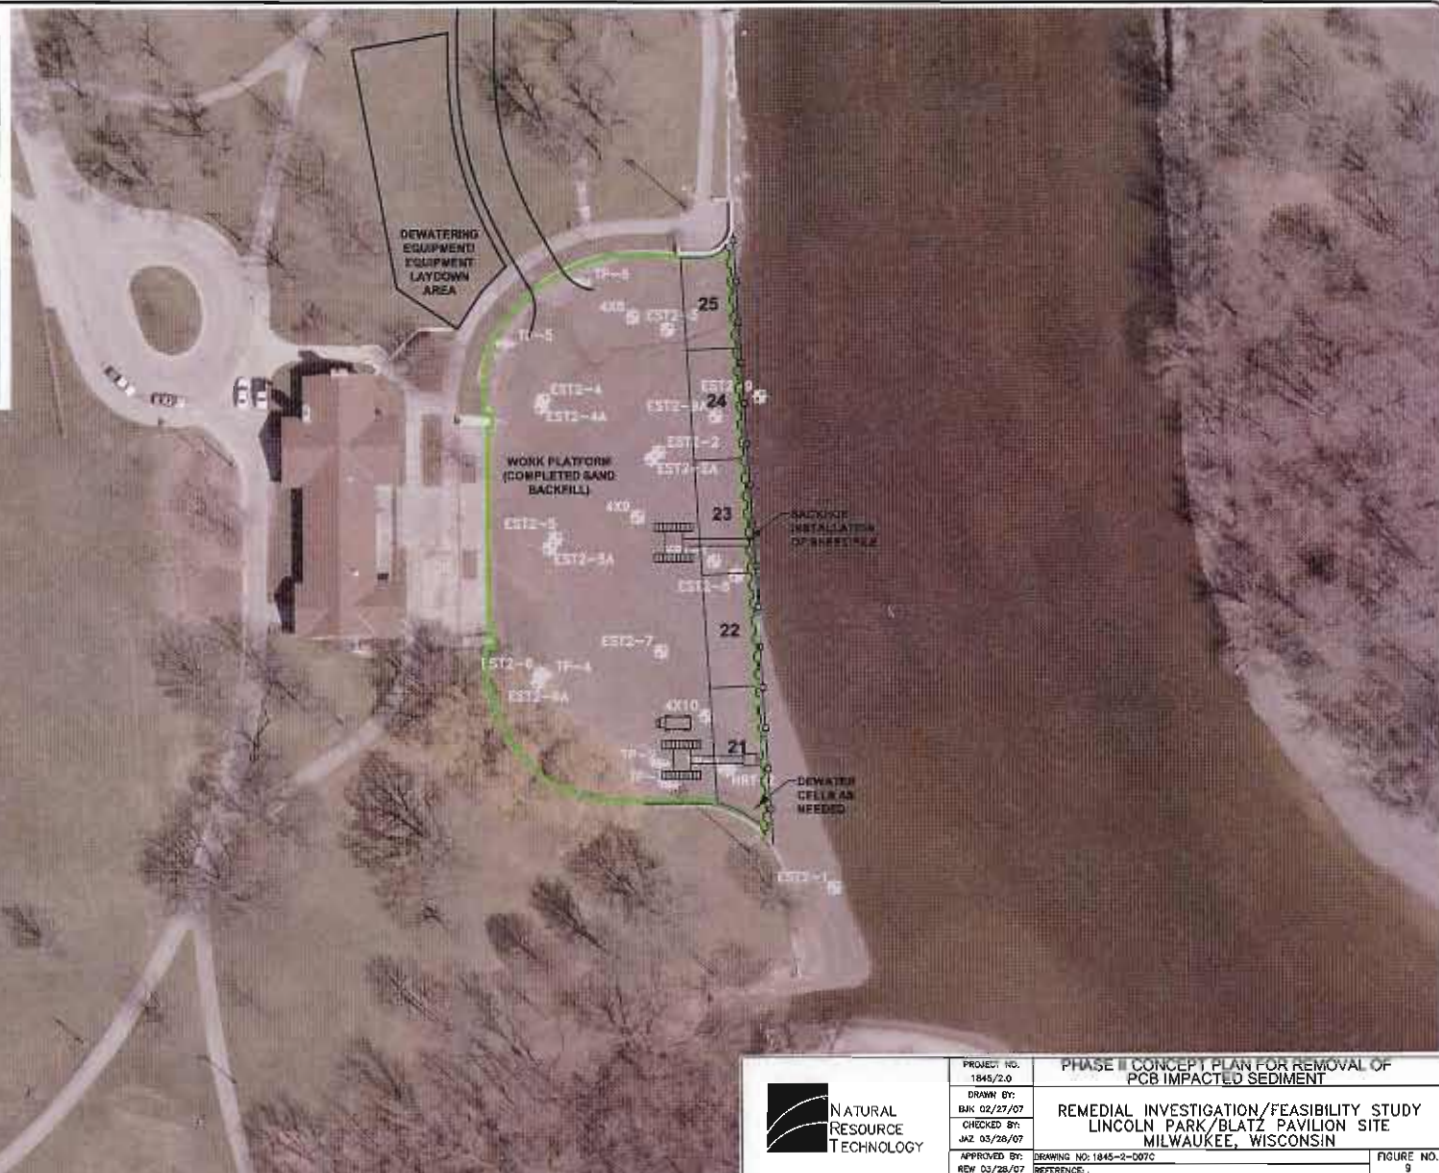
PHASE II CONCEPT PLAN FOR REMOVAL OF PCB IMPACTED SEDIMENT
REMEDIAL INVESTIGATION/FEASIBILITY STUDY
LINCOLN PARK/BLATZ PAVILION SITE
MILWAUKEE, WISCONSIN
DRAWING NO: 1845-2-007C
REFERENCE:
FIGURE NO.
9

Following completion of the Phase I cells (cells 1 through 20), a work platform will be established such that the temporary sheet pile shoring system can be installed (Figure 9). The shoring system is anticipated to consist of steel or vinyl sheet pile in 8 to 10 foot lengths. Backhoe methods are proposed to install the sheet pile into the clay till material below sediment. Based on field conditions and if approved by WDNR, the shoring system may not be installed or be only partially installed depending dewatering or stability needs.

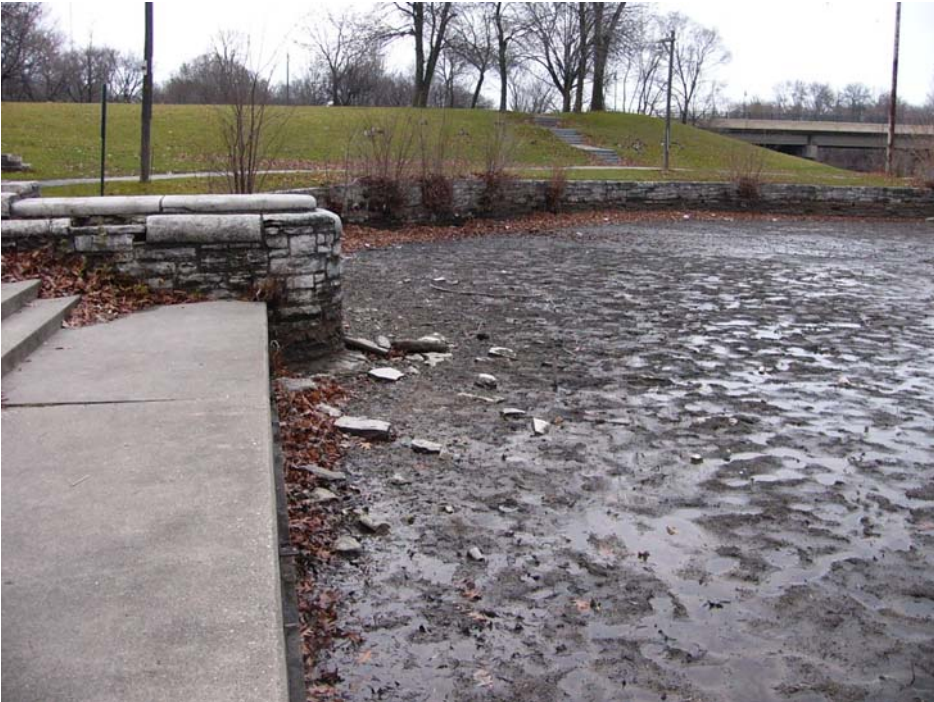
Photo #4. West side of Embayment looking north towards road.

of the wall is in a state of disrepair and shows evidence of significant deterioration at several locations consisting of spalling, loss of stone and penetration of root growth directly through the wall (see photograph 4, Appendix A). In addition, lateral earth pressures have resulted in movement of the wall particularly at the south end of the embayment. Further structural evaluation of the wall may be warranted depending on the location selected for possible access of heavy equipment. A preliminary retaining wall evaluation, prepared by GESTRA Engineering, is provided in Appendix E.

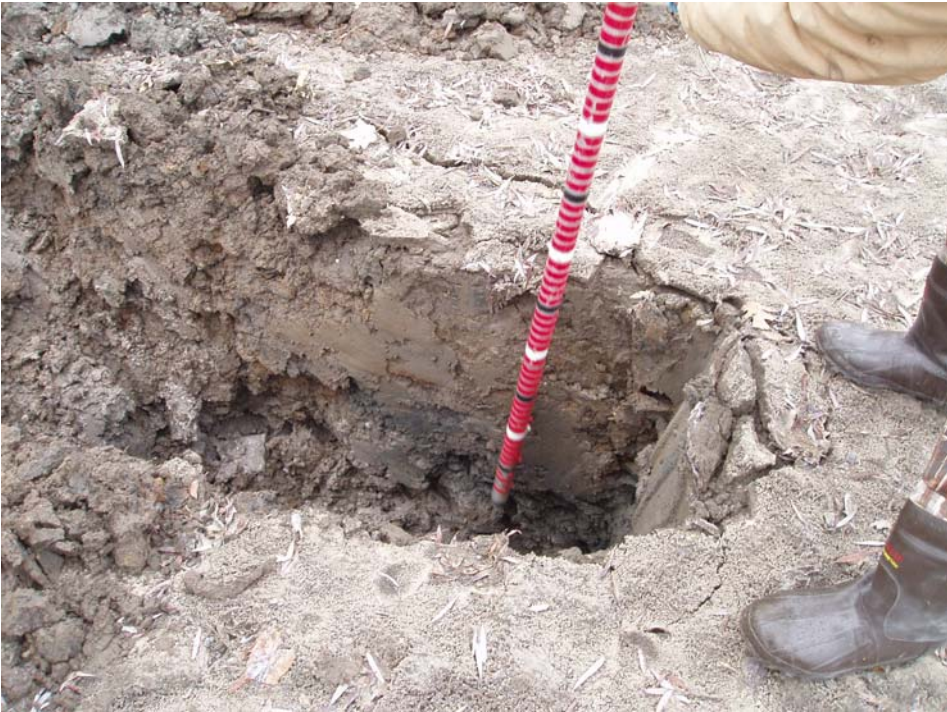
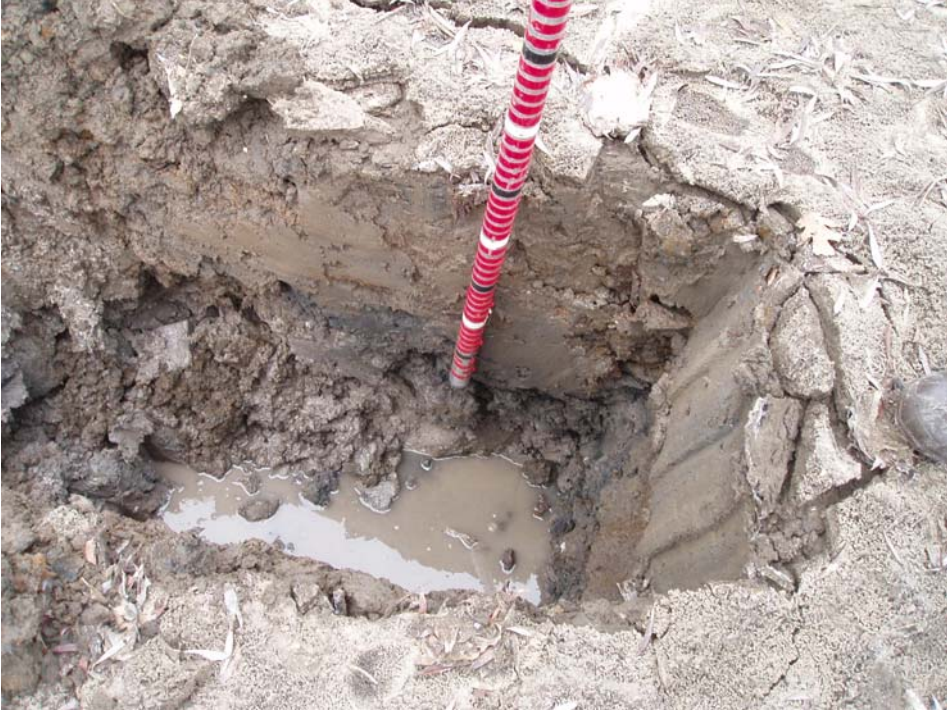
Photo #8. Test Pit #1, south end of Embayment out from retaining wall. White lines are feet.

Photo #9. Test Pit #1, south end of Embayment out from retaining wall. White lines are feet.

- Significant surface water infiltration was observed at TP-1 (closest to the river) where the test pit completely filled with water over approximately two hours;
- Surface water infiltration was observed in all of the test pits primarily along the clay/sediment interface;
- Surface water infiltration decreased in test pits excavated further from the river;
- In general, no free water was noted in excavated sediment that was temporarily stockpiled next to each test pit; and
- No discernable indication of groundwater infiltration was observed although the length of time the test pits were allowed to remain open was limited given the low permeability clay till.

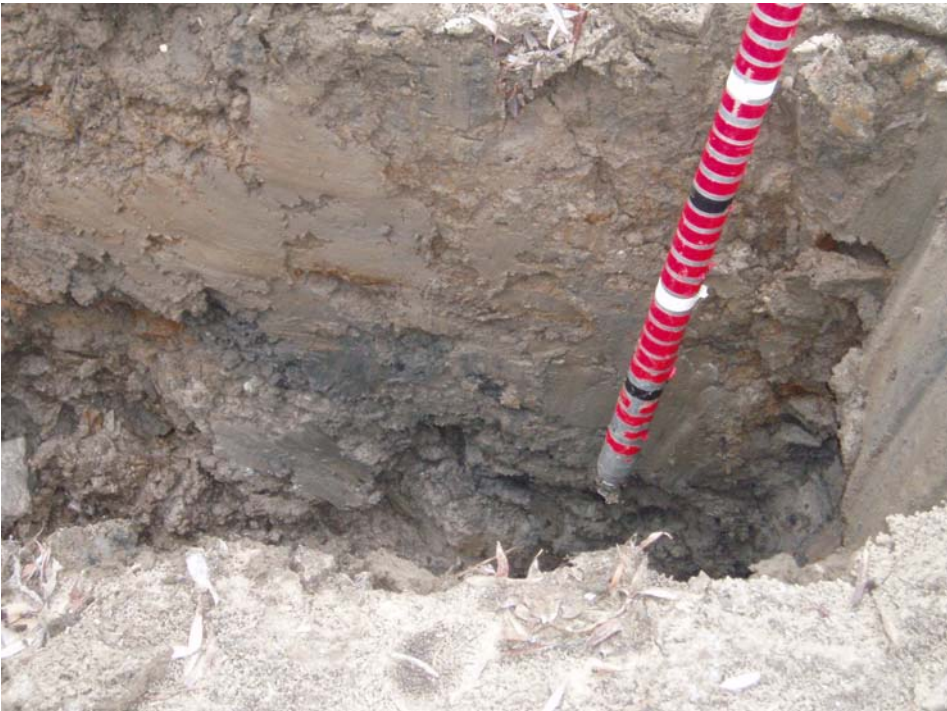
Photo #10. Test Pit #1, south end of Embayment out from retaining wall. Gray blocky material at the bottom is till.

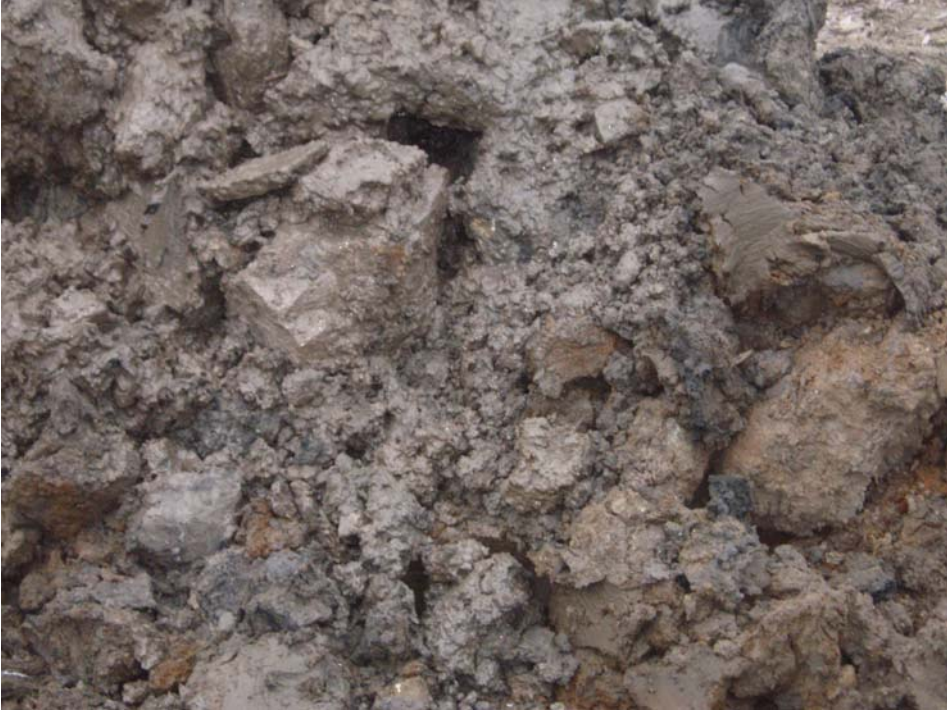
Photo #11. Test Pit #1, south end of Embayment out from retaining wall. Close up of till removed from the bottom of the pit, note large stone cobbles.

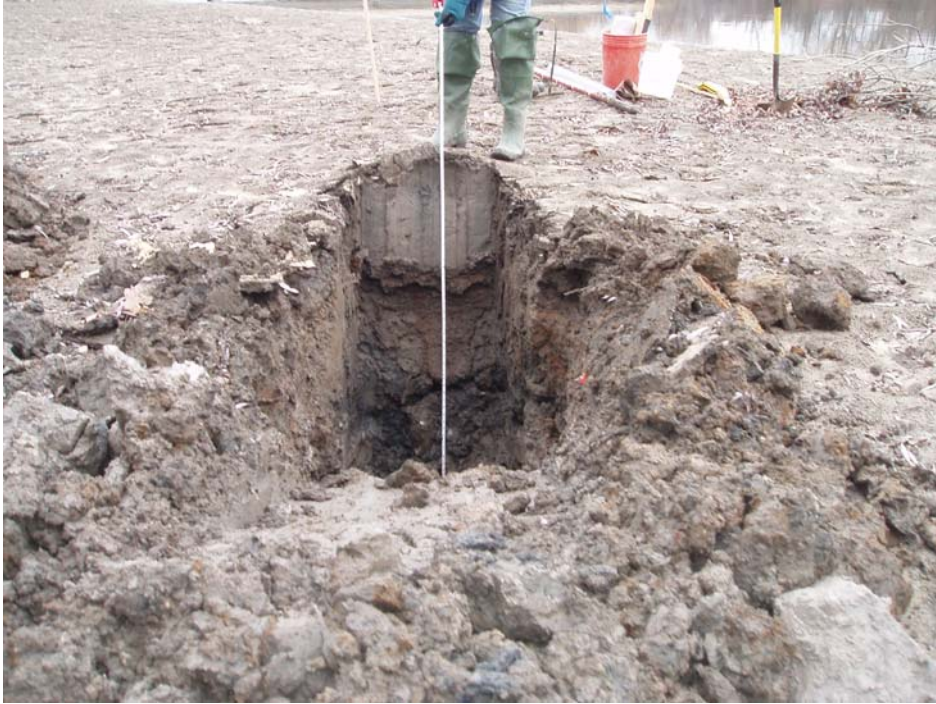
Photo #13. Test Pit #2, approximately 5 feet deep.

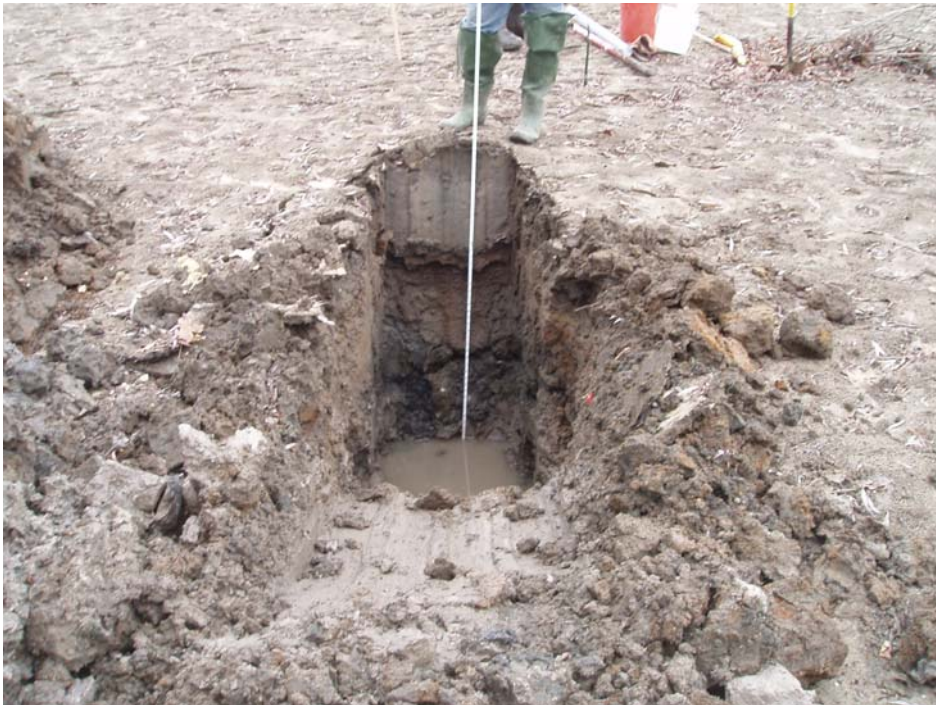
Photo #14. Test Pit #2, note surface water infiltration approximately 4 feet from the surface.

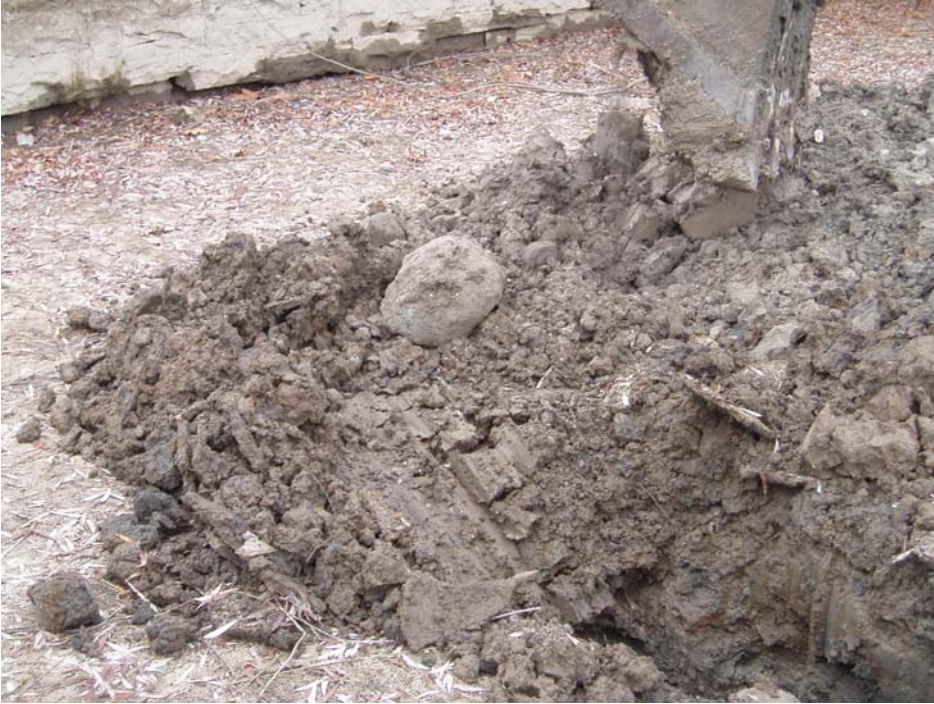
Photo #15. Test Pit #2, note large cobbles beneath the sediment.

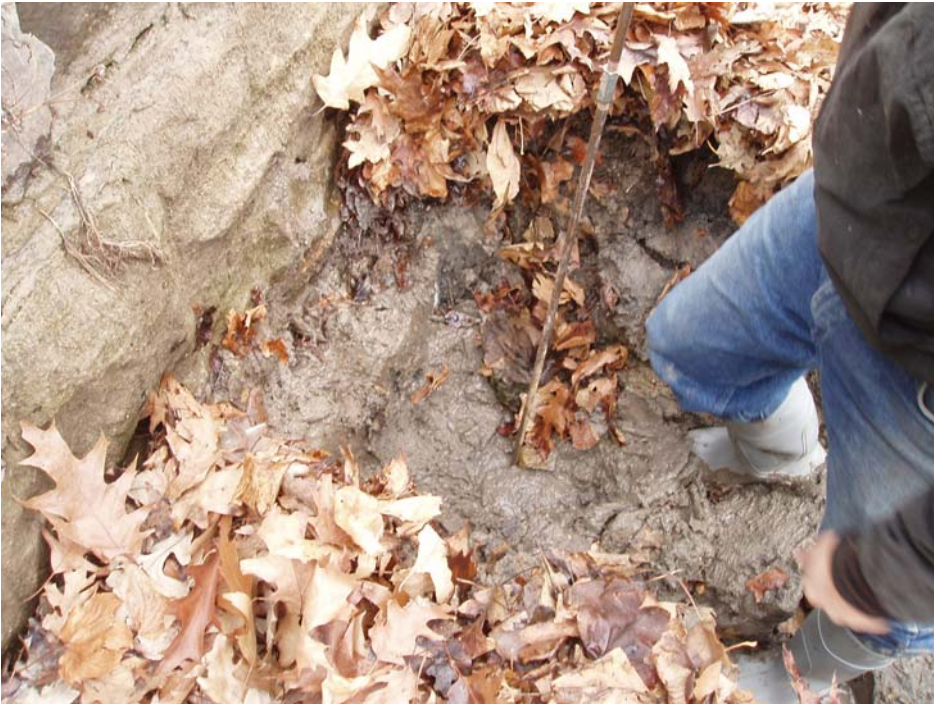
Photo #16. Test Pit #5 where retaining wall meets Embayment.

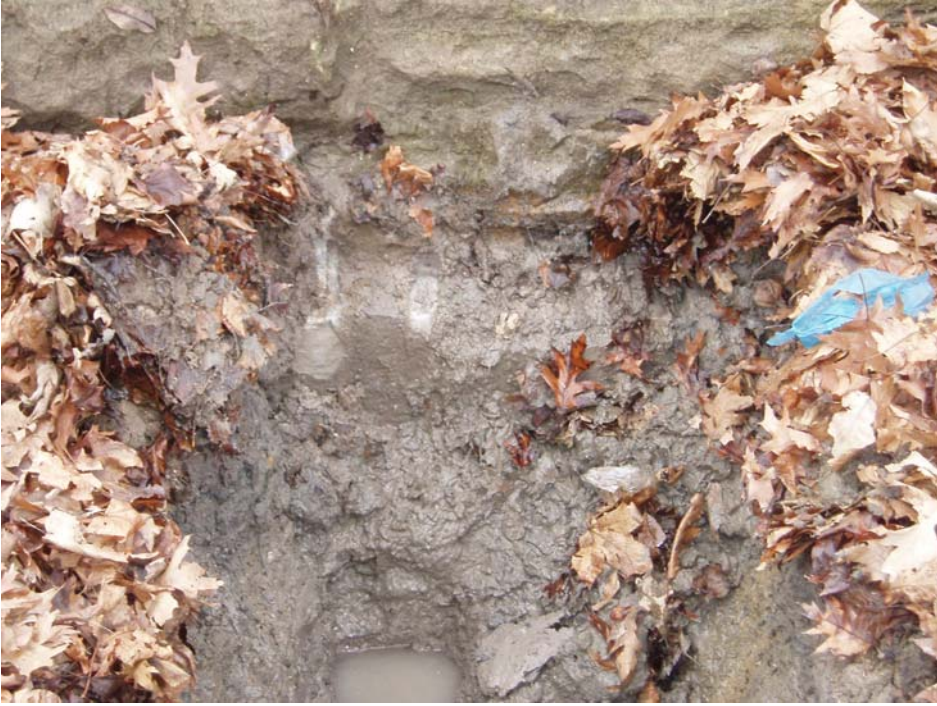
Photo #17. Test Pit #5, retaining wall excavation.

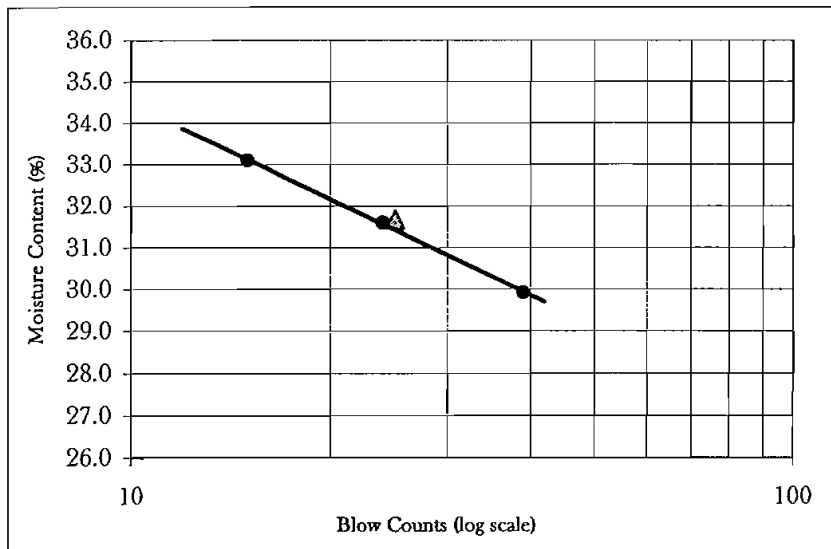
Liquid Limit 32
 Plastic Limit 17
 Plasticity Index 15
 USCS Symbol CL

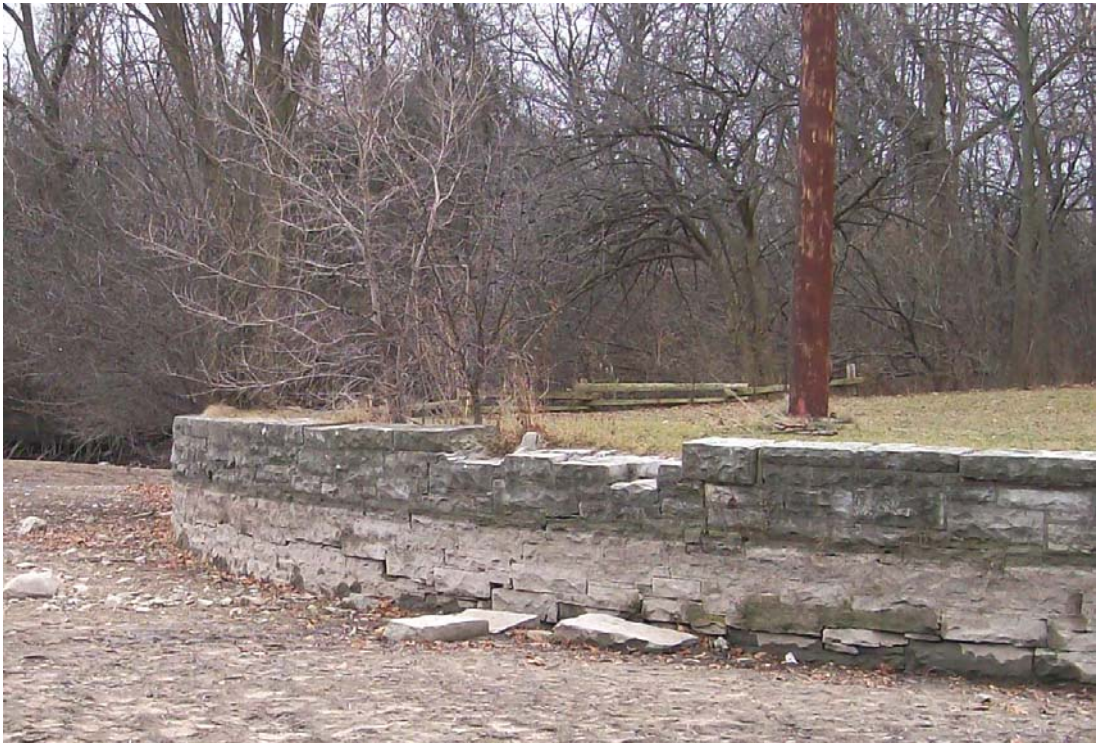
Photograph 1: south end of wall

1. At one location several top blocks (see photograph 1 below) were no longer in place and were lying at the base of the wall. These top row blocks are more decorative than functional.
2. There is slight overturning at portions of the south half of the wall. A plumb bob hung over the edge of the wall showed about 2-inches of overhang from vertical for portions of the 4-foot high wall.
3. There are some cracks forming between individual blocks in a "stairstep" pattern suggesting some differential movement of blocks may be occurring.
4. Some small trees growing behind the wall could be contributing to movement of the wall (photograph 1). More significant damage is occurring due to scrub trees growing within the wall face in the north half of the wall (photograph 2).
