Remedial Investigation/ Feasibility Study

Lincoln Park /Blatz Pavilion Site

March 29, 2007

Project 1845

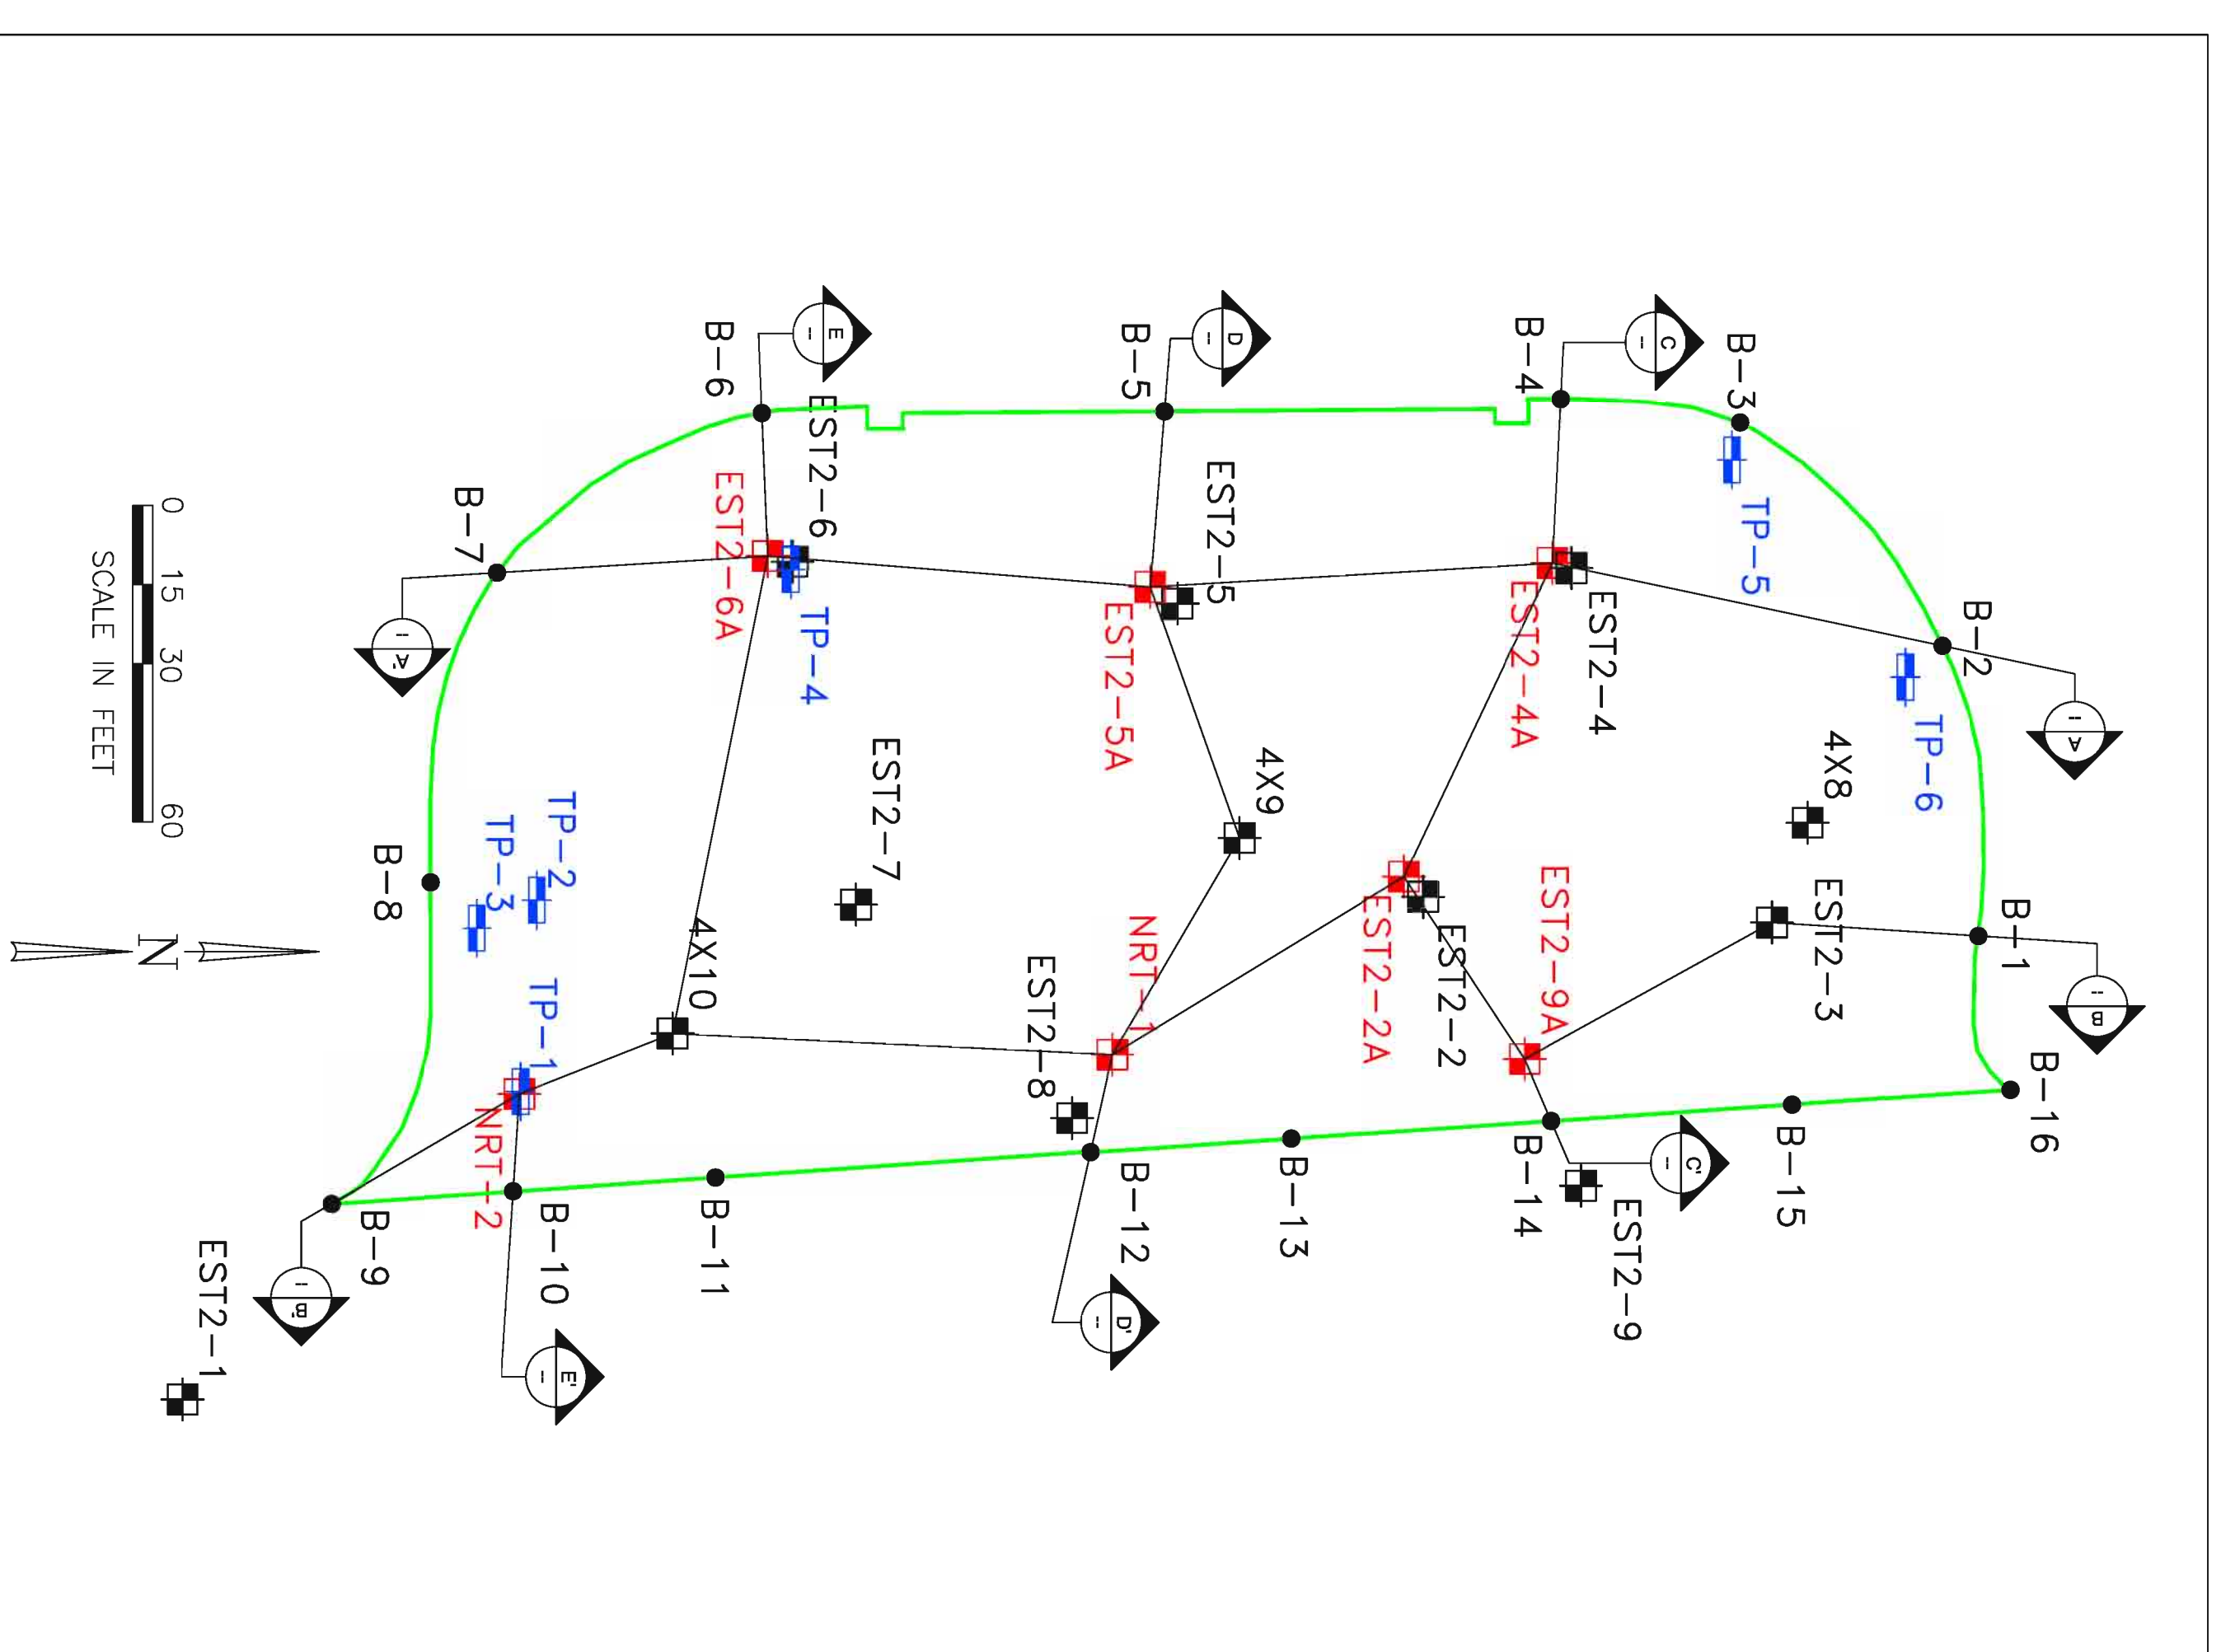
SEDIMENT CROSS SECTIONS
