# Technical Assistance, Environmental Liability Clarification or Post-Closure Modification Request

MASTER DRYCLEANING INC.  
6326 W. BLUEMOUND RD.  
WAUWATOSA, WI 53213

<b>FEHR GRAHAM</b> ENGINEERING & ENVIRONMENTAL	ILLINOIS IOWA WISCONSIN	TITLE: <b>REMAINING SOIL CHEMISTRY &amp; UTILITY EXCAVATION LIMITS</b>
	MASTER DRYCLEANING INC. 6326 W. BLUEMOUND RD. WAUWATOSA, WI 53213	
DRWN: MKH    DATE: 01/17/14    APPD: KE	BRRTS: 02-41-545142 JOB NO.: 15-1209 PLOT DATE: 7/7/17	FIGURE: <b>3</b>

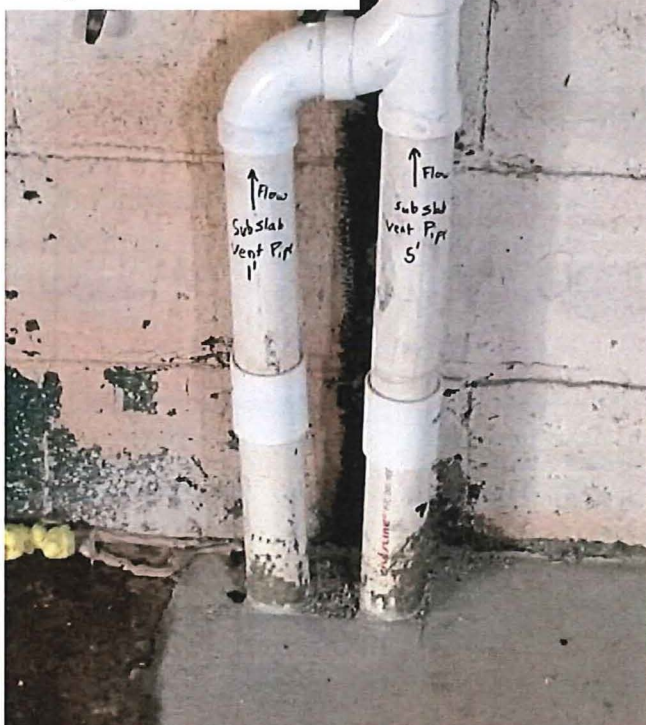
Detail of Subfloor Piping located on Building North Wall, showing connection to Piping that extends through Roof to Fan

The SSDS is comprised of one fan connected to two sub-floor pipes, installed to intercept vapor contamination beneath the concrete floor of the building. The fan is connected to two 25-foot long perforated pipes that run beneath the floor. One pipe was placed at a depth of five feet below grade, the other at a depth of one foot below grade, and both are bedded in pea gravel. The pea gravel is covered with a 15-mil thick plastic barrier (Stegowrap) that has been joined to the adjacent concrete with mastic prior to installation of the replacement three-inch thick concrete floor.
