January 16, 2007
(ECI 01-2300-3057)

RE: Site Investigation Scoping; Express Cleaners, Incorporated, 3941 North Main Street, Racine,
Wisconsin; WDNR BRRTS #02-52-547631

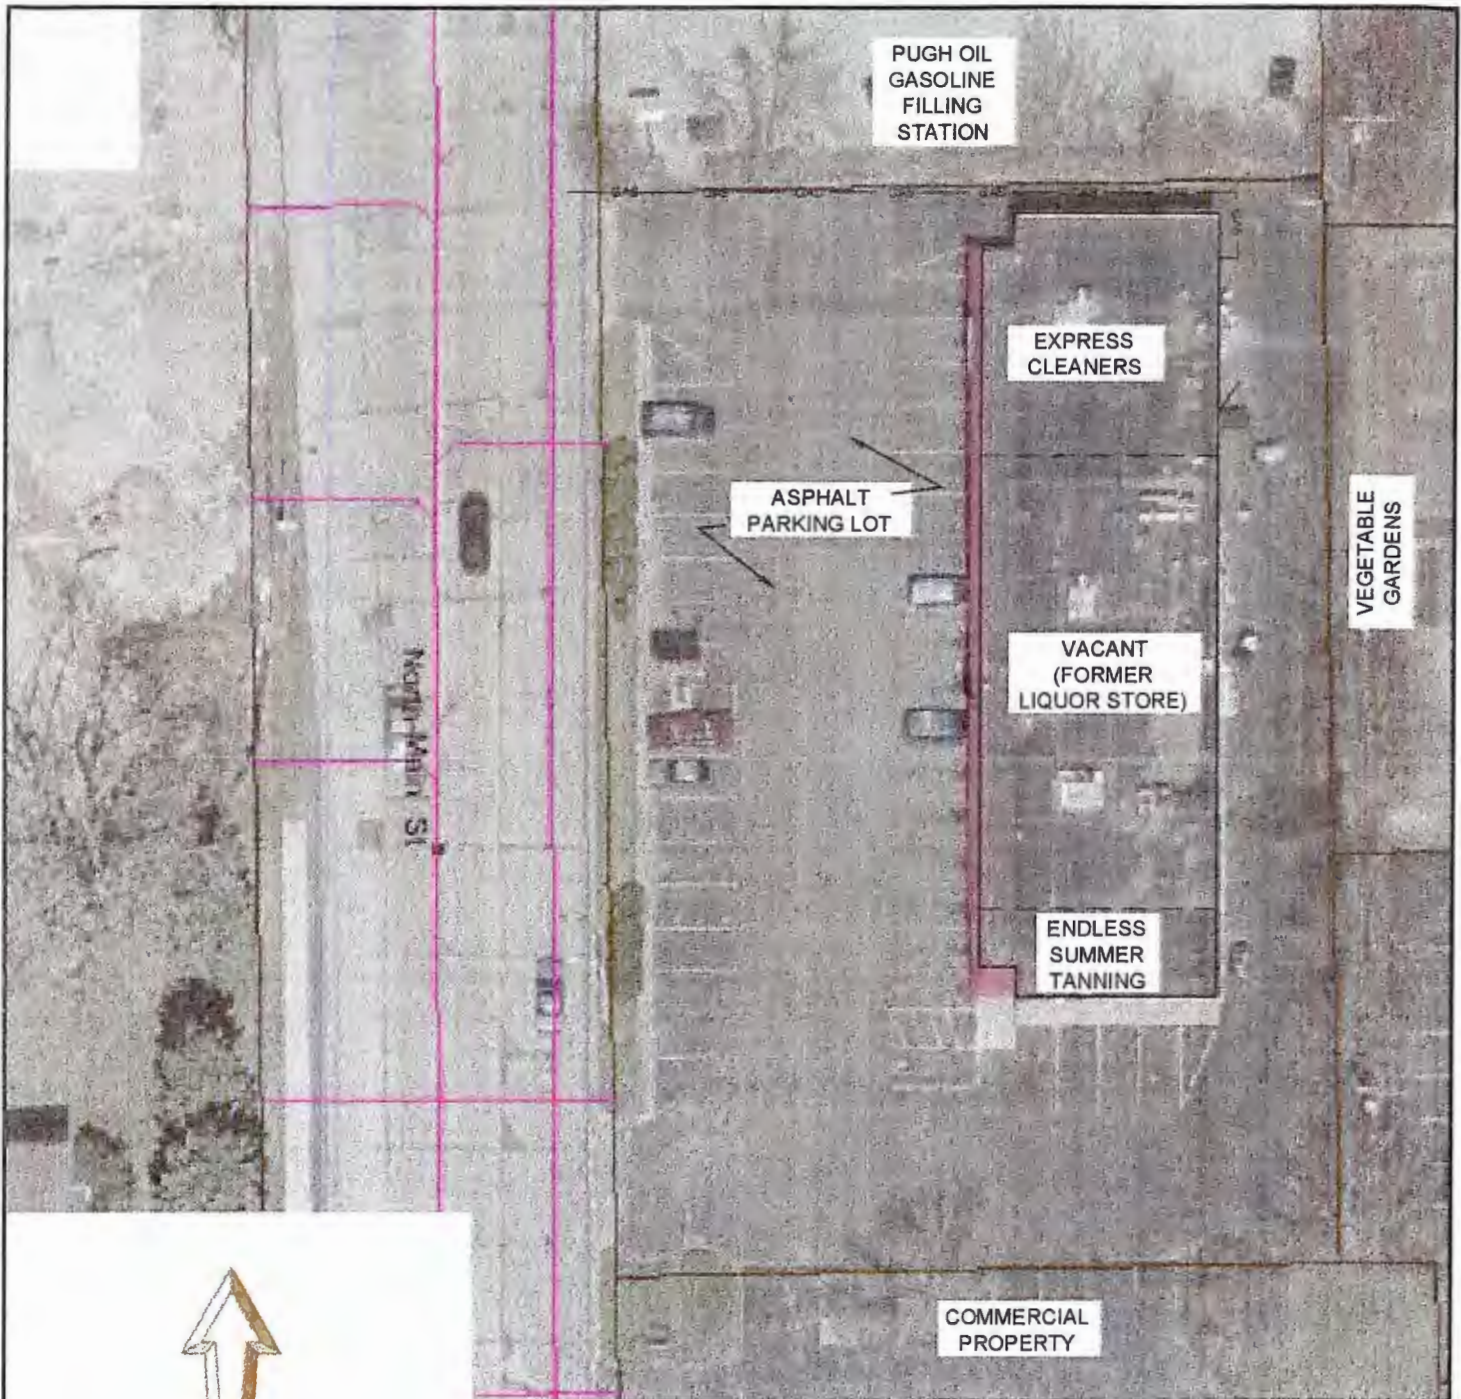
A single-story masonry building on a concrete slab occupies the Property. The remainder of the Property is covered by asphalt. The Property building is divided into three units (Figure 2). Express Cleaners has operated a dry cleaning business in the northern unit for approximately 1 year. The former and current layout of the dry cleaning equipment is illustrated in Figure 3. Tetrachloroethene (PCE) is the solvent currently used in the dry cleaning machine at the Site. The middle unit, (3931 North Main Street), formerly used as a liquor store, is currently vacant. A tanning salon has occupied the southern unit (3921 North Main Street) for at least 16 years.

During a site inspection conducted by Mr. Christopher Hatfield (Northern Environmental) on December 8, 2006, the observed Property uses were consistent with those reported in the Gabriel Phase I ESA. However, the drums of used PCE and filters were stored within the Site building. In addition, no floor drains were observed within the Site building. Two sealed sanitary sewer pipes were observed protruding from the concrete floor at the locations shown in Figure 3.

The type of contamination (PCE and its breakdown products) was identified during the Gabriel Phase II ESA. The amount of contamination is unknown. Boreholes completed during the Gabriel Phase II ESA are shown on Figure 3. The soil sampling results are summarized below.

Figures 2 and 3 illustrate the layout of the Site and surrounding area. The Gabriel Phase II ESA borehole locations are also shown in Figure 3. Water and sewer utilities likely enter beneath the southern end of the Site building and extend to the eastern side of the Site buildings (COR, 2006). Natural gas-burning furnaces are used to heat the building. Natural-gas service is provided by a buried utility pipe extending along the northern Property boundary and entering the northeast corner of the building.
