RE: Interim Report of Soil Remediation Pilot Test
Former Express Cleaners
Racine, Wisconsin
BRRTS Number 02-52-547631

COOL-OX™ Pilot Test, Former Express Cleaners, Racine WI - July 24, 2015

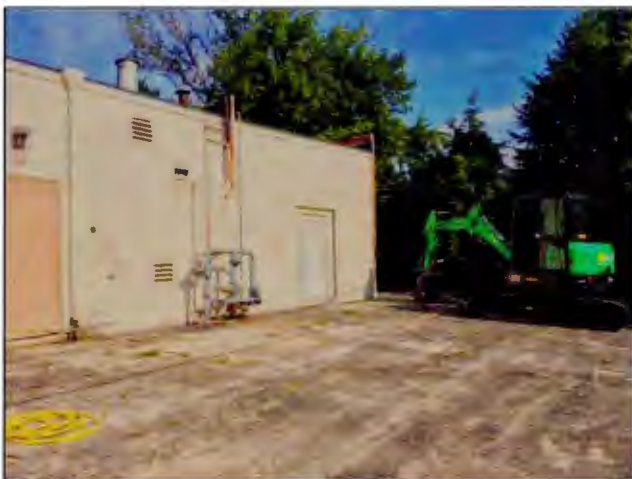
Photo 1. A view of the site prior to pilot test activities. The excavation was moved north several feet from the proposed location to accommodate the outside piping and monitoring well.

[Photo taken looking northwest]

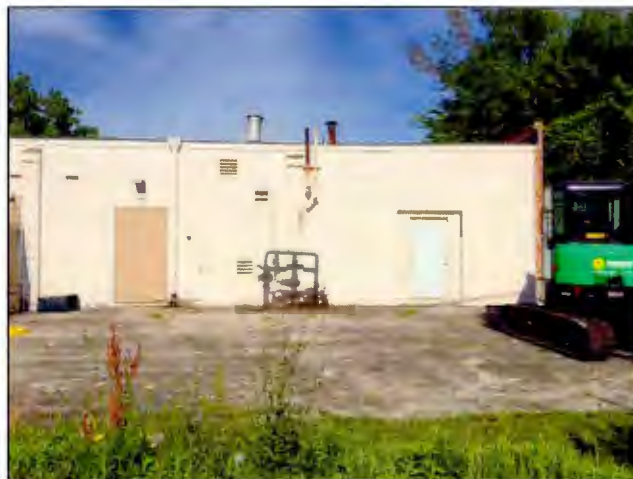
Photo 2. The pilot test location was located immediately outside the back door at the northeast corner of the former dry cleaning establishment.

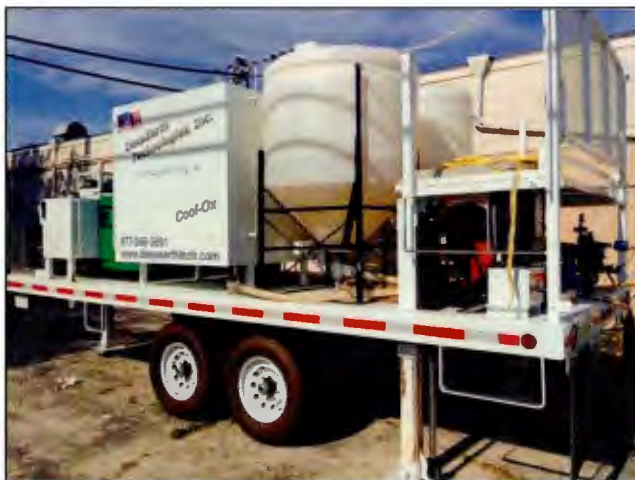
Photo 3. Deep Earth Technologies, Inc. was set up on the driveway south of the excavation and treatment area. Cool-Ox™ treatment solution was mixed in the pump truck.

The Cool-Ox™ reagent (treatment solution) was mixed by DET in the pump rig in a preparation area located south of the excavation. The treatment solution was pumped into the excavation with a hose. The Cool-Ox™ reagent was blended into the soil using the bucket of the backhoe to achieve a good blend and ensure contact with the soil. The reagent was blended into soils from the depth of 2.5 feet bls to approximately 5 feet bls, which was above the water table. After the lower section of soils was thoroughly mixed, the upper soils that were previously piled on plastic were returned to the excavation and thoroughly mixed with additional applications of Cool-Ox™ solution.

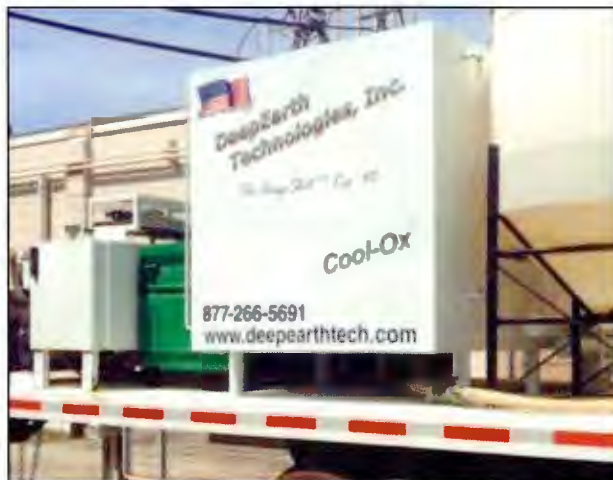
Photo 4. The patented Cool-Ox™ in-situ remediation technology utilized during the pilot test included chemical oxidation and accelerated biodegradation to eliminate volatile organic compounds in soils.

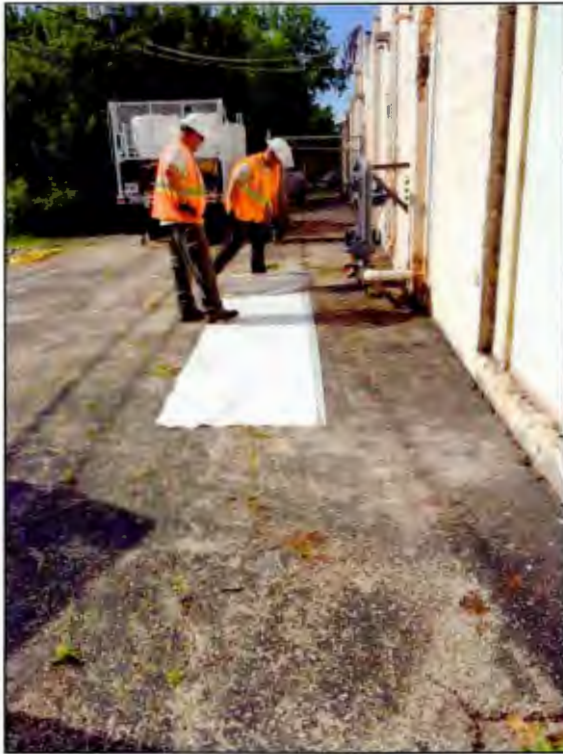
Photo 5. Plastic sheeting was placed near the area for piling excavated soil prior to remedial treatment.
[Photo taken looking south]

Remediation activities associated with the Pilot Test were conducted by Deep Earth Technologies (DET) on July 24, 2015. Upon completion of a Tailgate Safety Meeting, DET placed plastic sheeting south of the designated lay-down area within the area of contamination. Asphalt pavement was removed with a backhoe from a 5-foot by 5-foot area adjacent to the eastern wall of the building and placed alongside the excavation within the designated containment area. The upper 2.5 feet of soil was removed from the designated Pilot Test area using a backhoe and placed on the plastic sheeting.

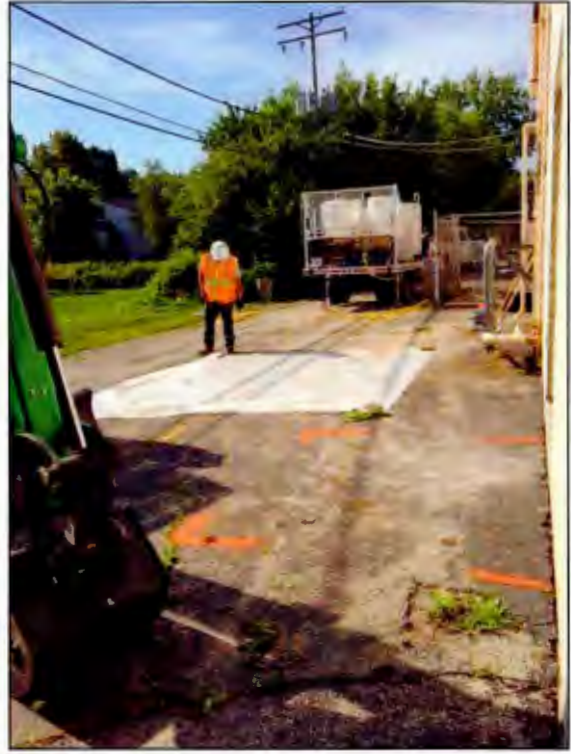
Photo 6. The treatment area was marked out to be approximately 5 feet wide by 5 feet long.
[Photo taken looking southeast]

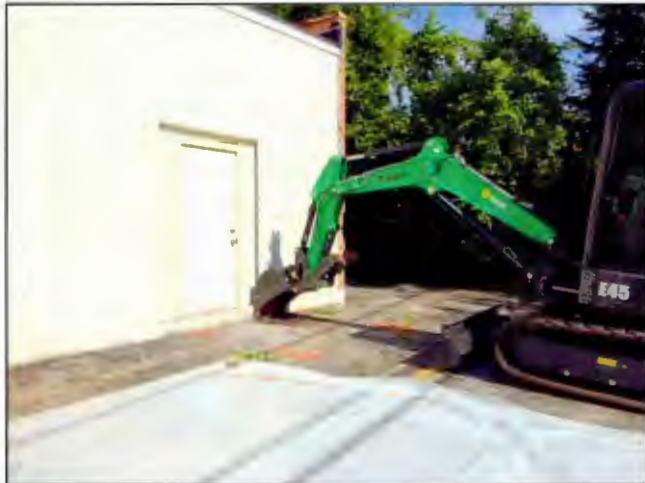
Photo 7. The top asphalt layer was removed by backhoe to expose the contaminated soils below.
[Photo taken looking northwest]

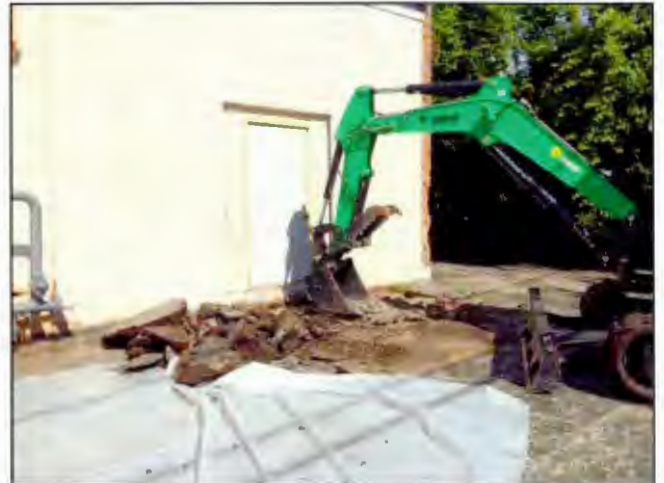
Photo 8. Excavated soil was maintained on plastic within the containment area until replaced and treated.
[Photo taken looking northwest]

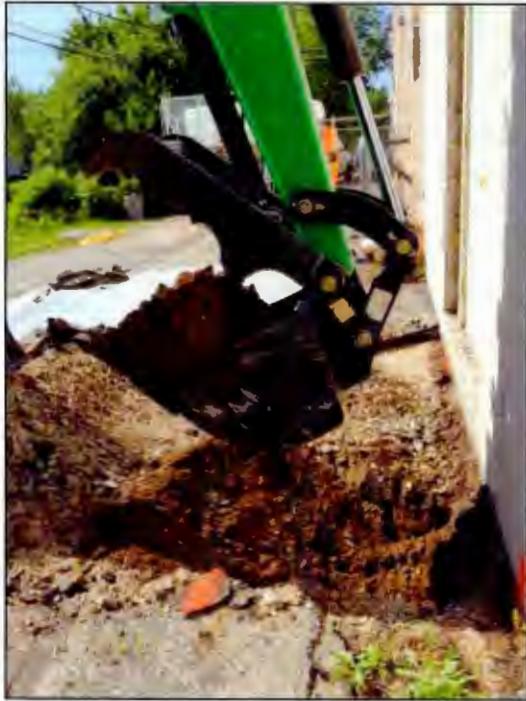
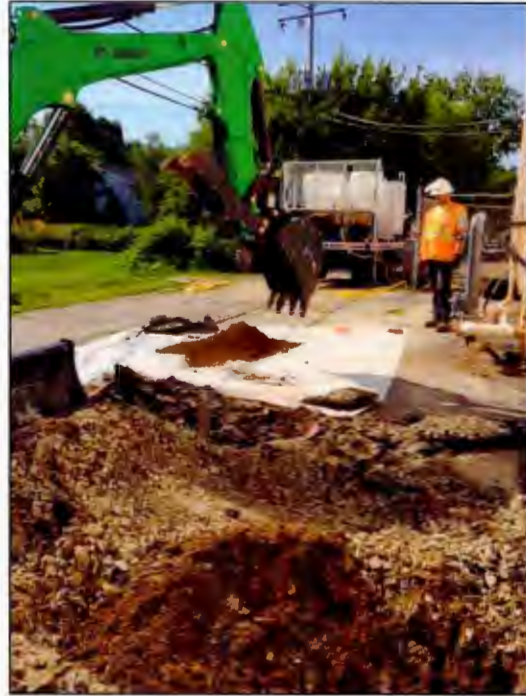
Photos 9 and 10. Materials beneath the site consisted of gravel fill in the upper one foot, underlain by silty brown sand and silty sand to depth. The excavated soil was placed on plastic sheeting.
[Photo taken looking south]

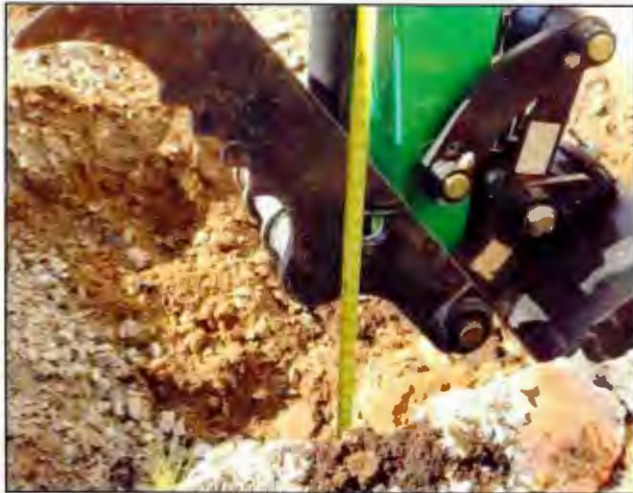
Photo 11. The upper 2.5 feet of soil was removed and placed on plastic to allow for treatment of the lower portion of soil. Extensive soil staining was present throughout the excavation. No odors were observed.
[Photo taken looking south]

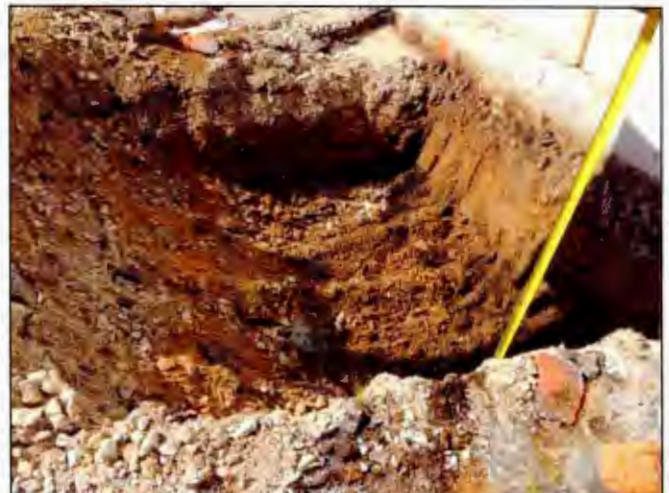
Photo 12. Upon removal of the upper section of soil, a soil sample was collected from the soil pile utilizing a Terracore™ sampler for analysis of CVOCs. Soil was estimated to be from approximately 2.5 feet below surface.
[Photo taken looking south]

Samples were promptly collected from the excavated soil removed at a depth of 2.5 feet below land surface (bls). Utilizing a Terracore™ sampler, two plungers of soil were removed from the soil pile and placed directly into tared vials containing a methanol (MeOH) preservative for analysis of chlorinated volatile organic compounds (CVOCs). An additional glass bottle was packed with soil for a percent solids calculation.

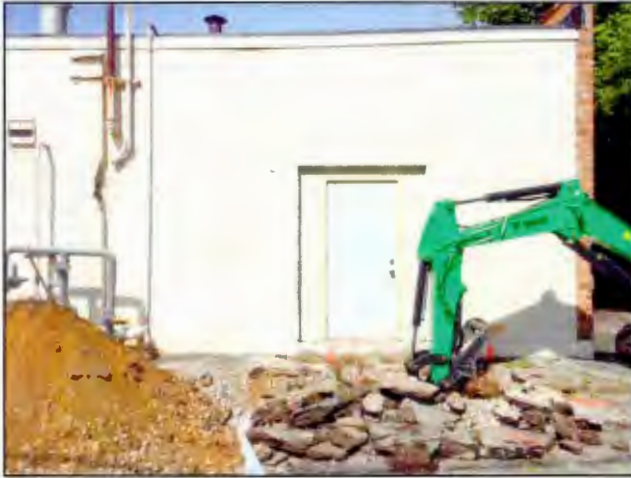
Photo 13. The remedial excavation was completed to 2.5 feet. Soil was piled on plastic south of the treatment area. [Photo taken looking west]

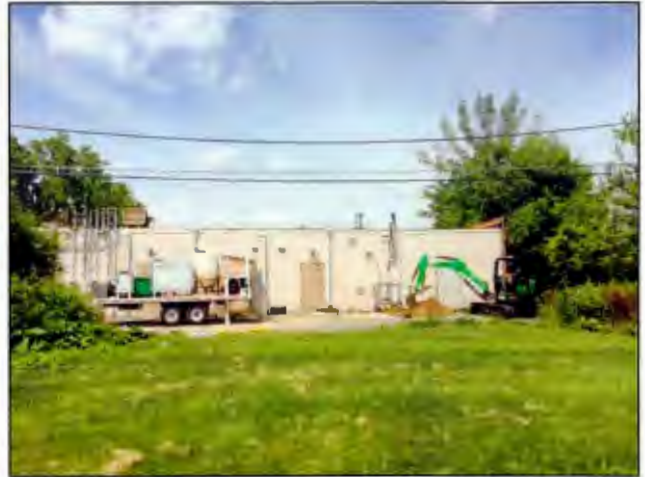
Photo 14. Full view of the pilot test set-up, and the pump truck located south of the treatment area. The pilot test was located immediately outside the back door of the former drycleaning facility at the north end of the building. [Photo taken looking west]

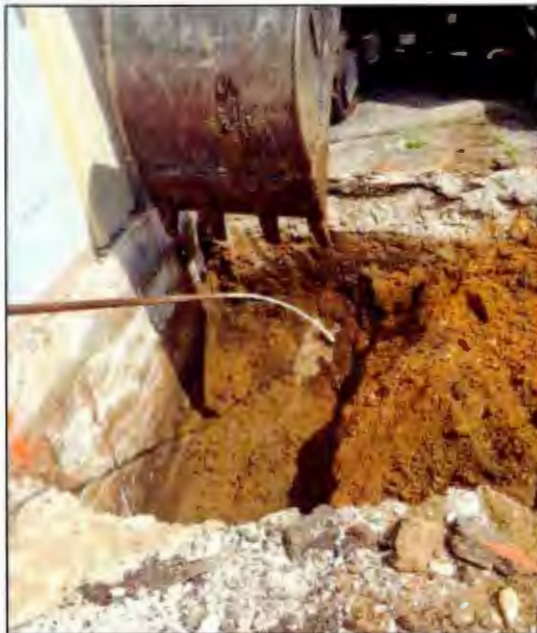
Photo 15. Soils were accessed to 5 feet (just above saturated soils). Using a Terracore™ sampler, a sample was collected from soils from the 4.5-ft depth from the backhoe bucket prior to applying the Cool-Ox™ treatment solution. [Photo taken looking northwest]

Samples were also promptly collected from the accessible soil when the excavation reached 4.5 feet bls. A bucket of soil was removed from this depth at the southwestern corner of the excavation with the backhoe. Utilizing a Terracore sampler, two plungers of soil were removed and placed directly into tared vials containing a MeOH preservative for analysis of CVOCs. An additional glass bottle was packed with soil for a percent solids calculation.

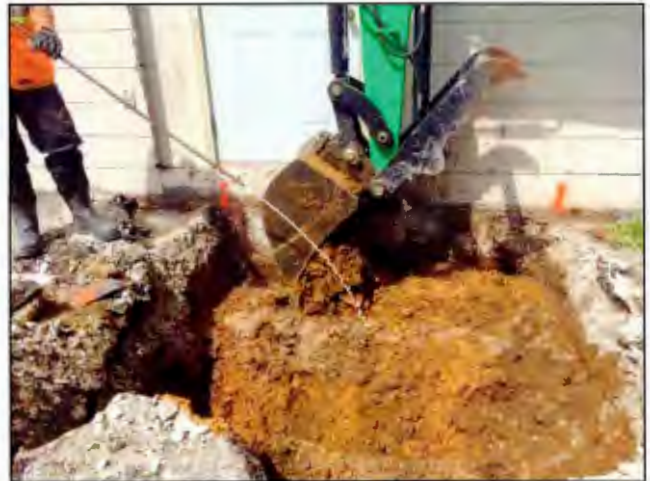
Photo 16. Cool-Ox™ was applied to the area of excavation and thoroughly blended with the lower three feet of soil using the bucket of the backhoe. The application rate of the solution was approximately ten gallons of solution per cubic yard. [Photo taken looking west]

The final excavation was measured to be six feet wide, five feet long, and five feet deep, for an estimated total of 6 cubic yards. As estimated, Cool-Ox™ was applied at the approximate rate of 10 gallons per cubic yard of soil, which is the same application rate proposed for the full-scale remediation. A total of 60 gallons of Cool-Ox™ were applied during the in-situ treatment.

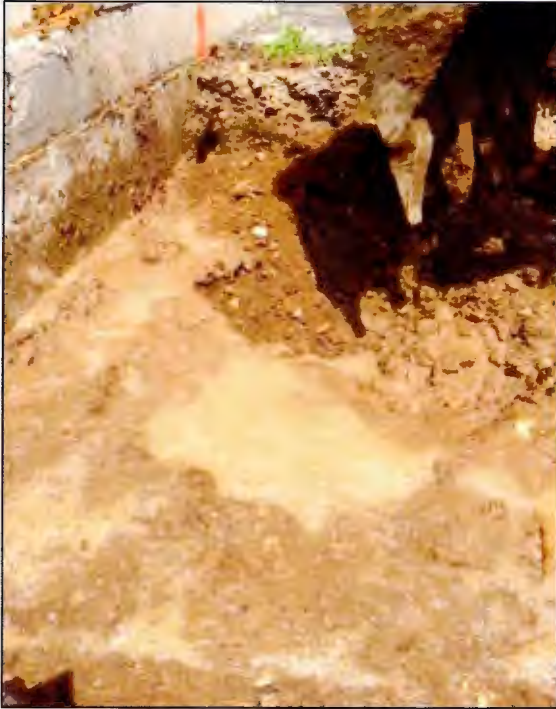
Photo 17. The chemical reaction occurring upon treatment with Cool-Ox™ included bubbling and foaming as the solution was blended with soils.
[Photo taken looking northwest]

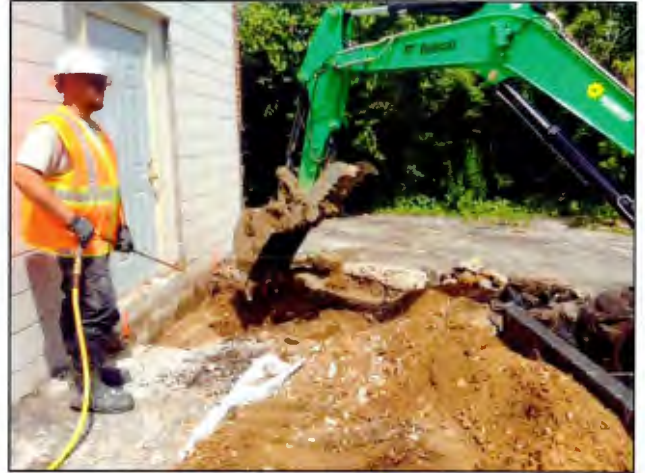
Photo 18. Excavated soils from the upper 2.5 feet were placed back into the excavation and blended with the treatment solution in the same manner as the in-situ soil. The size of the final treatment area was six feet wide (west to east) by five feet long (north to south) by 5 feet deep.
[Photo taken looking north]

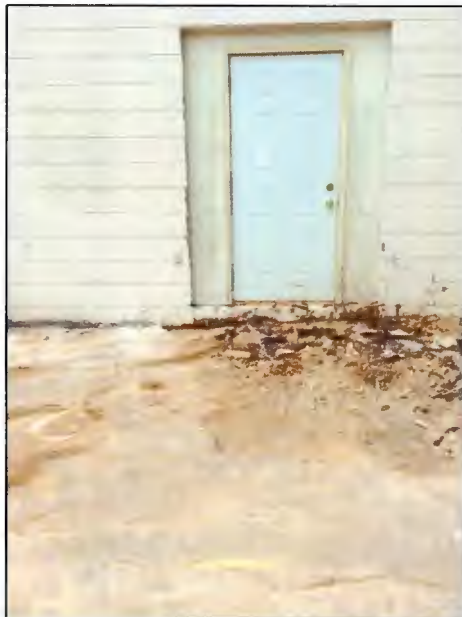
Photo 19. All soils were returned to the excavation and the asphalt placed on top.
[Photo taken looking west]

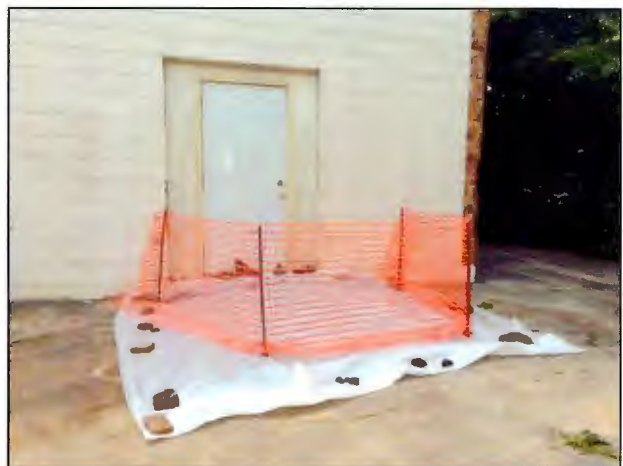
Photo 20. The area was secured by plastic sheeting over treated soils and fencing around the perimeter.
[Photo taken looking northwest]

After the soil was placed back into the excavated area and treated, the backhoe bucket was brushed off and washed with water which was allowed to settle into the excavation. The Pilot Test area was covered and secured with plastic. Snow fencing was placed around the perimeter of the excavation to secure the area.
