Former Bocaner Property – Update Cover Maintenance Plan  
224 S 4<sup>th</sup> Street  
Wausau, WI 54403  
WDNR BRRTS #02-37-547992

## COVER MAINTENANCE PLAN

City of Wausau Dog Park (Former Bocaner Property)

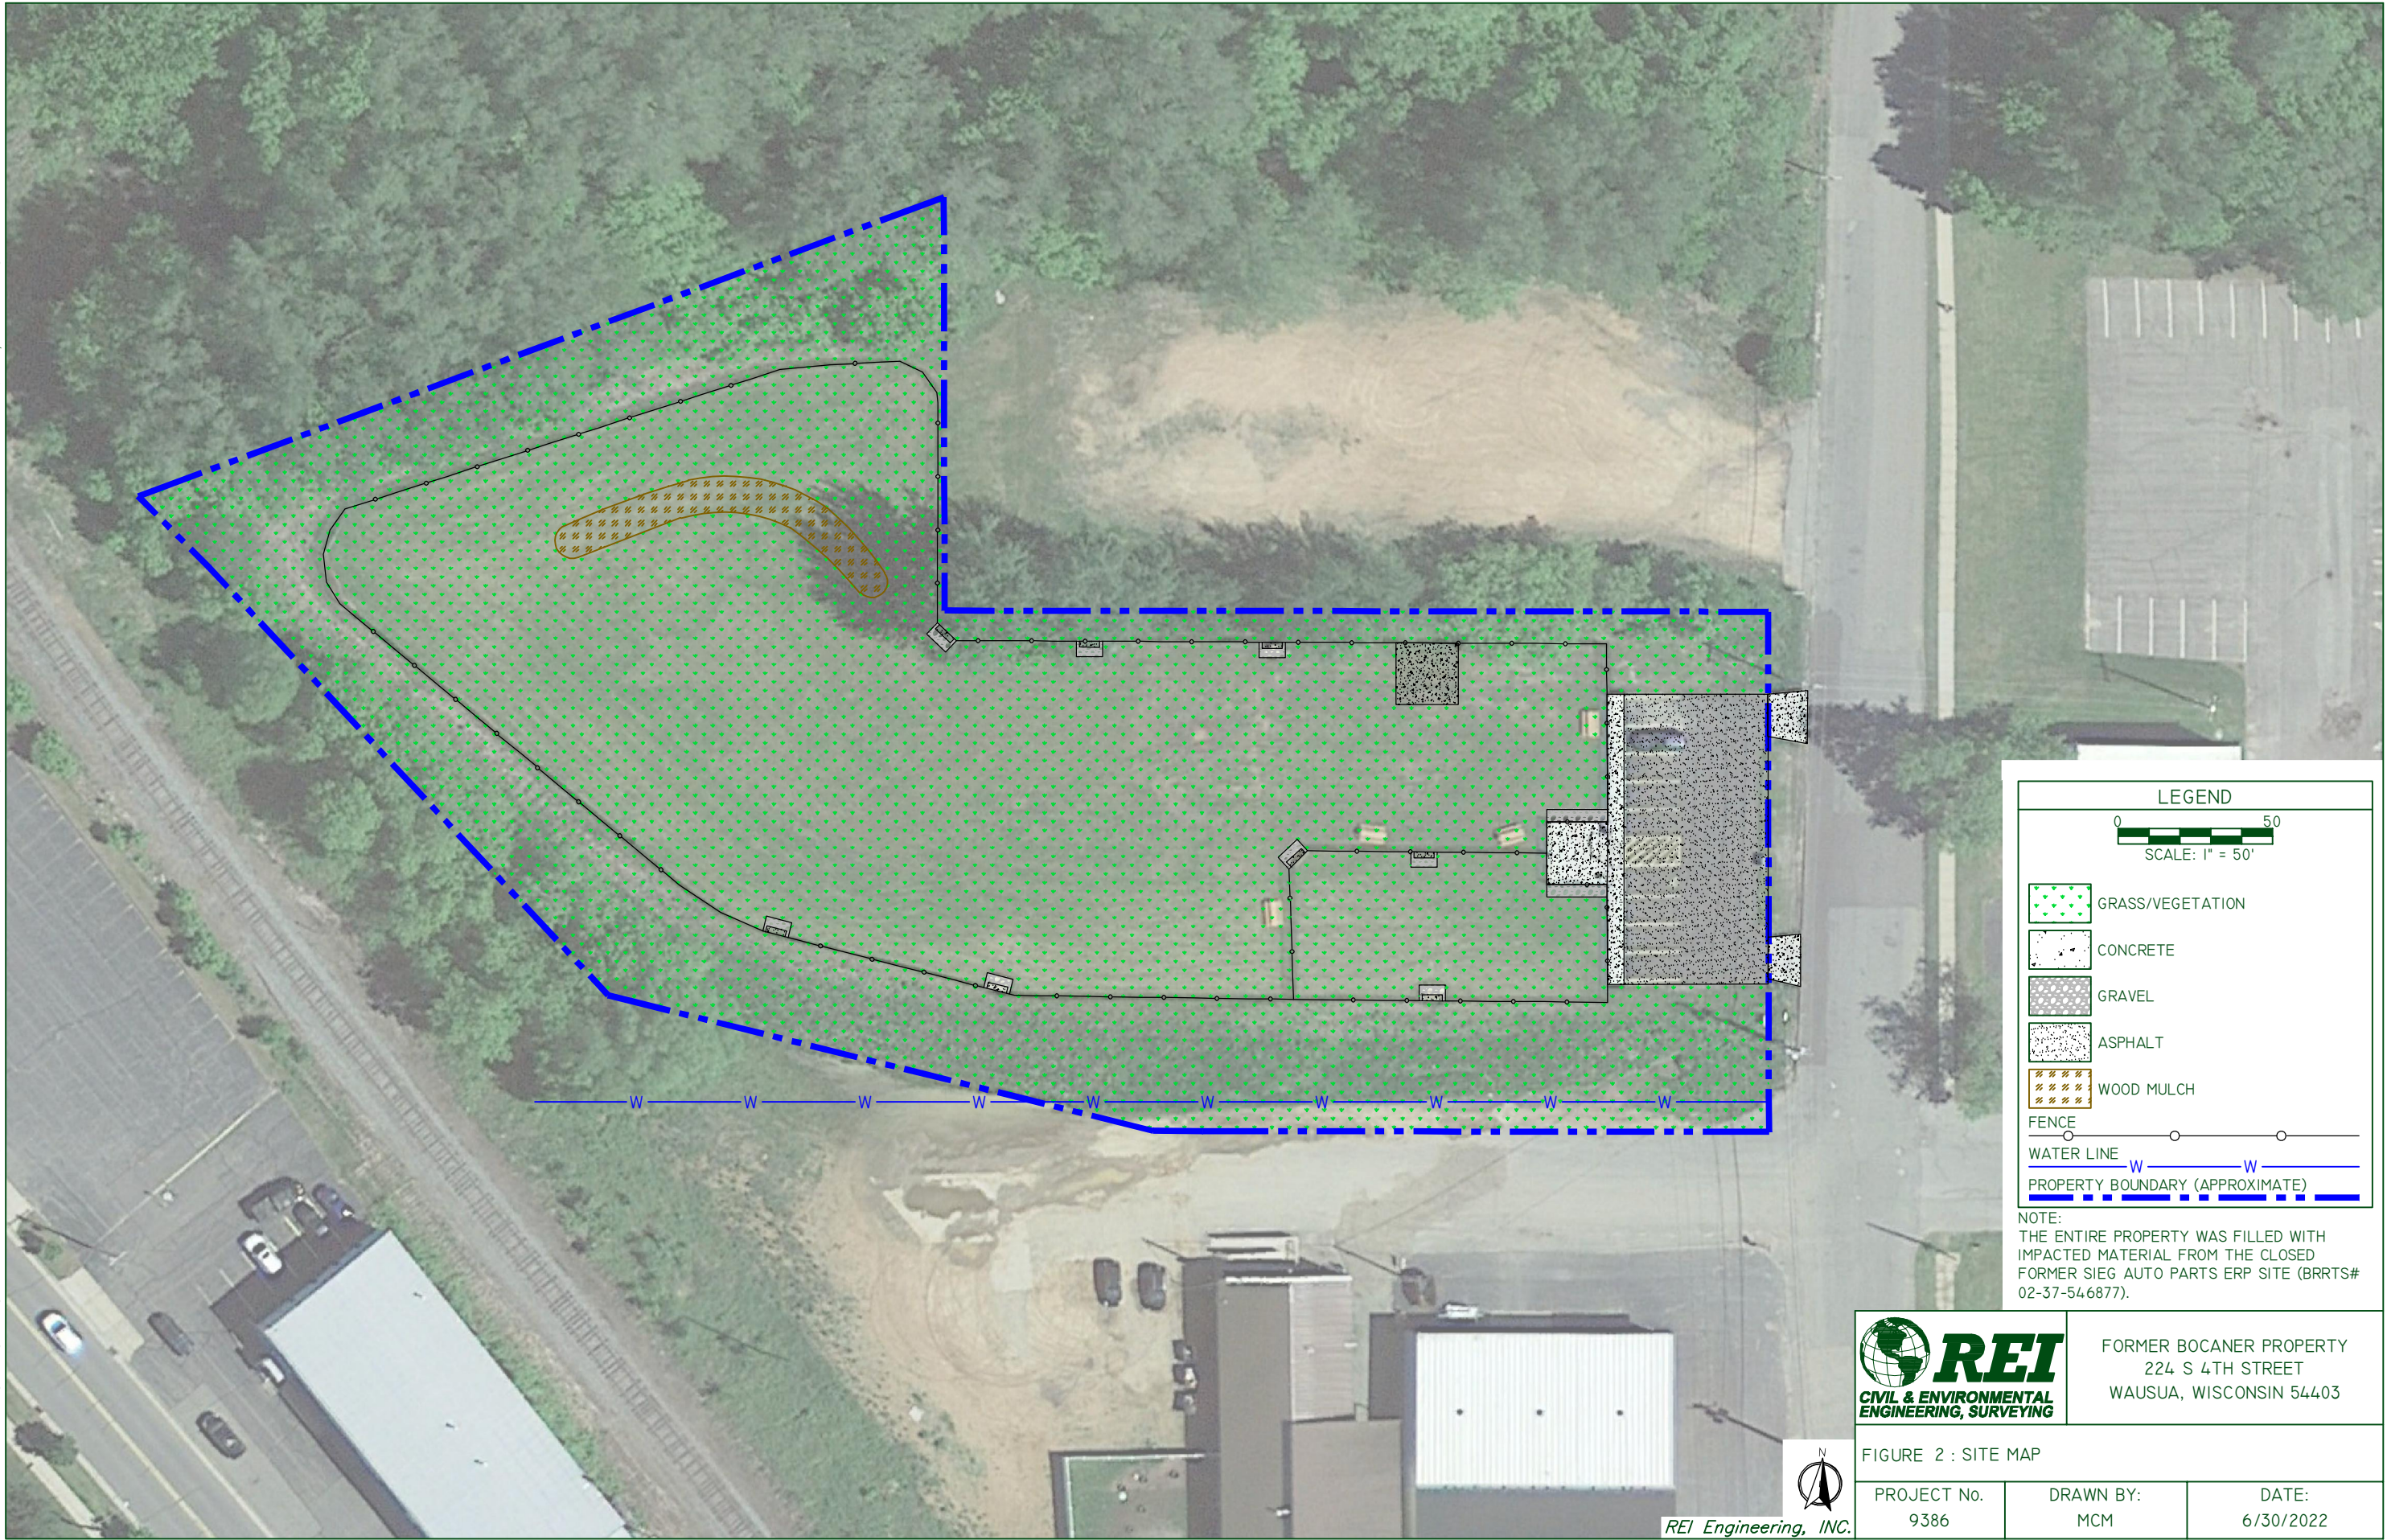
FIGURE 2 : SITE MAP

The vegetative cover consists of at least twelve (12) inches of clean sand fill overlain by six (6) inches of clean topsoil with grass vegetation. The property has been redeveloped into a dog park and select locations have had at least part of the topsoil portion of the original topsoil removed and replaced with gravel, concrete, or asphalt. The cover is located over the entire

site as shown on the attached Figure 2.

NOTE:  
THE ENTIRE PROPERTY WAS FILLED WITH IMPACTED MATERIAL FROM THE CLOSED FORMER SIEG AUTO PARTS ERP SITE (BRRTS# 02-37-546877).

The vegetative cover overlying the contaminated soil and as depicted in Figure 2, will be inspected once a year, normally in the spring after all snow and ice is gone, for deterioration, cracks and other potential problems that can cause exposure to underlying soils. The inspections will be performed by the property owner or their designated representative. The inspections will be performed to evaluate damage due to settling, exposure to the weather, wear from traffic, increasing age and other factors. Any area where soils have become or are likely to become exposed will be documented.

The following activities are prohibited on any portion of the property where [pavement, a building foundation, soil cover, engineered cap or other barrier] is required as shown on the attached map, unless prior written approval has been obtained from the Wisconsin Department of Natural Resources:

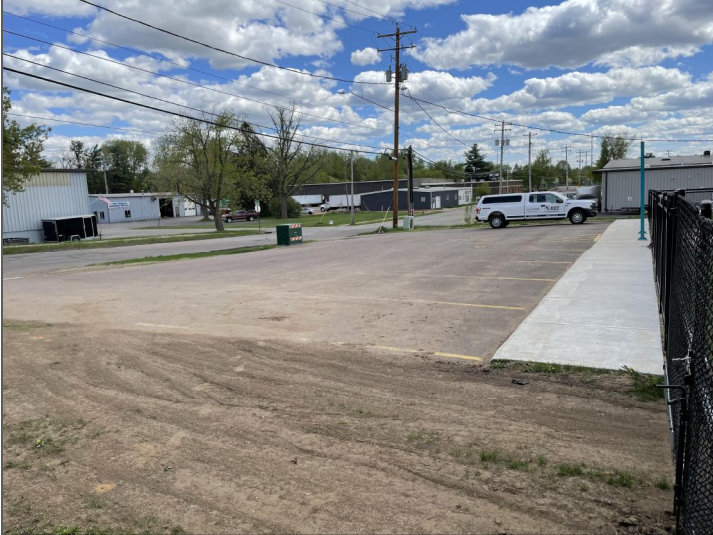
Title: Overview of parking area. View towards the south-southeast.

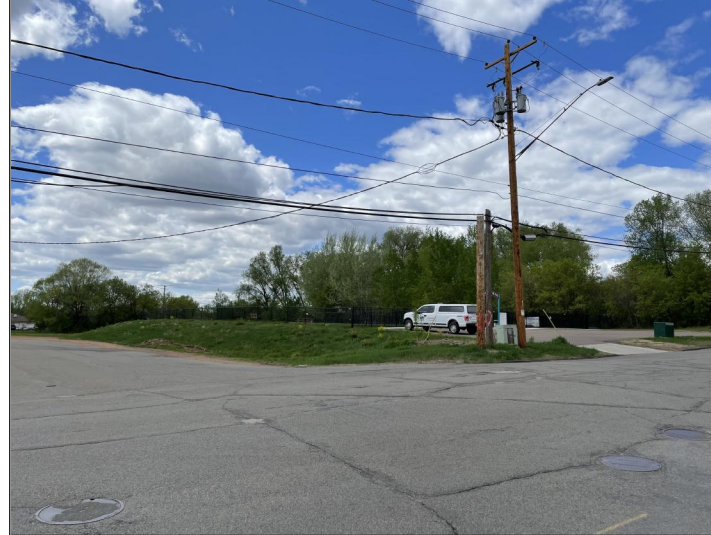
Title: Property overview. View towards the northwest.
