**Figure 1
System Drawing**

VAPOR
PROTECTION
SERVICES®

Rob Hoverman/ Brian Kappen
Harborview Cleaners

105 N. Franklin St.
Port Washington, WI 53074

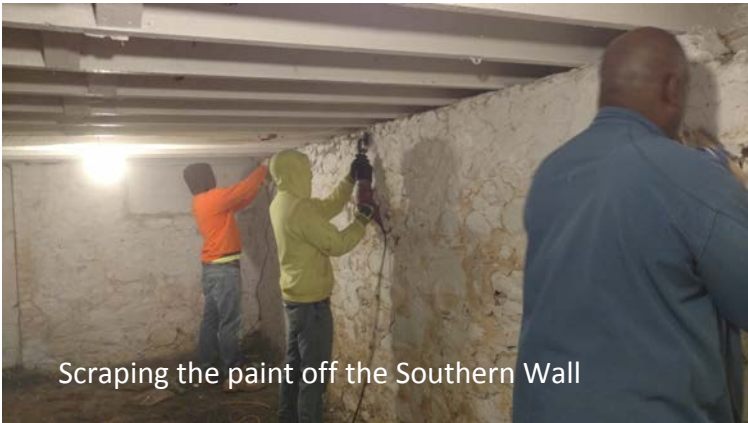
Scraping the paint off the Southern Wall

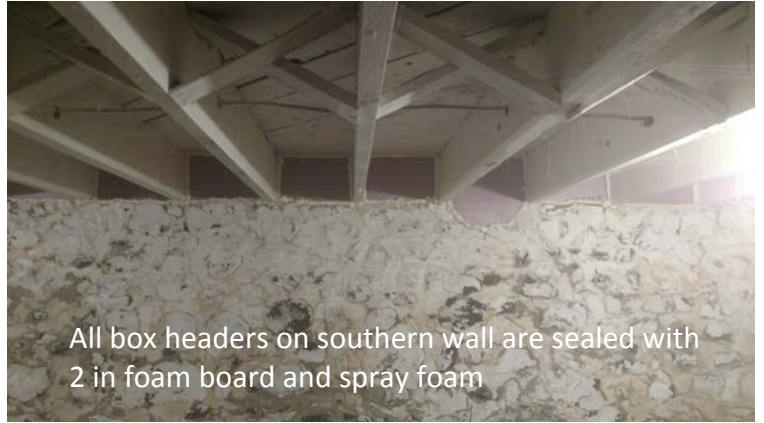
All box headers on southern wall are sealed with 2 in foam board and spray foam

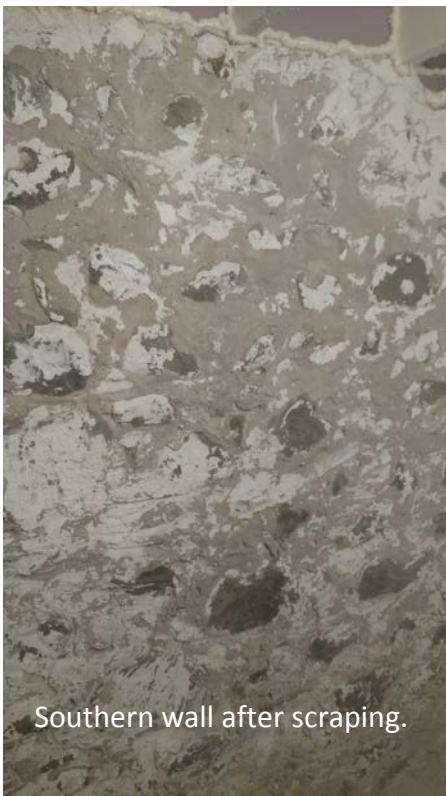
Southern wall after scraping.

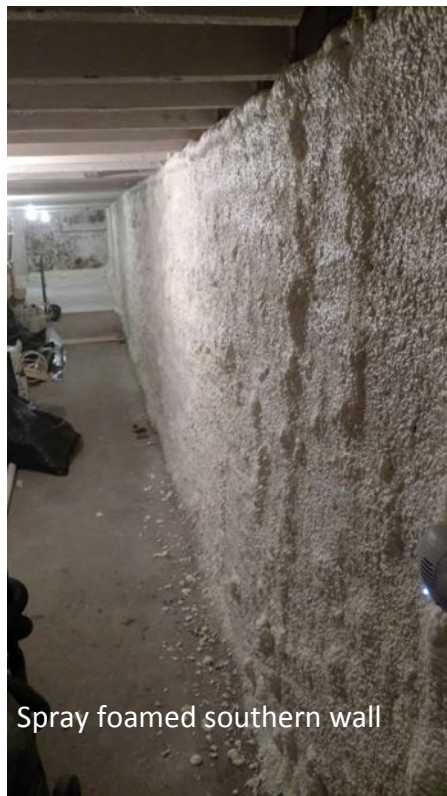
Spray foamed southern wall

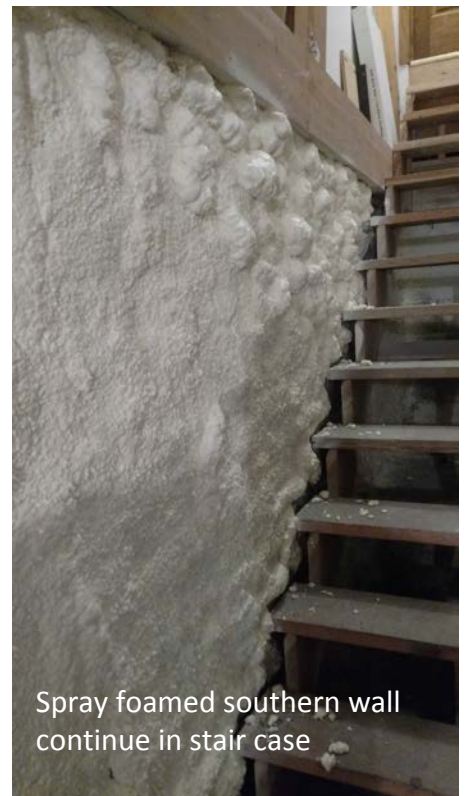
Spray foamed southern wall continue in stair case

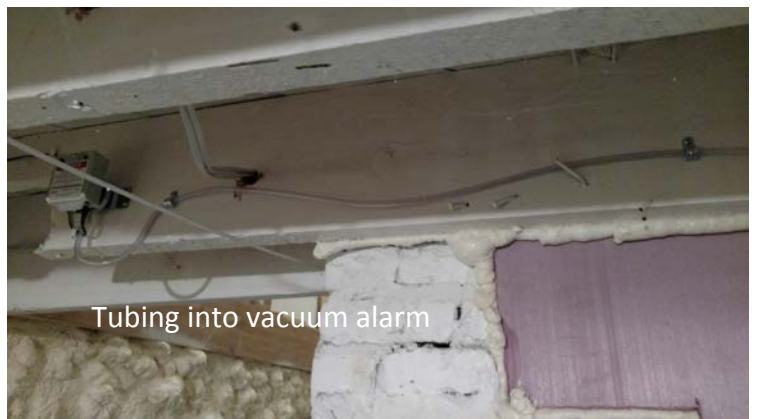
Tubing into vacuum alarm

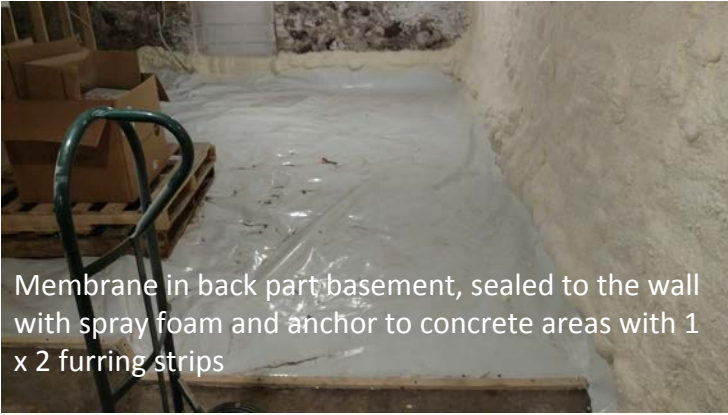
Membrane in back part basement, sealed to the wall with spray foam and anchor to concrete areas with 1 x 2 furring strips

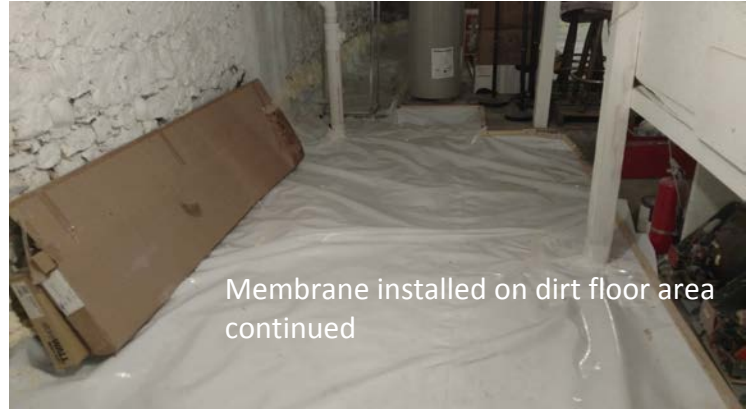
Membrane installed on dirt floor area continued

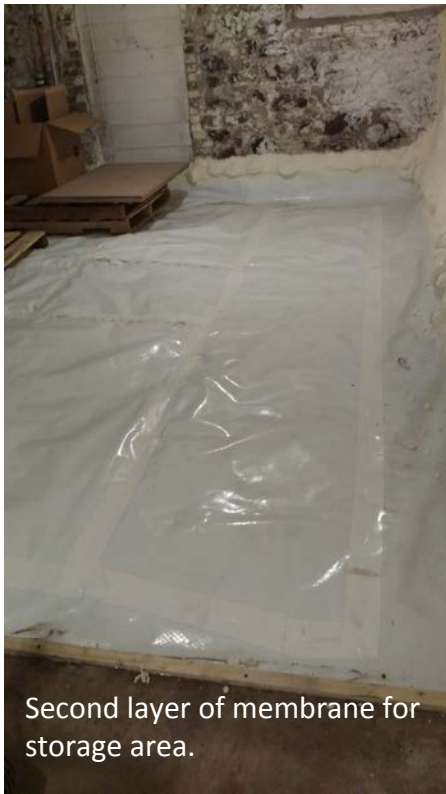
Second layer of membrane for storage area.

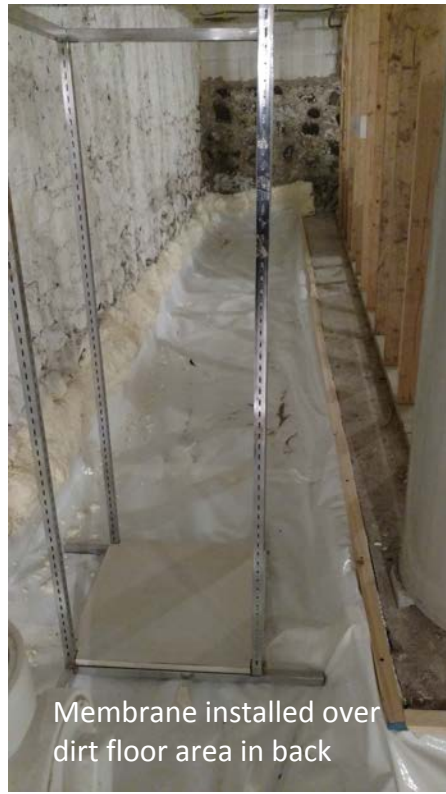
Membrane installed over dirt floor area in back

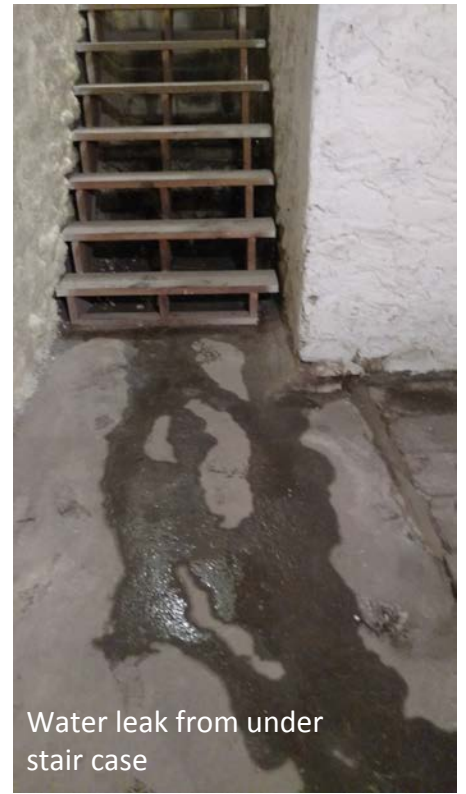
Water leak from under stair case

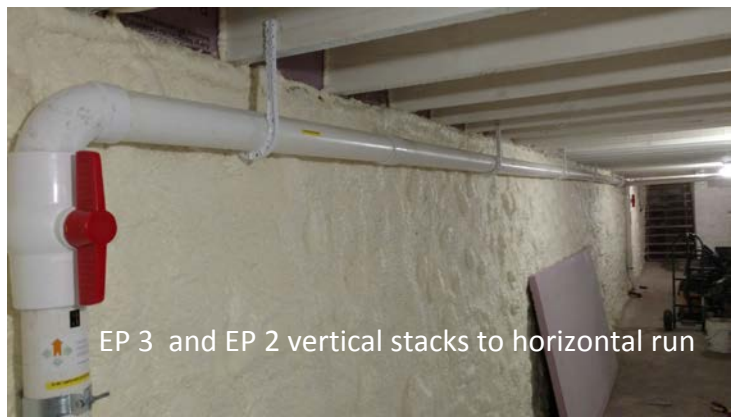
EP 3 and EP 2 vertical stacks to horizontal run

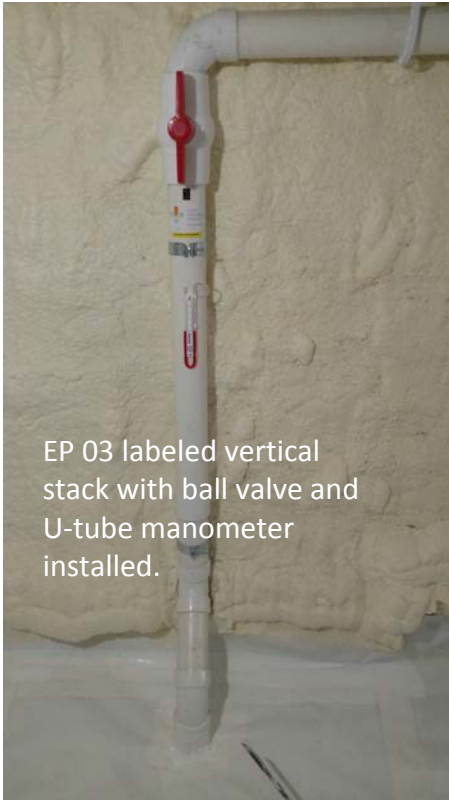
EP 03 labeled vertical stack with ball valve and U-tube manometer installed.

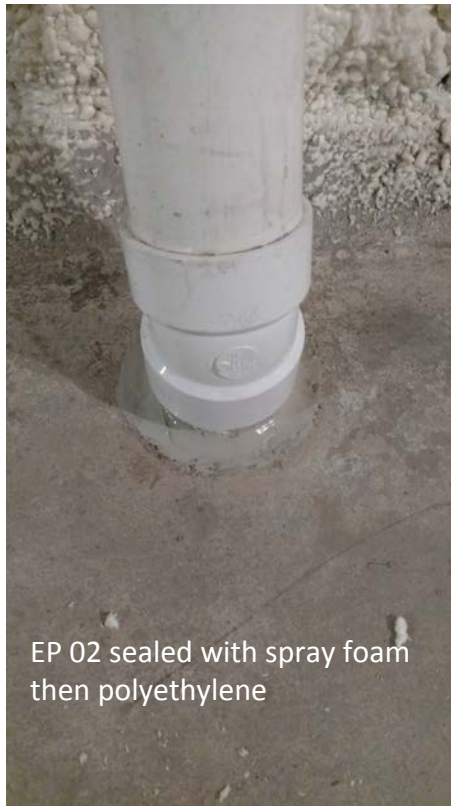
EP 02 sealed with spray foam then polyethylene

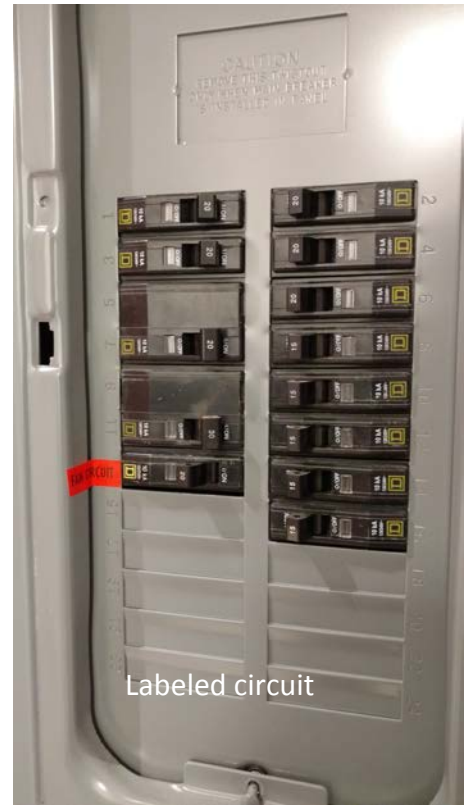
Labeled circuit

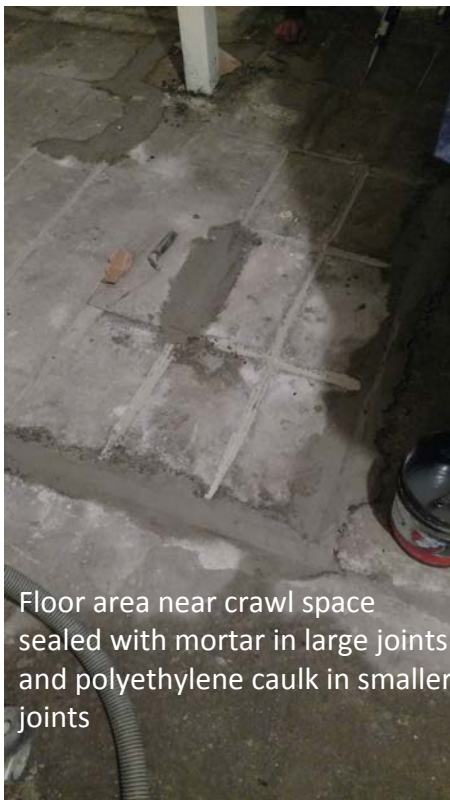
Floor area near crawl space sealed with mortar in large joints and polyethylene caulk in smaller joints

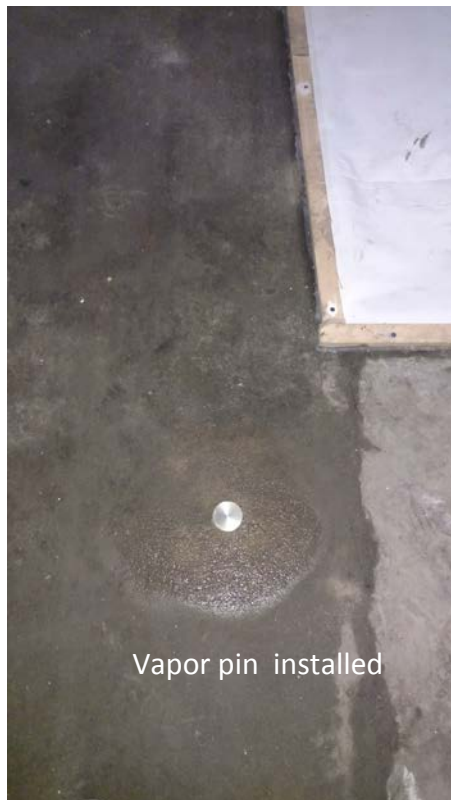
Vapor pin installed

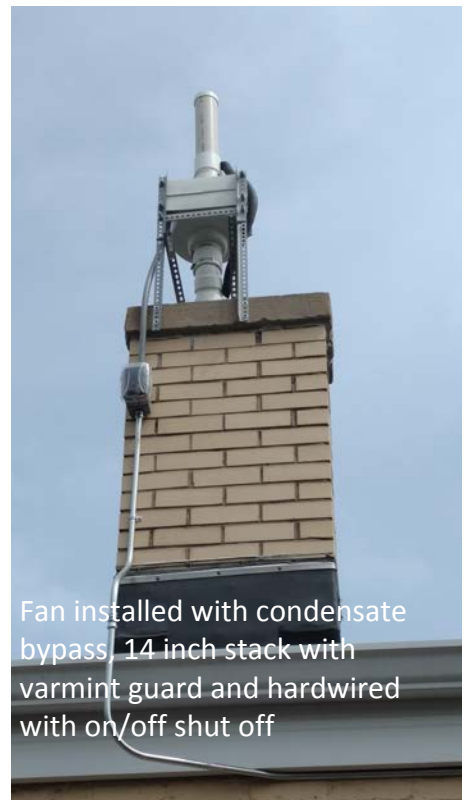
Fan installed with condensate bypass 14 inch stack with varmint guard and hardwired with on/off shut off
