Re: One Hour Fabricare DERF Site
4704 W. Burleigh Street
Milwaukee, Wisconsin
BRRS No. 02-41-548391

Subject: Vapor Results from Indoor, Subslab, and Ambient Air

**One Hour Fabricare
Vapor Sampling – June 2020
4704 W. Burleigh Street
Milwaukee, Wisconsin**

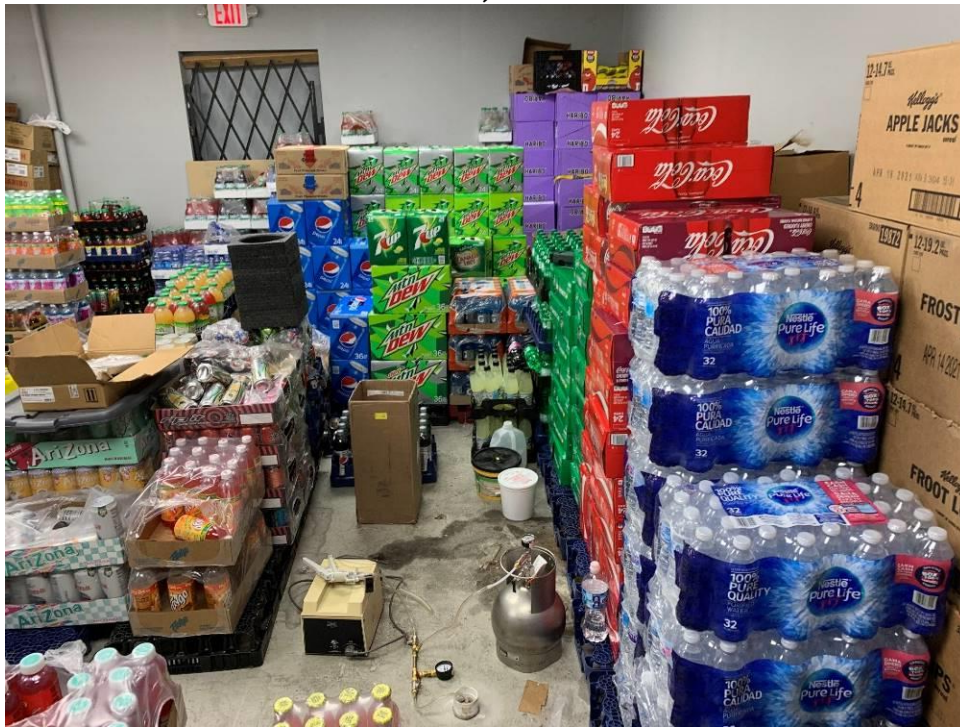
Photo #1 Subslab Vapor Sample at 4704 W. Burleigh Avenue.

3. The Property (former gas station and drycleaner convenience store) at 4704 W. Burleigh Street does not have any detections of tested compounds above standards in the indoor air. The subslab air at the approximate location of the former drycleaning machine has elevated concentrations of PCE, above standards for subslab vapor at a Commercial Building.

4. The subsurface vapors at the former drycleaning machine at the Property indicate steps should be taken to prevent subslab vapors from entering the building. A subslab vapor mitigation system should be installed, or preferably a more aggressive remedial action should be implemented to reduce the presence of known contaminant mass beneath the floor.

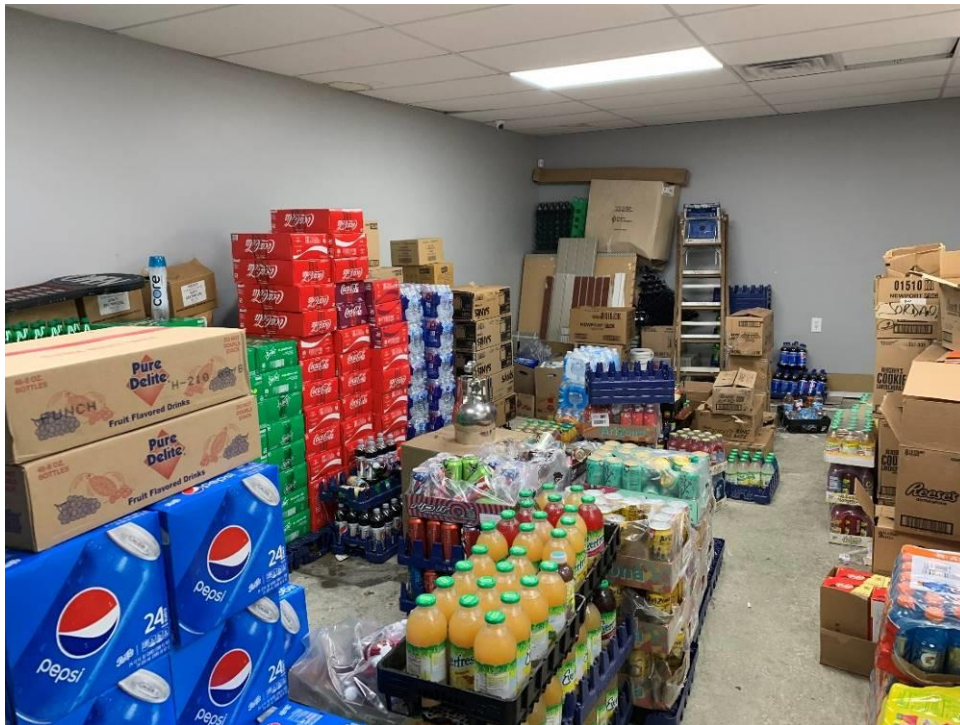
Photo #2 Indoor Air Sample at 4704 W. Burleigh Avenue.

3. The indoor air of the former drycleaner indicates results are acceptable from a health standpoint for occupancy. Based on these results, if desired, the tenant of the store can seek a permit from the City of Milwaukee to handle food in the building.

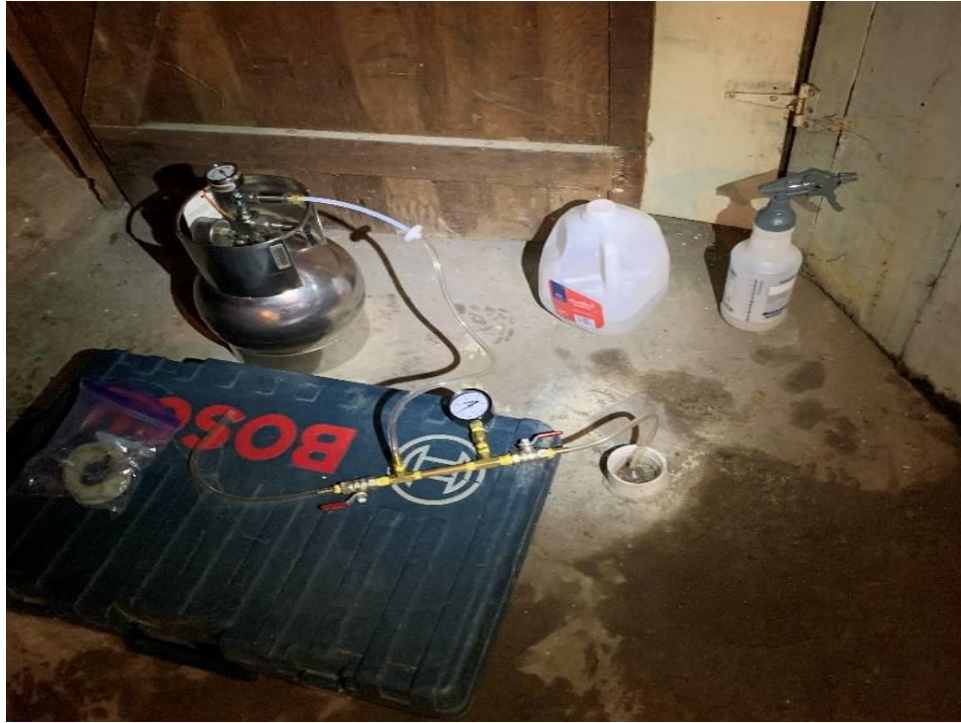
Photo #3 Subslab Vapor Sampling at 4714-4716 W. Burleigh Avenue, North Sample.

1. The Commercial Property at 4714-4716 W. Burleigh Street does not have any detections of tested compounds above standards in the basement subslab air.

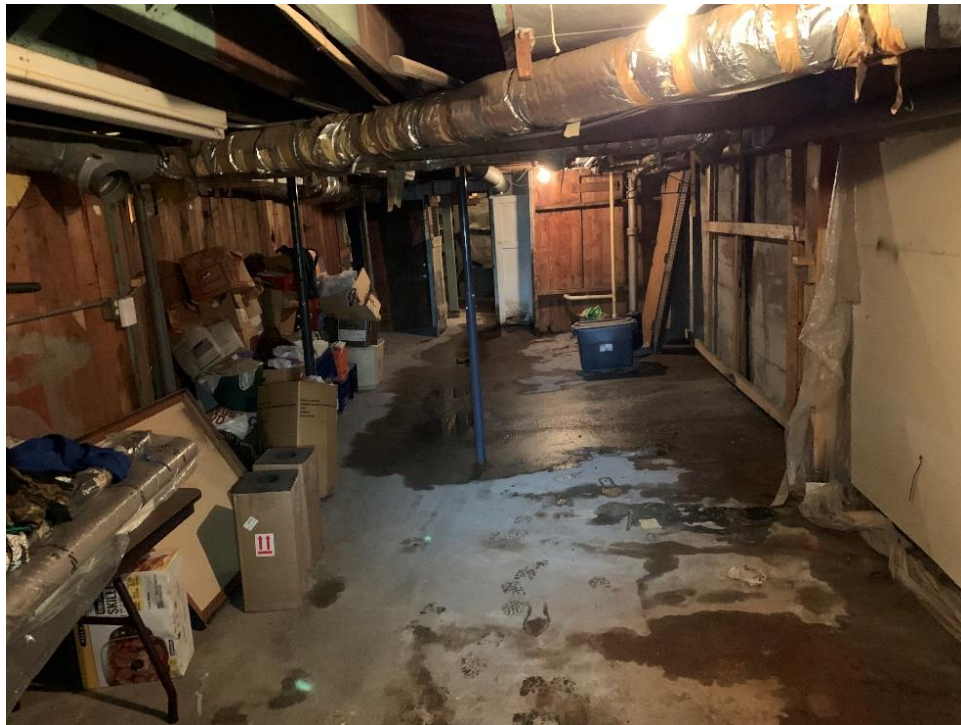
Photo #4 Subslab Vapor Sampling at 4714-4716 W. Burleigh Avenue. South Sample obtained in lower center of photograph.

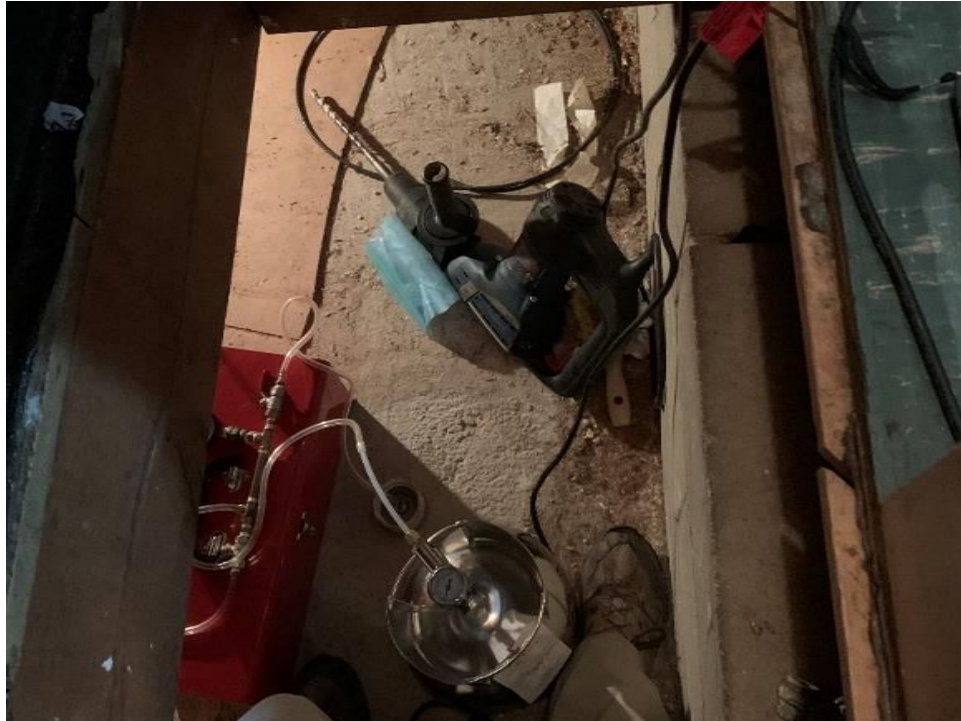
Photo #5 Subslab Vapor Sampling in crawlspace at 3119 N. 47th Street residence.

2. The Residential Property at 3119 N. 47th Street does not have any elevated detections of tested compounds in the subslab crawlspace air, but it does have elevated levels of two compounds, naphthalene and tetrachloroethene (PCE) – the drycleaning solvent – in the air within the crawlspace. The crawlspace extends beneath the entire residence to a depth of approximately 3 feet below the building flooring, and the space is vacant. The crawlspace provides access to some utilities (cable, water), but it is not occupied or used for storage. The poured concrete floor of the crawlspace is only a few inches thick, but is in good condition. There is spray-on foam-type insulation on the interior walls of the entire crawlspace cement block walls, which potentially could off-gas some of the observed chemicals, particularly naphthalene, since the subslab vapors do not contain elevated concentrations of these tested compounds.

1. No further action is required for the 4714-4716 building.
2. Further testing is needed for the 3119 N. 47th Street residence. Another crawlspace ambient sample and an indoor air sample from the occupied residential space should be obtained. Both of these samples should be 24-hour samples, with analysis for the same 10 compounds as previously evaluated. The crawlspace sample location should be the same as the previous location. The indoor air sample should be obtained from the approximate breathing height (3 to 4 feet) in a frequently occupied location, such as the bedroom, kitchen table, or TV room. Cleansers, paints, solvents, fingernail polish, and other products that may contain the tested chemicals should be removed from the test area and placed in the garage or sealed in air-tight containers during the testing.

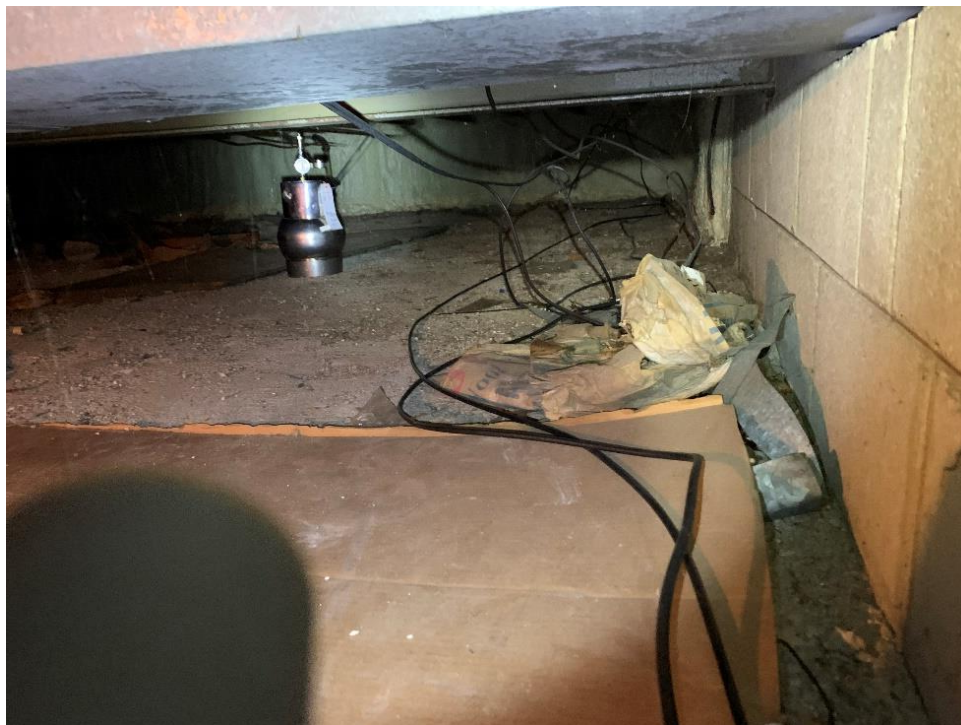
Photo #6 Indoor Air Vapor Sampling in crawlspace at 3119 N. 47th Street residence.

If results indicate elevated levels of chemicals are observed, it may be necessary to vent the 3119 Crawlspace with a radon-type low-flow fan.

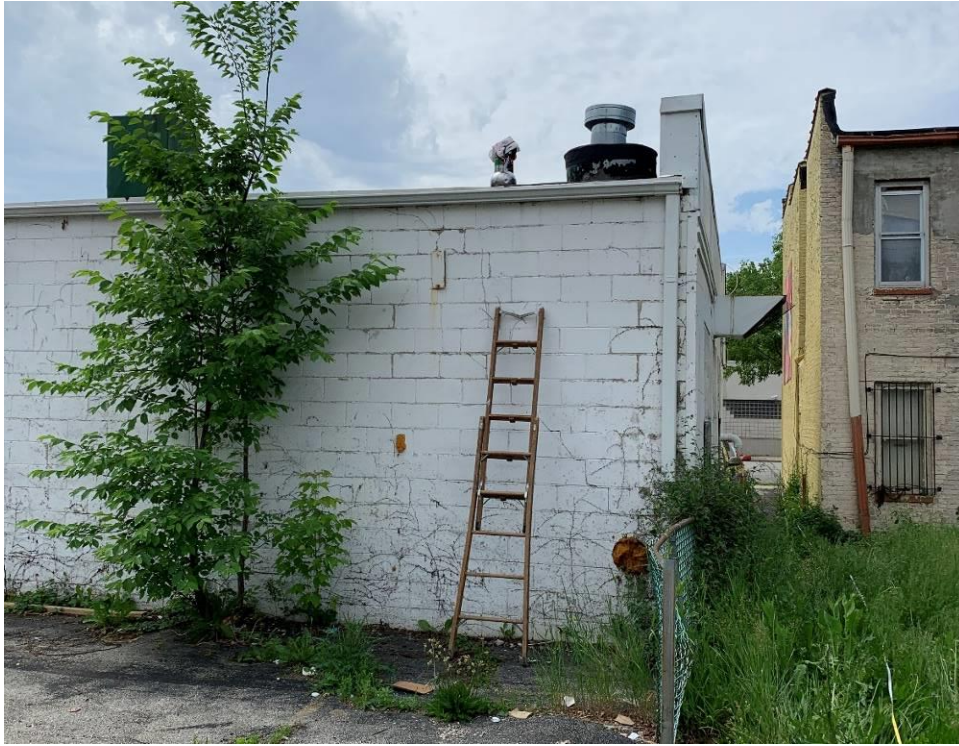
4. The ambient outside air obtained from the northwest corner roof of the former drycleaner at 4704 W. Burleigh Street did not have detectable concentrations of any drycleaning compounds, and only trace amounts of petroleum compounds, far below any action levels.

Photo #7 Ambient Air Sampling on roof of 4704 W. Burleigh Avenue building.
