Stantec Consulting Services Inc. 12075 Corporate Parkway, Suite 200 Mequon WI 53092

September 27, 2016 File: 193703931

### Reference: RLF Eligibility Determination Supplemental Information on Continuing Obligations 1512 Washington Street Manitowoc, Wisconsin USEPA Cooperative Agreement No. BF-00E01242 Stantec Project No. 193703931

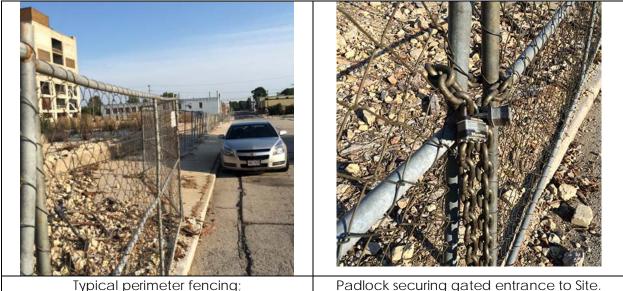
**Preventing or limiting human exposure.** Prior to acquisition, a perimeter fence was installed around the rights-of-way to prevent access to the property and the fence secured a padlock. City police and building inspection staff drive by the Site during regular patrols of the area to further control Site access.

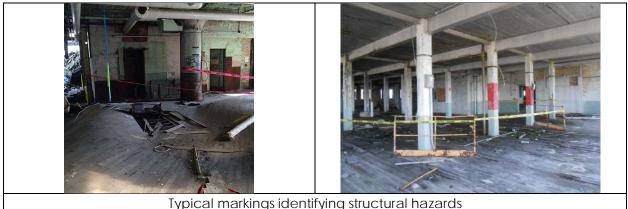
A structural engineer completed a building condition assessment to identify significant structural concerns with the property (Stantec, 2016d and 2016k). The assessment included marking/flagging significant structural liabilities with tape/paint to control access (see typical photos below). The markings have been maintained as needed due to weather disturbance/etc.

The building condition assessment (Stantec, 2016k) did not identify conditions of imminent catastrophic building collapse, therefore, no shoring/structural support for the overall structure was warranted to protect the community.

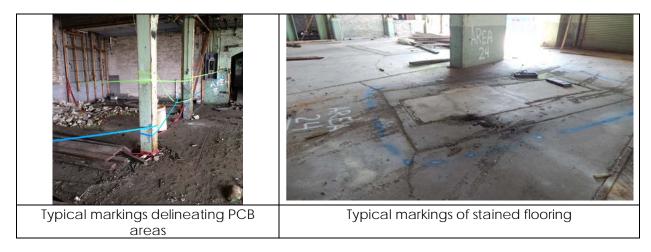
To prevent potential exposure to polychlorinated biphenyls (PCBs), known PCB release areas were marked/delineated with tape/paint (see photo below). In addition, apparent stains to flooring were identified/delineated by Stantec (2016h) to prevent potential human exposure to residual impacts (see photo below). A site-specific sampling and analysis plan was developed to characterize/delineate horizontal and vertical extents of residual impacts to each area (Stantec, 2016l). Implementation of the plan is pending final USEPA approval.
