Brownfields Assessment and Cleanup Grants: Application for Petroleum Eligibility Determination

Petroleum Eligibility for 1512 Washington St; Manitowoc, Wisconsin

Reference: Photographic Documentation of Former Mirro Building Current Ground Floor Features 1512 Washington Street Manitowoc, Wisconsin USEPA Cooperative Agreement No. BF-00E01529-0 Stantec Project No. 193703139

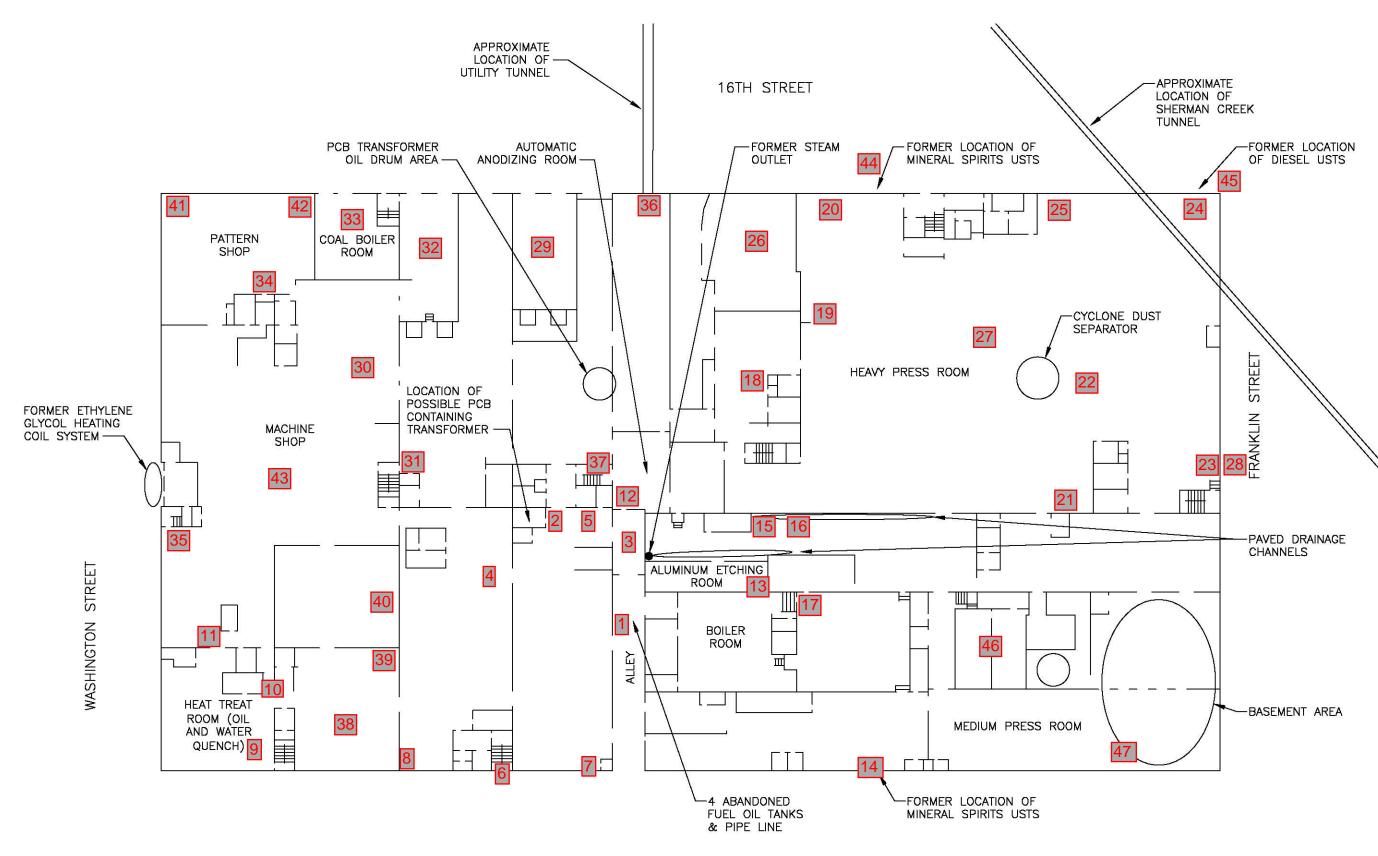
Ground Floor Plan

This collection is somewhat unique in that access to the individual photographs is through the attached PDF basemap of the Property. The grey numbered boxes on the basemap are photograph locations. Each photograph location is linked a folder on a Stantec FTP site containing photographs taken the specific location. Simply click the blue box outlining a photograph location on Figure 1 and the photographs will appear in your web browser. The FTP Site will remain active until at least September 30, 2017.

Table 1 is attached and provides notes related to each photograph location.

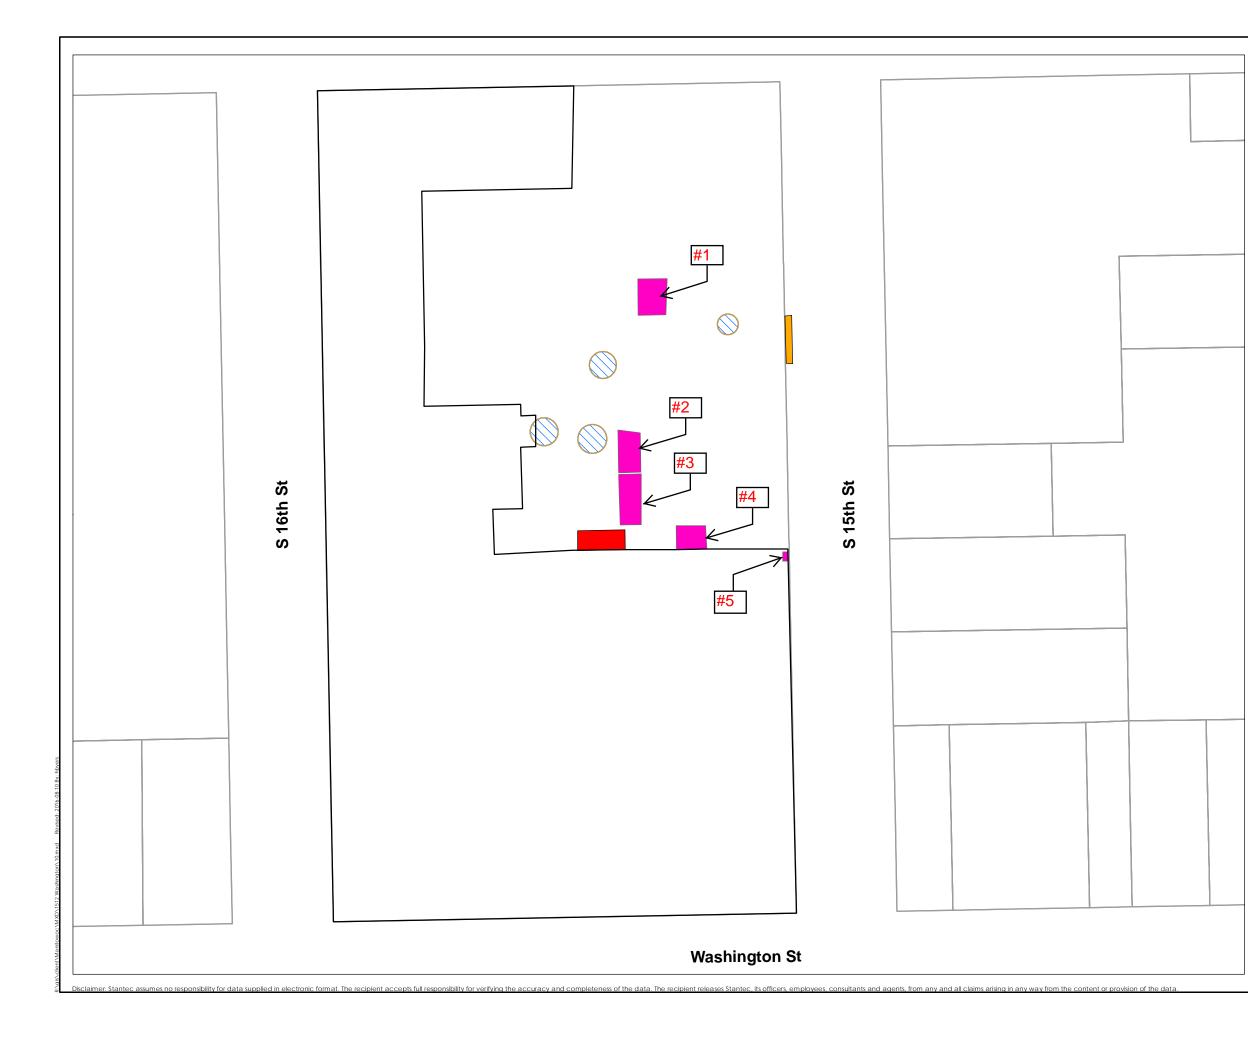
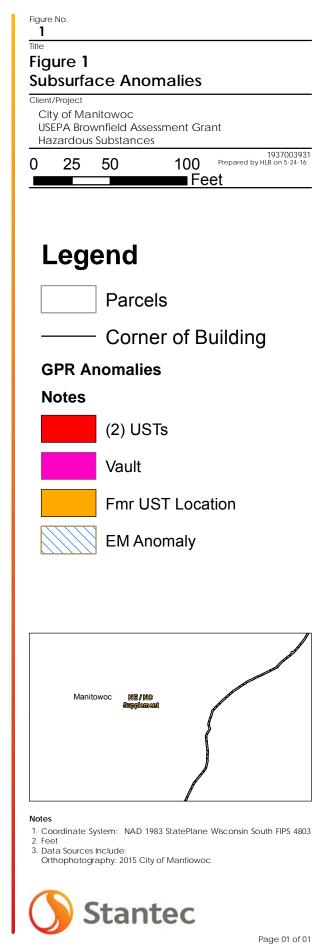
Figure 1 – Results of a geophysical survey using ground penetrating radar and electromagnetic surveying techniques. The survey identified two USTs abandoned in place. For more details, see Stantec (2016g) in Attachment D.

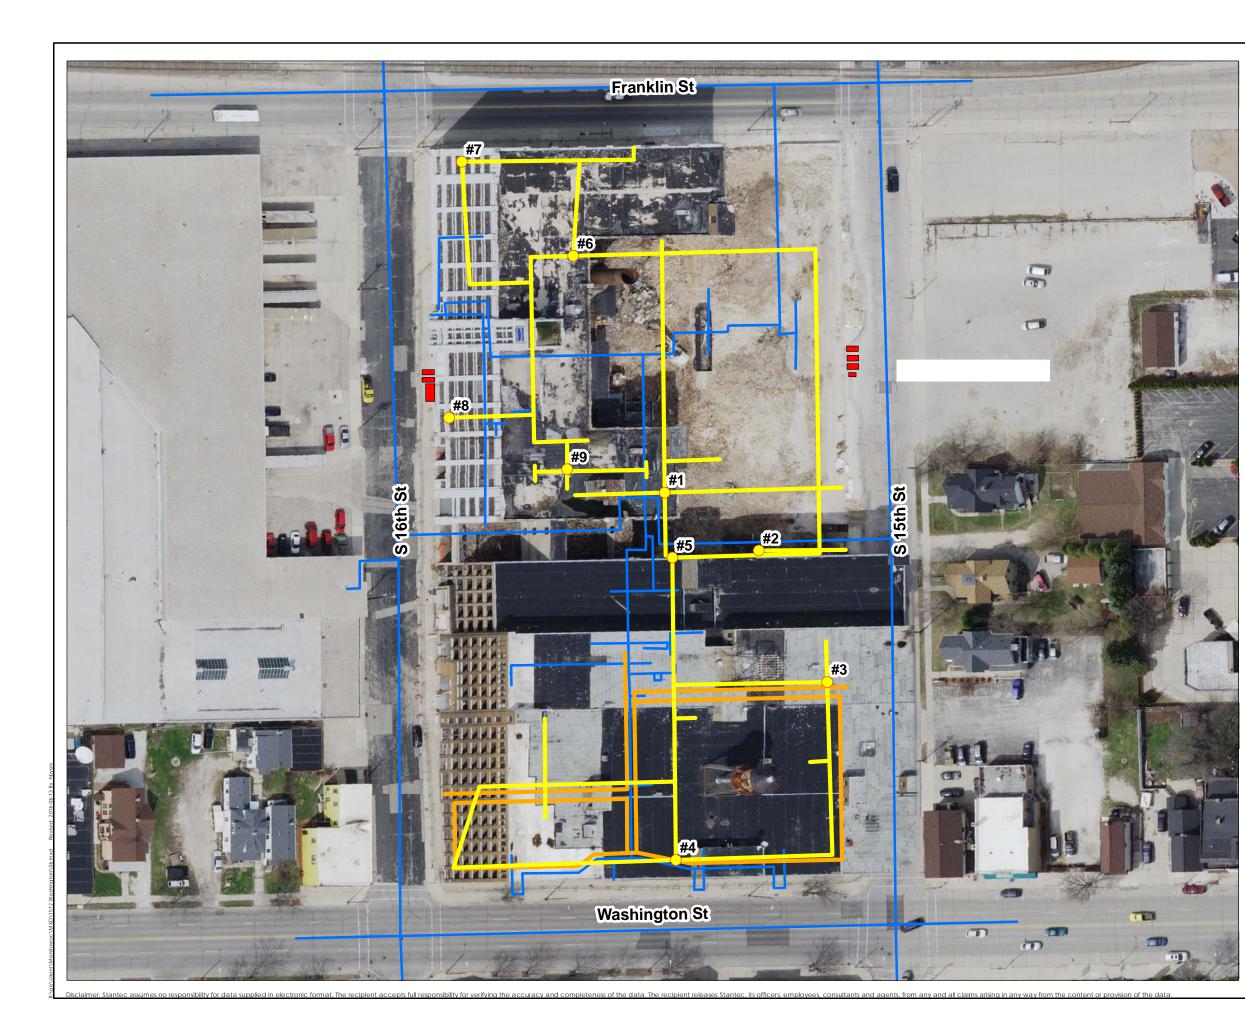
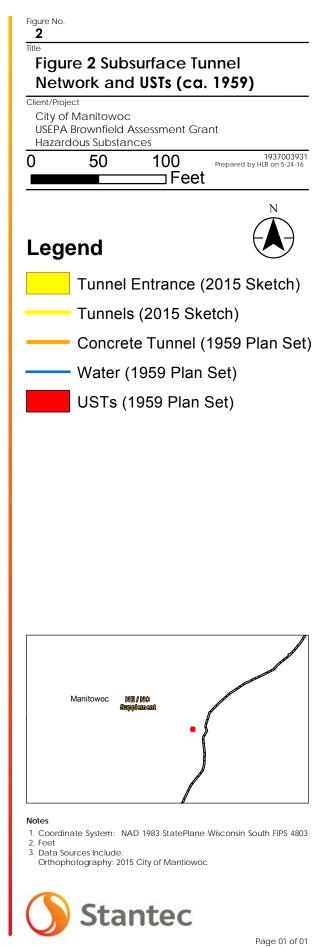
Figure 2 – Illustrates the locations of USTs previously located at the Site. For more details, see Stantec (2016b) in Attachment D.

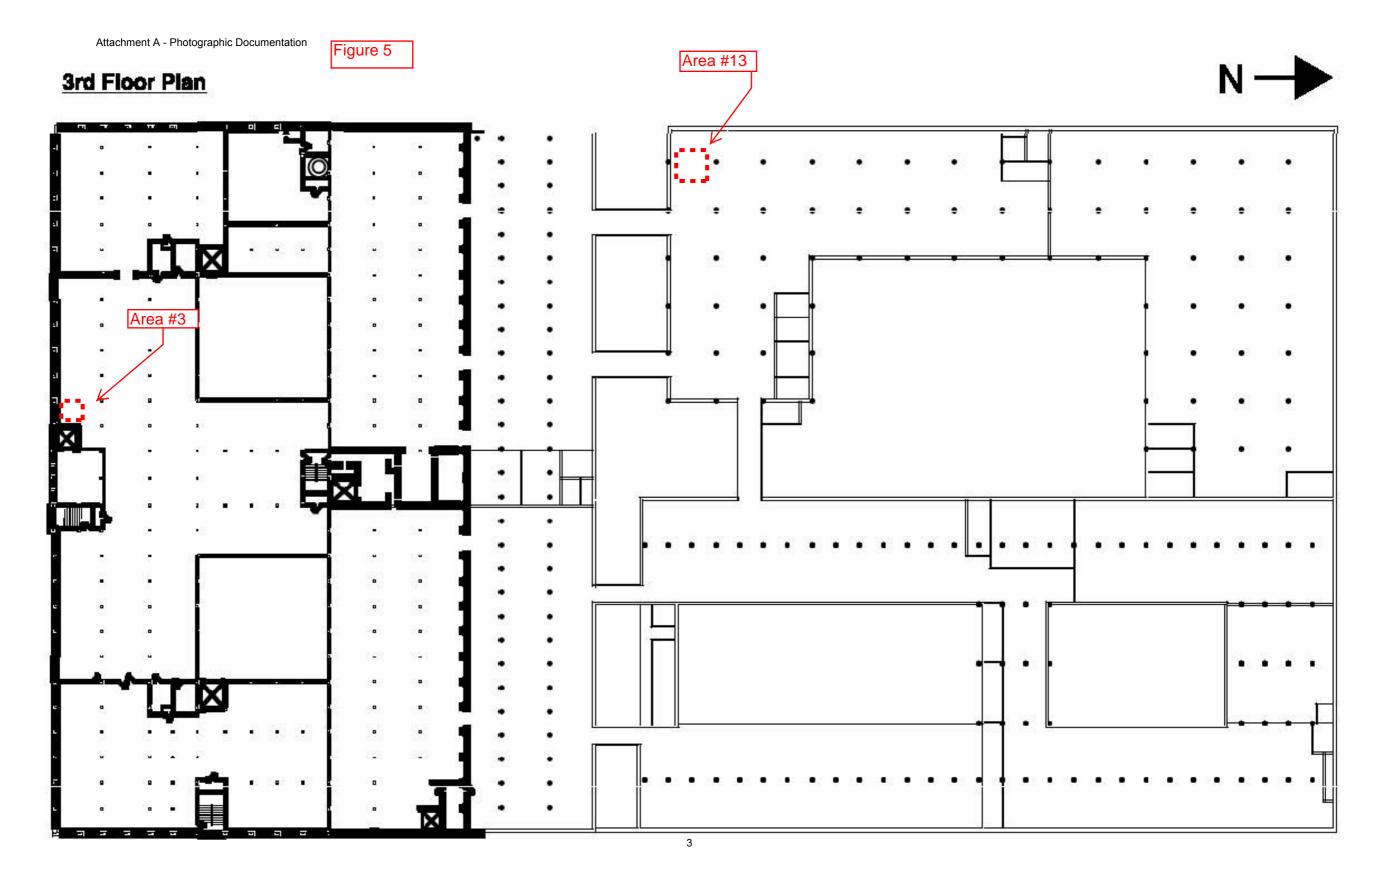
4th Floor Plan

Figures 4 – 7 – Illustrates the approximate extent of apparent petroleum stains/releases to building materials on upper floors. For more details, see Stantec (2016h) in Attachment D.

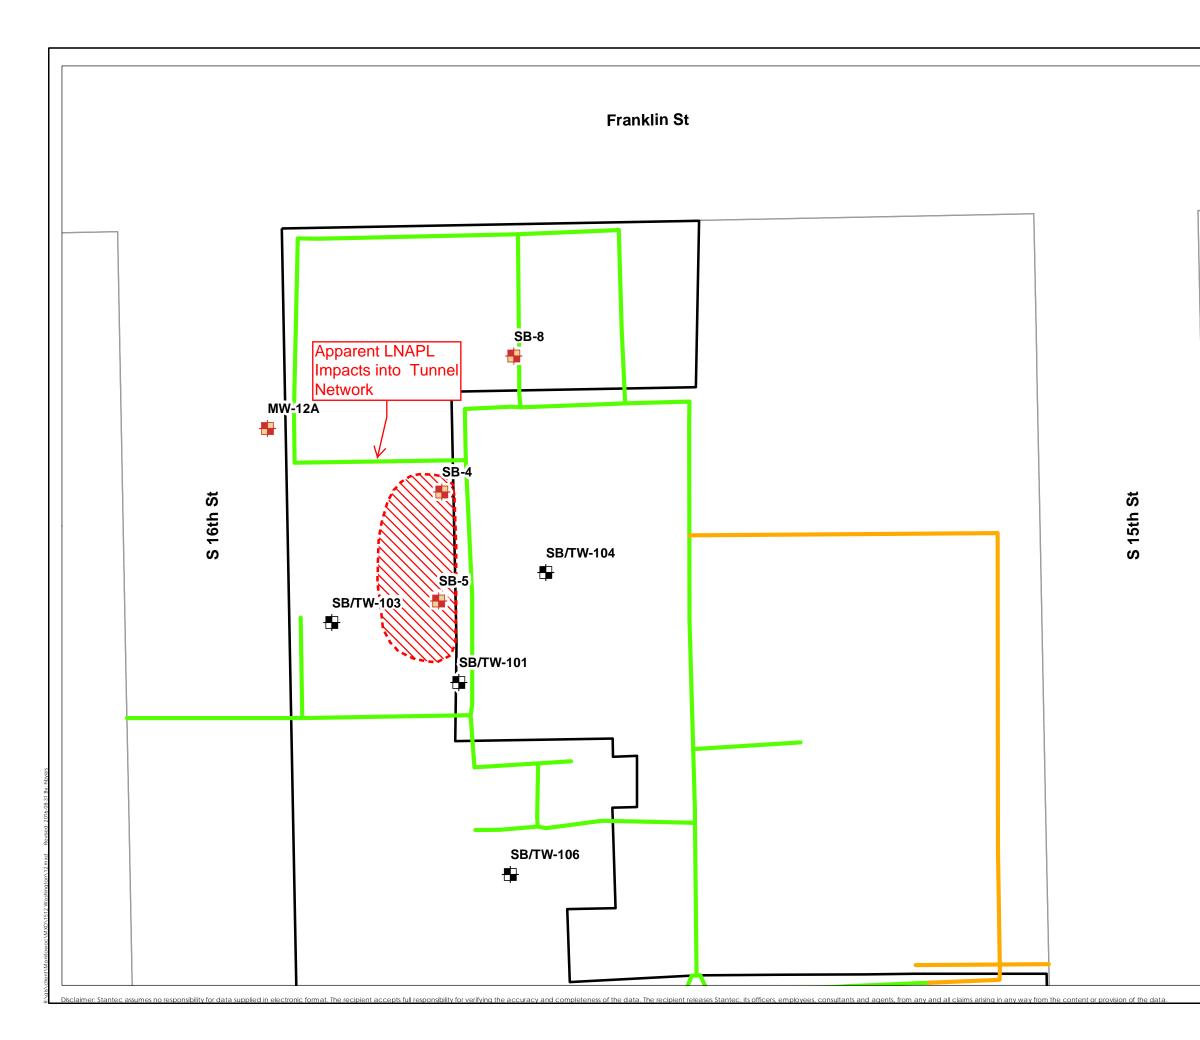
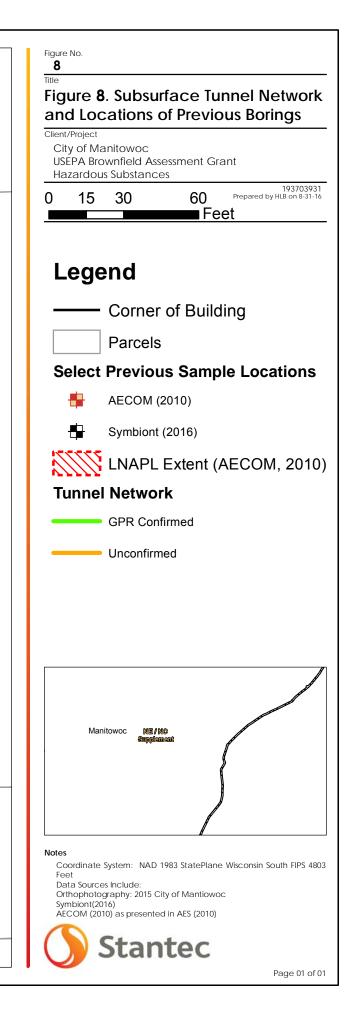
Figure 8 – Illustrates the horizontal extent of previously detected light non-aqueous phase liquid at the Site. Figure 4 also illustrates the location/orientation of the subsurface service tunnel network and illustrates the location of apparent petroleum impacts to the tunnel network.
