February 15, 2013

Project Reference #13621

**RE: Impacted Soil Screening Criteria
Former Lakefield Sand & Gravel Property
7003 West Good Hope Road, Milwaukee, Wisconsin
WDNR BRRTS No. 02-41-548828 FID No. 241377070**

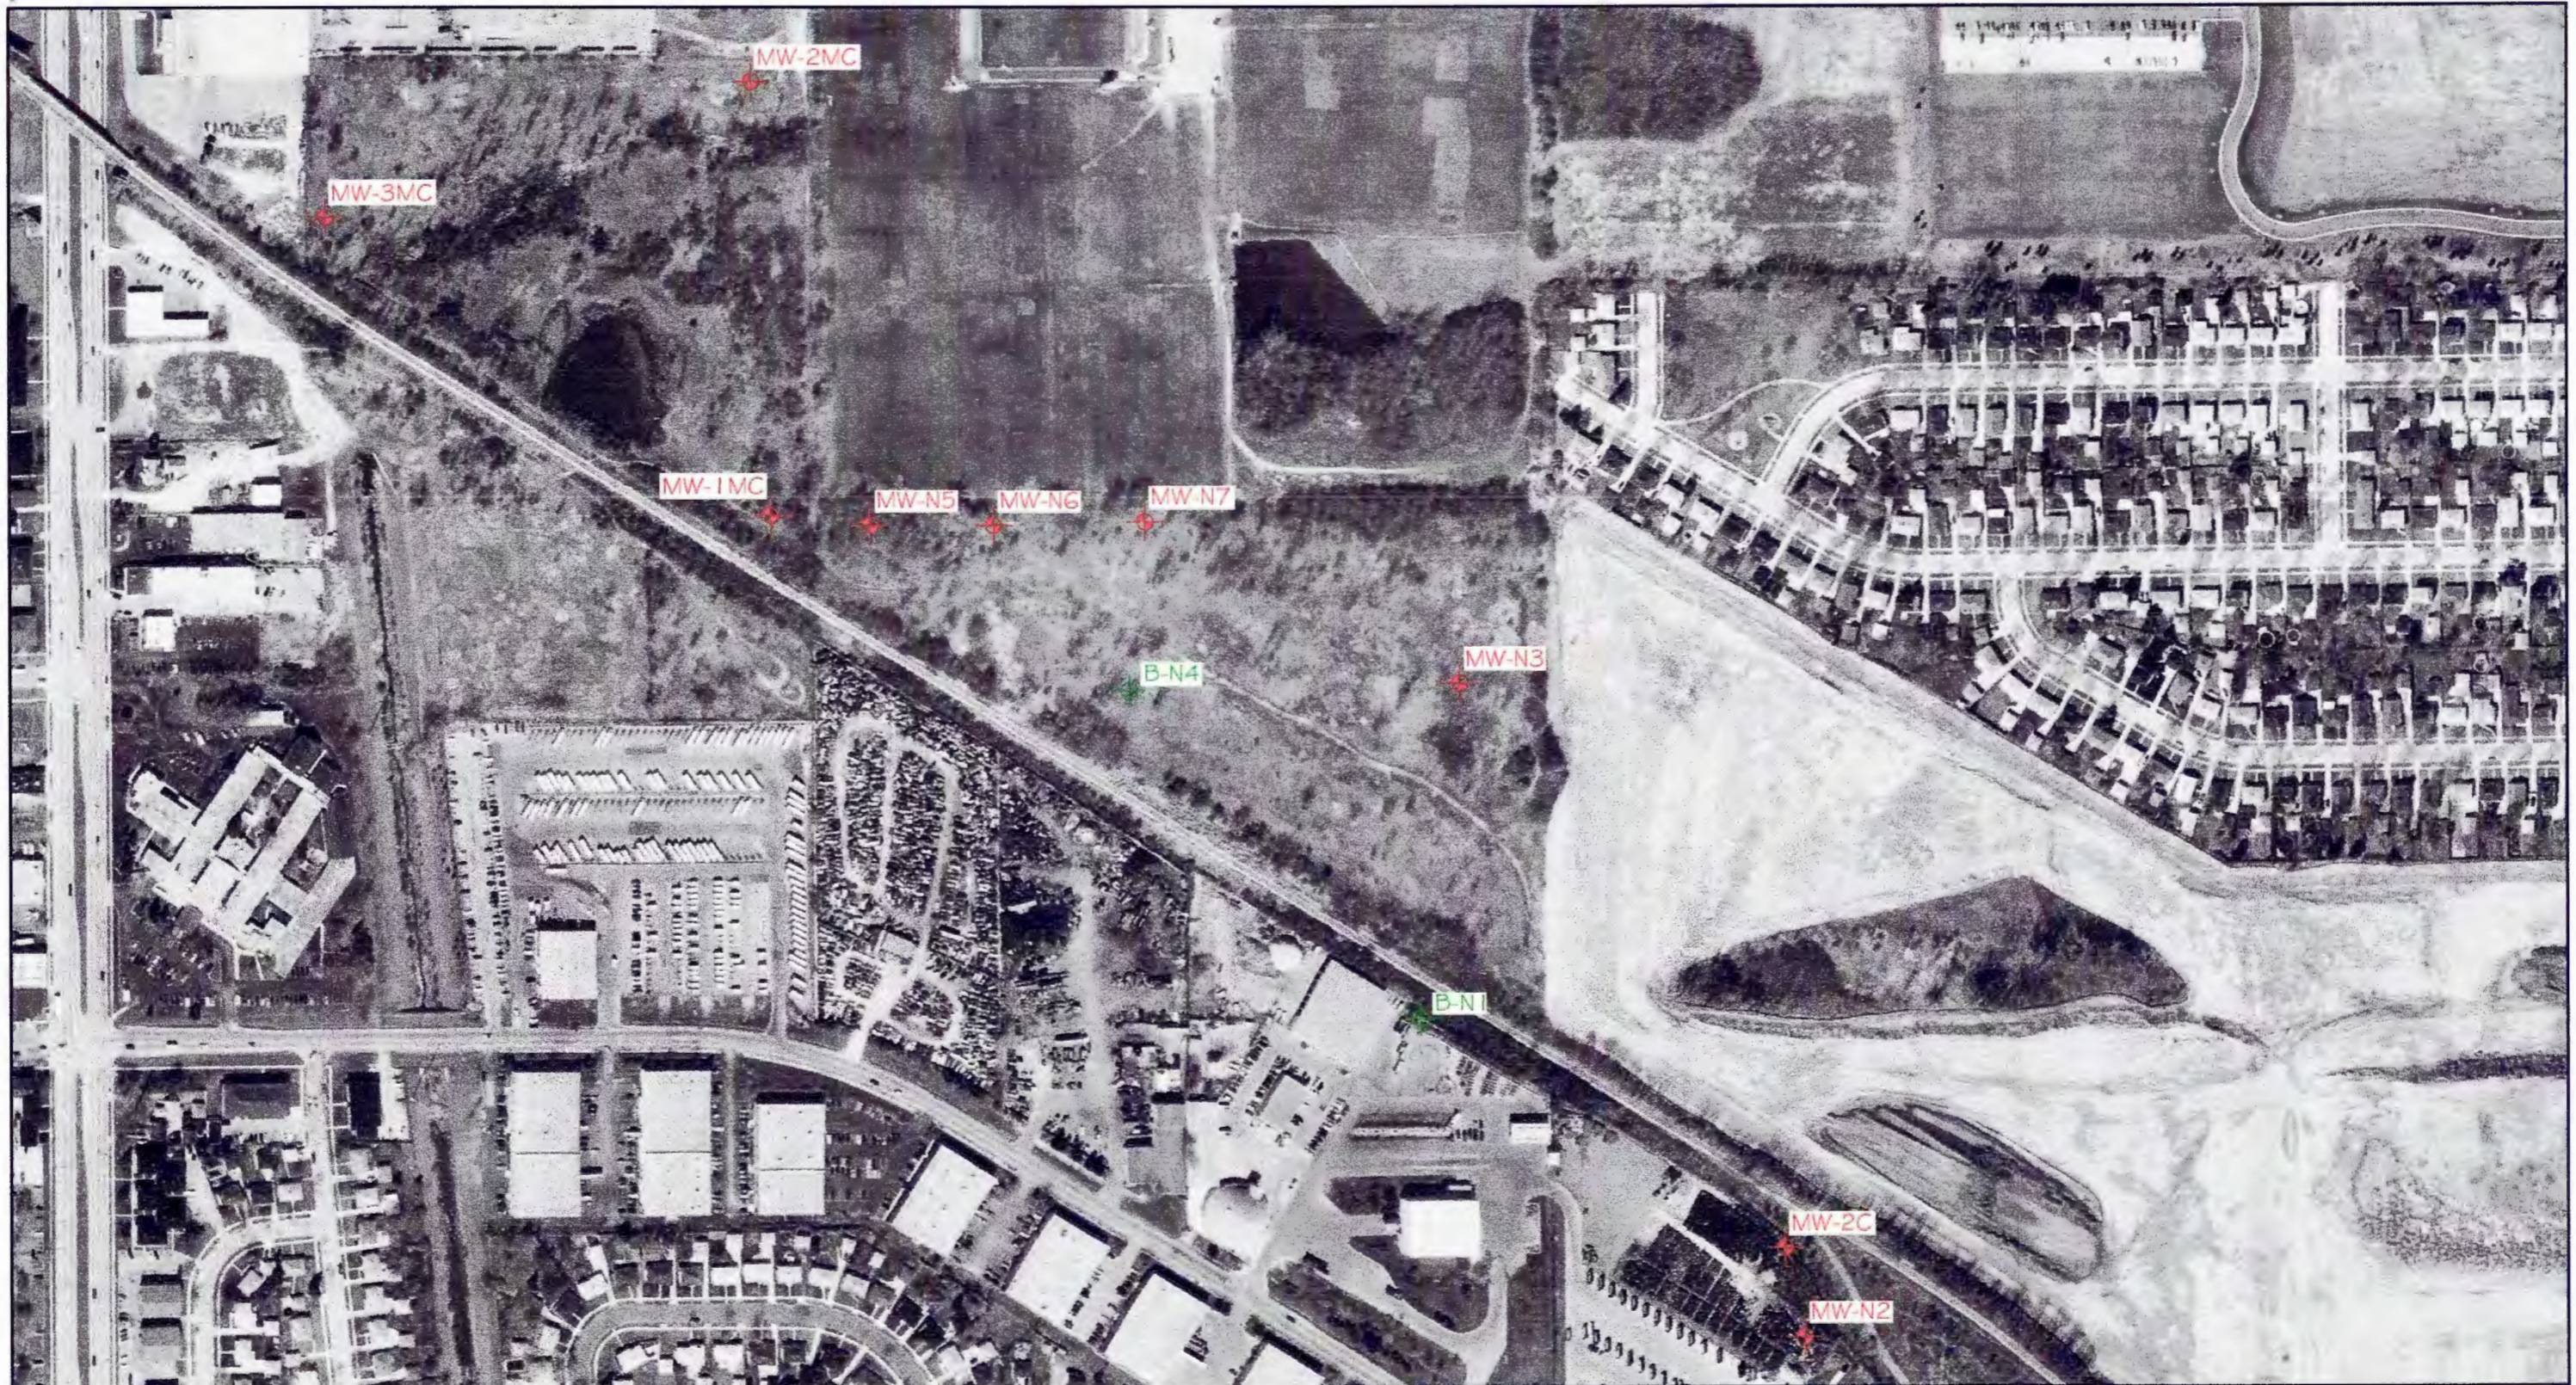
PROJECT NUMBER: DNR 01-2100-2764 FIGURE 1

- ▲ A site figure showing borehole and monitoring well locations (Figure 1)
- ▲ A table summarizing monitoring well and groundwater elevation data (Table 1)
- ▲ Photocopies of field notes maintained by Northern Environmental
- ▲ Soil Boring Log Information Forms (Form 4400-122)
- ▲ Borehole Abandonment Forms (Form 3300-5B)
- ▲ Monitoring Well Construction Forms (Form 4400-113A)
- ▲ Monitoring Well Development Forms (Form 4400-113B)
- ▲ Groundwater Monitoring Well Information Form (Form 4400-89)
- ▲ Grain size analysis results

On July 28, 2004, Northern Environmental surveyed the elevation of the top of polyvinyl chloride well casing and ground surface at each of the five new wells, three existing wells (MW-1MC, MW-2MC, and MW-3MC) on the former Melody Top property, and an existing well (MW-2C) on the city of Milwaukee property. Figure 1 shows the borehole and monitoring well locations based on GPS coordinates provided by the WDNR. Well elevation and water level measurements are provided in Table 1.

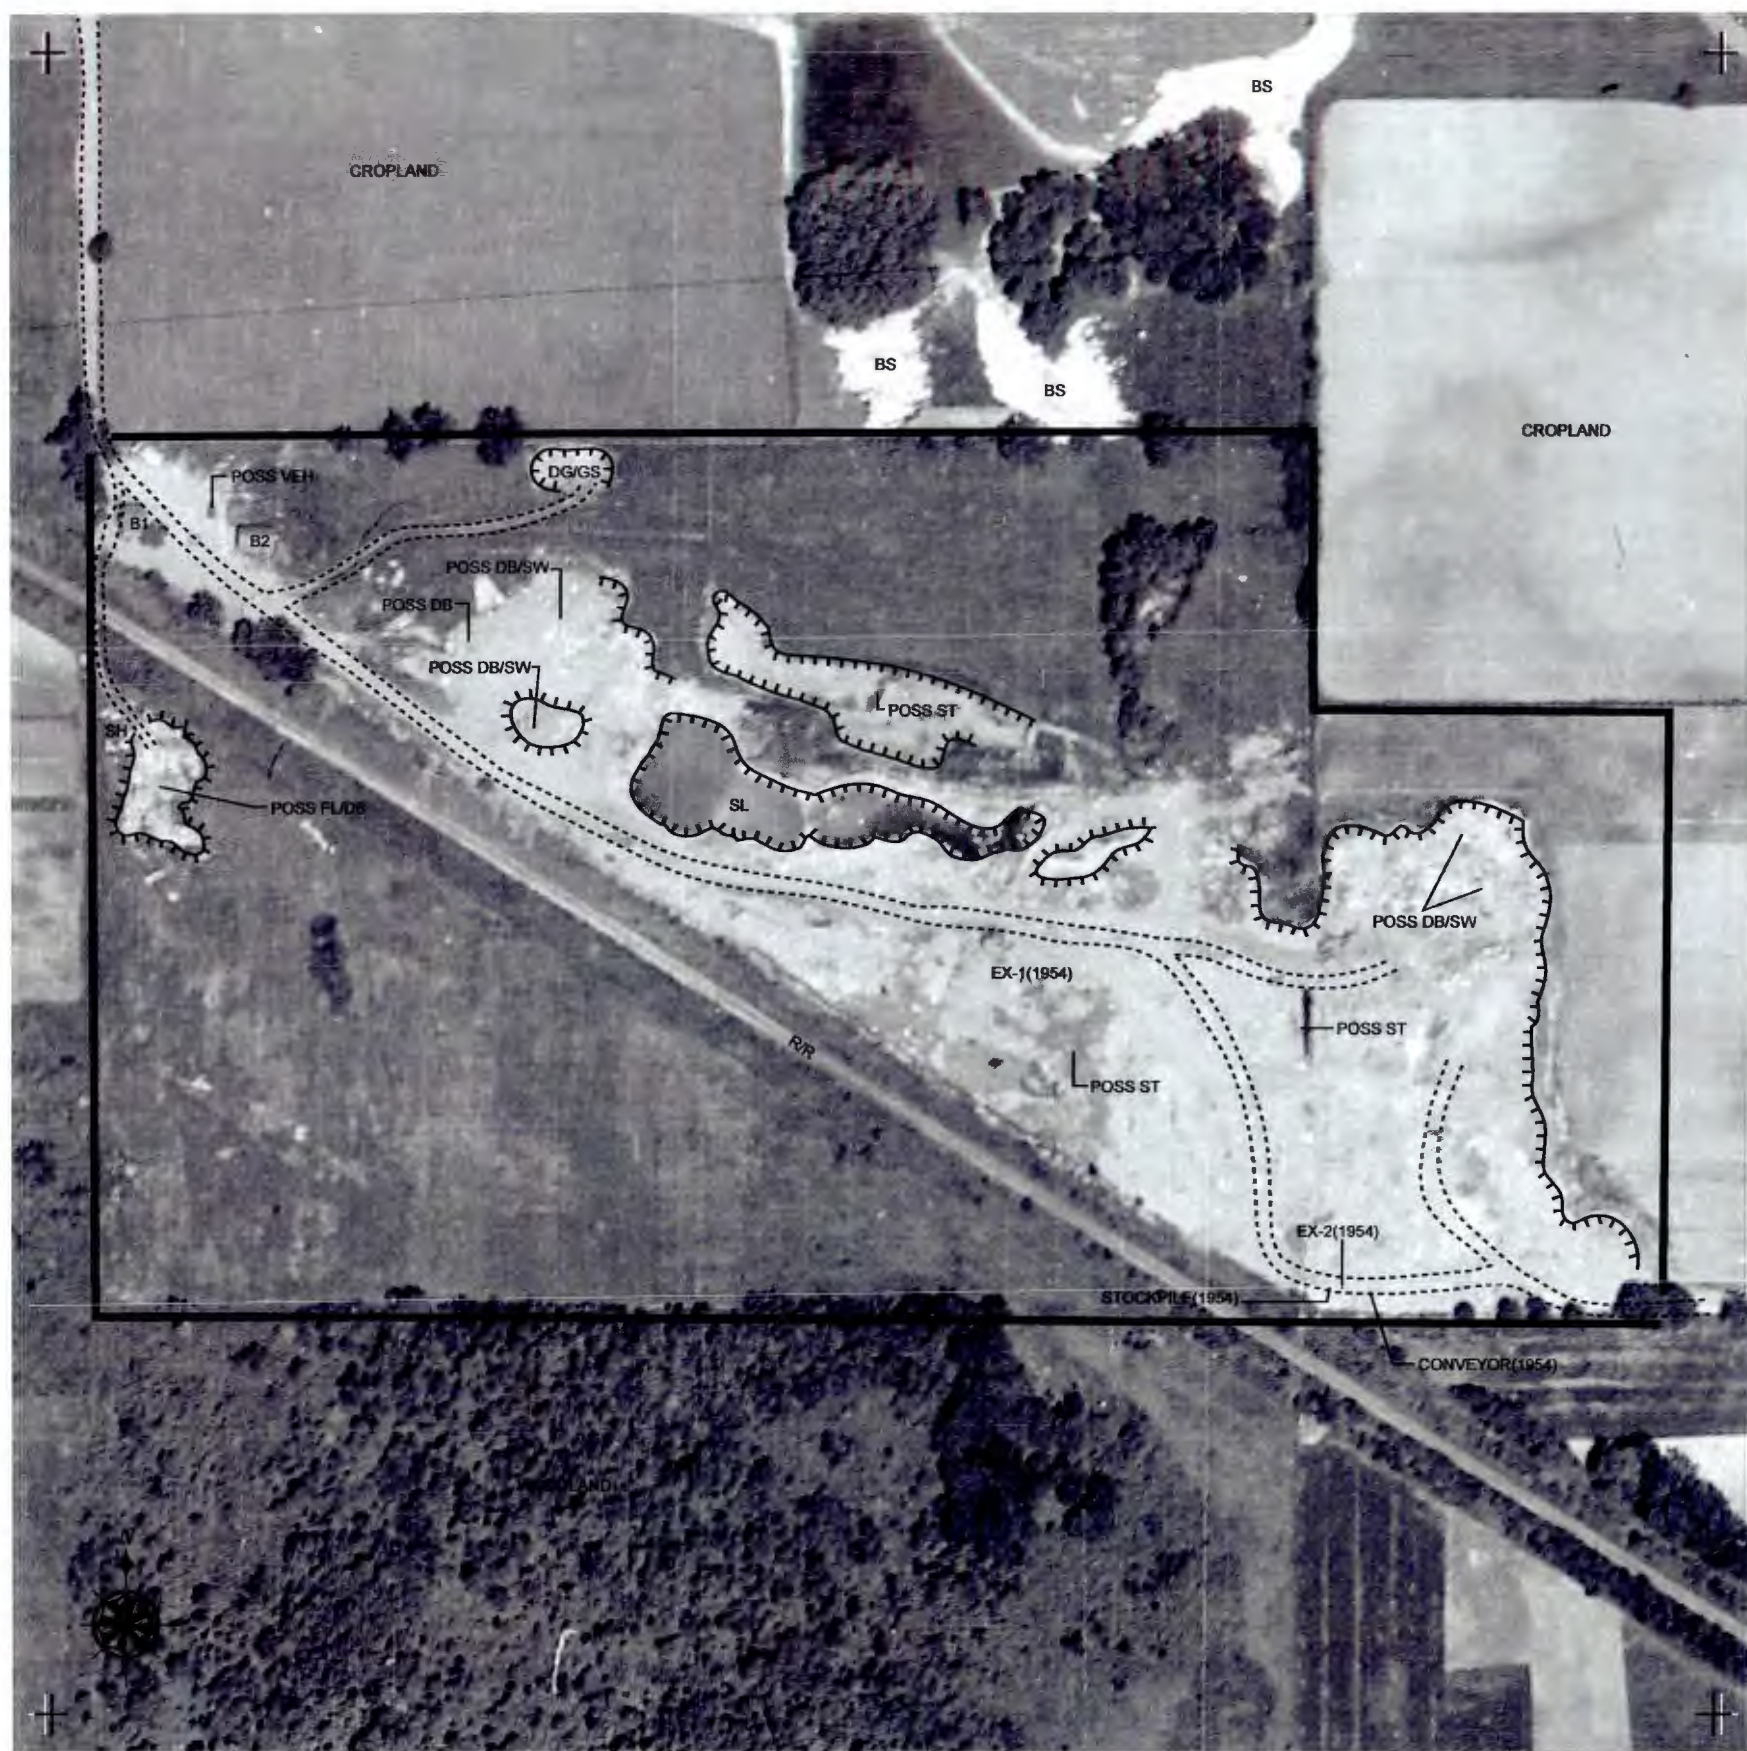
Light-toned areas of bare soil are noted north of the site and do not appear to be related to activity on the site.

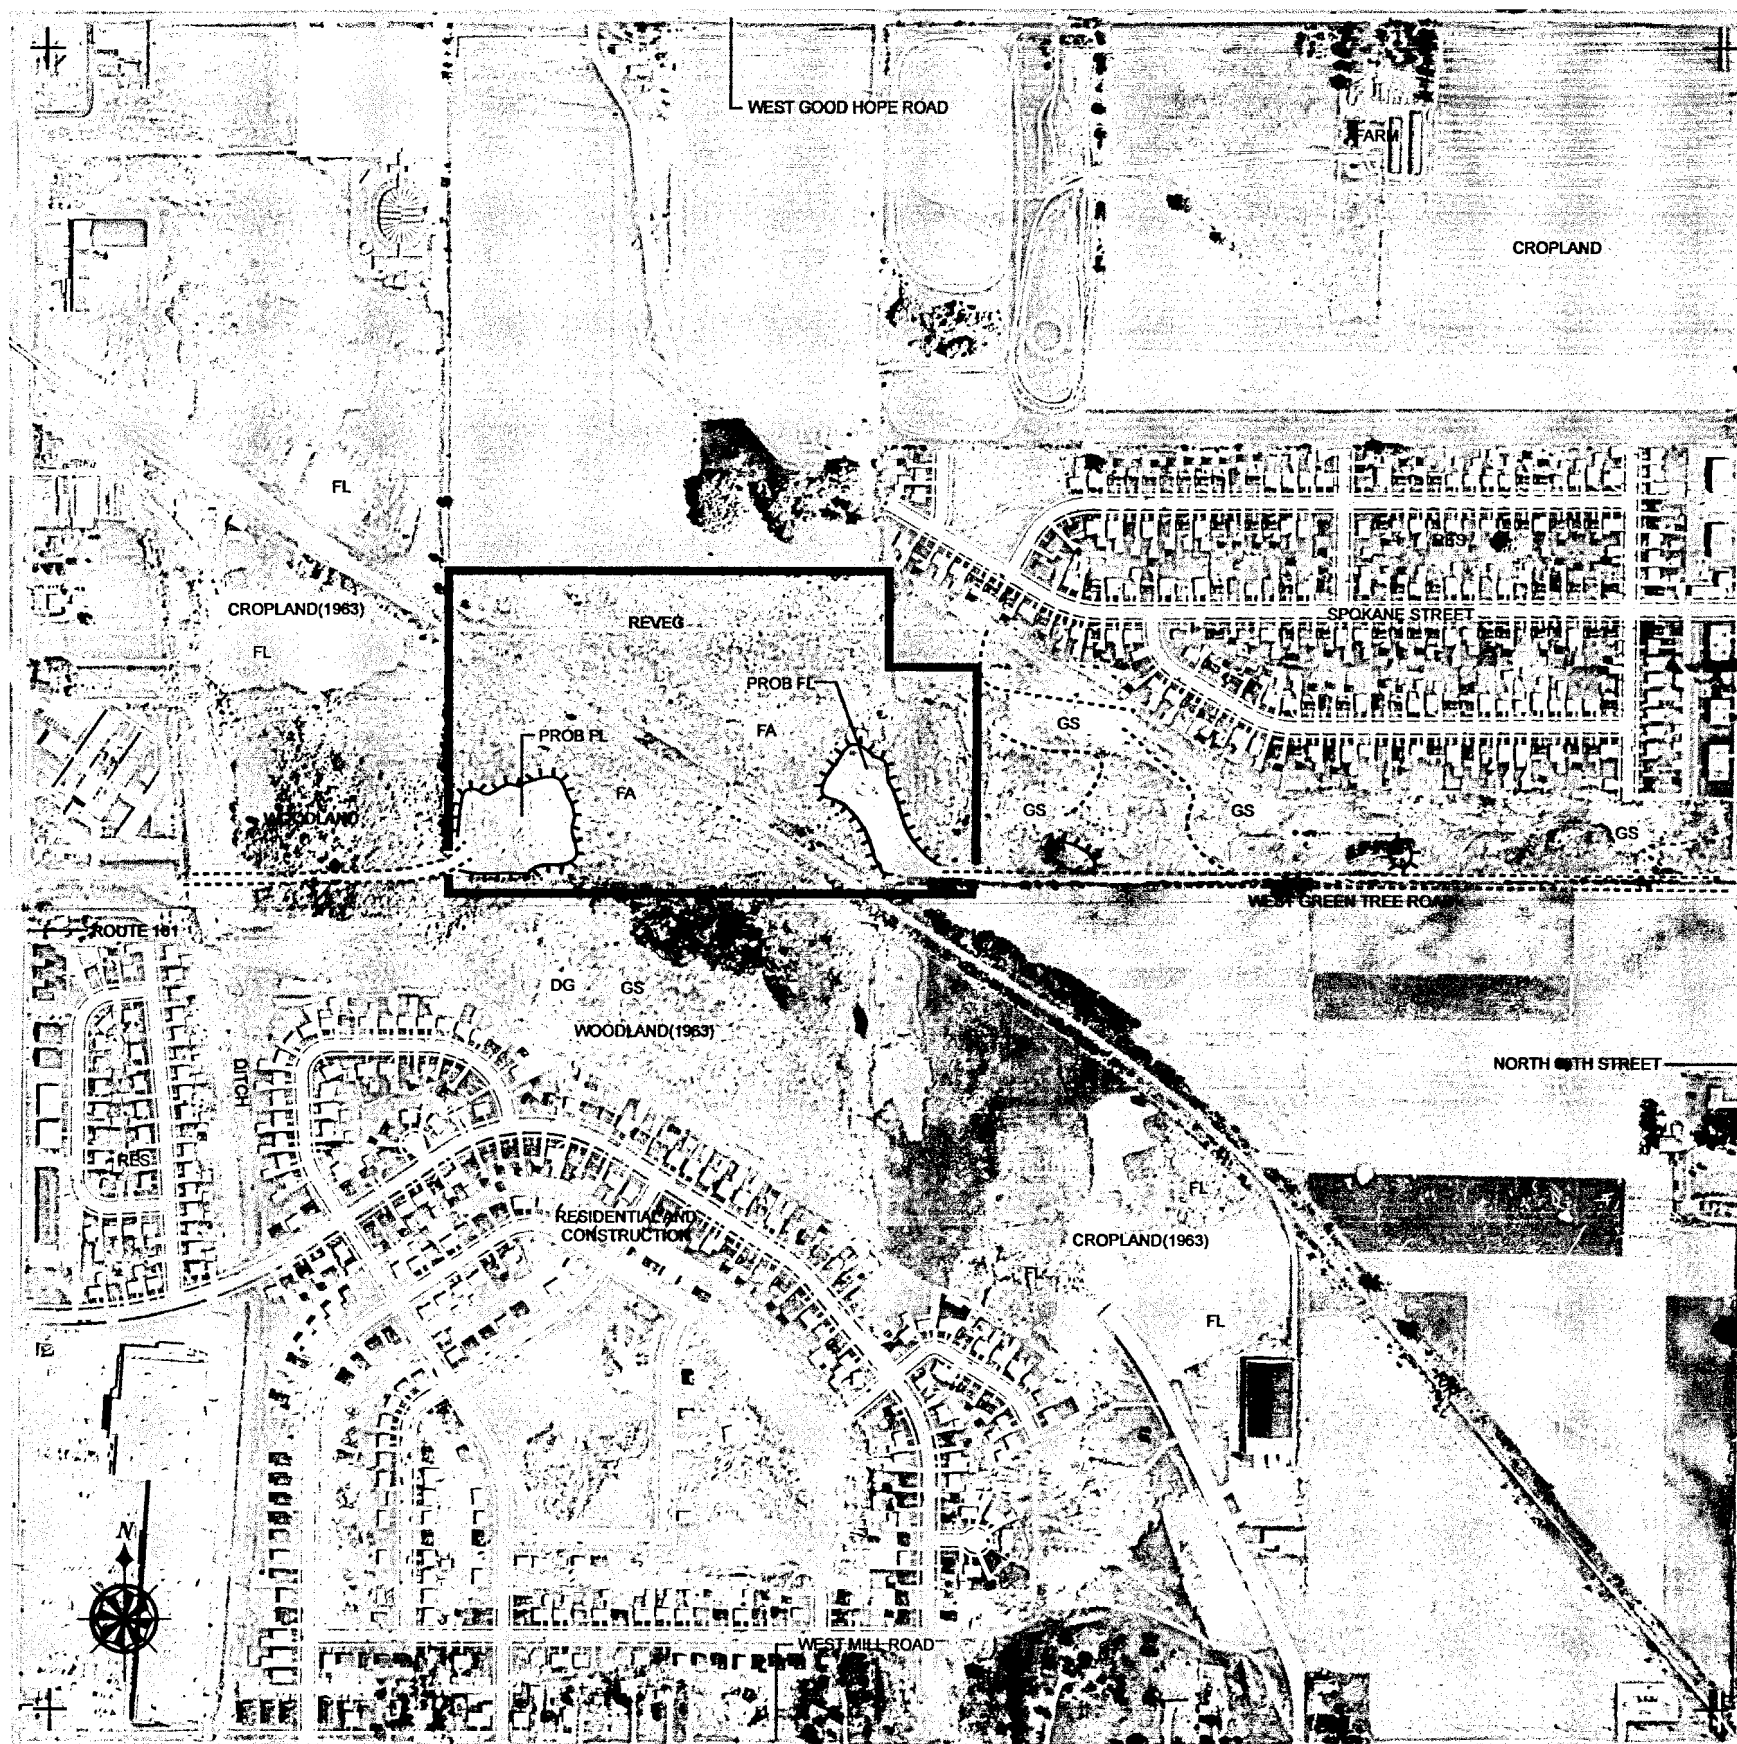
Additional earthmoving, filling, and construction activity is evident west and northwest of the site. No waste disposal or dumping is visible in this construction area.
