Re: **Data Transmittal**

Clare Central Apartments
1003 and 1033 West Atkinson Avenue
Milwaukee, Wisconsin
Terracon Project No. 58107058A
WDNR BRRTS #02-41-549867
VPLE BRRTS #06-41-560680

SOIL CVOC ISOCONCENTRATION MAP (0-4' BGS)
CLARE CENTRAL APARTMENTS
1003 AND 1033 WEST ATKINSON AVENUE
WISCONSIN

GROUNDWATER CONTOUR MAP (5/11/2017)
CLARE CENTRAL APARTMENTS
1003 AND 1033 WEST ATKINSON AVENUE
MILWAUKEE
WISCONSIN
EXHIBIT 4

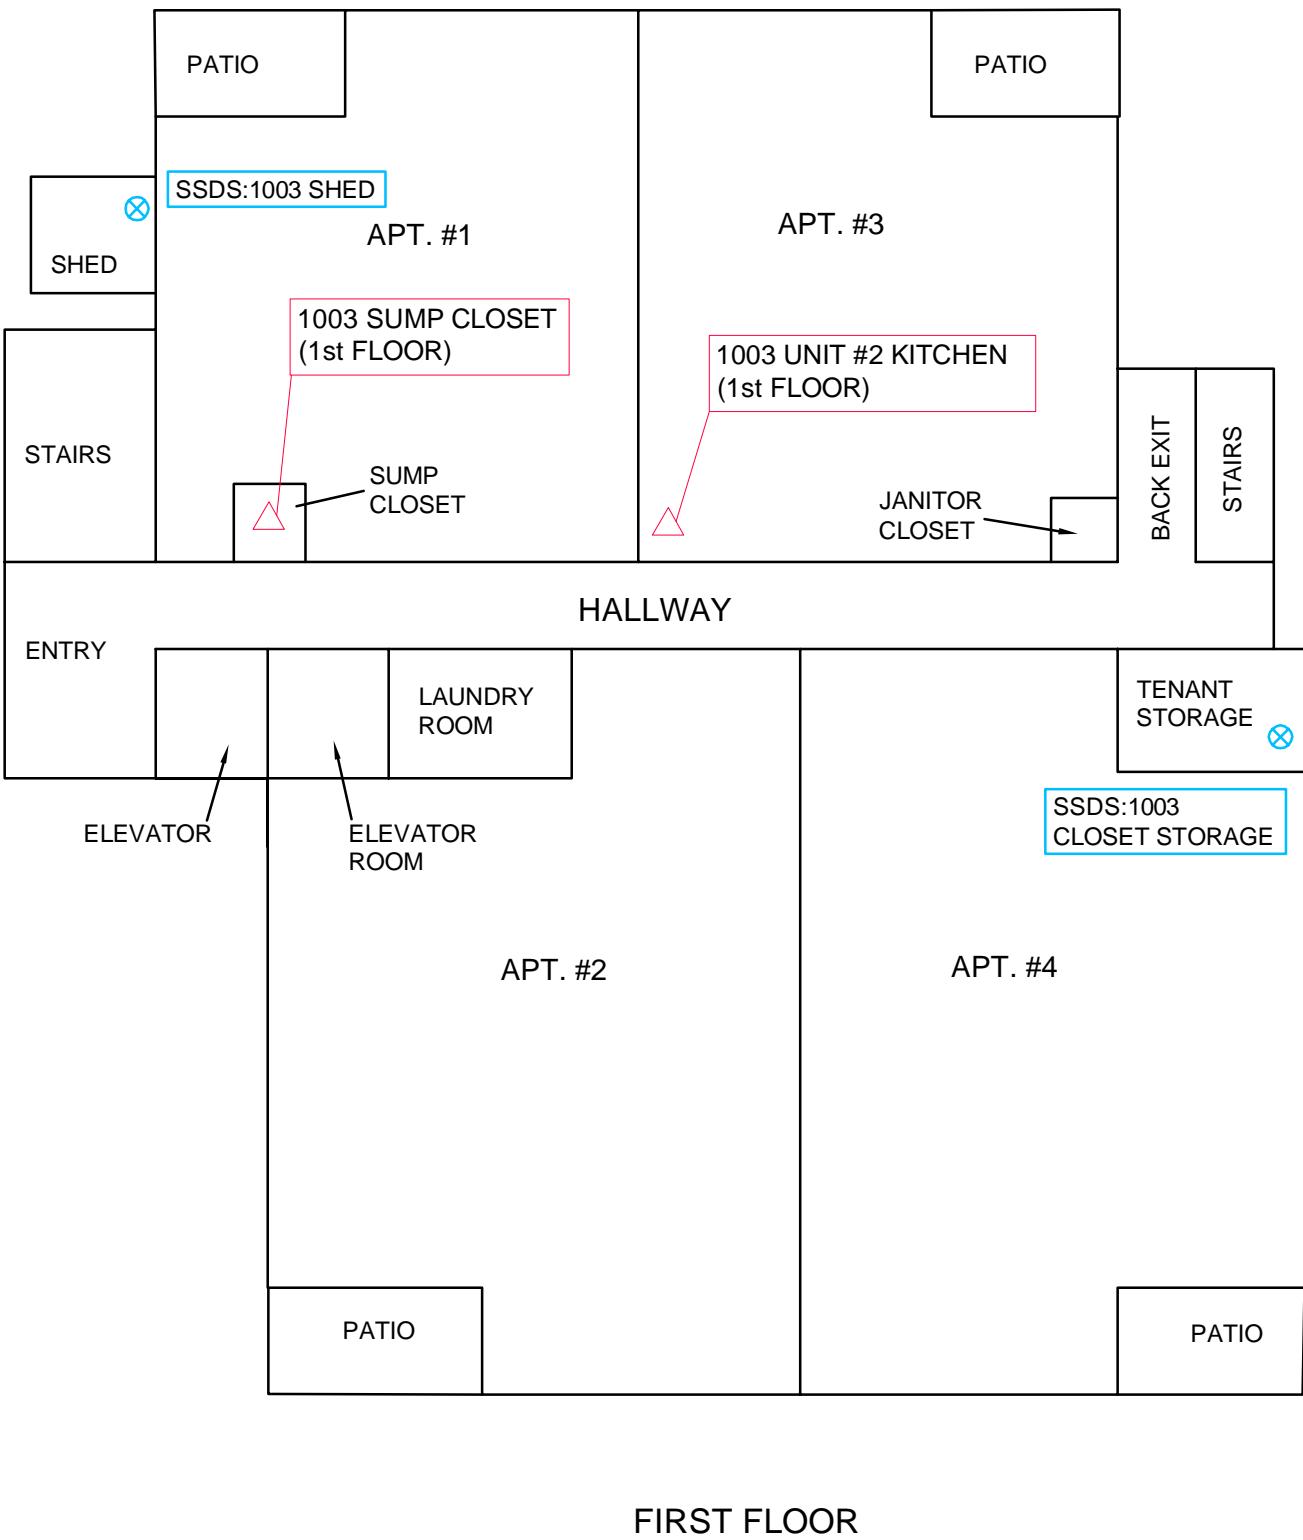
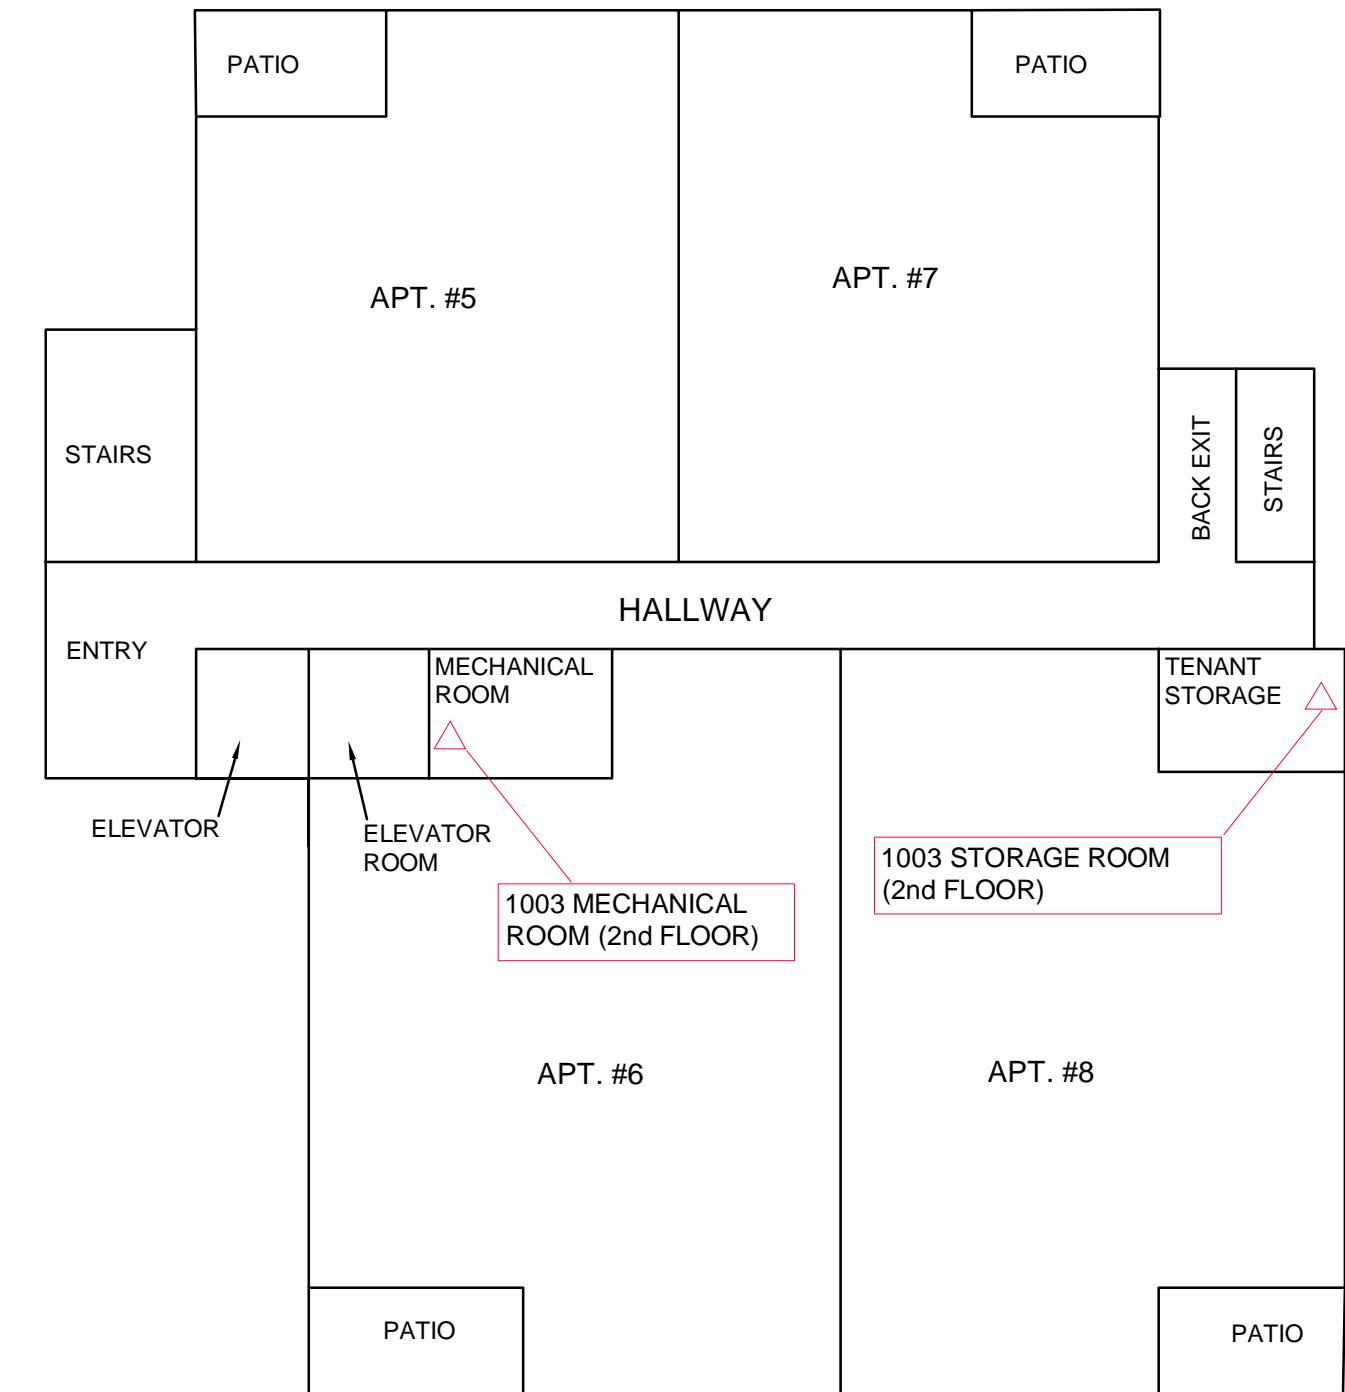
SUB-SLAB DEPRESSURIZATION SYSTEM & AMBIENT AIR SAMPLING LOCATIONS - 1003 BUILDING CLARE CENTRAL APARTMENTS 1003 WEST ATKINSON AVENUE MILWAUKEE
WISCONSIN

On January 18, 2018, Terracon personnel collected ambient air samples from the Clare Central complexes. The 24-hour ambient air samples were collected in laboratory-prepared 6-liter Summa canisters with a flow regulator calibrated for 24-hour collection. The ambient air samples collected within the Summa canisters were submitted to the laboratory for analysis of tetrachloroethylene (PCE), TCE, trans-dichloroethylene (DCE), cis-DCE, and VC using EPA Method TO-15. CVOCs were not detected at concentrations above vapor action levels (VALs). Historical air analytical results are summarized on Table 4, and sampling location maps for the apartment complexes are presented on Exhibits 5 and 6.

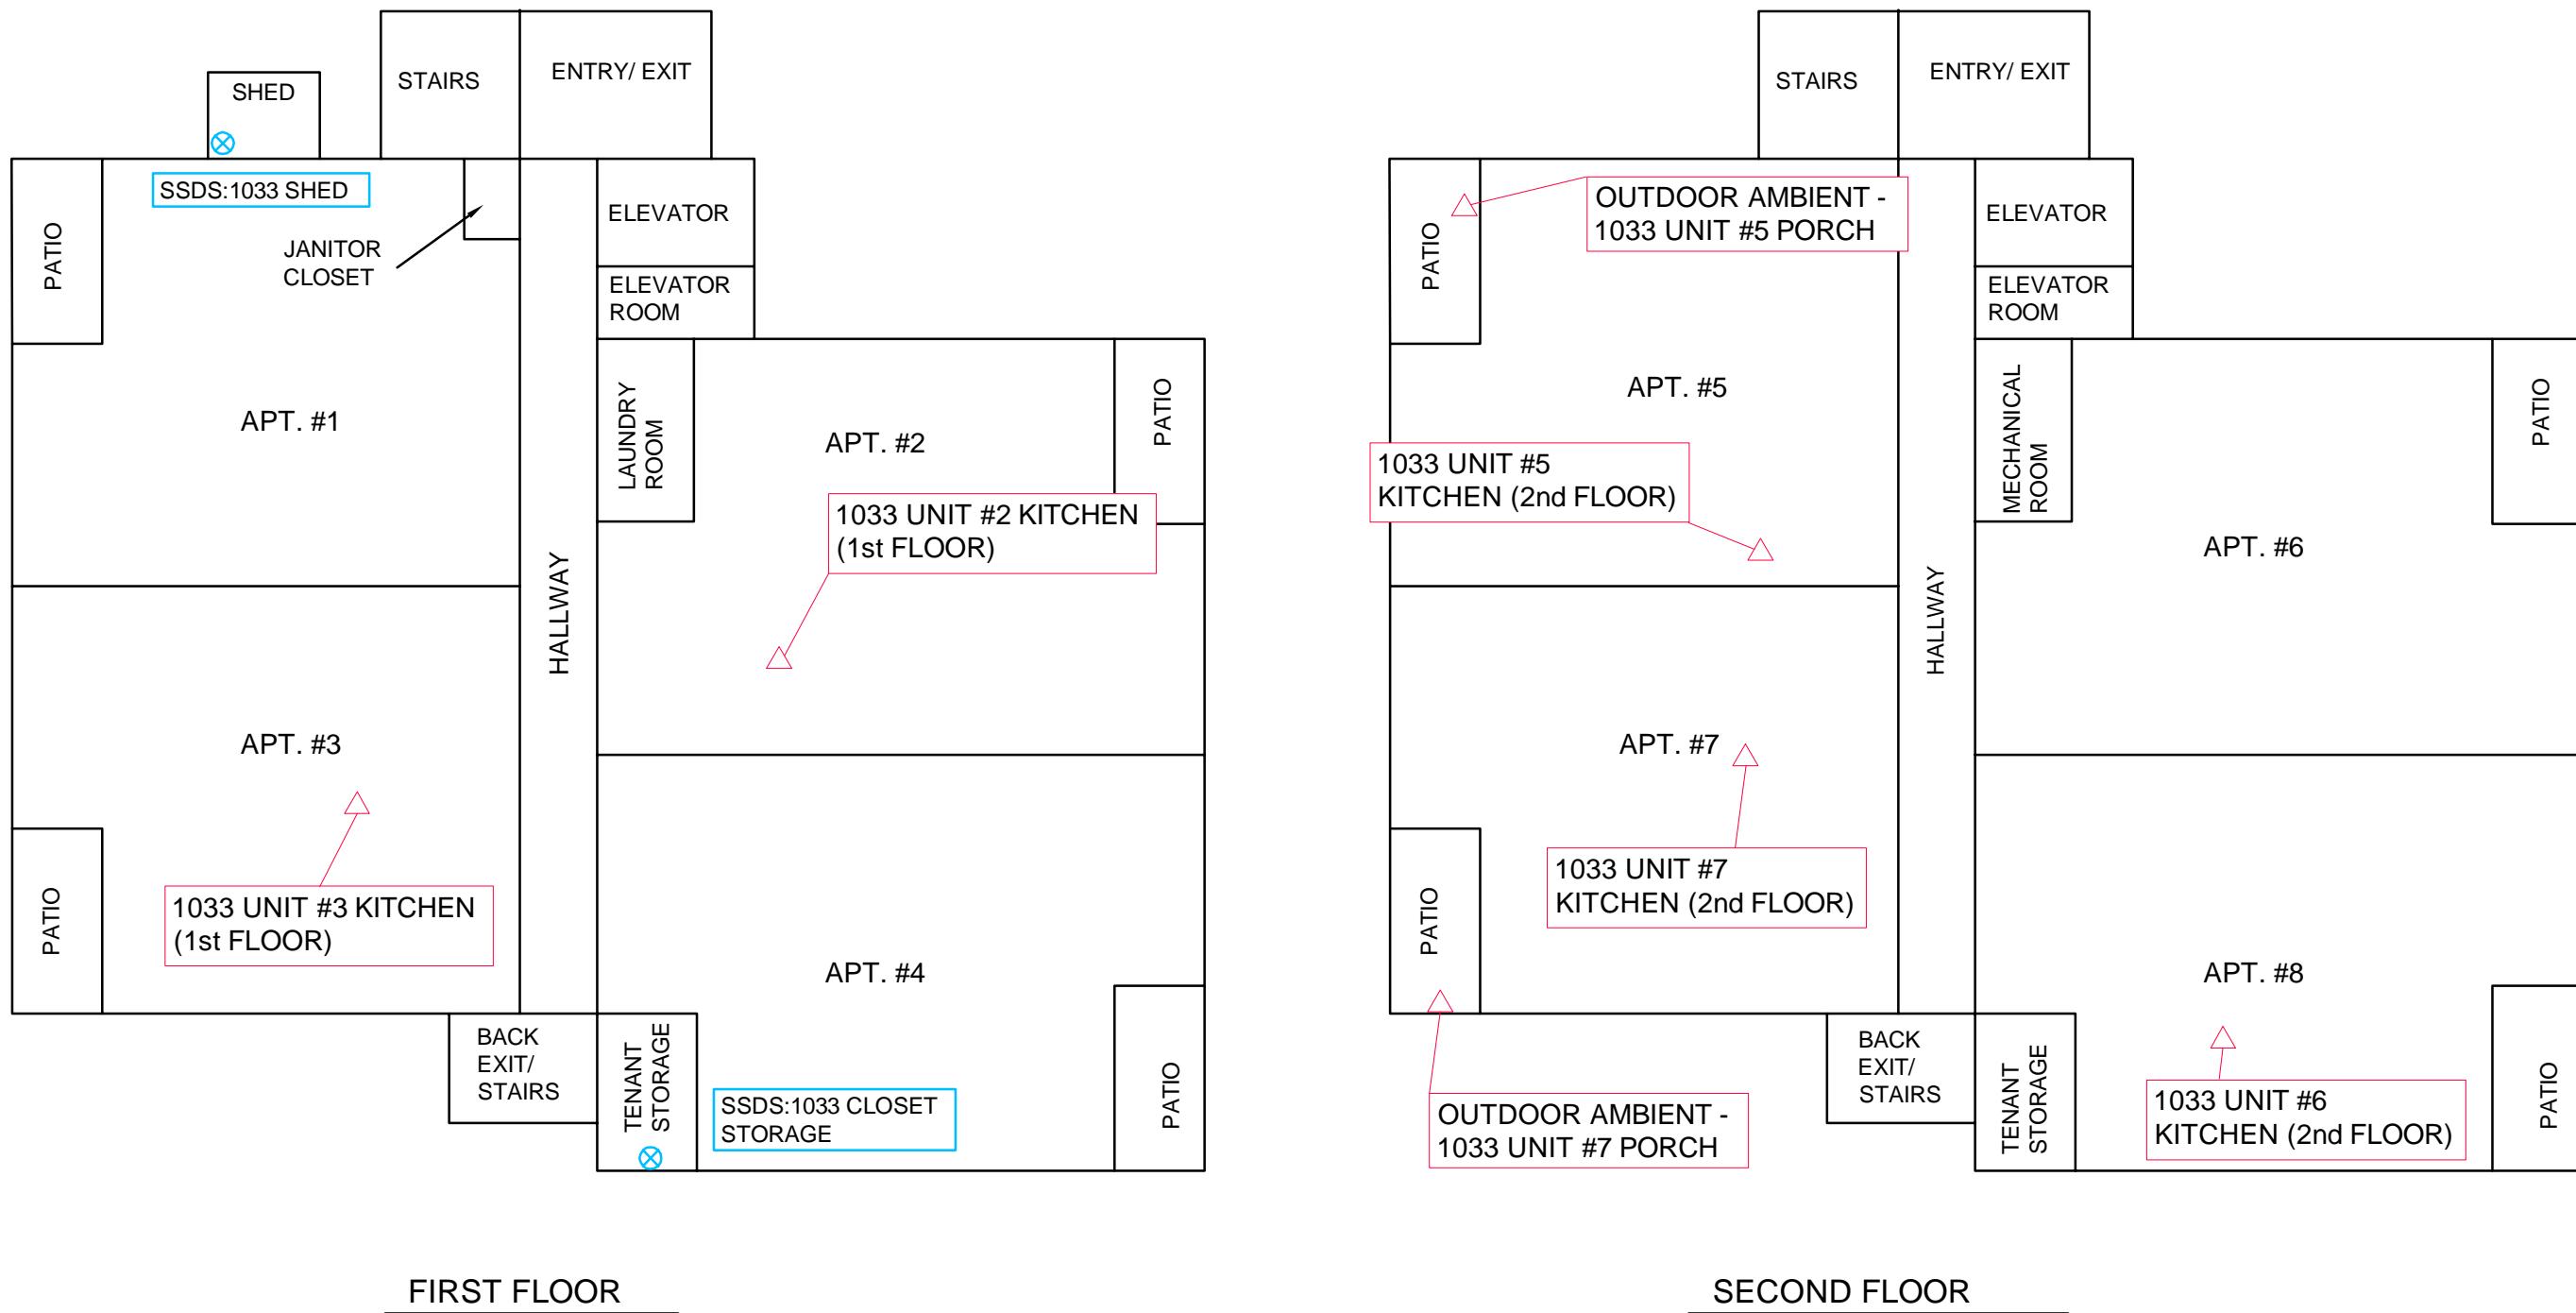
N
E
6
EXHIBIT

SUB-SLAB DEPRESSURIZATION SYSTEM & AMBIENT AIR SAMPLING LOCATIONS - 1033 BUILDING	
CLARE CENTRAL APARTMENTS 1033 WEST ATKINSON AVENUE	WISCONSIN

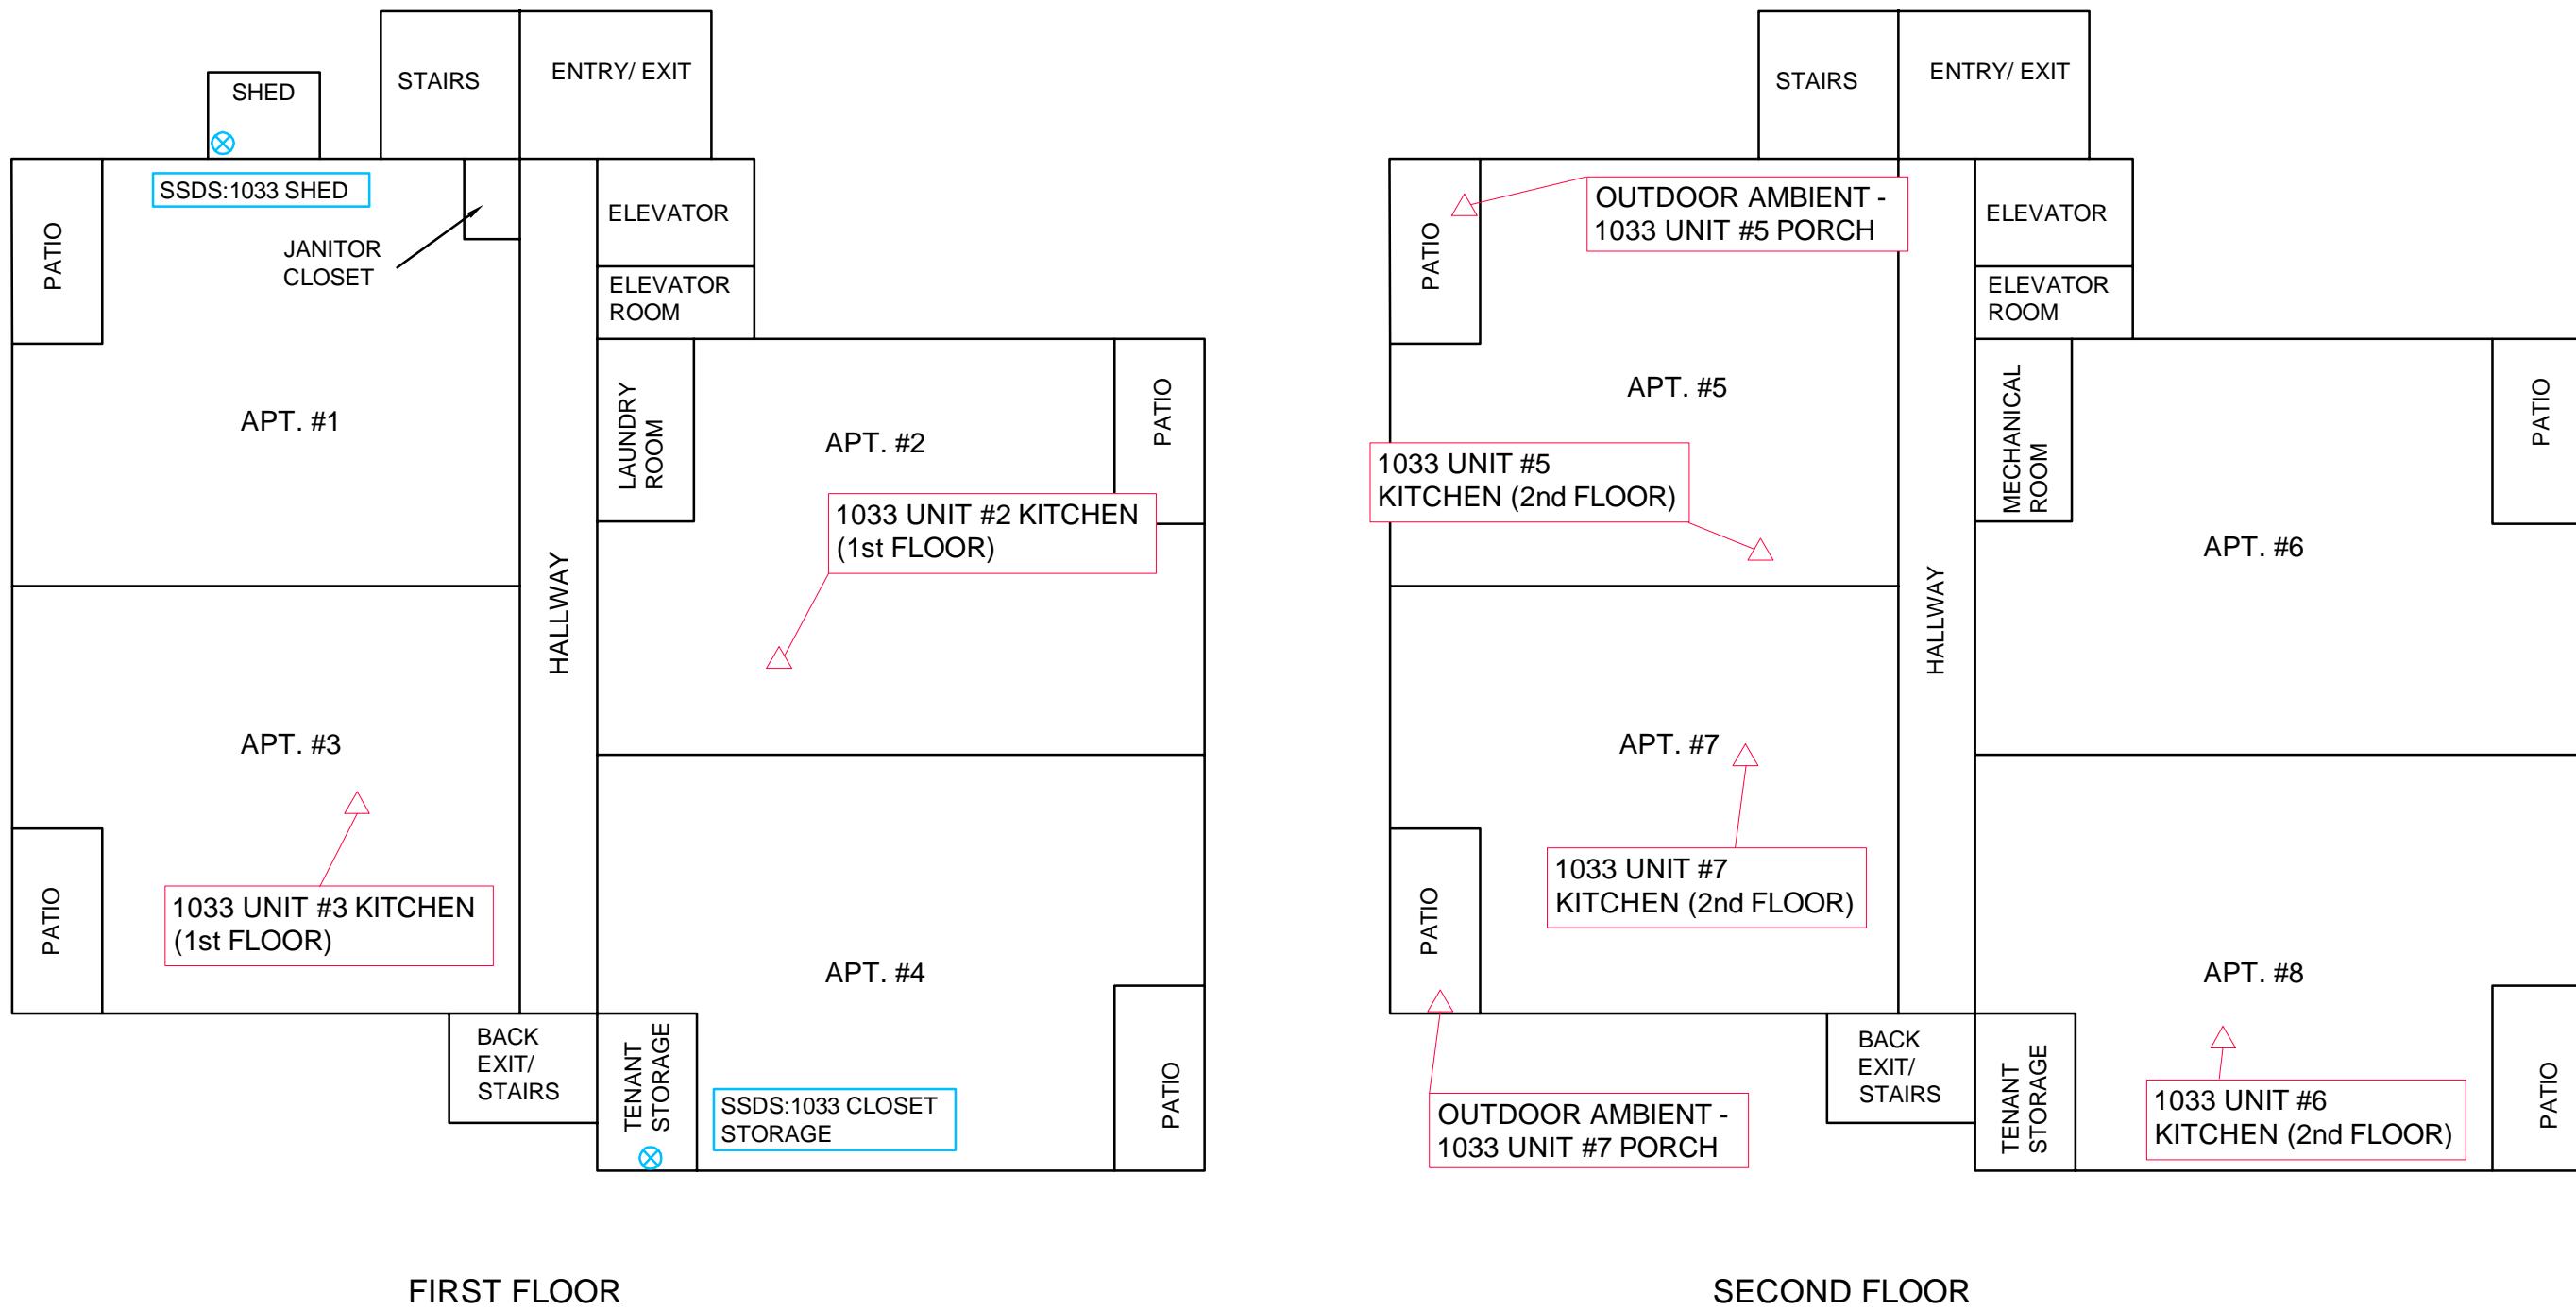
EXHIBIT
D.1.b

SUB-SLAB DEPRESSURIZATION SYSTEM & AMBIENT AIR SAMPLING LOCATIONS - 1033 BUILDING	
CLARE CENTRAL APARTMENTS 1033 WEST ATKINSON AVENUE	WISCONSIN

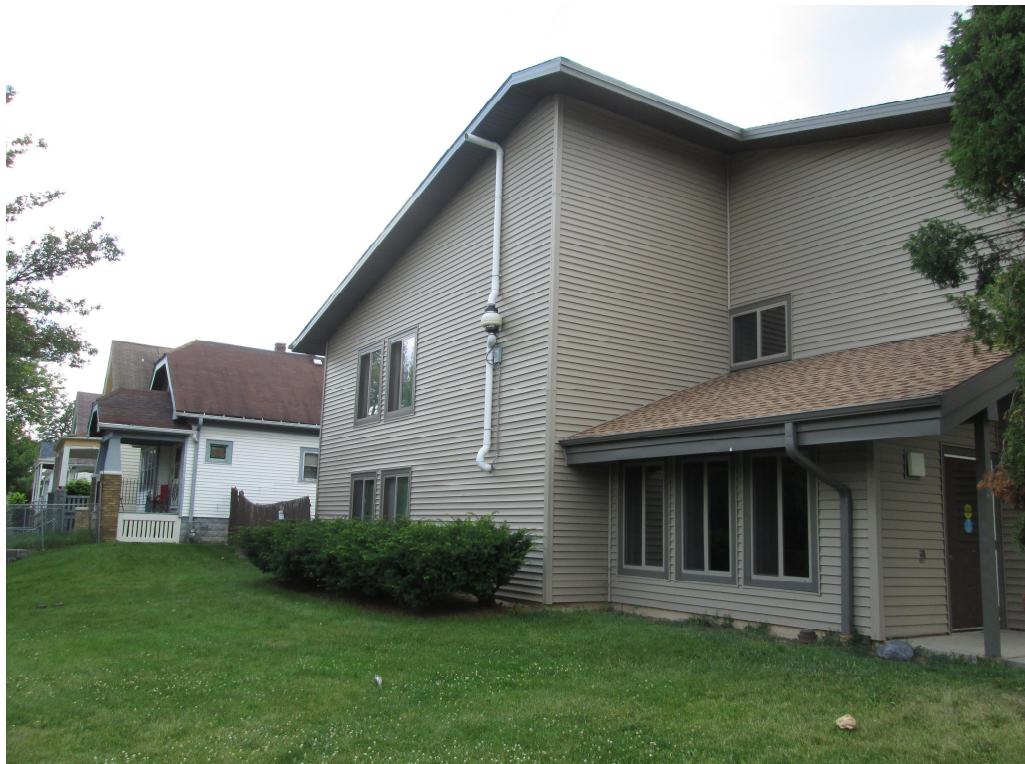
Photograph looking south at 1003 West Atkinson Closet SSDS exterior piping on east side of building.

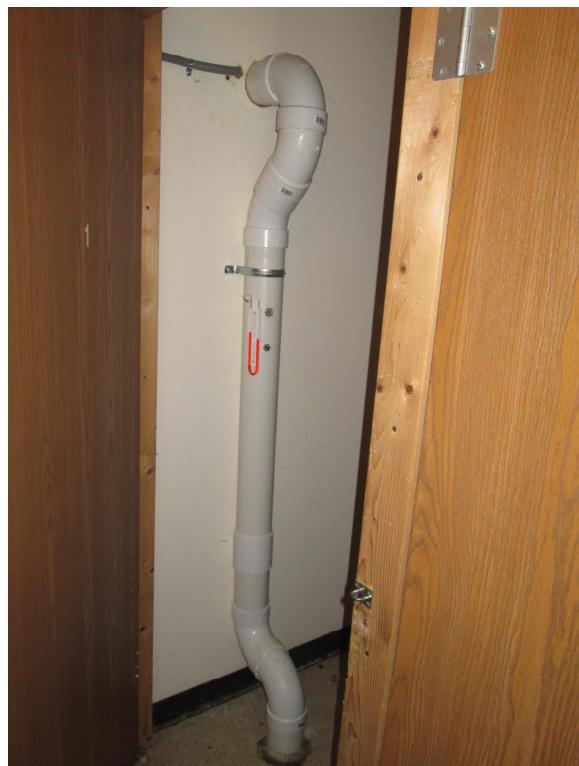
Photograph looking at SSDS system inside 1003 West Atkinson closet located inside the east side of building.

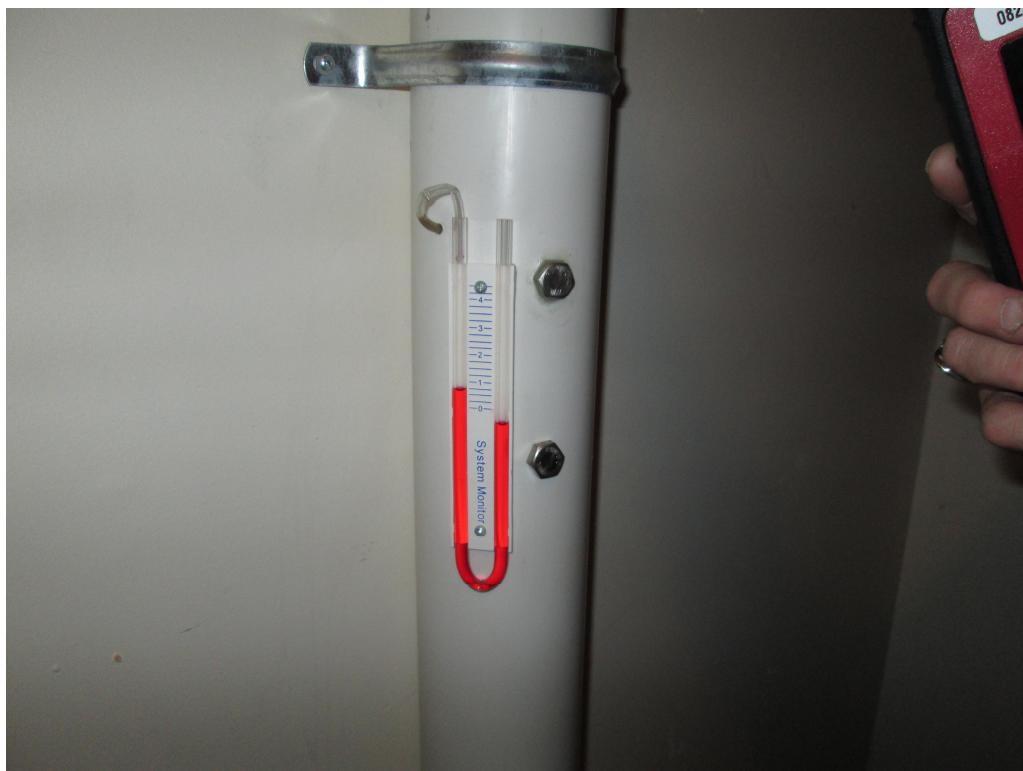
Photograph looking at 1003 West Atkinson closet SSDS manometer located in east side of building.

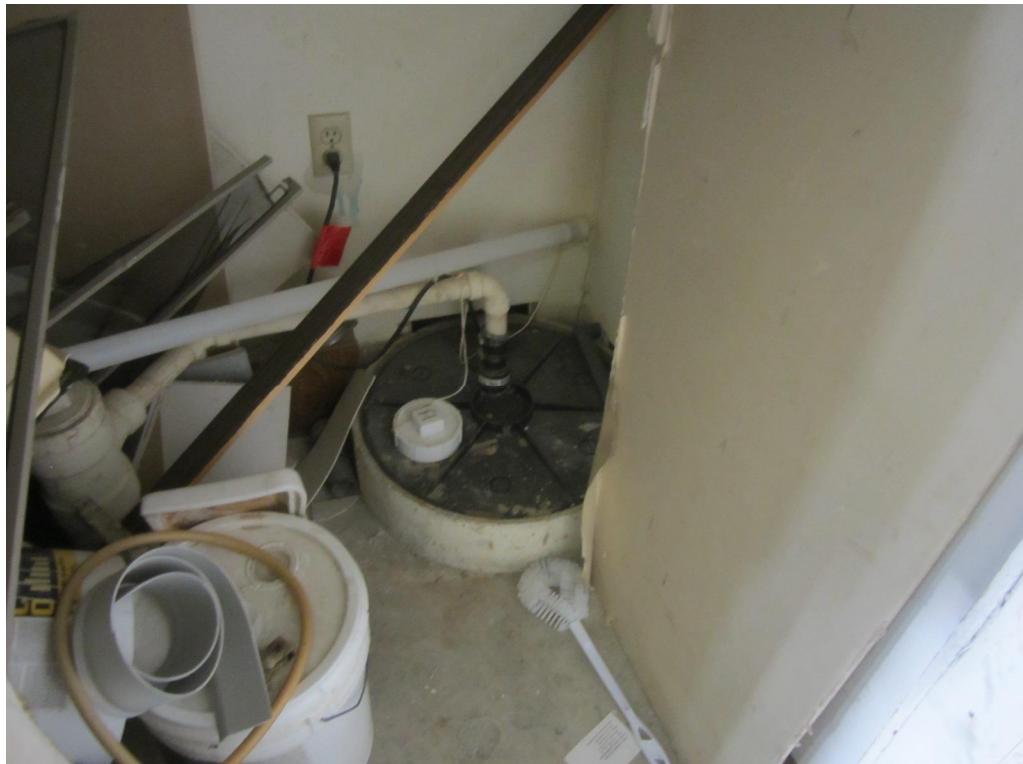
Photograph looking at 1003 West Atkinson sealed sump located across the hall from the elevator.

- “In the DNR’s March 2, 2016 letter, it was requested that the sub-slab depressurization systems (SSDSs) in the two Clare Central Apartment buildings and in the residence at 3618 North 11th Street be inspected on a regular basis and that the inspection results be documented. At that time, the DNR should have specified that maintenance plans should be prepared for the SSDSs. Therefore, prepare a maintenance plan for each SSDS. DNR guidance RR-981 titled *Maintenance Plans for Vapor Mitigation Systems* provides a description of what should be included in the maintenance plans. Please verify that the sump crocks in the building have been sealed”.

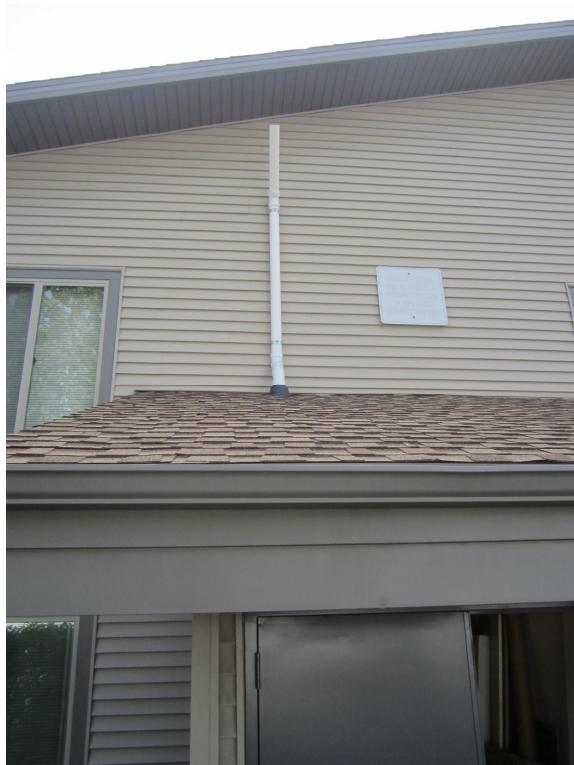
Photograph looking east at 1003 West Atkinson Shed SSDS exterior piping on west side of building.

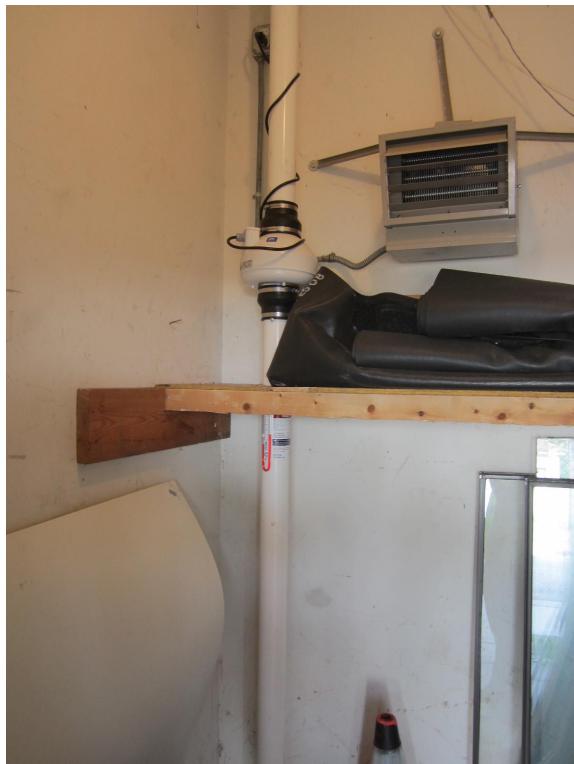
Photograph looking at SSDS system inside 1003 West Atkinson shed located on west side of building.

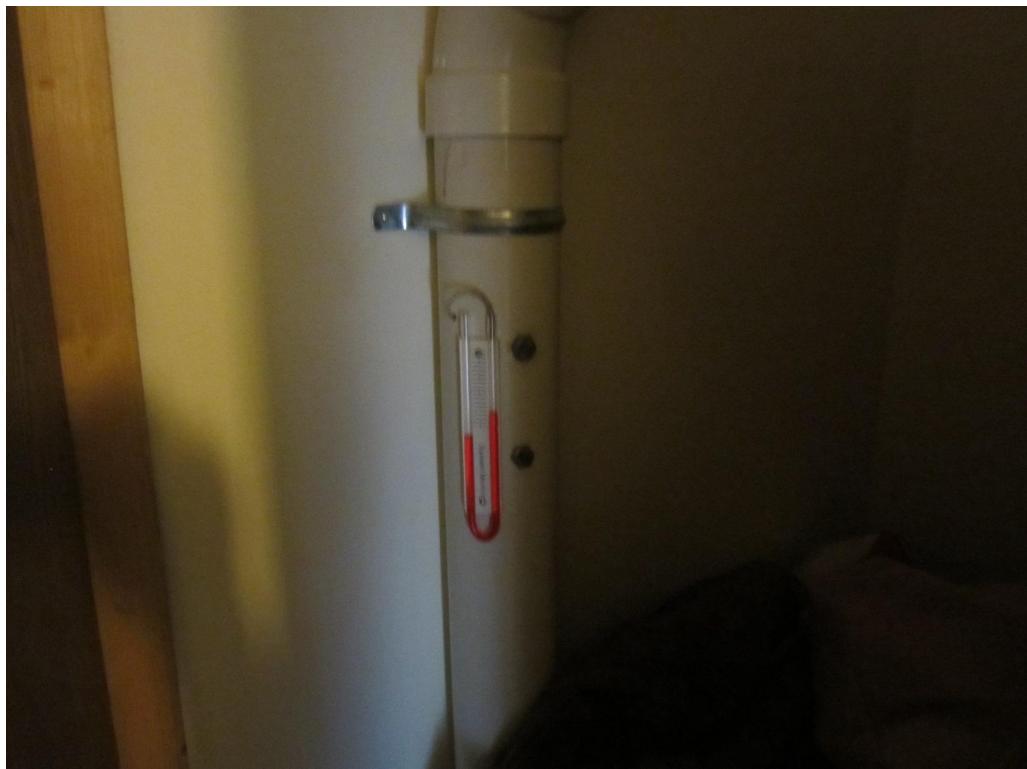
Photograph looking at 1003 West Atkinson Shed SSDS manometer.

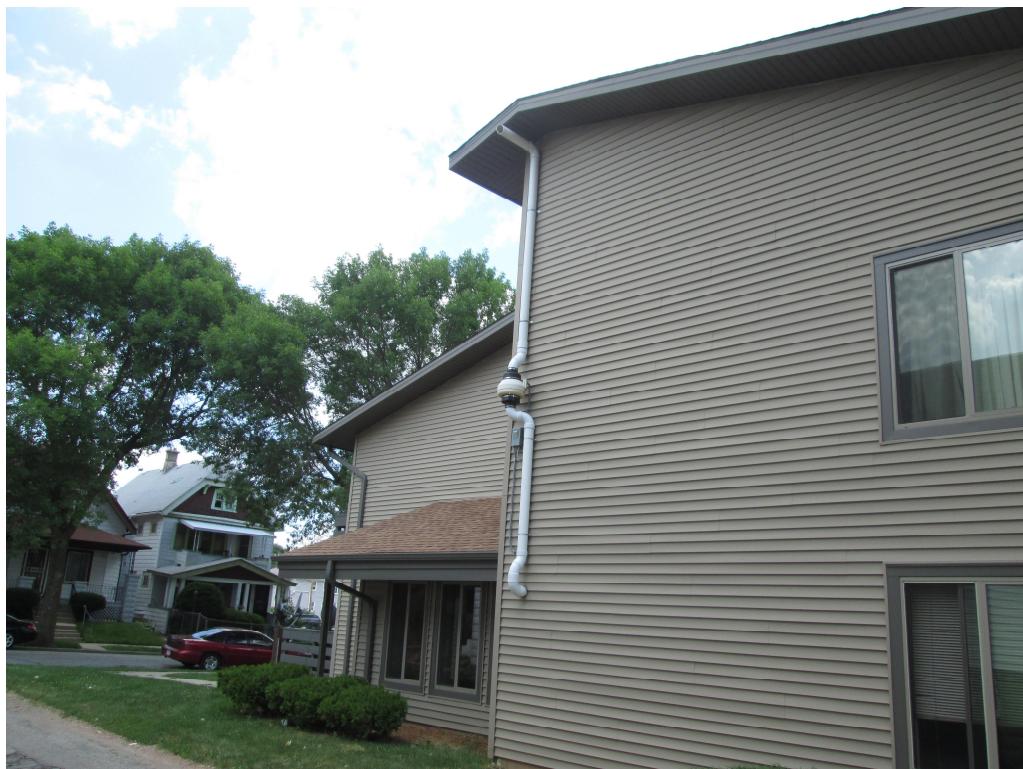
Photograph looking west at 1033 West Atkinson Closet SSDS system and exterior piping on south side of building.

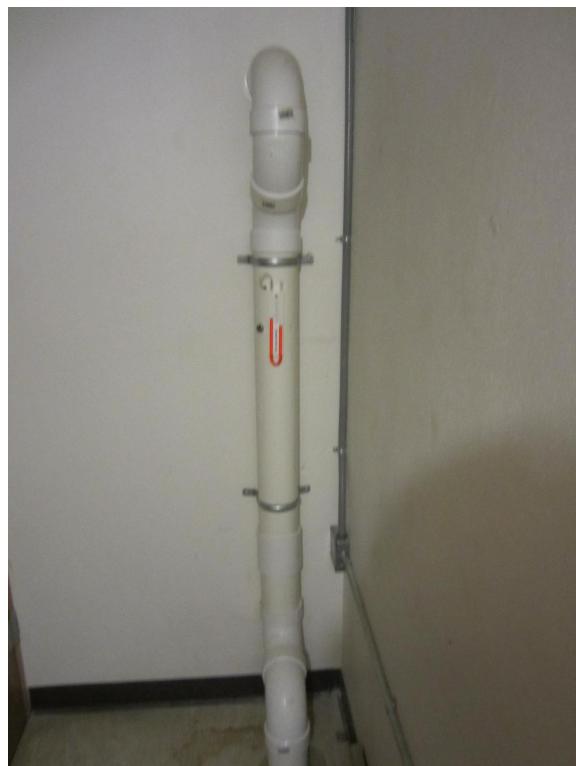
Photograph looking at SSDS system piping inside 1033 West Atkinson closet located in south side of building.

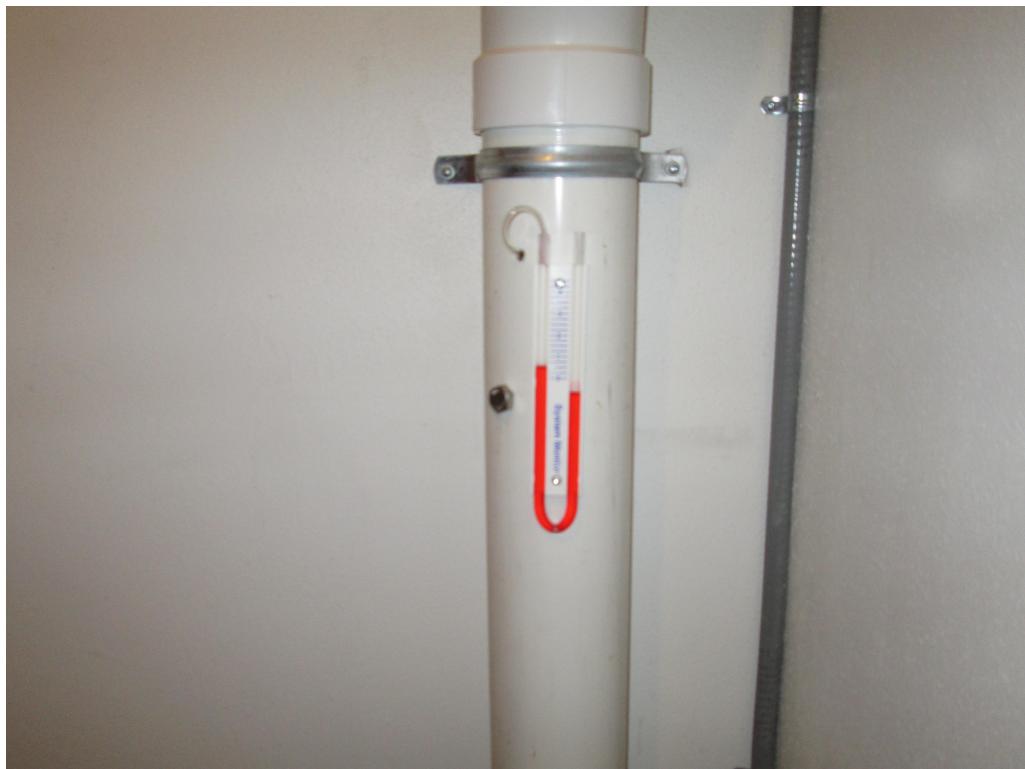
Photograph looking at 1033 West Atkinson Closet SSDS manometer.

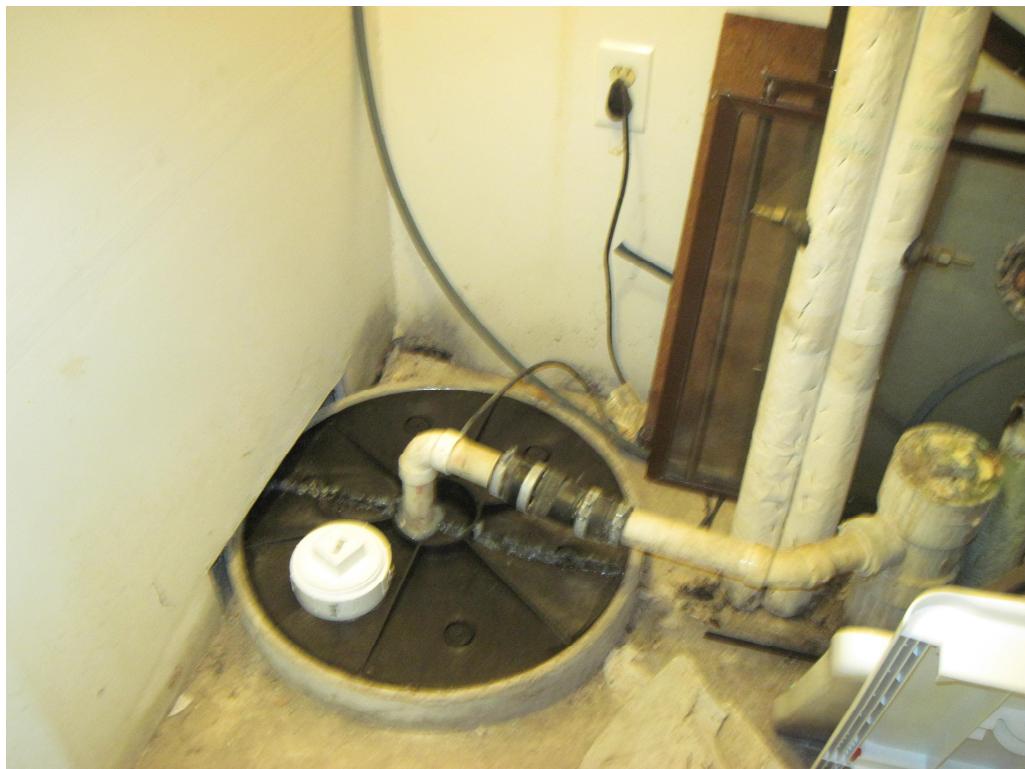
Photograph looking at 1033 West Atkinson sealed sump located across the hall from elevator.

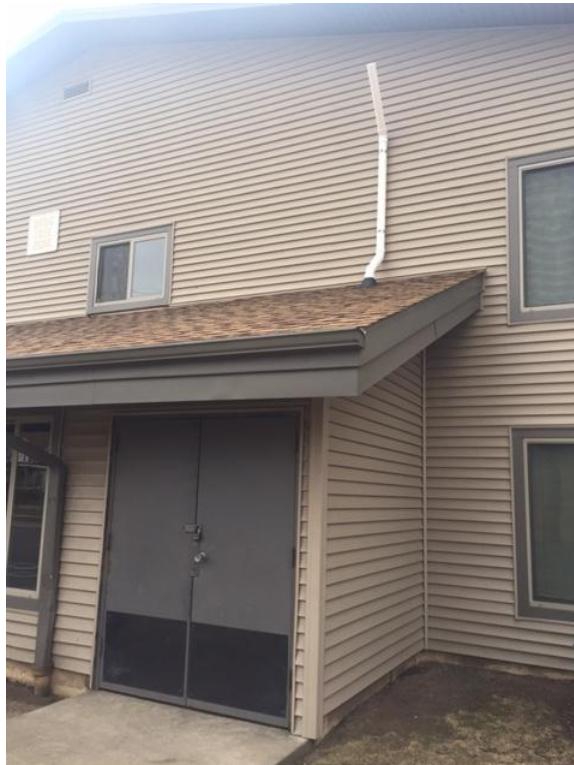
Photograph looking south at 1033 West Atkinson Shed SSDS exterior piping on north side of building.

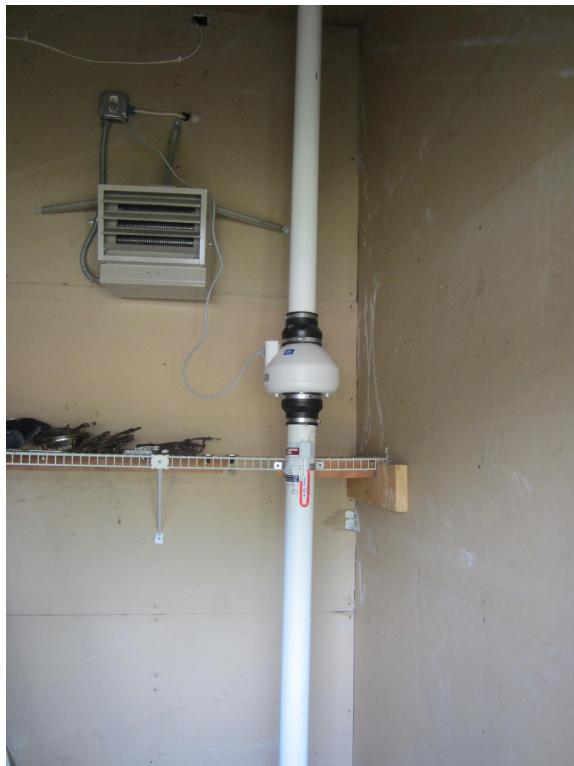
Photograph looking at SSDS system inside 1033 West Atkinson shed located on north side of building.

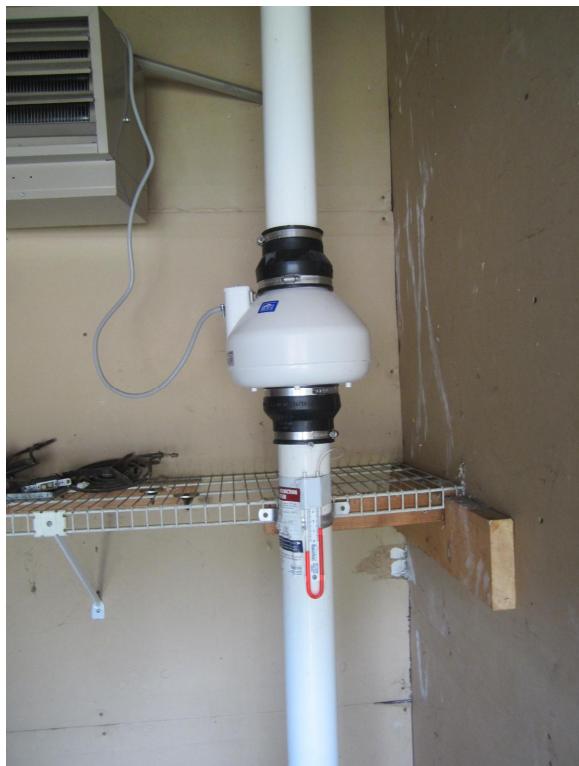
Photograph looking at 1033 West Atkinson Shed SSDS manometer.
