Reference: June 2021 Vapor Intrusion Assessment; Whitefish Bay Cleaners Property, 419 West Silver Spring Drive, Glendale, WI; BRTS Activity #02-41-550821; Stantec Project #: 193707230

This letter documents the Vapor Intrusion Assessment portion of work completed by Stantec Consulting Services Inc. (Stantec), during June 2021, of a historical tetrachloroethene (PCE) release at Whitefish Bay Cleaners, 419 West Silver Spring Drive, Glendale, Wisconsin (herein referred to as "the Site"). The methods used to conduct this vapor intrusion assessment are consistent with those described in the workplan and cost estimate – additional investigation letter dated August 21, 2019 (Stantec, 2019).

Reference: Vapor Intrusion Assessment; Whitefish Bay Cleaners Property

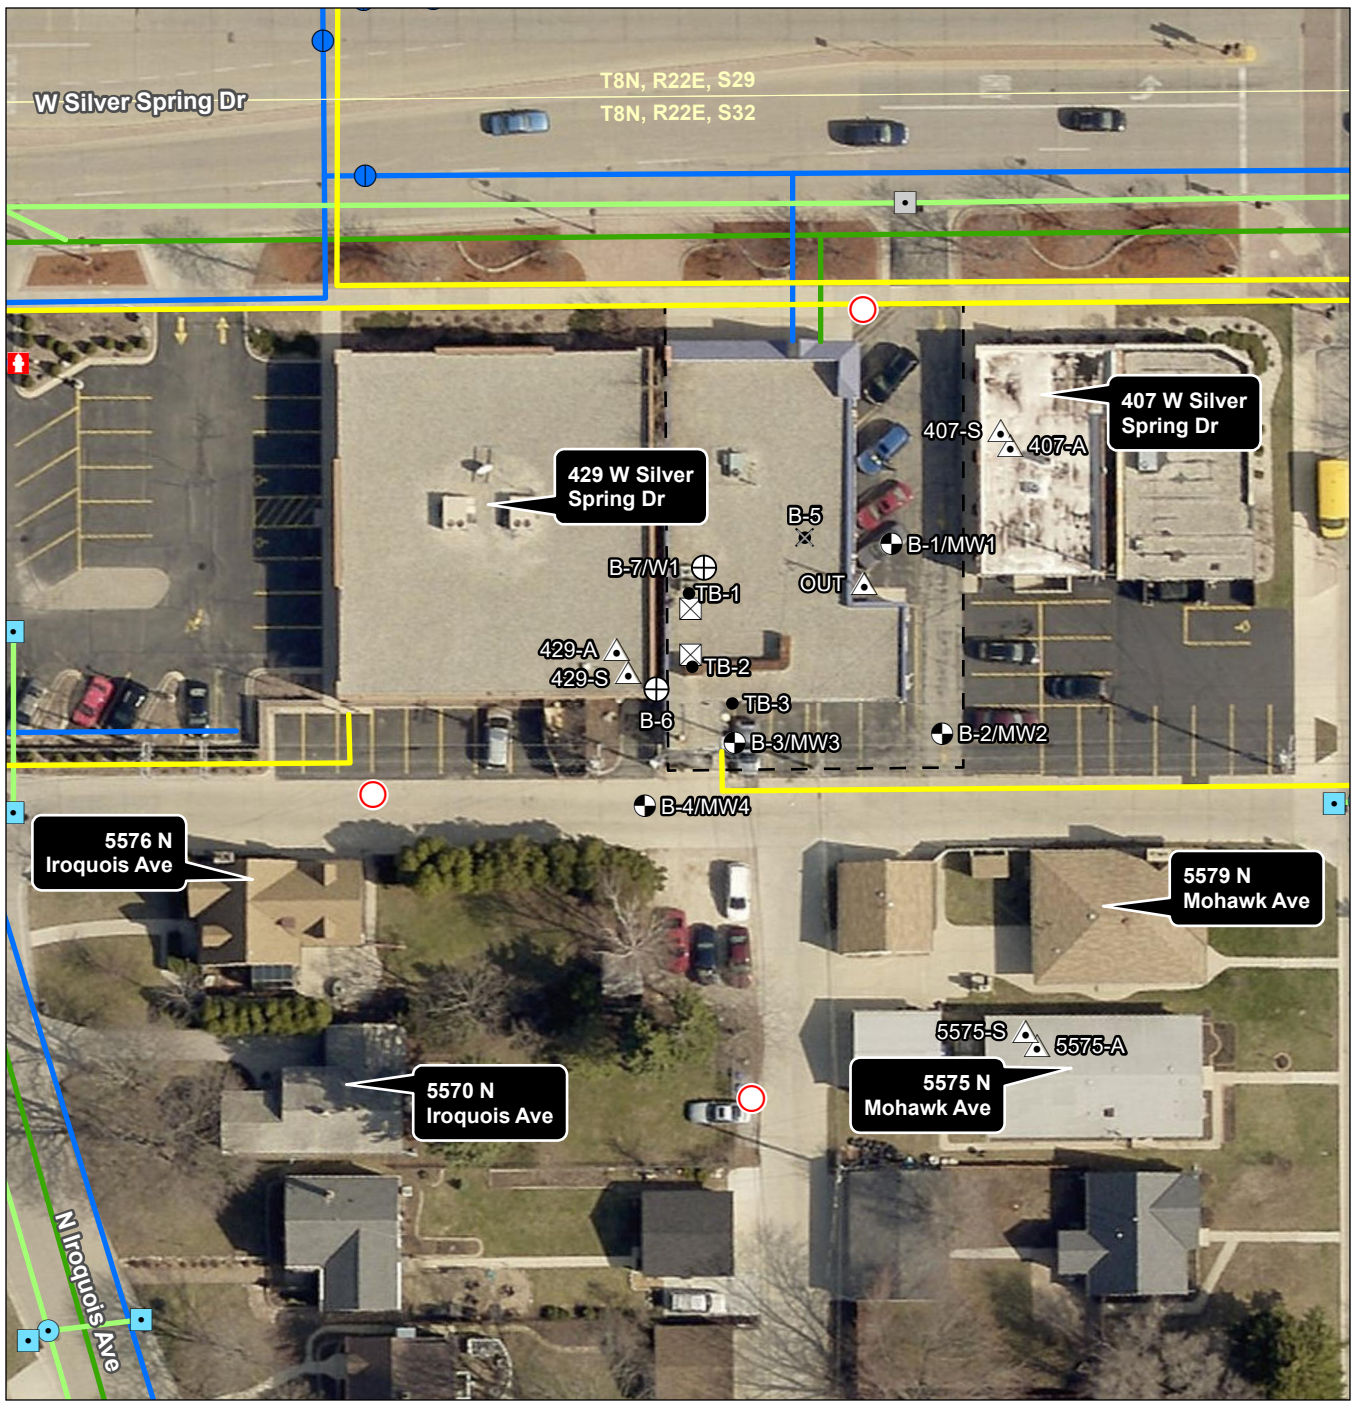
During November 2013, Stantec, on behalf of Whitefish Bay Cleaners, submitted a Site Investigation Workplan to the WDNR. During August 2014, Stantec oversaw the collection of sub-surface soil samples from boreholes B-1 through B-7 and installation of groundwater monitoring wells MW1 through MW4 and TW1 at the Site or in the adjacent public alleyway. During September 2014, Stantec collected groundwater samples from the wells. The Site layout and borehole and groundwater monitoring wells locations are shown on Figure 1.

On June 3 and 4, 2021, Stantec personnel collected indoor air samples at two commercial buildings and one residential home that provided Stantec access (429 W Silver Spring [sample ID 429-A], 407 W Silver Spring [sample ID 407-A], and 5575 N Mohawk Ave [sample ID 5575-A]). Stantec collected one indoor air sample at each location at the lowest floor of the structure. The 429 West Silver Spring property was slab-on-grade construction and did not have a basement, so the indoor air sample was collected from the ground level. Approximate sample locations are shown on Figure 1.

On June 3, 2021, Stantec personnel installed sub-slab vapor pins at two of the three commercial properties (429 W Silver Spring and 407 W Silver Spring), and the one residential home (5575 N Mohawk Ave) using a hammer drill (WDNR, 2014). A 5/8-inch diameter drill bit was used to fully penetrate the concrete floor and allow for VaporPin® installation. The VaporPin® was fitted with a stainless-steel sealable hose barb to allow for sample collection. Vapor point locations relative to site features and areas of concern are illustrated on Figure 1.

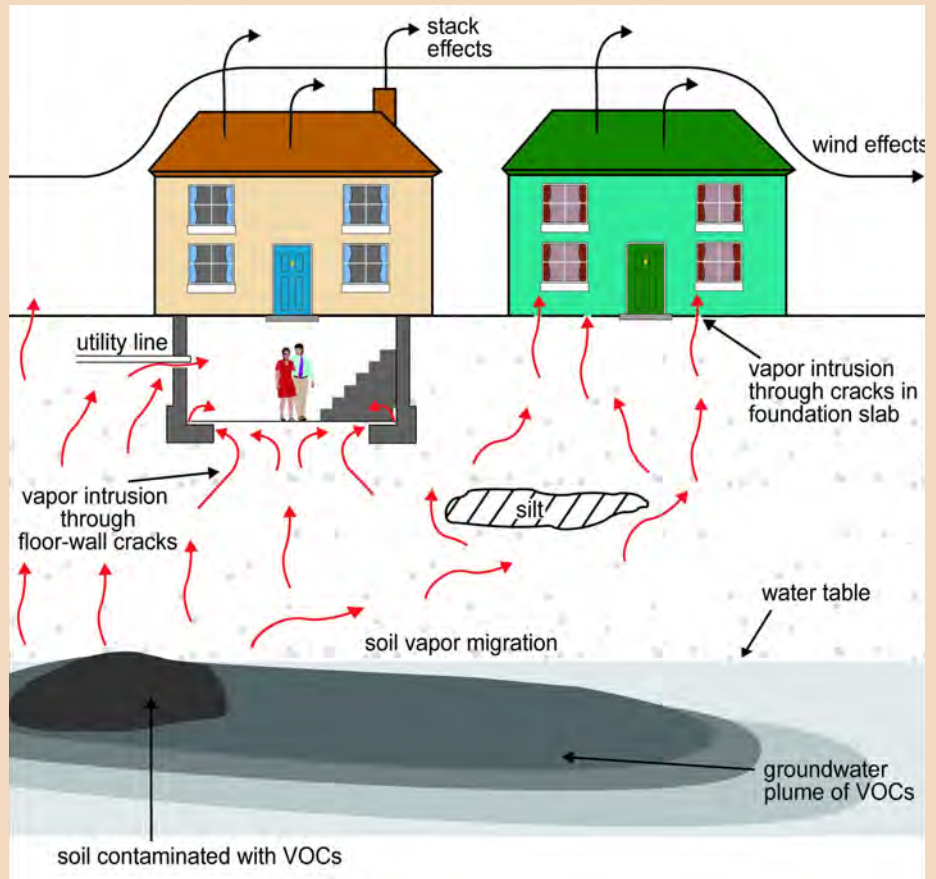
How Vapors Enter a Building

If you live near a commercial or industrial facility or landfill where VOCs have entered either the soil or groundwater, there may be a potential for those chemicals to travel as vapors into your home or business. Vapors can enter buildings in various ways, including through cracks in the foundation and openings for utility lines. Building ventilation and weather can influence the extent of vapor intrusion.

Adapted from U.S. Environmental Protection Agency (EPA) graphic.
www.epa.gov/oswer/vaporintrusion/basic.html

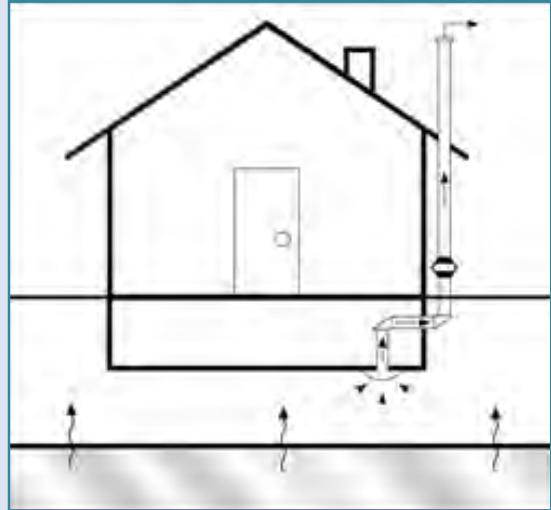
If potentially harmful chemical vapor intrusion is detected in a home or business, the most common solution is to install a sub-slab depressurization system. This system captures and redirects soil vapors from below the building foundation before they enter the indoor air. Vapors are vented outside of the building where they disperse into the air and are rendered harmless.

Sub-slab depressurization systems also prevent radon from entering homes, which is an added health benefit in radon-prone areas.

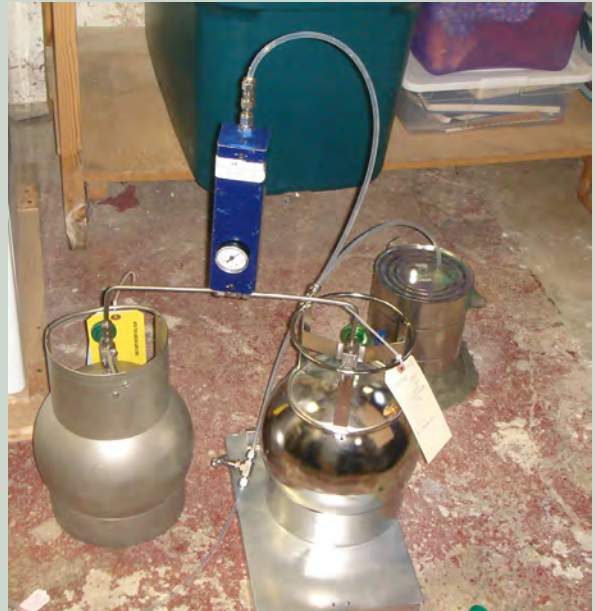
A sub-slab vapor sampling system is usually in place for a day or two during the sampling process. The metal canisters (foreground) collect the vapor sample from the port (smaller canister in back of photo). The same canisters can be used to collect indoor air samples.

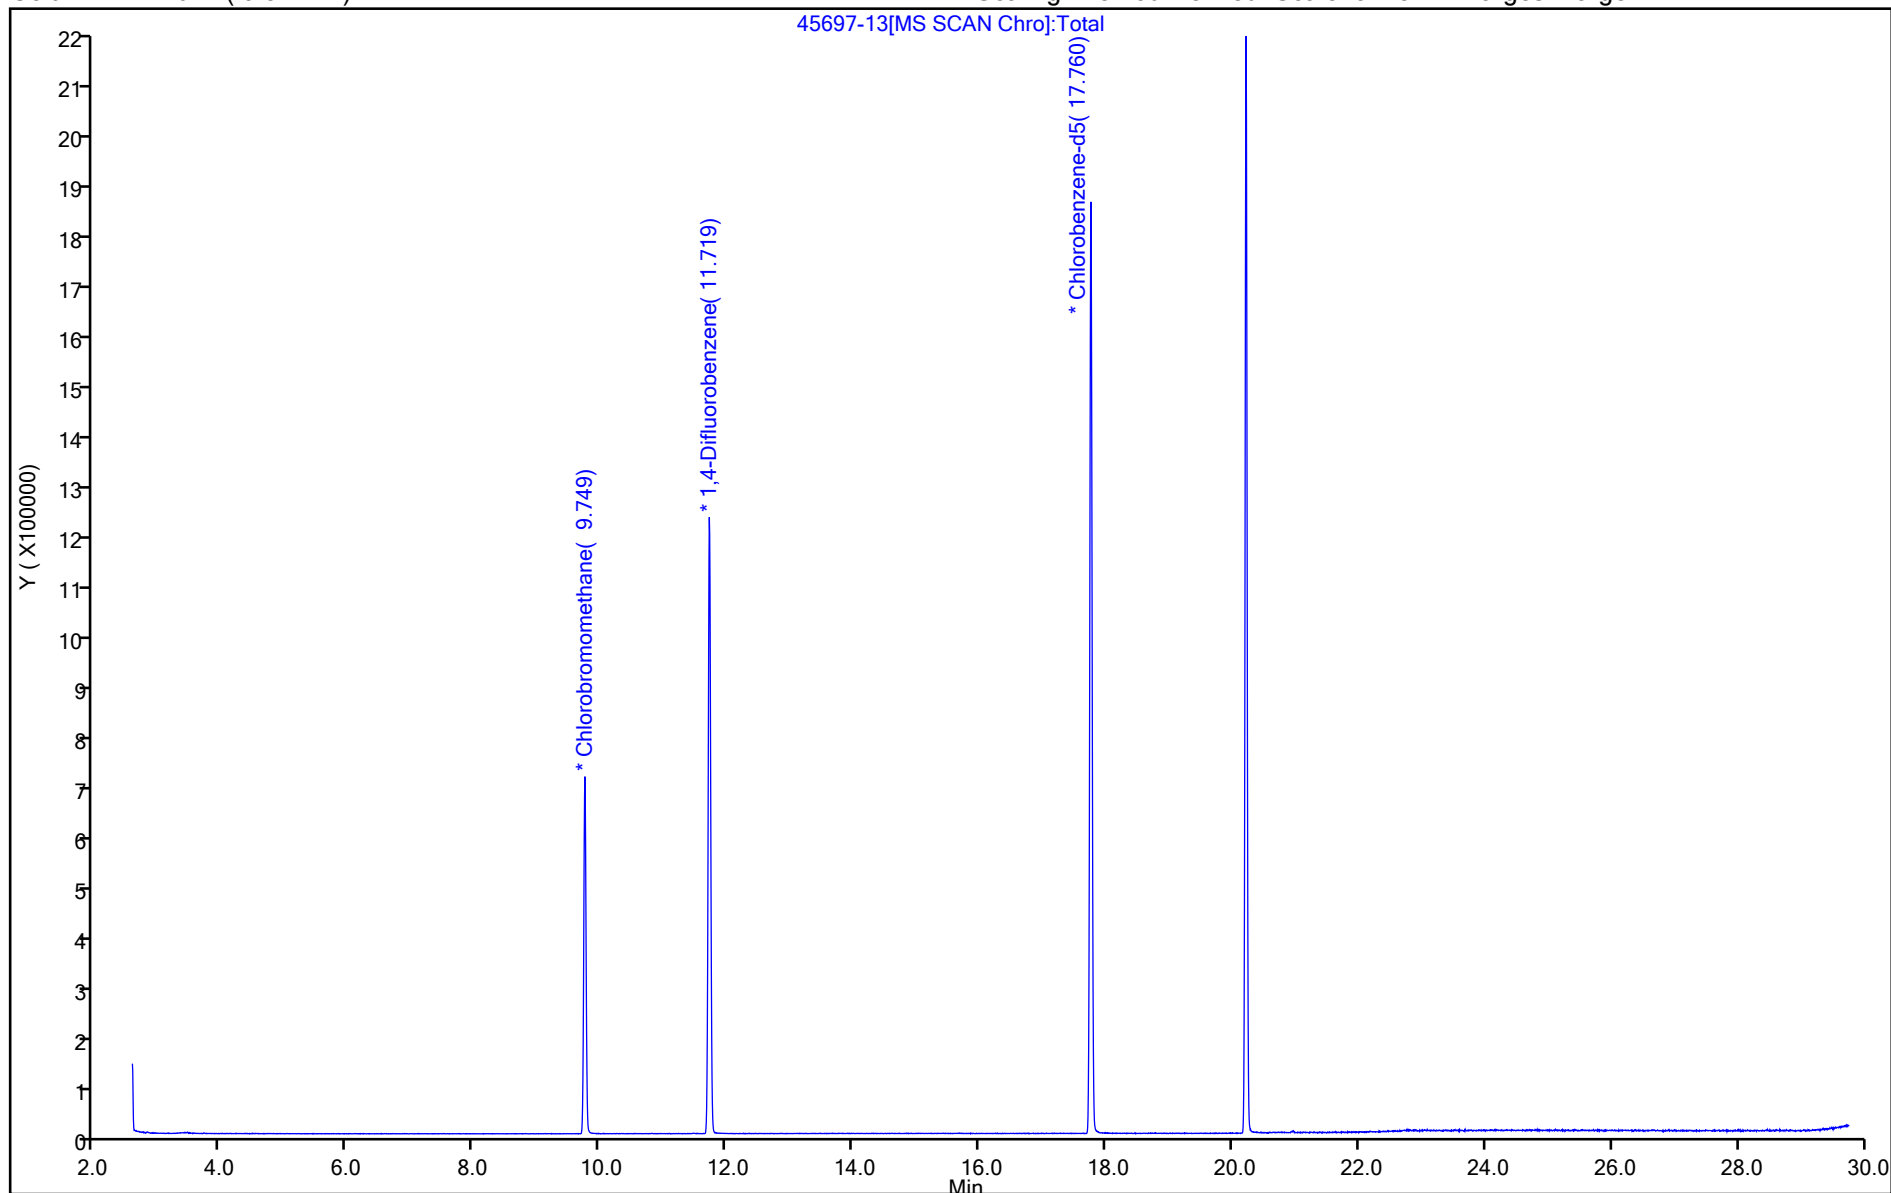
Data File: \\chromfs\Burlington\ChromData\CHC.i\20210426-45697.b\45697-13.D
 Injection Date: 26-Apr-2021 17:46:30 Instrument ID: CHC.i
 Lims ID: 200-58163-A-9 Lab Sample ID: 200-58163-9
 Client ID: 5903
 Operator ID: vtp ALS Bottle#: 12 Worklist Smp#: 13
 Purge Vol: 200.000 mL Dil. Factor: 0.2000
 Method: TO15_MasterMethod_(v1)_CHC.i Limit Group: AI_TO15_ICAL
 Column: RTX-624 (0.32 mm) Detector: MS SCAN

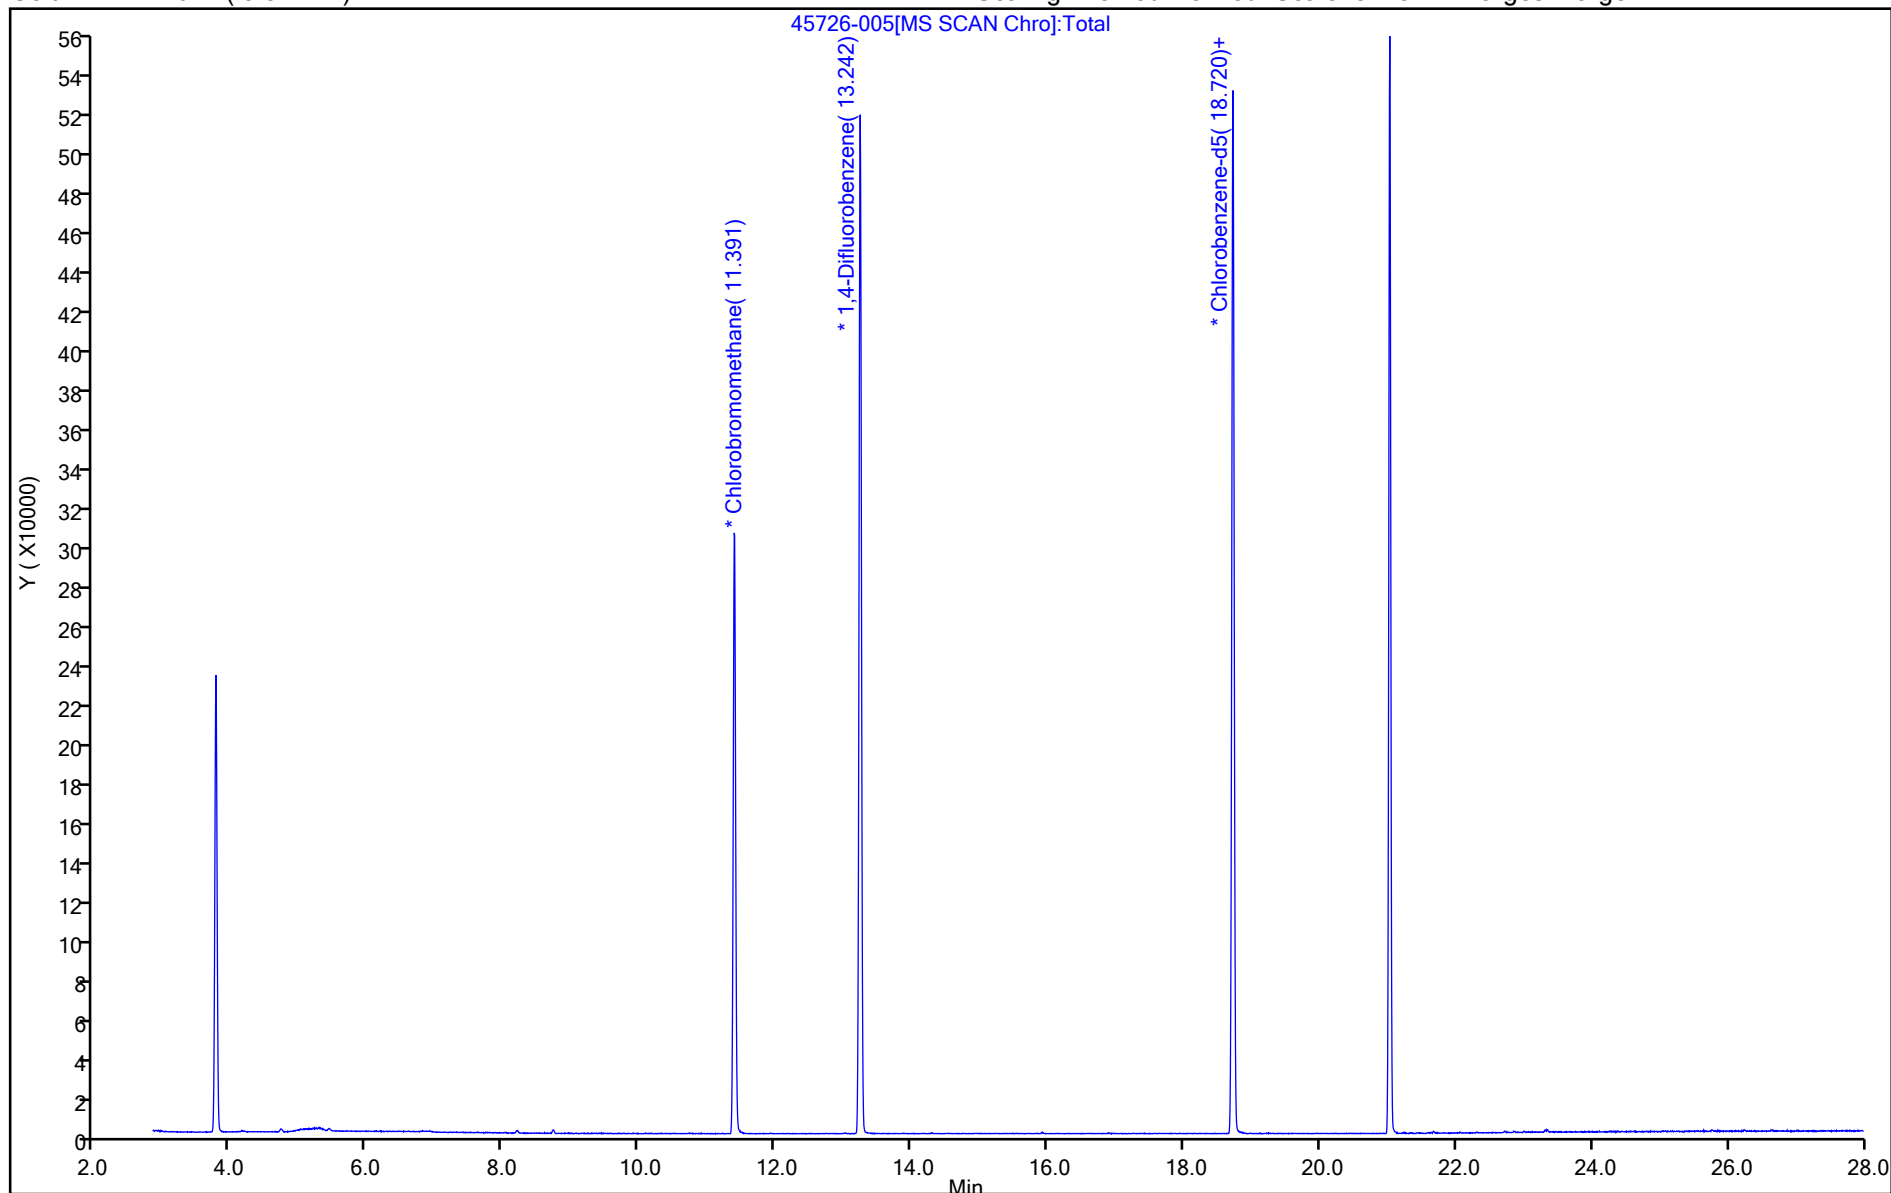
Data File: \\chromfs\Burlington\ChromData\CHW.i\20210427-45726.b\45726-005.d
Injection Date: 27-Apr-2021 14:25:30 Instrument ID: CHW.i
Lims ID: 200-58182-A-10 Lab Sample ID: 200-58182-10
Client ID: 5463
Operator ID: ggg ALS Bottle#: 4 Worklist Smp#: 5
Purge Vol: 200.000 mL Dil. Factor: 0.2000
Method: TO15_TO3_MasterMethod_W Limit Group: AI_TO15_ICAL
Column: RTX-624 (0.32 mm) Detector: MS SCAN

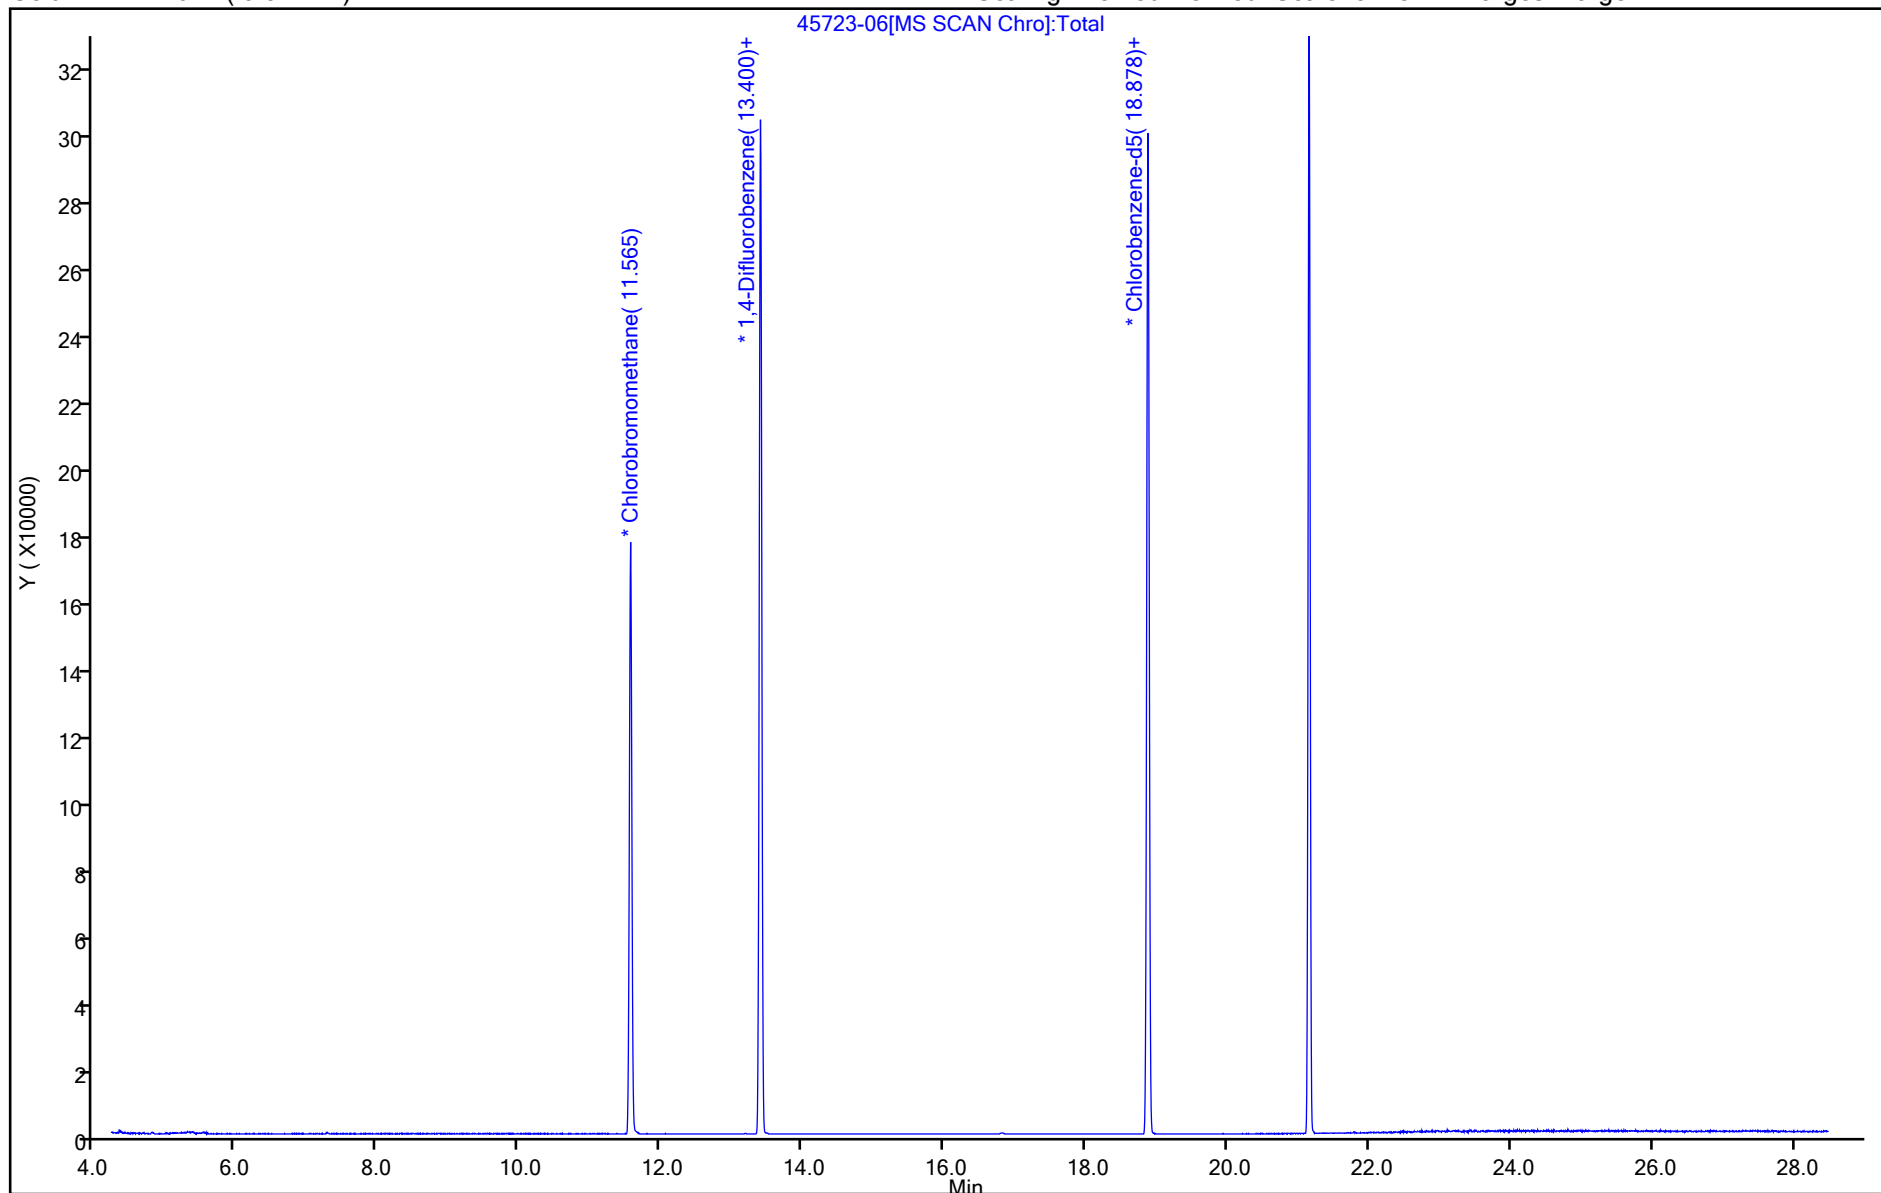
Data File: \\chromfs\Burlington\ChromData\CHX.i\20210427-45723.b\45723-06.D
 Injection Date: 27-Apr-2021 11:52:30 Instrument ID: CHX.i
 Lims ID: 200-58186-A-10 Lab Sample ID: 200-58186-10
 Client ID: 5094
 Operator ID: ggg ALS Bottle#: 5 Worklist Smp#: 6
 Purge Vol: 200.000 mL Dil. Factor: 0.2000
 Method: TO15_MasterMethod_X.m Limit Group: AI_TO15_ICAL
 Column: RTX-624 (0.32 mm) Detector: MS SCAN
