NOTICE OF CONTAMINATION

3. Based on information submitted to the Department, the Department has determined that contaminants discharged from the Bella Landscaping, LLC (formerly Hillcrest Landscaping) property to the adjacent WE Energy property, located at 8655 North 43<sup>rd</sup> Street, in the City of Brown Deer, County of Milwaukee, Wisconsin, which has the above legal description, has contaminated soil and stressed vegetation in the vicinity of a wood pile on the west side property line for hazardous wastes, as shown on the attached site map (Exhibit A) and photographs (Exhibit B, C, and D). Three soil boring locations (Exhibit "A") were analyzed for volatile organic compounds at the six-inch and one-to-two feet below ground surface. Laboratory analysis indicated the following results:

Hillcrest Property  
 Exhibit # 2A: General Location and Aerial View  
 Source: Southeastern Wisconsin Yr. 2005 Photomapper  
 WDNR Mapped Wetland Inventory  
 WDNR Waterways  
 AMS 9/21/2007

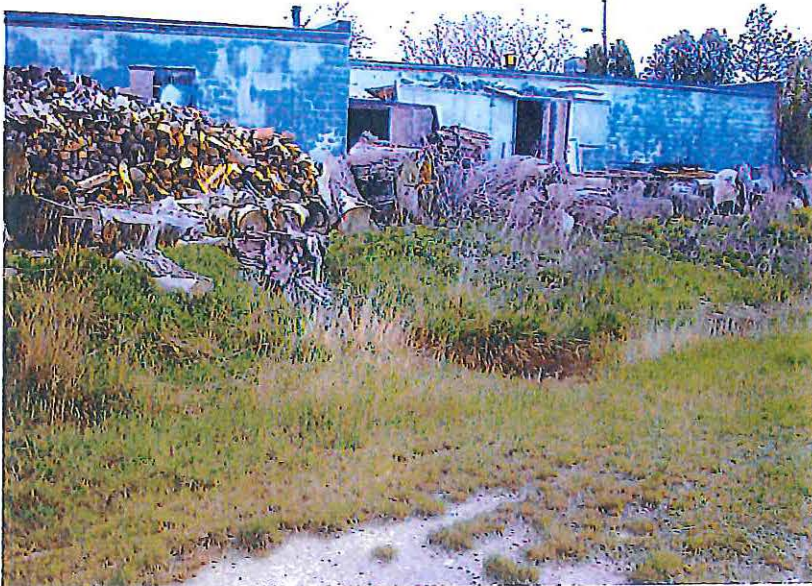
View to the southeast, west side of 8655 N. 43<sup>rd</sup> Street.  
Discharge area visible in the center of the photo.

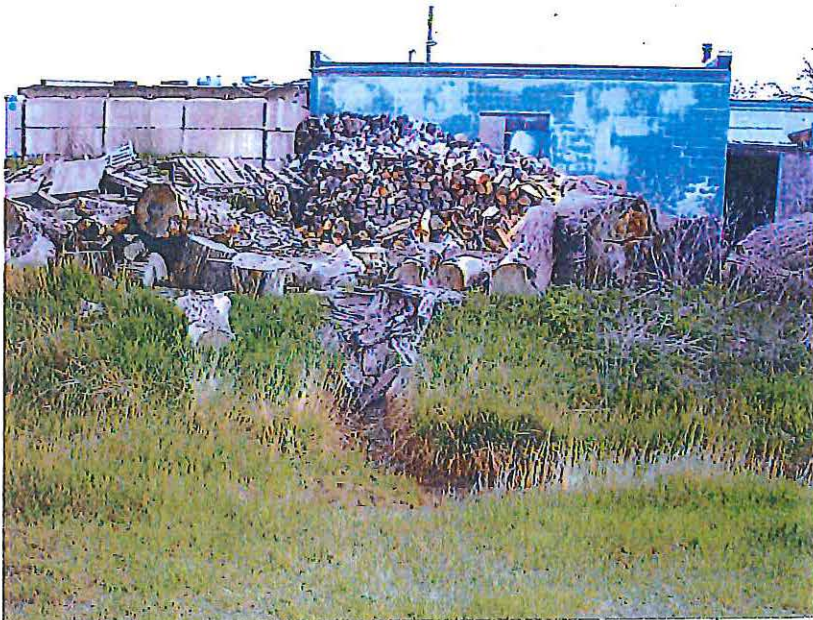
View directly to the east, looking at the west side of 8655 43<sup>rd</sup> Street.  
Discharge area in the middle of the photo.

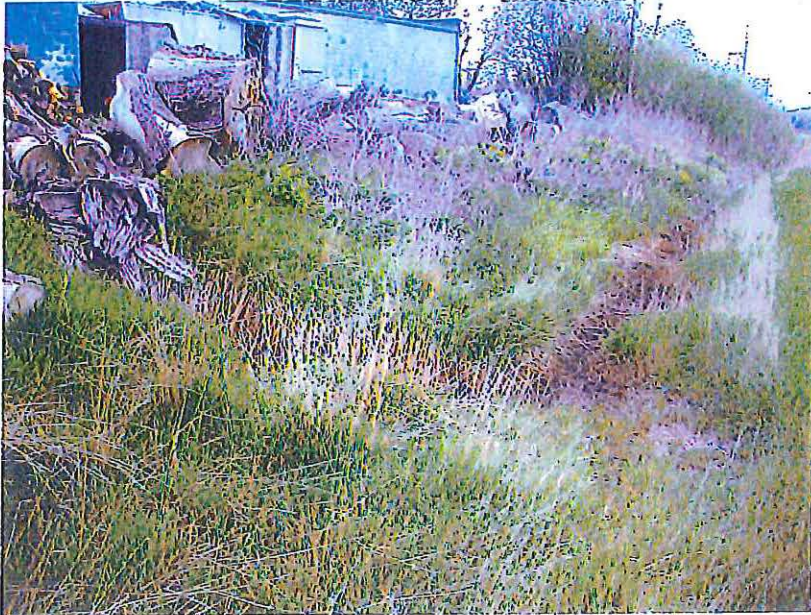
View to the southeast, west side of 8655 N. 43<sup>rd</sup> Street.  
Shows flow of discharge from under the bark and debris to the west, and then southward along east side of ROW.

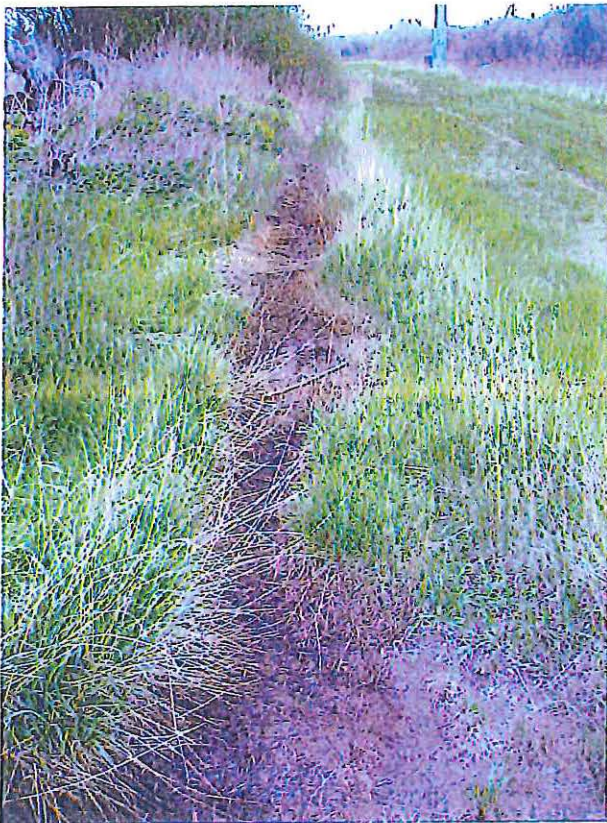
View to the south along east side of ROW.

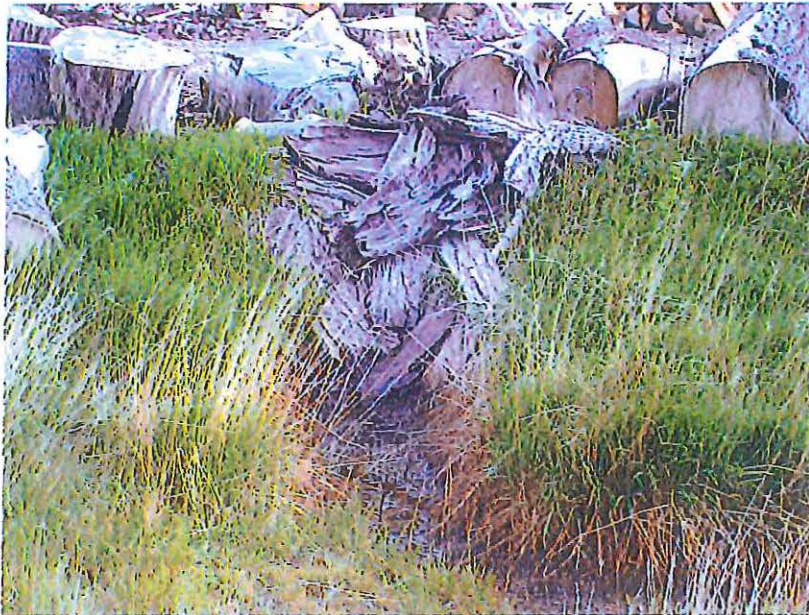
View to the east from ROW of the discharge area.  
Some petroleum odor, and staining of bark and vegetation. No visible oil sheen.

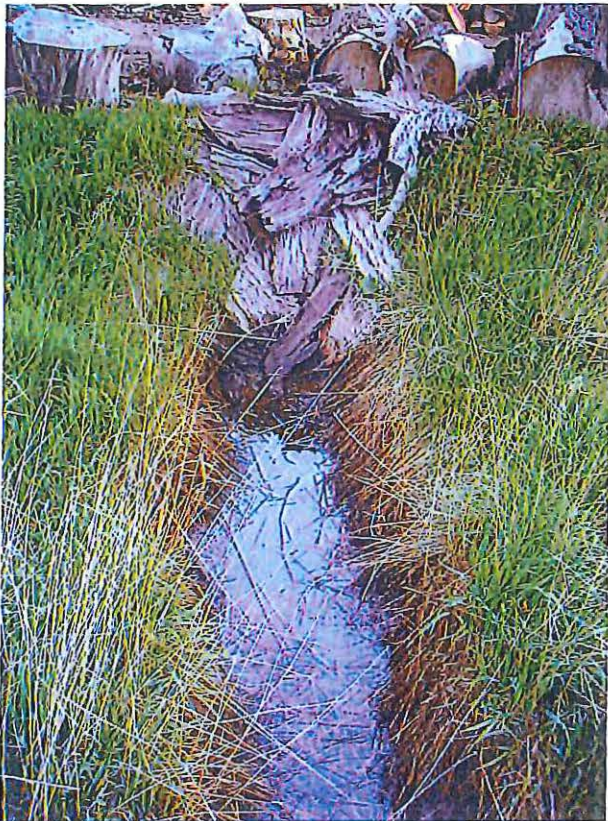
View to the east.  
Water in the ditch dug away from the discharge point.
