Re: Klismith Property (former Newman Appraisal Service)
157 N Main Street
Amherst, Wisconsin
BRRS No. 02-50-550910

Subject: Site Investigation Report

Site Investigation Report

**Klismith Property (former
Newman Appraisal Service)**
Amherst, Wisconsin

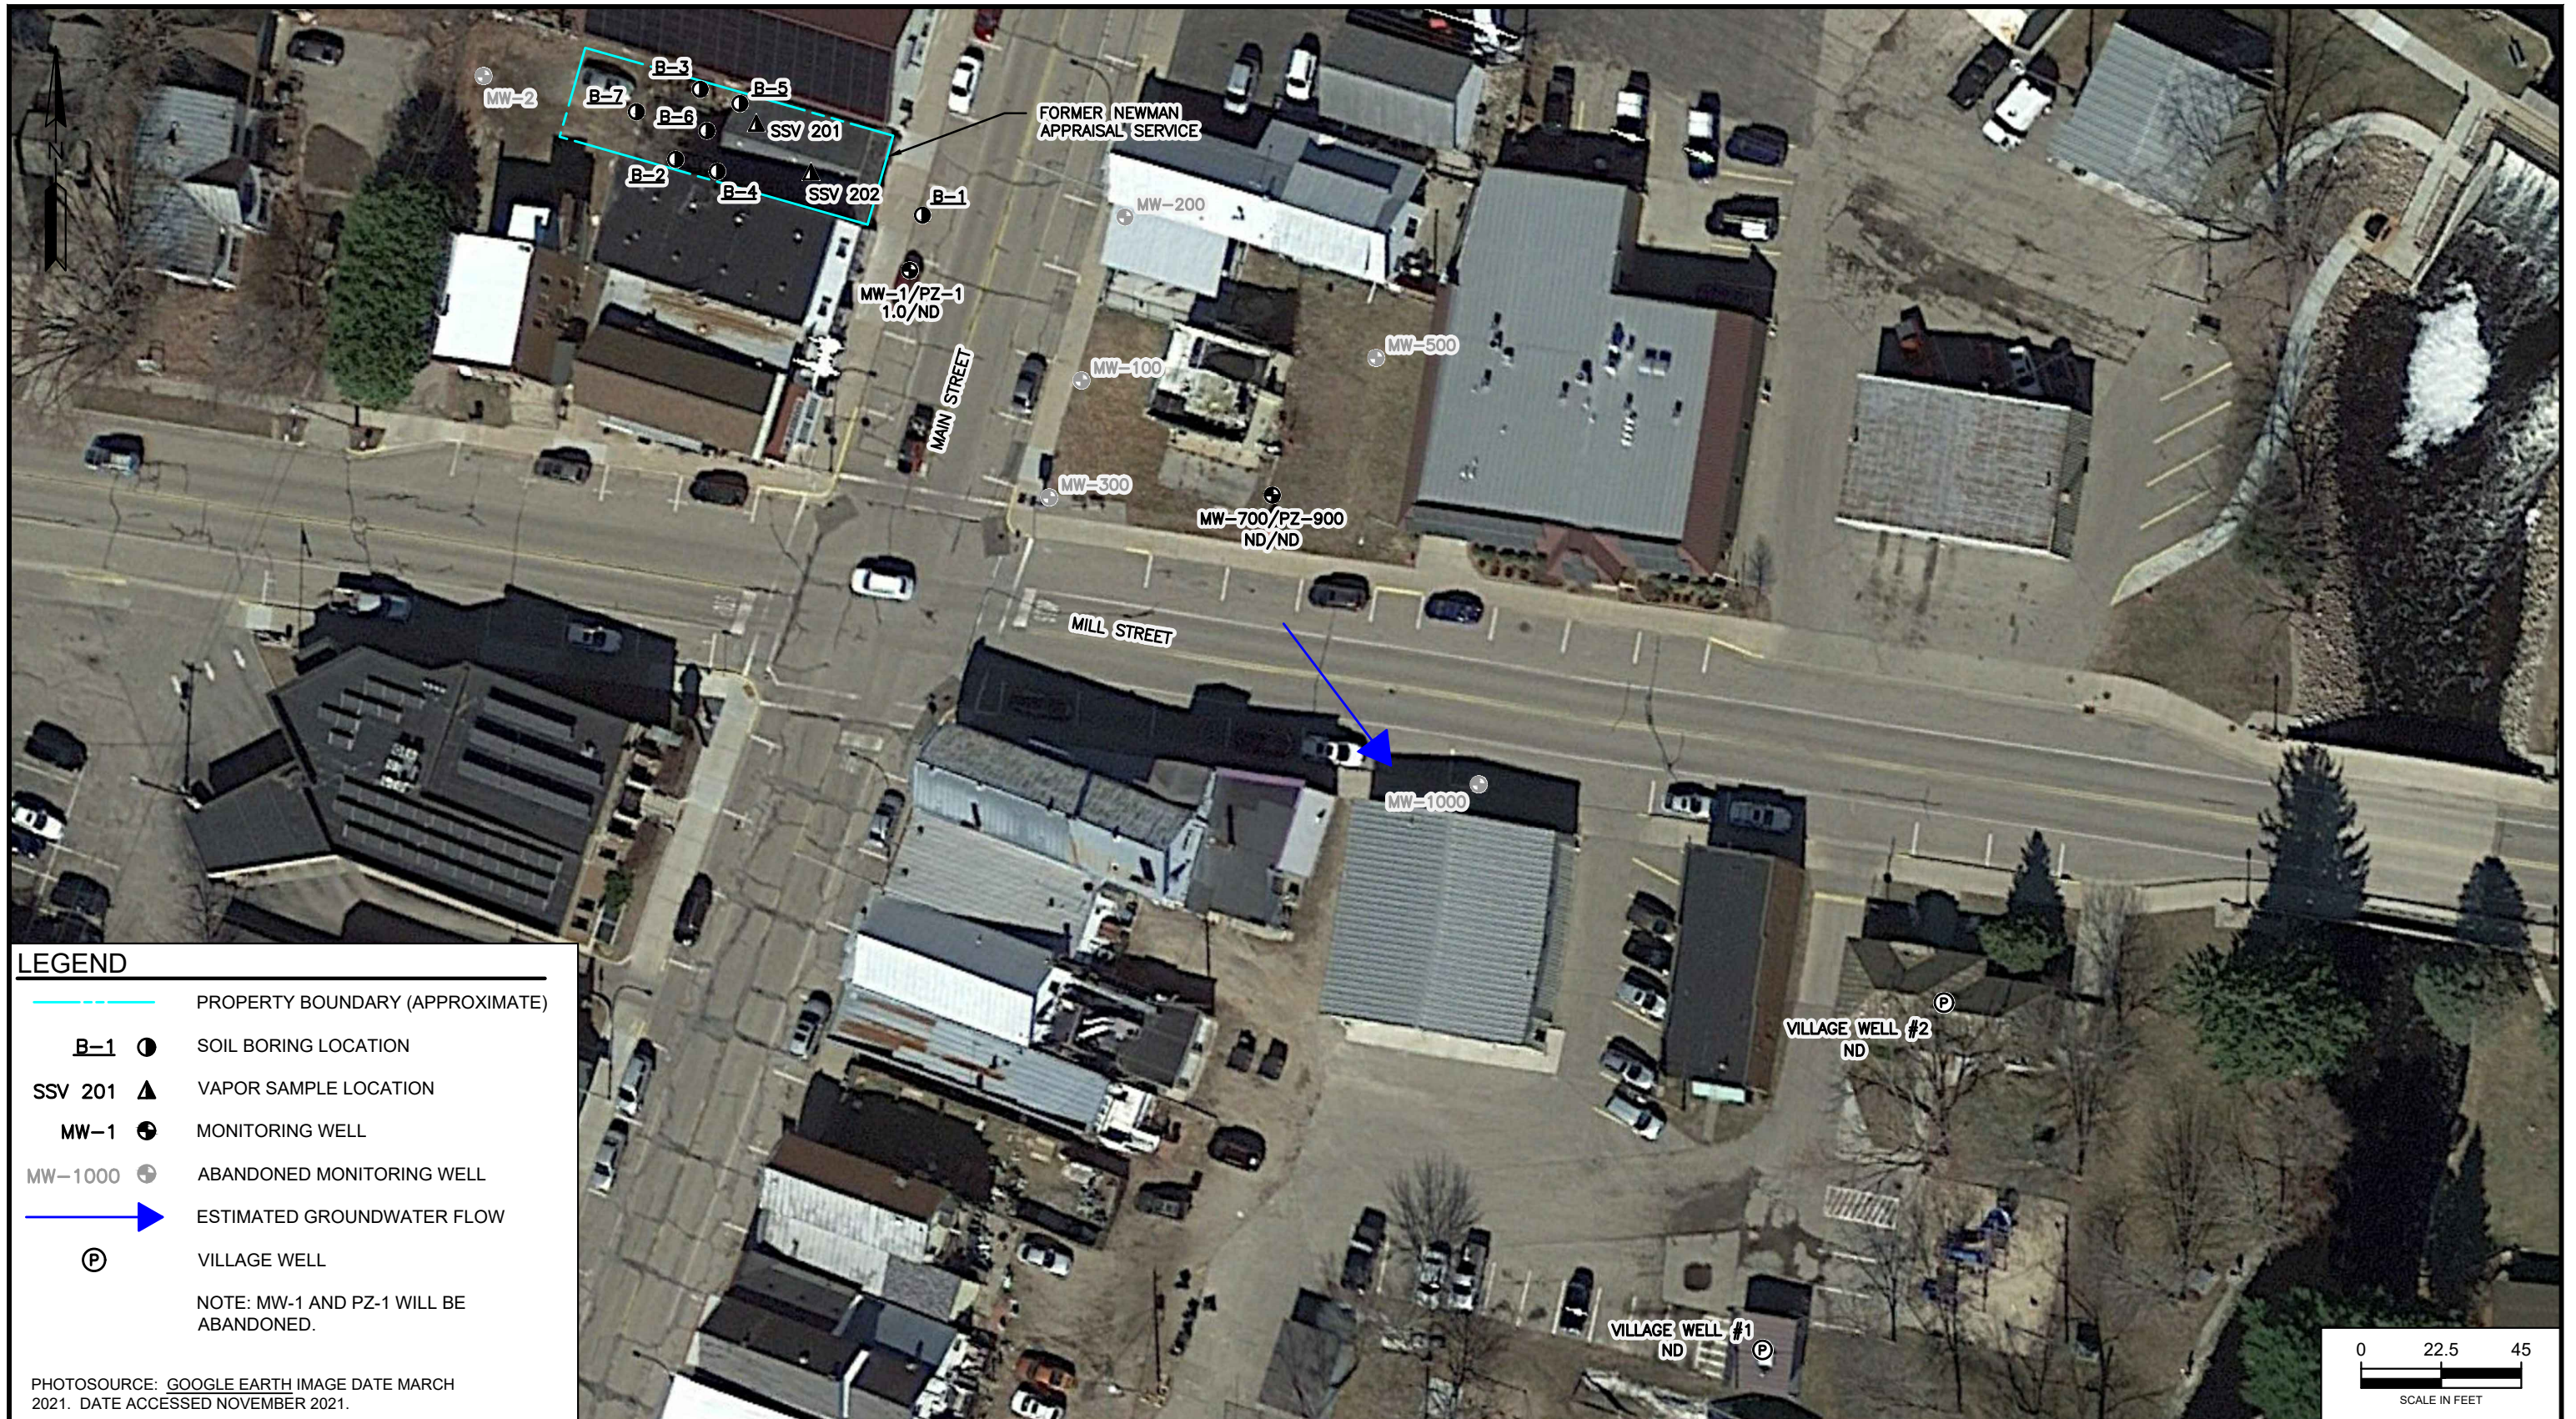
DATE:	MARCH 2022
SCALE:	1"=45'
DRAWN BY:	ASR
APPROVED:	PA
FIGURE 2

SITE LAYOUT AND SAMPLE LOCATIONS

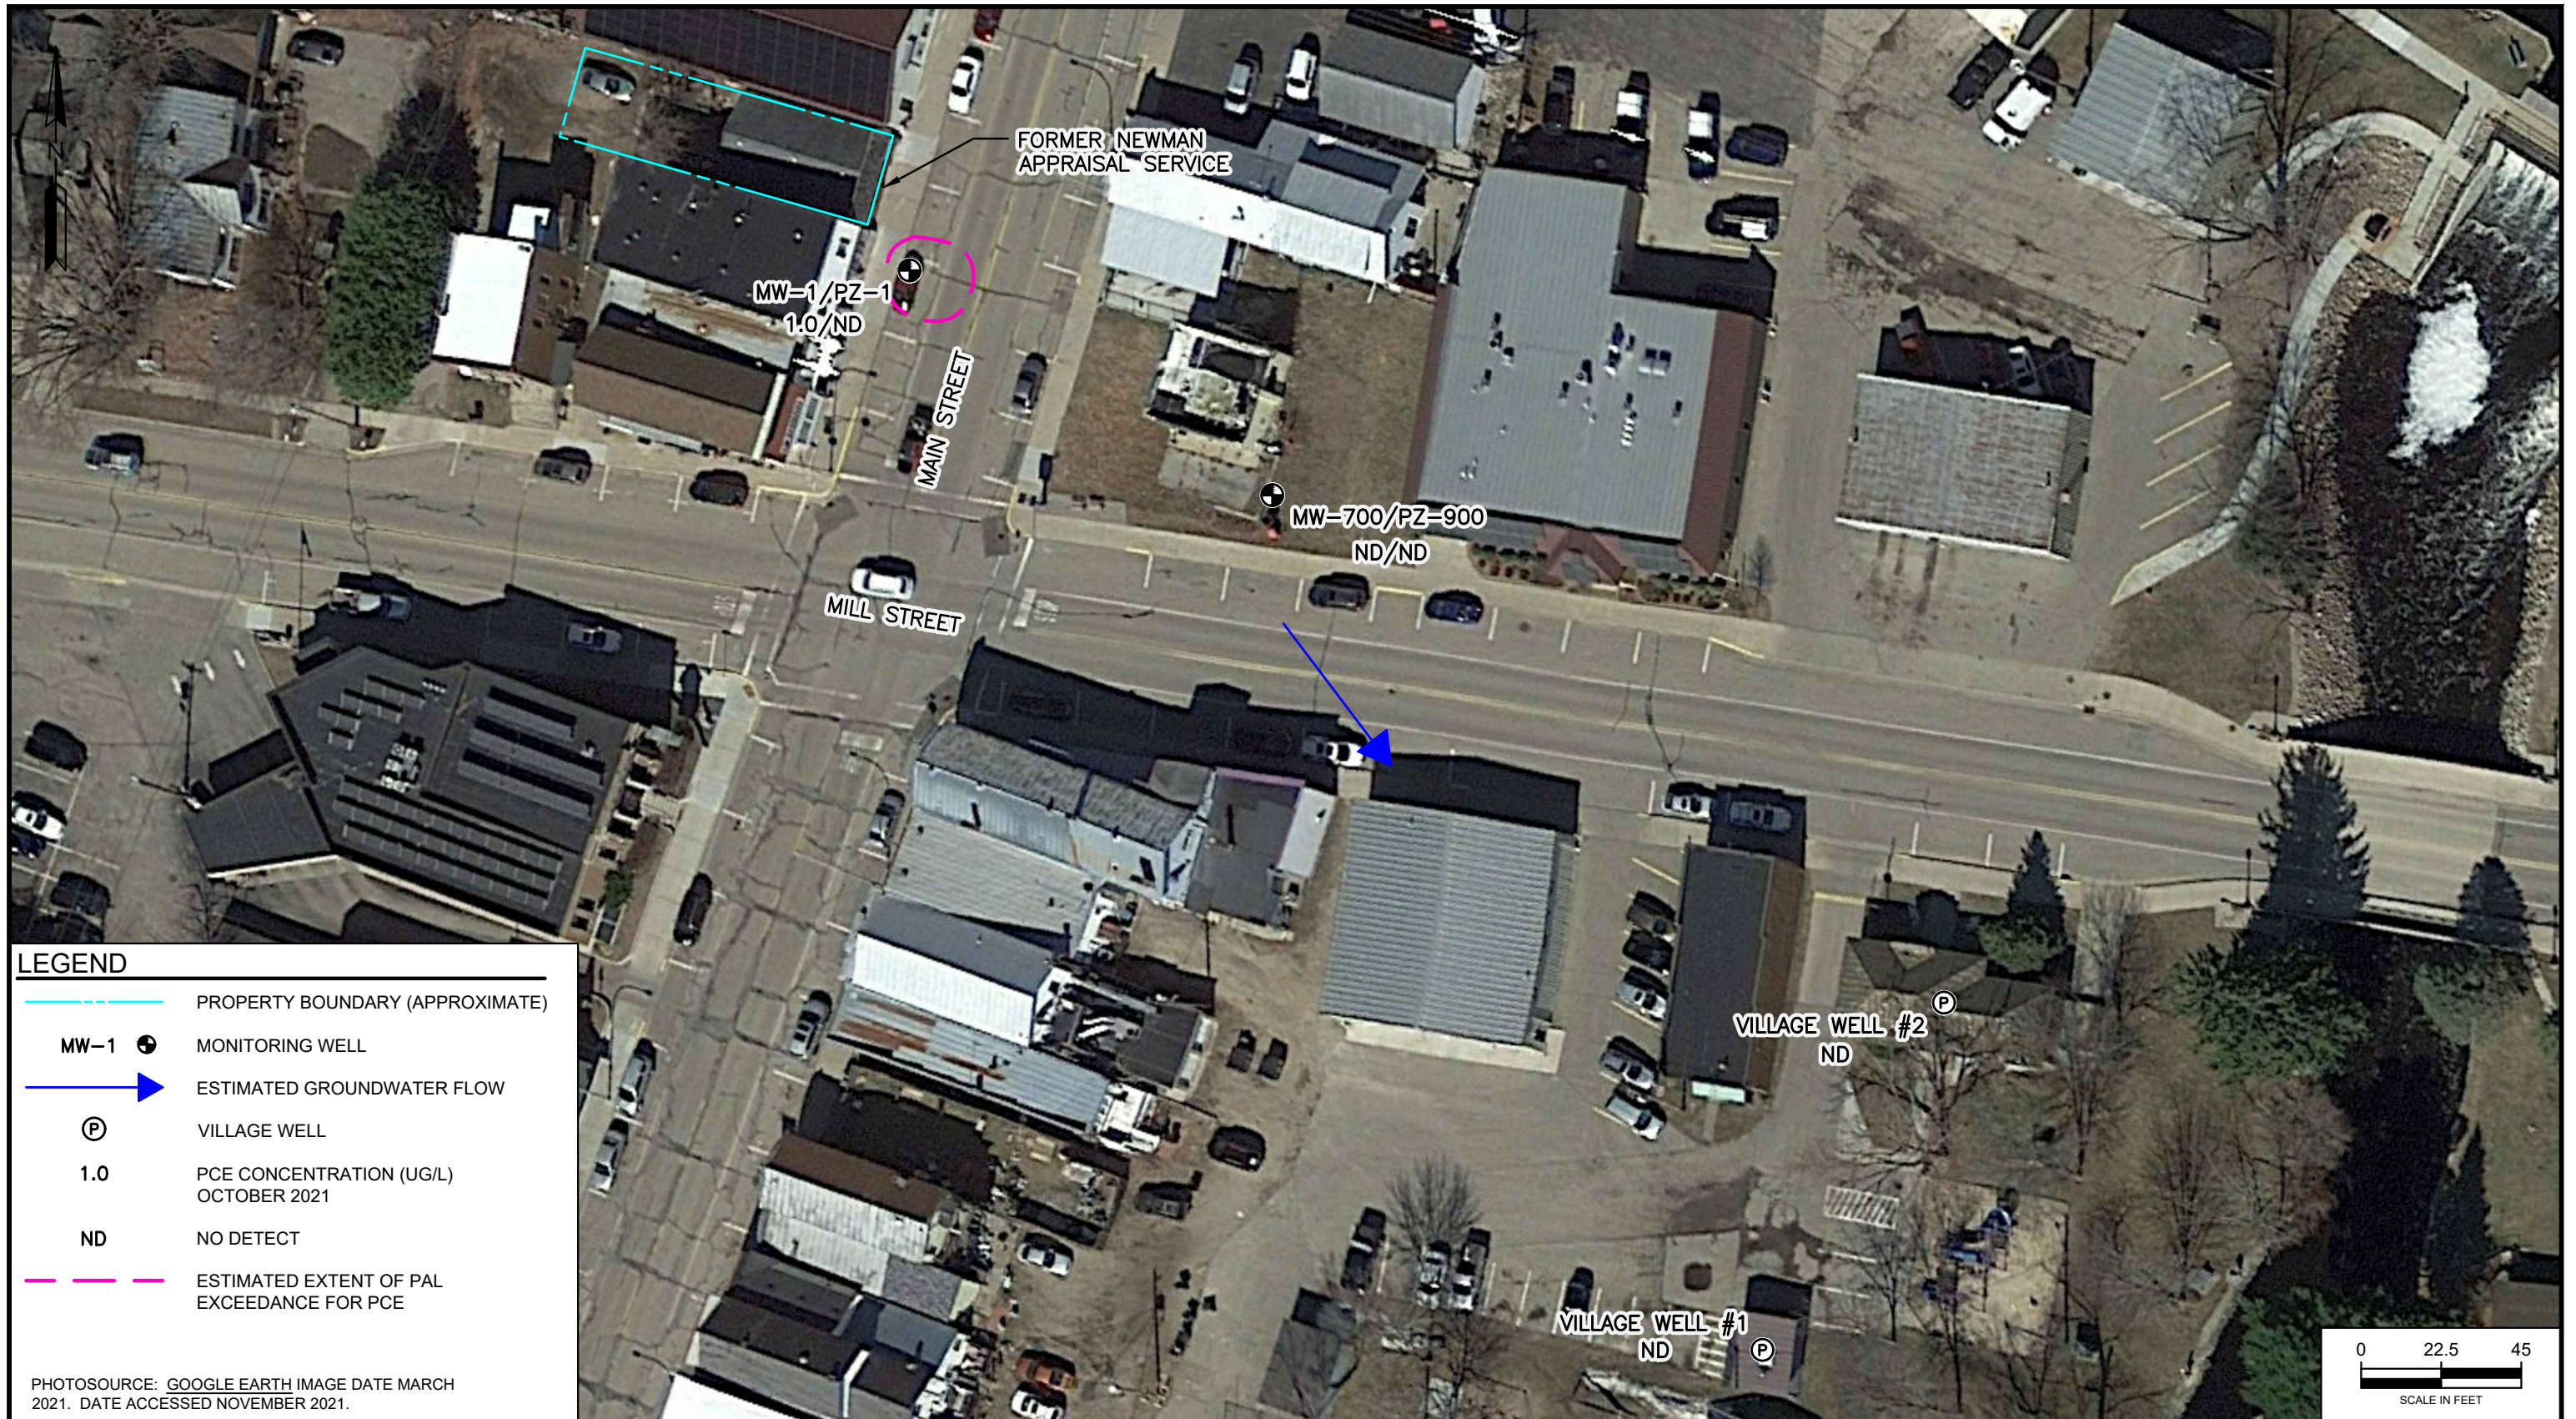
PROPERTY BOUNDARY (APPROXIMATE)
MW-1	MONITORING WELL
	ESTIMATED GROUNDWATER FLOW
	VILLAGE WELL
1.0	PCE CONCENTRATION (UG/L) OCTOBER 2021
ND	NO DETECT
	ESTIMATED EXTENT OF PAL EXCEEDANCE FOR PCE

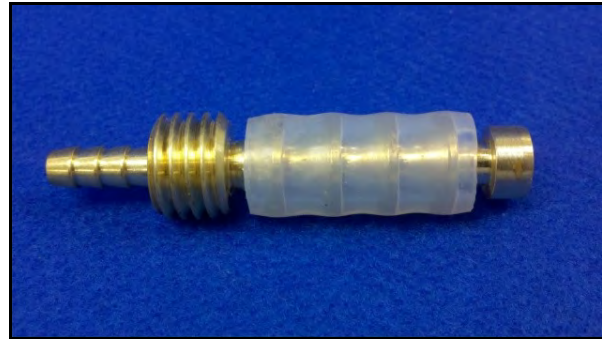
Figure 1. Assembled Vapor Pin™.

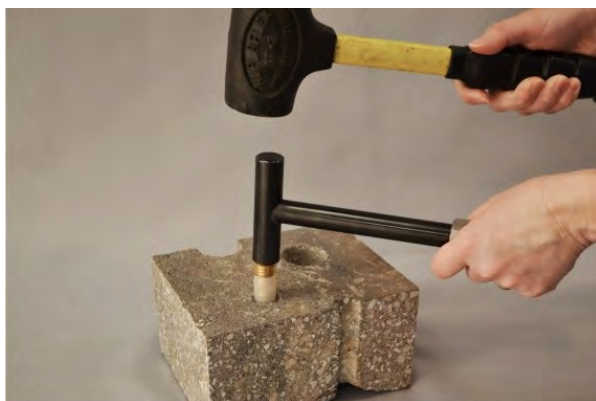
- 1) Check for buried obstacles (pipes, electrical lines, etc.) prior to proceeding.
- 2) Set up wet/dry vacuum to collect drill cuttings.
- 3) If a flush mount installation is required, drill a 1½-inch diameter hole at least 1¾-inches into the slab.
- 4) Drill a 5/8-inch diameter hole through the slab and approximately 1-inch into the underlying soil to form a void.
- 5) Remove the drill bit, brush the hole with the bottle brush, and remove the loose cuttings with the vacuum.
- 6) Place the lower end of Vapor Pin™ assembly into the drilled hole. Place the small hole located in the handle of the extraction/installation tool over the Vapor Pin™ to protect the barb fitting and cap, and tap the Vapor Pin™ into place using a dead blow hammer (Figure 2). Make sure

the extraction/installation tool is aligned parallel to the Vapor Pin™ to avoid damaging the barb fitting.

Figure 2. Installing the Vapor Pin™.

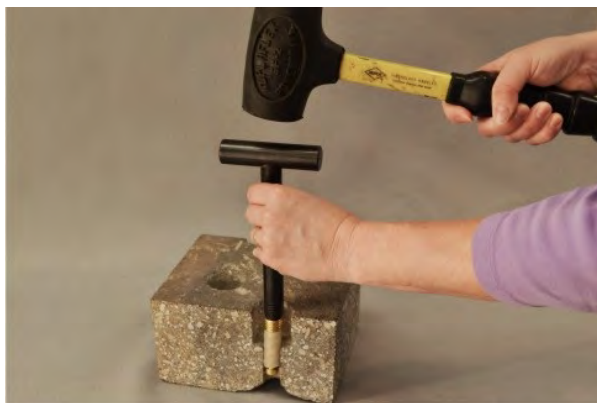
For flush mount installations, unscrew the threaded coupling from the installation/extraction handle and use the hole in the end of the tool to assist with the installation (Figure 3).

Figure 3. Flush-mount installation.

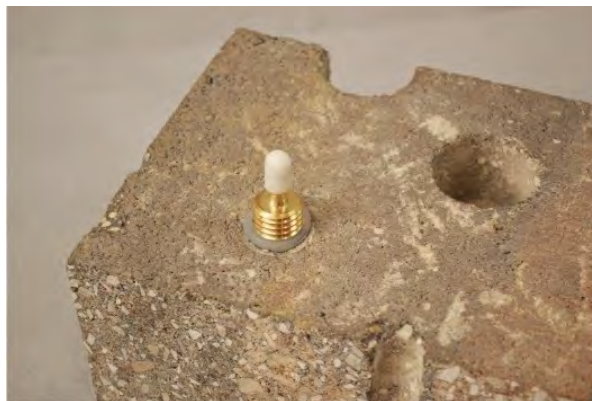
During installation, the silicone sleeve will form a slight bulge between the slab and the Vapor Pin™ shoulder. Place the protective cap on Vapor Pin™ to prevent vapor loss prior to sampling (Figure 4).

Figure 4. Installed Vapor Pin™.

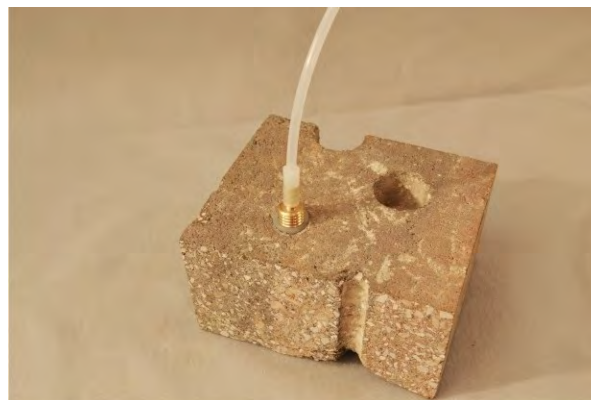
- 7) For flush mount installations, cover the Vapor Pin™ with a flush mount cover, using either the plastic cover or the optional stainless-steel Secure Cover.
- 8) Allow 20 minutes or more (consult applicable guidance for your situation) for the sub-slab soil-gas conditions to equilibrate prior to sampling.
- 9) Remove protective cap and connect sample tubing to the barb fitting of the Vapor Pin™ (Figure 5).

Figure 5. Vapor Pin™ sample connection.

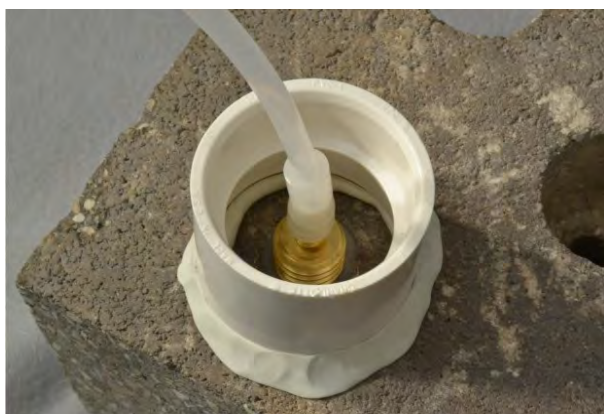
10) Conduct leak tests in accordance with applicable guidance. If the method of leak testing is not specified, an attractive alternative can be the use of a water dam and vacuum pump, as described in SOP Leak Testing the Vapor Pin™ via Mechanical Means (Figure 6).

Figure 6. Water dam used for leak detection.

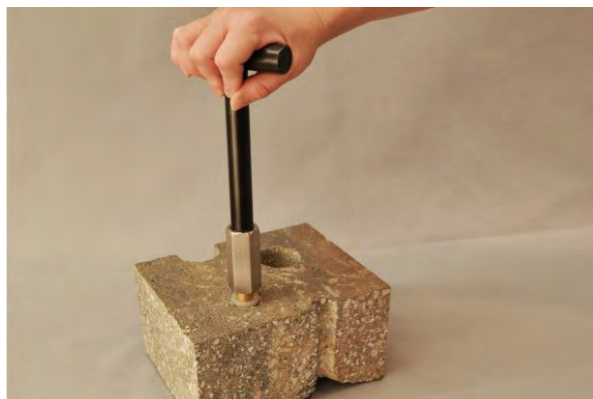
- 1) Remove the protective cap, and thread the installation/extraction tool onto the barrel of the Vapor Pin™ (Figure 7). Continue turning the tool to assist in extraction, then pull the Vapor Pin™ from the hole.
- 2) Fill the void with hydraulic cement and smooth with the trowel or putty knife. Urethane caulk is widely recommended for installing radon systems and can provide a

Figure 7. Removing the Vapor Pin™.
