BRRTS #: 02-13-551964
ACTIVITY NAME: KLINKE DRY CLEANERS CAMPUS
PROPERTY ADDRESS: 2875 UNIVERSITY AVE
MUNICIPALITY: MADISON
PARCEL ID #: 60-0709-212-0609-5

The Department of Natural Resources (DNR) considers the Klinke Dry Cleaners – Campus site closed, with continuing obligations. No further investigation or remediation is required at this time. However, you, future property owners, and occupants of the property must comply with the continuing obligations as explained in the conditions of closure in this letter. Please read over this letter closely to ensure that you comply with all conditions and other on-going requirements. Provide this letter and any attachments listed at the end of this letter to anyone who purchases, rents or leases this property from you.

This active dry cleaner site had soil and sub-slab vapor contaminated with chlorinated volatile organic compounds (VOCs). Chlorinated VOC vapors were also found in indoor air which were likely from a spotting agent in use at the dry cleaner. No remedial actions were taken. A vapor mitigation system was installed at the site to address the sub-slab vapors. The conditions of closure and continuing obligations required were

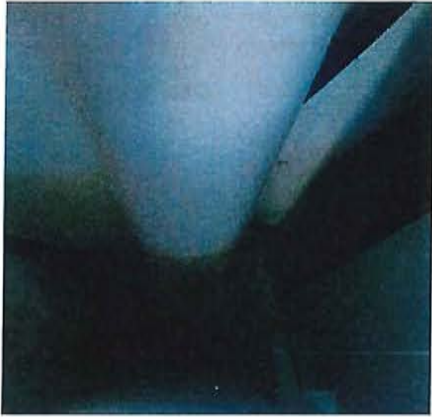
Extraction Point 1

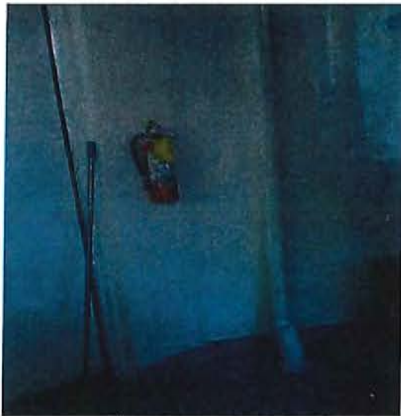
Extraction Point 2

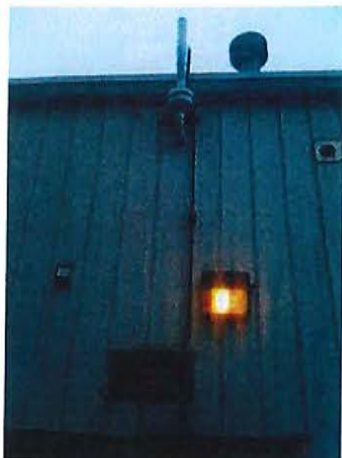
Fan

2. Never open a RadonAway fan, which is factory sealed and designed to be maintenance-free for the life of the fan. Should the fan's casing be opened or the factory seal broken, the five-year factory warranty and any service warranty may be voided.

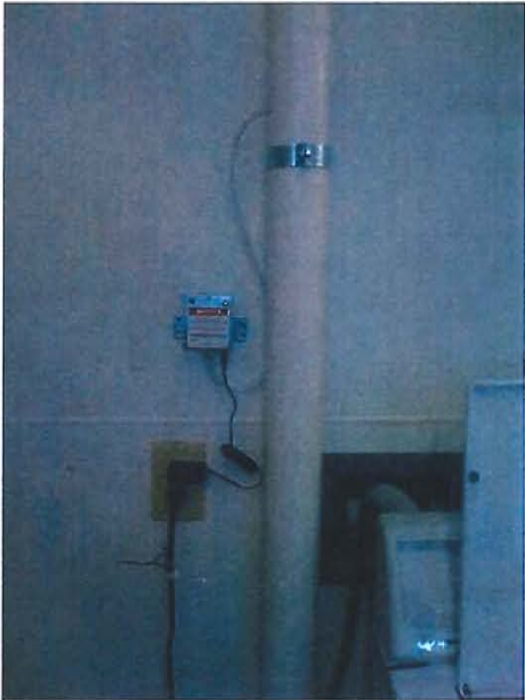
Alarm System

1. Test the system alarm. With the system alarm plugged in, disconnect the clear tubing from the PVC pipe. Both the read indicator light and the audible alarm will be on. Reconnect the clear pressure tubing to the piping. The red light and the audible alarm will go off. The green light will come on. Contact VPS immediately for repair and/or maintenance.

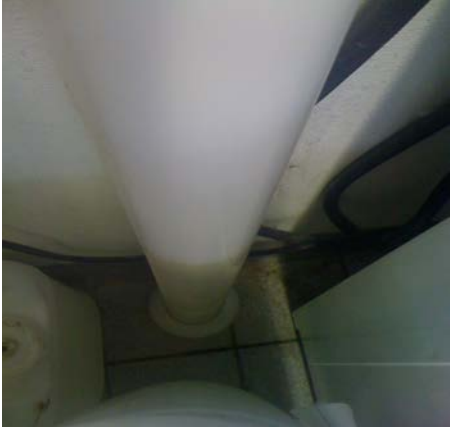
Extraction Point 1

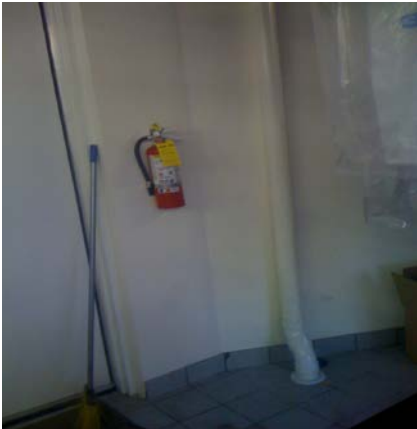
Extraction Point 2

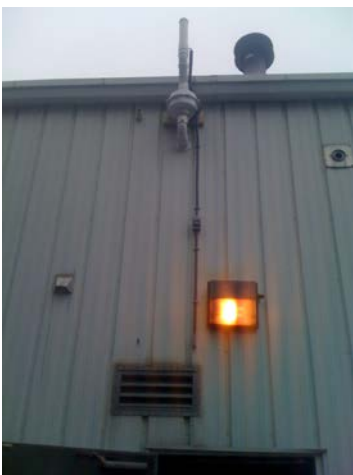
Fan

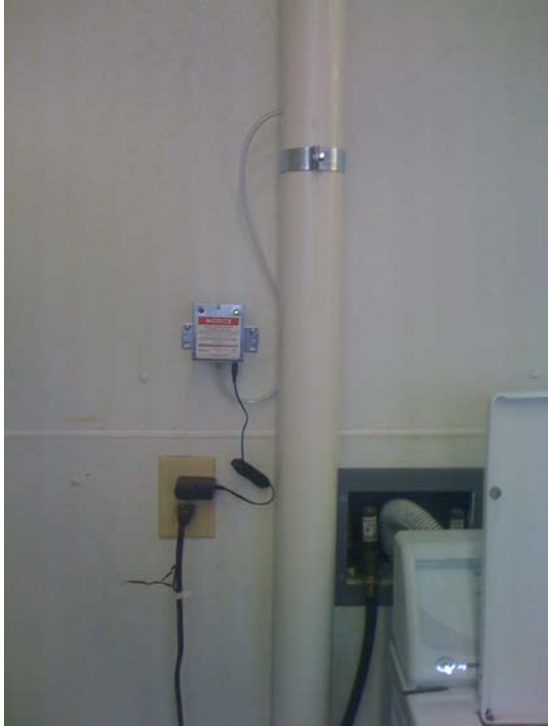
Alarm System
