SUBJECT: Case Closure with Continuing Obligations
Care'n Cleaners – 735 West Main Street, Waupun, WI
BRRTS Activity # 02-14-552053

Residual Soil Contamination

Client/Project
 Care'N Cleaners
 735 West Main Street
 Waupun, Wisconsin

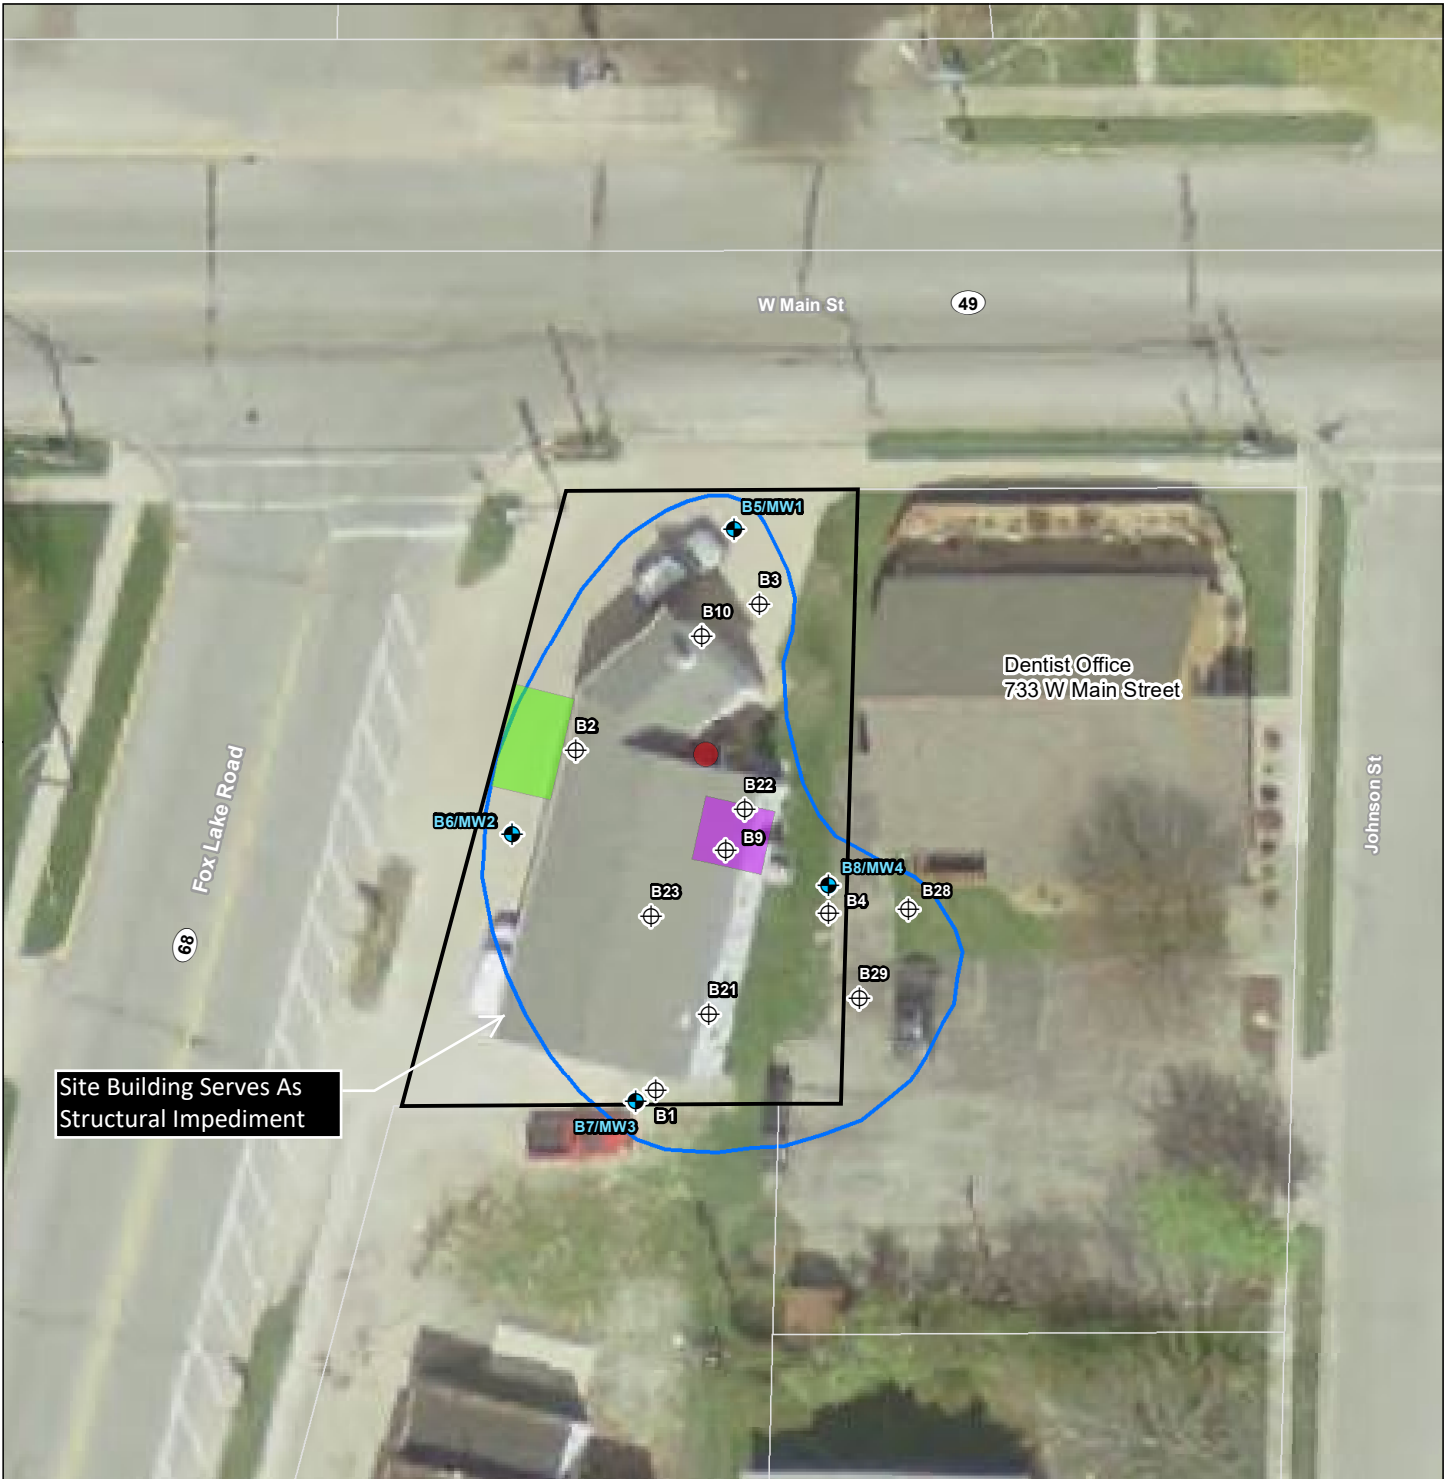
B.2.b.

- Approximate Site Boundary
- Parcel Boundary
- Borehole Location
- Soil Borehole / Monitoring Well Location
- AST - PCE - Removed 1980s
- Drycleaning Machine Area
- Former Gas UST Area
- General extent of soil contamination exceeding the NR 720 Groundwater Protection RCL (0-4 fbg)

Soil contamination remains over much of the source property at beneath portions of the neighboring properties to the east and south as indicated on the enclosed map (Figure B.2.b., Residual Soil Contamination, 2021-07-13). If

Structural Impediment (Wis. Stat. § 292.12(2)(b), Wis. Admin. Code §§ NR 726.15(2)(f), NR 727.07(2))
The remaining building on the source property as shown on the enclosed map (Figure B.2.b., Residual Soil Contamination, 2021-07-13) made complete site investigation and/or remediation of the contamination on this property impracticable. Upon removal of the structural impediment, the property owner shall evaluate the need to investigate the degree and extent of chlorinated solvent contamination obstructed by the structural impediment. If contamination is found at that time, the property owner shall remediate the contamination in accordance with Wis. Admin. Code chs. NR 700 to 799.

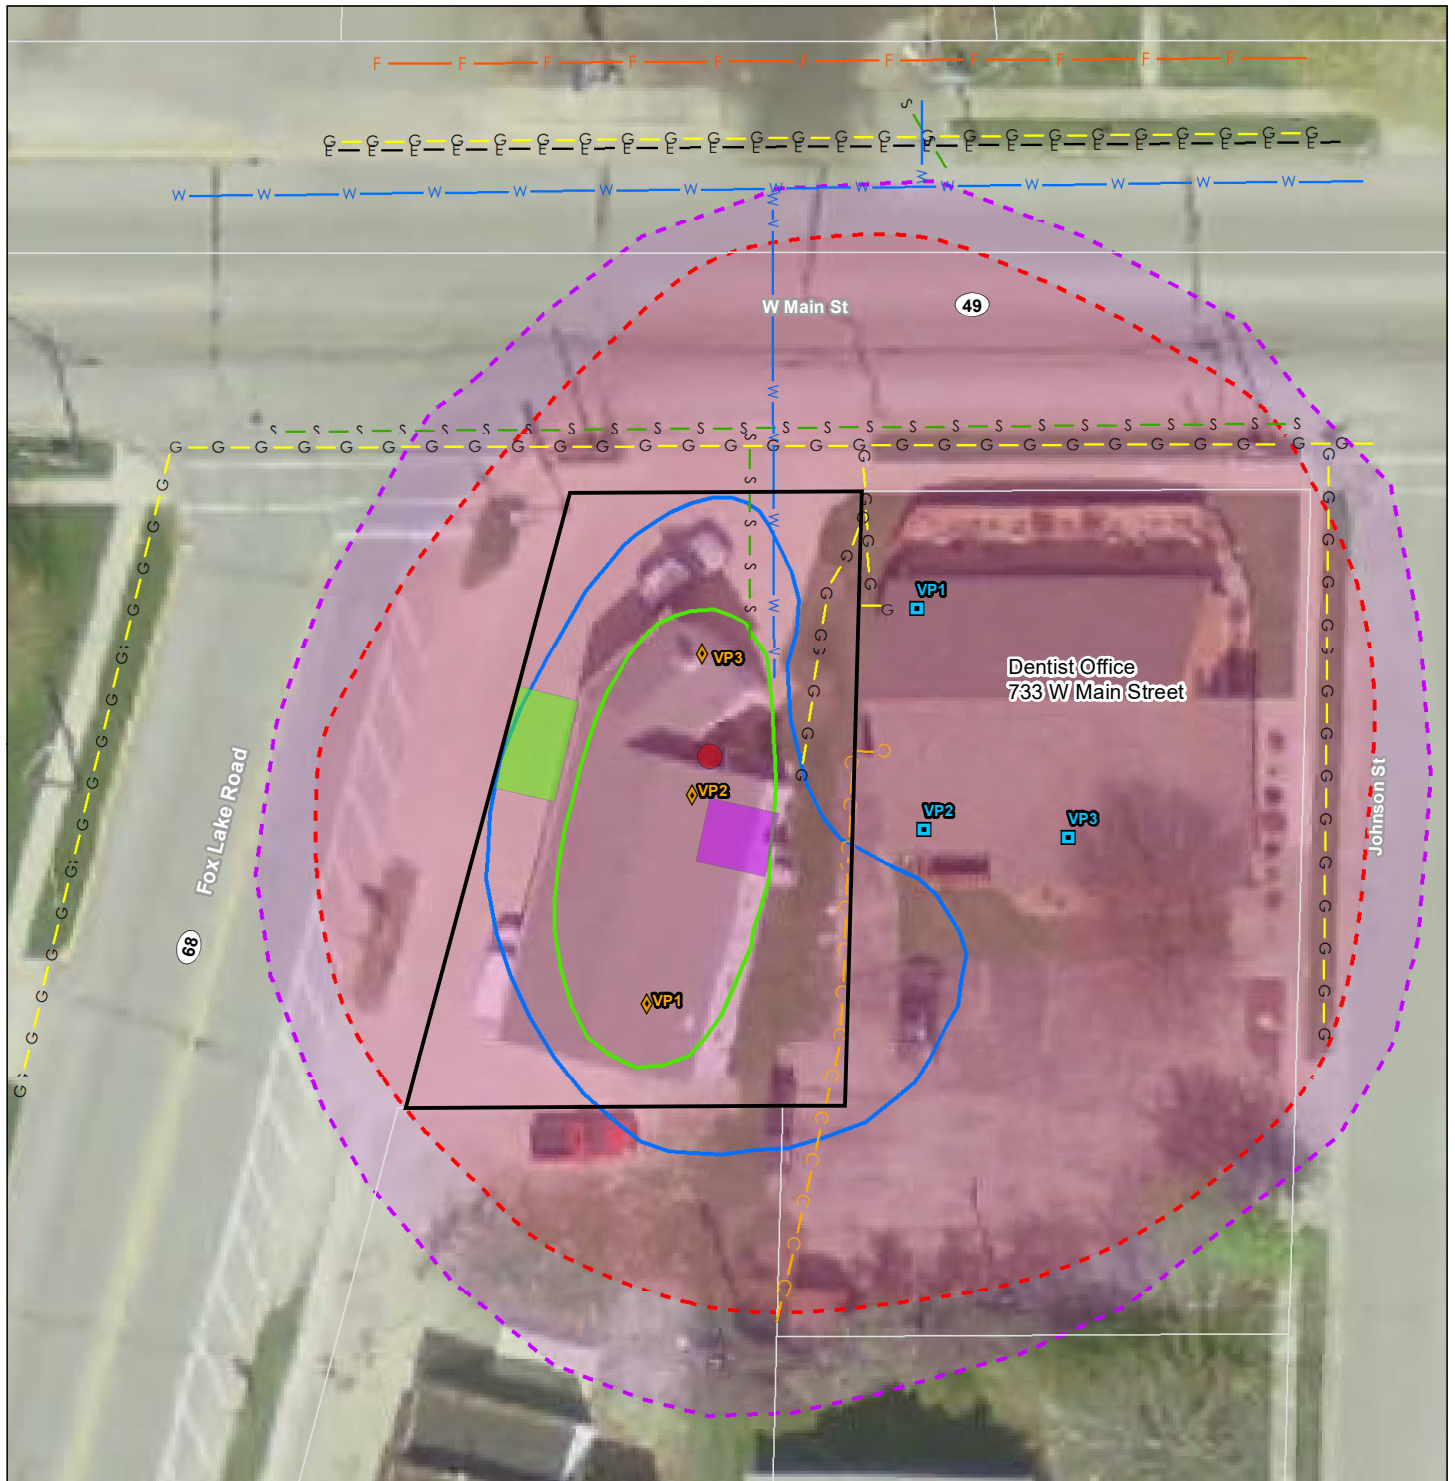
B.4.a.

- Approximate Site Boundary
- Parcel Boundary
- ◆ Vapor Point inside 735 West Main Street
- Vapor Point inside 733 West Main Street
- E Electric
- F Fiber Optic Line
- G Buried Gas Line
- S Sanitary Sewer
- W Water Line

Vapor Intrusion Map

VI - Vapor Mitigation Systems: (Wis. Stat. § 292.12(2), Wis. Admin. Code § NR 726.15(2)(h), (i), (j) or (m))
Vapor mitigation systems, which may include vapor barriers, are used to interrupt the vapor pathway, thereby reducing or preventing vapors from moving into the building. Soil vapor beneath the source property building contains PCE and its breakdown products at levels that would pose a risk to human health, if allowed to migrate into an occupied building on the property. See the enclosed map (Figure B.4.a., Vapor Intrusion Map, 2021-07-13).

The vapor mitigation system includes three sub-slab pick-up points and two fans, which are installed along the east side and northeast corner of the building. The property owner shall maintain, operate and inspect the vapor mitigation system, installed on October 2, 2019, in accordance with the enclosed maintenance plan, dated September 1, 2021. System components must be repaired or replaced immediately upon discovery of a malfunction. The property owner shall document inspections on the VMS inspection log (Form 4400-321). See the Other Closure Requirements section of this letter for more details.

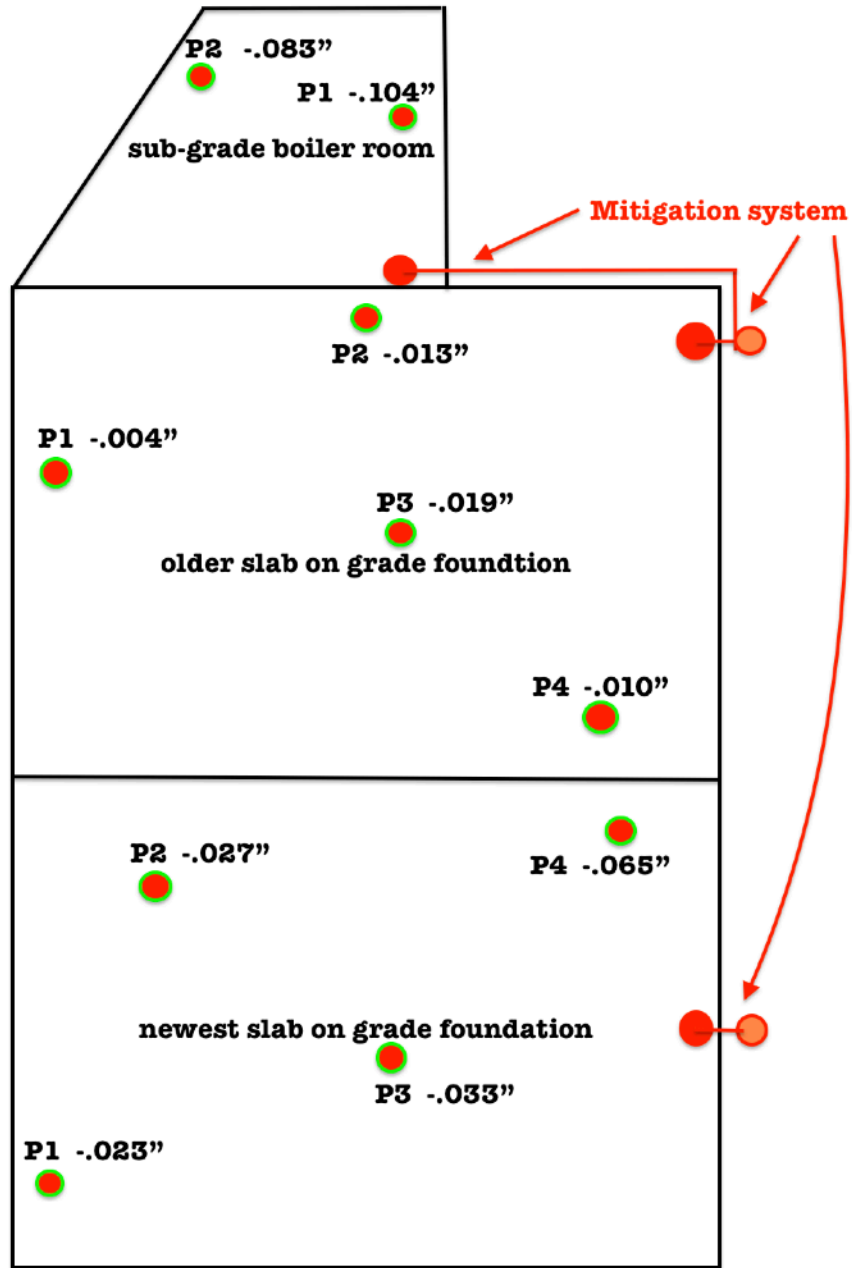
D.2 Location Map

Provided below is a location map detailing the location and extent of the vapor mitigation installed in the basement of the Site building.

The sub-slab depressurization system consists of two roof-mounted ventilation fans, three collection points within the building slabs, and connective piping. The collection points are located within the extent of the identified soil vapor contamination plume. The collection points penetrate the building's floor slabs and terminate within the underlying base course material. The fans create a negative pressure beneath the floor slabs to reduce the potential for sub-slab vapors to infiltrate the building. Vapors extracted by the system are vented to the atmosphere through stacks located on the roof of the existing building.

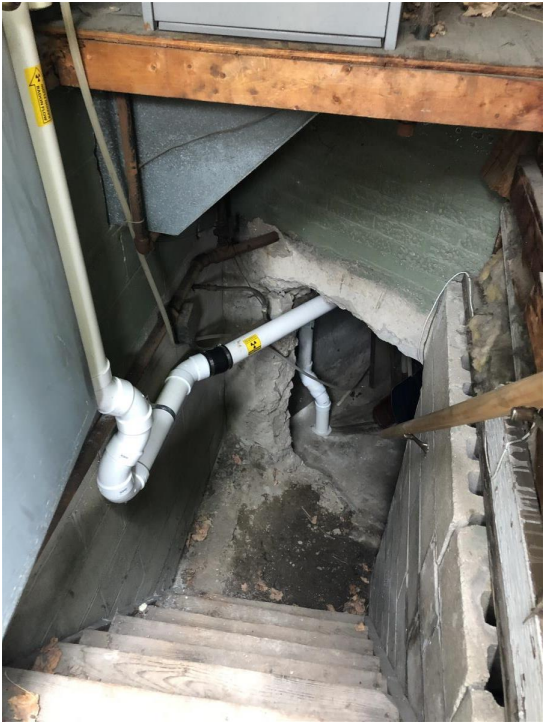
Photograph ID: 1

Photograph ID: : 1	
Survey Date: 10/3/2019	
Comments: Typical Sub-slab Depressurization Point

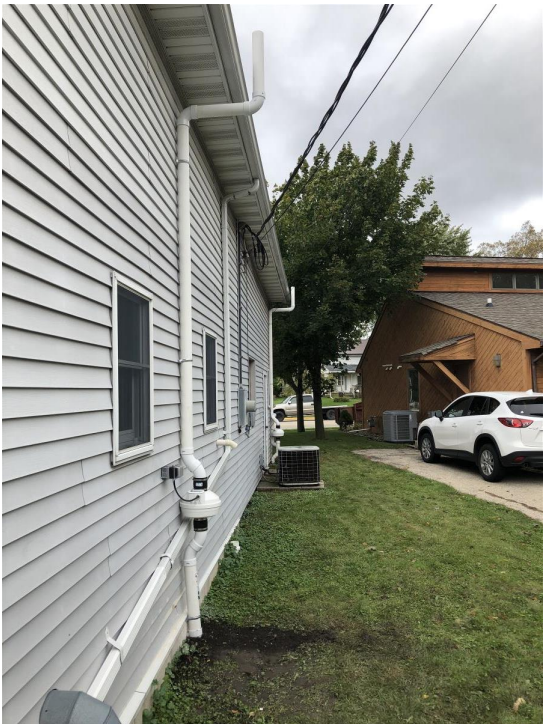
Photograph ID: 2

Photograph ID: : 2	
Survey Date: 10/3/2019	
Comments: Mitigation System Air Discharge Piping

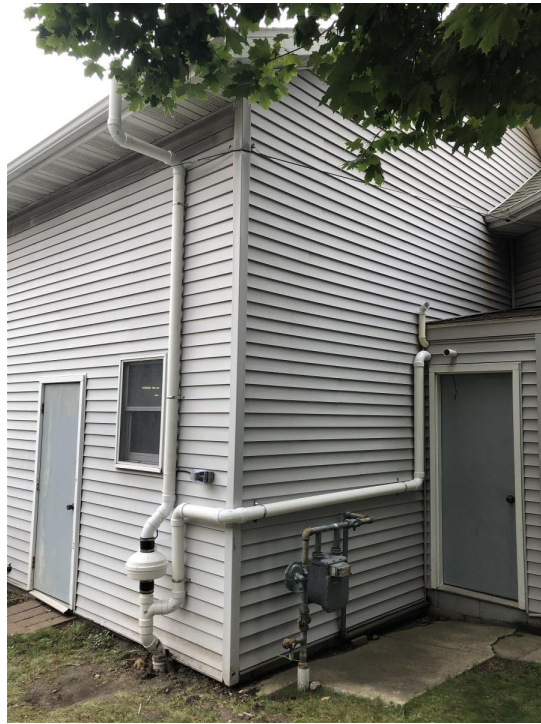
Photograph ID: 3
Photograph ID: : 3
Survey Date: 10/3/2019
Comments: Mitigation System Air Discharge Piping

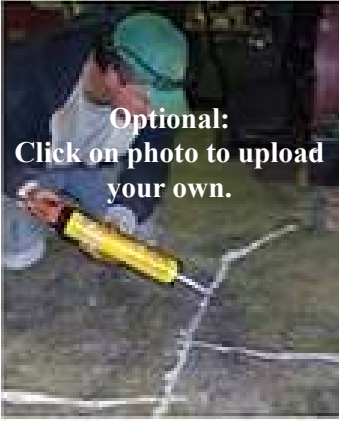
SYSTEM COMPONENT				DATE:
NAME	WHAT DOES IT DO?	WHAT DO I CHECK?	WHAT SHOULD I SEE?	WHAT TO FIX?
Foundation Floor	Foundation is a barrier that minimizes soil gas entry into building, and helps fan to work efficiently.	Foundation Condition Foundation Footprint	No penetrating cracks or holes in foundation. Check if there have been alterations or additions to building or footprint.	Seal cracks or other penetrations as you would to prevent water from entering. If building floor plan has changed, notify DNR and contact a mitigation professional to evaluate if modifications to the vapor mitigation system are necessary.
PHOTO

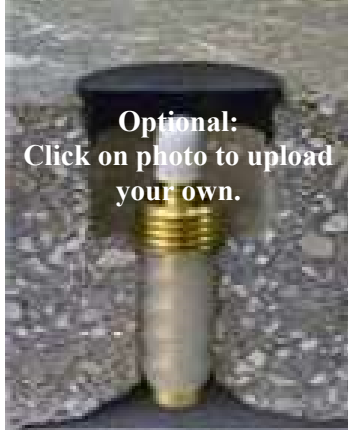
SYSTEM COMPONENT		DATE:		
NAME	WHAT DOES IT DO?	WHAT DO I CHECK?	WHAT SHOULD I SEE?	WHAT TO FIX?
Sub Slab Vapor Port	This is a sample port to measure vacuum or take sample of soil gas if needed. It needs to remain sealed when not in use to prevent soil gas entry into the home.	Port Seal/Cap	If able to measure the vacuum with a micromanometer, the pressure differential should be at least 0.004 inches of H ₂ O or at least one Pascal.	Repair or replace the seal and cover as needed.
		Port Condition	Port is sealed and capped when not in use.	Permanently seal hole if sample port is ever removed.
PHOTO			NOTES: (If taken, record the pressure differential reading. Identify specific building and location description:) <input type="checkbox"/> Not Applicable
