SUBJECT: Shorewood Queensway – Aunt Peg’s Site Building Assessment

This memorandum presents EnviroForensics’ technical summary regarding an on-site meeting Wednesday September 4, 2013 with representatives of Terracon on behalf of Aunt Peg’s. The objective of the meeting was to assess the performance of the SSDS and to discuss potential needs for additional sampling. Present at the site for EnviroForensics were Rob Hoverman, Senior Project Manager and Kyle Heimstead, Field Geologist. For Terracon, Scott Hodgson, Project Geologist and Paul Lenaker, Senior Staff Geologist were present.

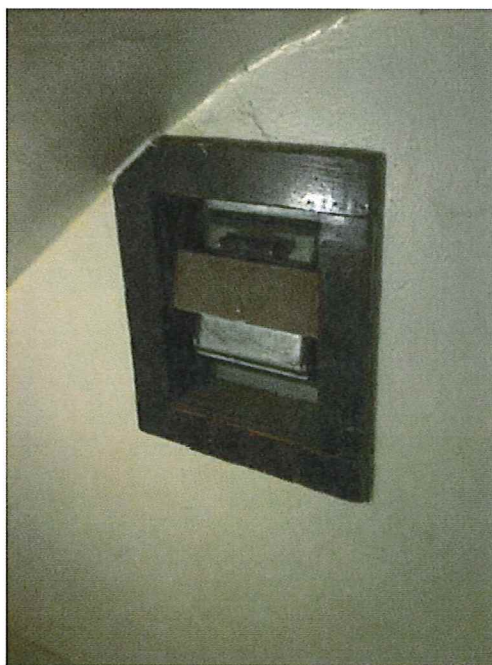
There were historical trash incinerators present in the basements below 4320 and 4332, but currently inoperable. Each incinerator was connected to the first and second floors of the building via small trash chutes. These trash chutes would have been utilized by building occupants to dispose of trash via the chutes that were connected to each floor. Each incinerator chute was secured in the closed position at the time of the assessment. A photograph of an incinerator chute is presented in Attachment 1. While these chutes are a connecting pathway to the basements, the likelihood of these being a migratory pathway for contaminated vapors is limited.

Sealed incinerator chute

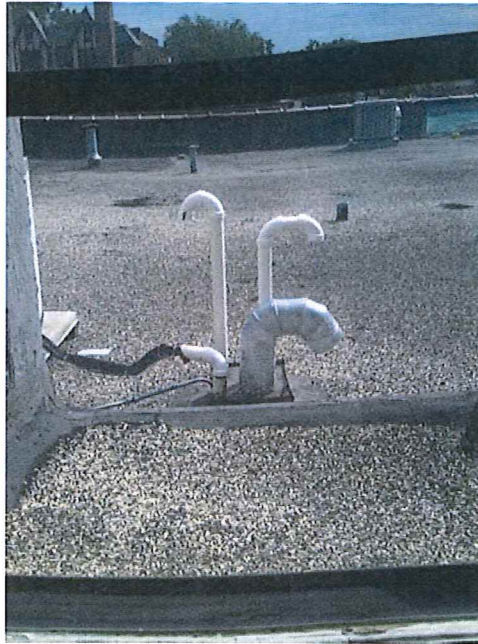
A secondary pathway was identified from the SSDS exhaust to 4312, 4314, and 4316 via fresh air intakes located on the common roof. Each unit had a separate intake, which is connected to the air handlers and furnaces in the basement of each unit. The discharge of the SSDS was located at a similar elevation to each of these intakes, which has the potential to be drawn in by the fresh air intakes. Attachment 1 shows a photograph of a metal fresh air intake on the roof taken from the window in apartment #204.

Fresh air intake
