# SUPERFUND PRELIMINARY ASSESSMENT

STERLING DRY CLEANERS  
City of Appleton, Wisconsin  
CERCLIS ID WIN #000510415

Prepared by:  
Wisconsin Department of Natural Resources  
Northeast Region

September 2012

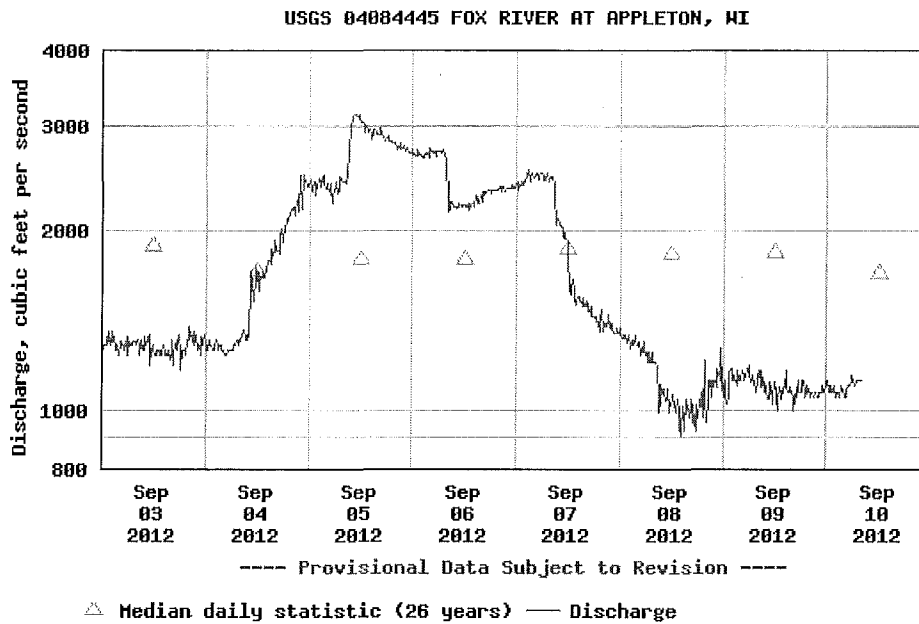
**Discharge, cubic feet per second**

Most recent instantaneous value: 1,126 09-10-2012 08:00 CDT

The nearest surface water is the Fox River which is located approximately one mile north from the SDC property. SDC is in an urbanized area with storm water and sanitary sewer controls. Due to distance and topography, there is no likelihood of an observed release to surface water by overland flow, flood or runoff. The SDC property is capped with asphalt, concrete, and buildings. Groundwater is present in slowly permeable soils underlain by silty clay, glacial till, and lacustrine sediments and dolomitic bedrock is present at depths of greater than 50 feet. The Fox River is a major river in Northeast Wisconsin that flows on top of the Dolostone bedrock in the City of Appleton and flows at an average rate of 1800 cubic feet per second ([Reference 16](#)).
