SUBJECT: Final Case Closure with Continuing Obligations
Former TLC Dry Cleaning, 668 North High Point Road, Madison, Wisconsin
DNR BRRTS Activity Number: 02-13-552185

This property is a former dry cleaning facility that ceased operation in 2014. Tetrachloroethylene, a common dry cleaning fluid, was found in soil, groundwater and indoor air. Remedial actions were limited due to the presence of the building on-site. A vapor mitigation system must be operated in a portion of the building to ensure indoor air quality. The conditions of closure and continuing obligations required were based on the property being used for commercial purposes.

D.2.b Vapor Mitigation System Details Diagram
Former TLC Cleaning Facility
668 N. High Point Road
Madison, Wisconsin

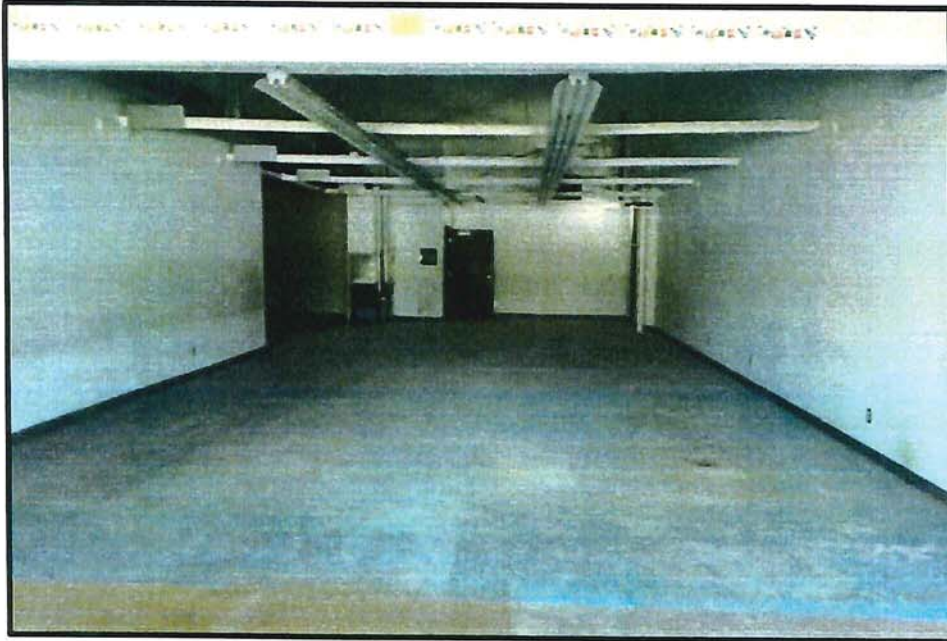
Photo 1 – Looking south at the interior of the former dry cleaning space. The dry cleaning business is no longer operational at the site. The dry cleaning machine formerly sat in the center background of the space shown in this photo.

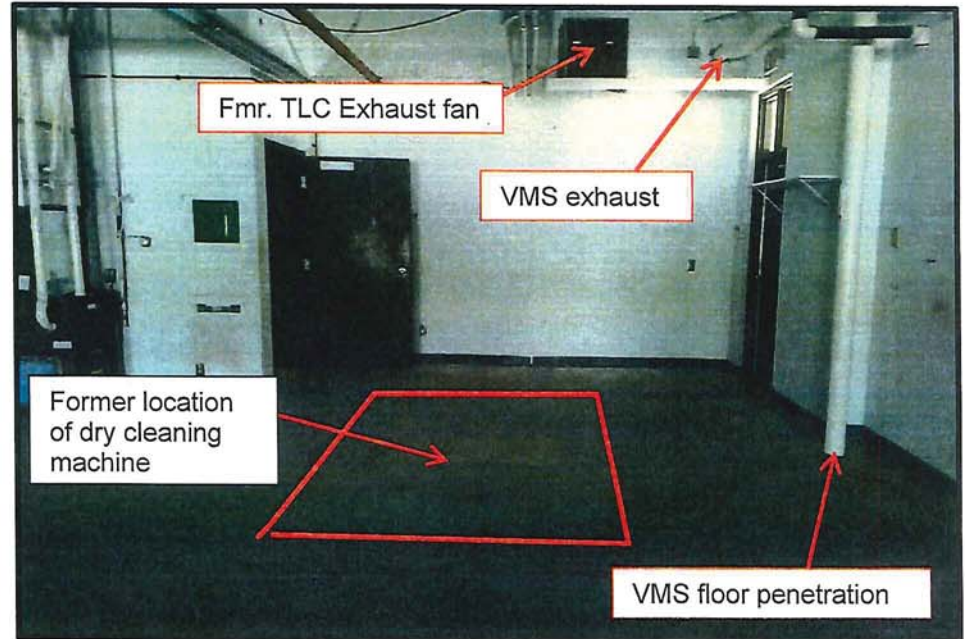
Photo 2 – This photograph was taken from a close up vantage compared to Photo 1 and shows the former location of the dry cleaning machine and the location of the VMS installed in November 2014.

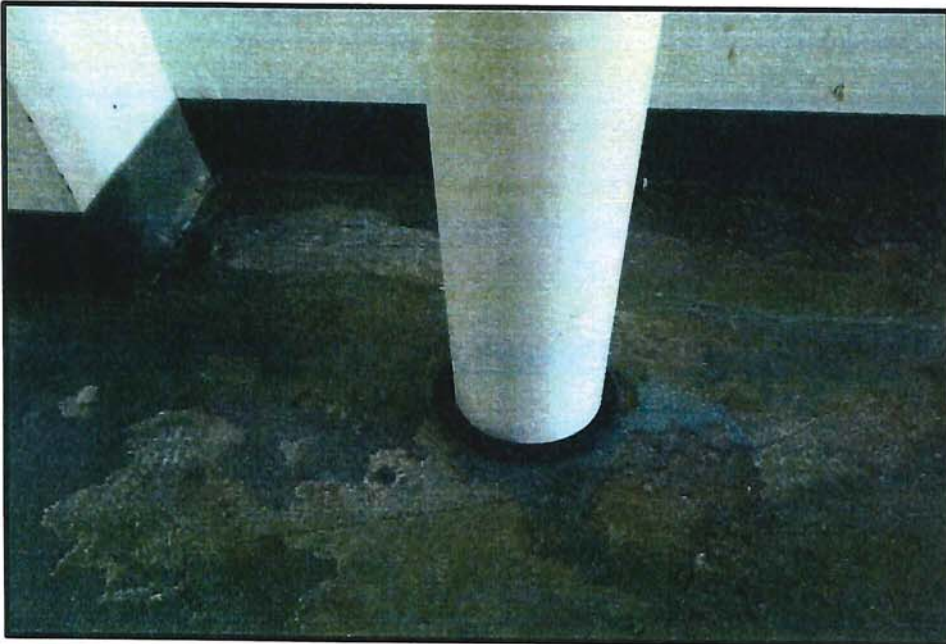
Photo 3 – This photograph shows a close up of the floor penetration of the VMS. The floor penetration was sealed with a rubber gasket and caulk. The concrete is approximately 5 to 6 inches thick and approximately 5 inches of sub slab concrete was removed.

surface as practical. Any repairs or other penetrations through the existing flooring must be conducted to provide as impermeable a flooring surface as practical. Any repair or replacement activities shall be documented in the attached Inspection Log.

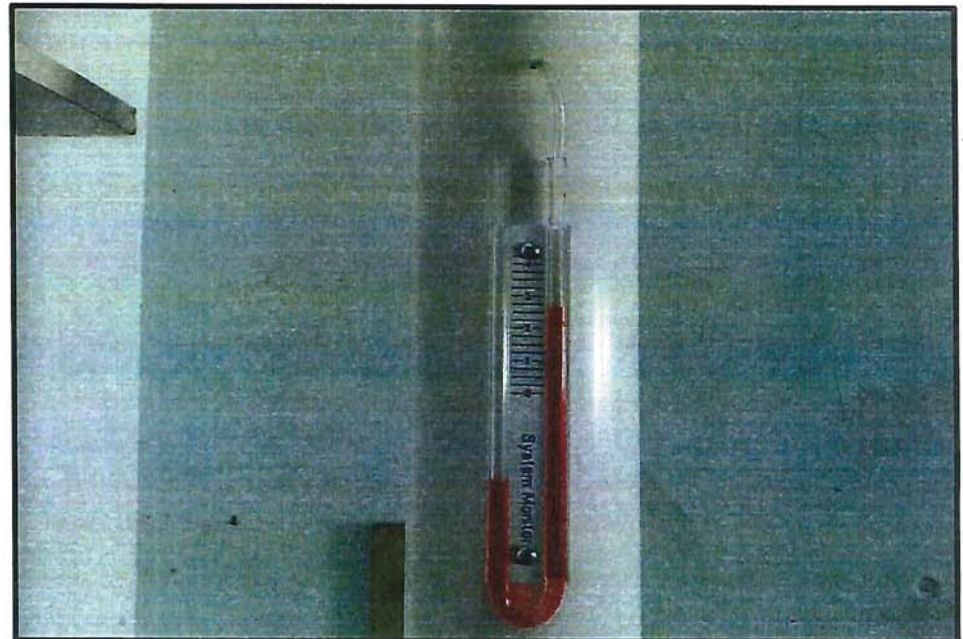
Photo 4 – This photograph shows a close up of the manometer showing that the system is operational.

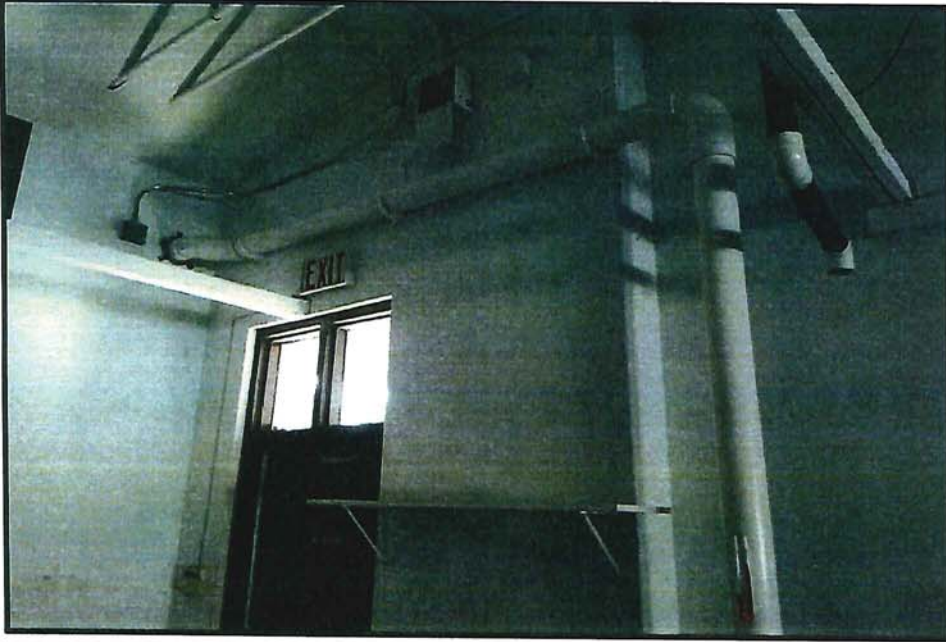
Photo 5 – This photograph shows the upper PVC piping of the VMS and the exit point through the wall. This photograph also shows that the exterior fan is hardwired to the internal power source.

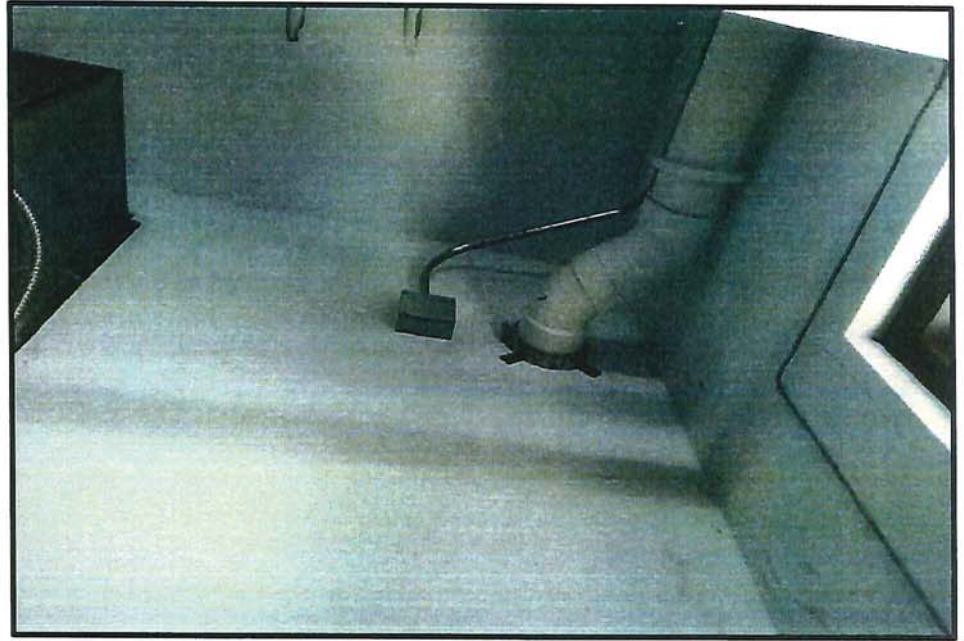
Photo 6 – This photograph shows a close up of the exit point and the interior electrical junction box.

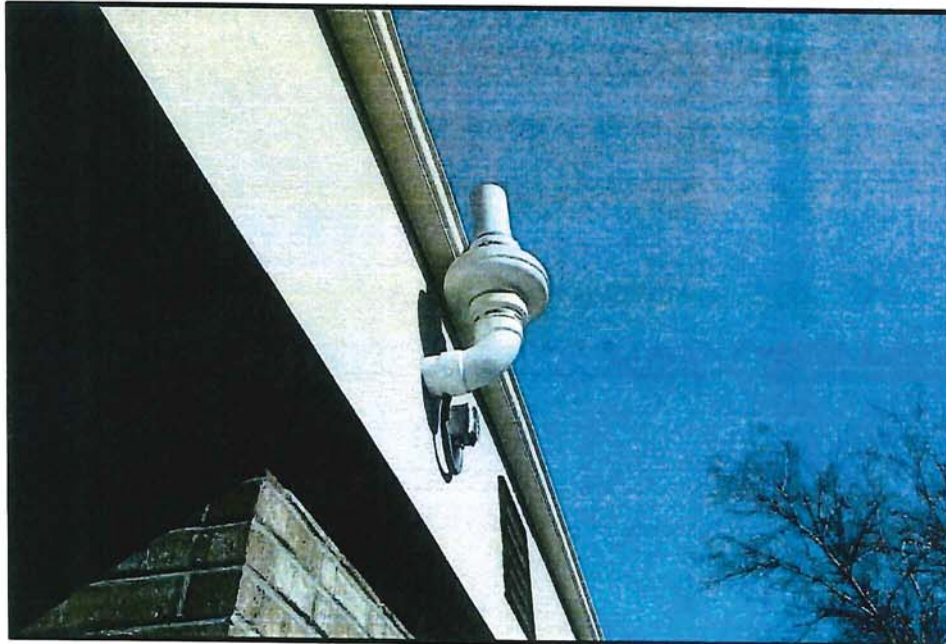
Photo 7 – This photograph looks northeast and up at the exterior fan

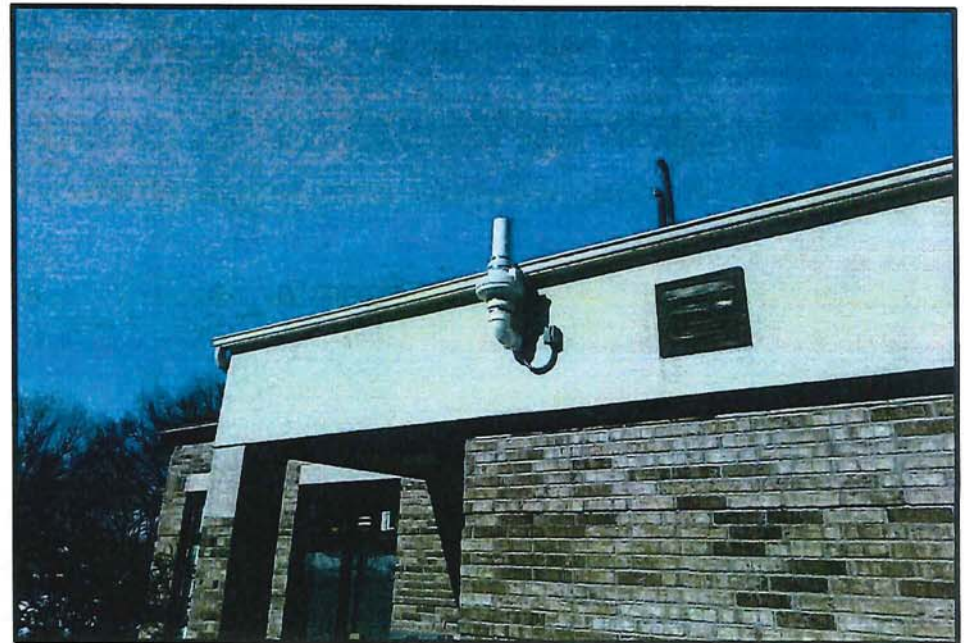
Photo 8 – This photograph looks at the same fan shown in Photo 7 and how the exhaust point terminates above the roof line.

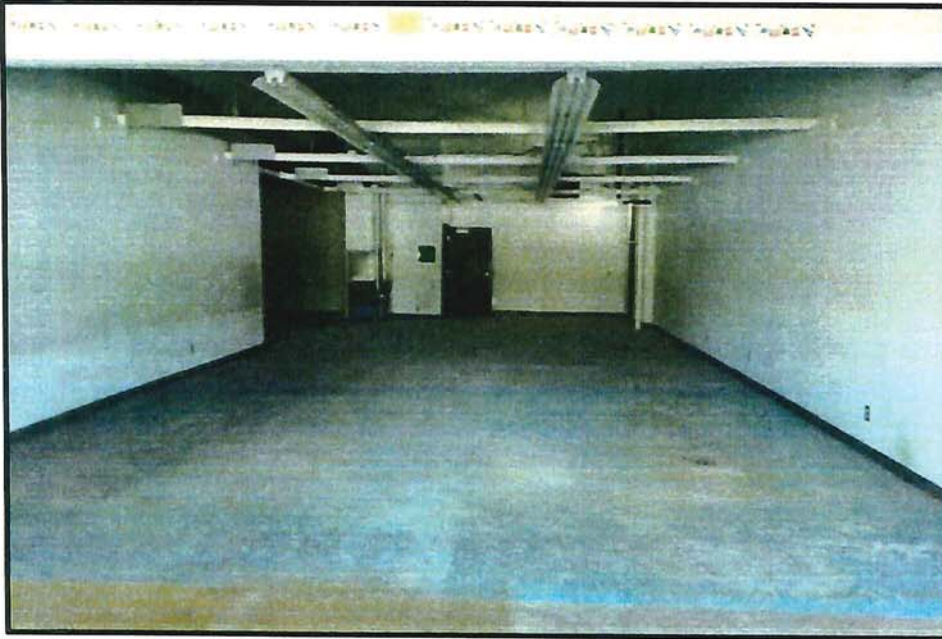
Photo 1 – Looking south at the interior of the former dry cleaning space. The dry cleaning business is no longer operational at the site. The dry cleaning machine formerly sat in the center background of the space shown in this photo.

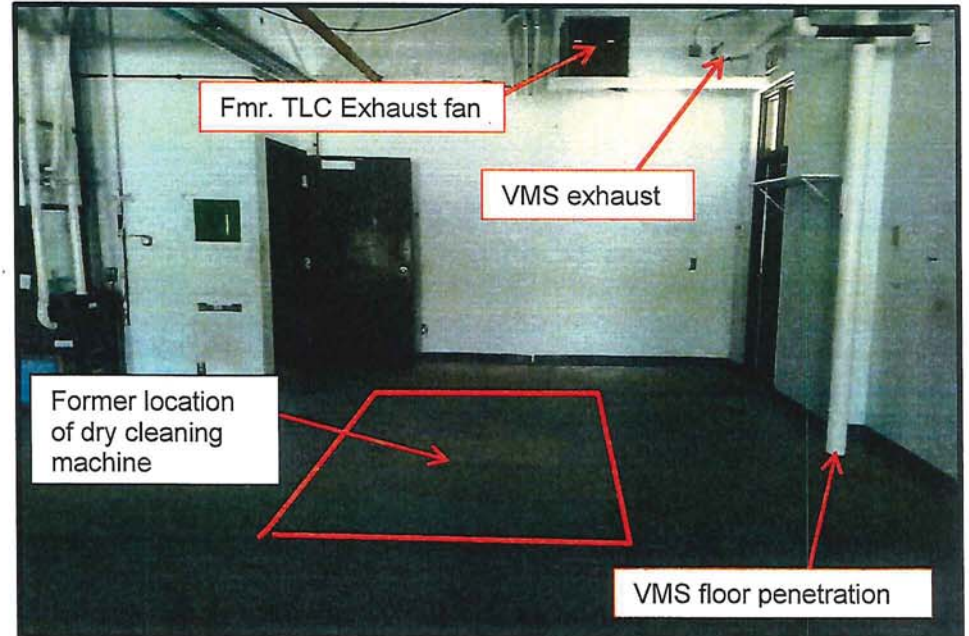
Photo 2 – This photograph was taken from a close up vantage compared to Photo 1 and shows the former location of the dry cleaning machine and the location of the VMS installed in November 2014.

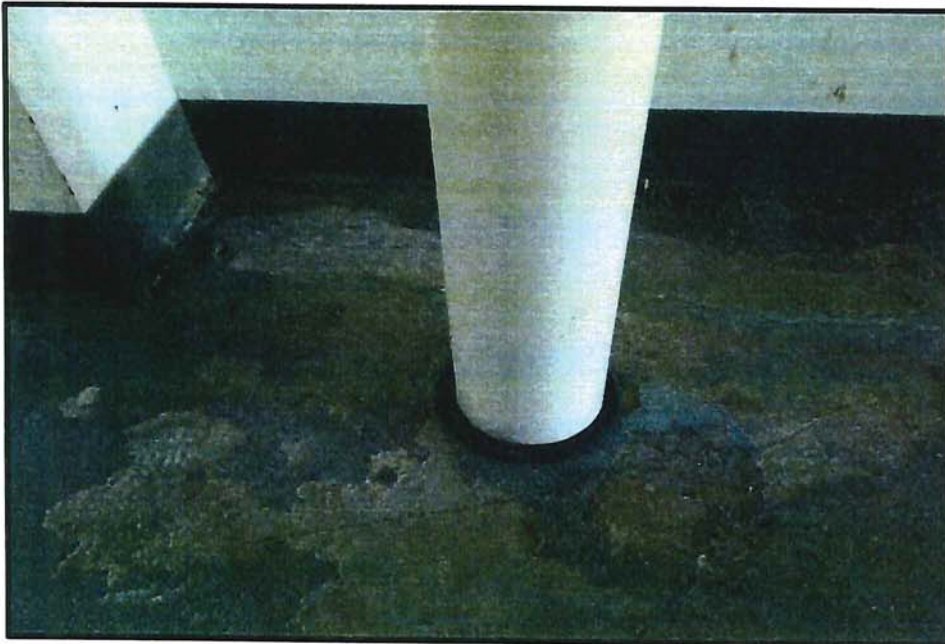
Photo 3 – This photograph shows a close up of the floor penetration of the VMS. The floor penetration was sealed with a rubber gasket and caulk. The concrete is approximately 5 to 6 inches thick and approximately 5 inches of sub-slab concrete was removed.

surface as practical. Any repairs or other penetrations through the existing flooring must be conducted to provide as impermeable a flooring surface as practical. Any repair or replacement activities shall be documented in the attached Inspection Log.

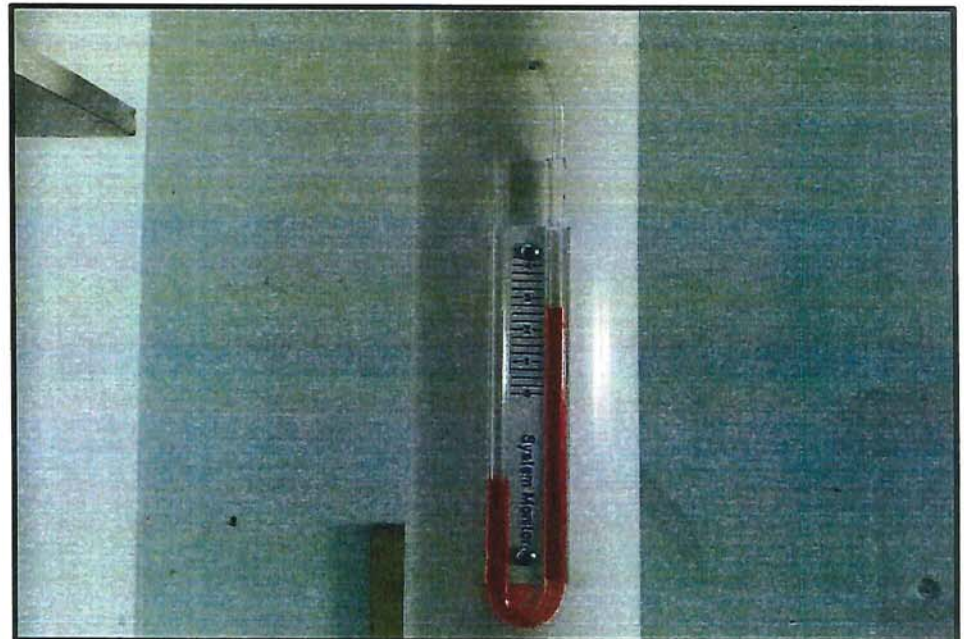
Photo 4 – This photograph shows a close up of the manometer showing that the system is operational.

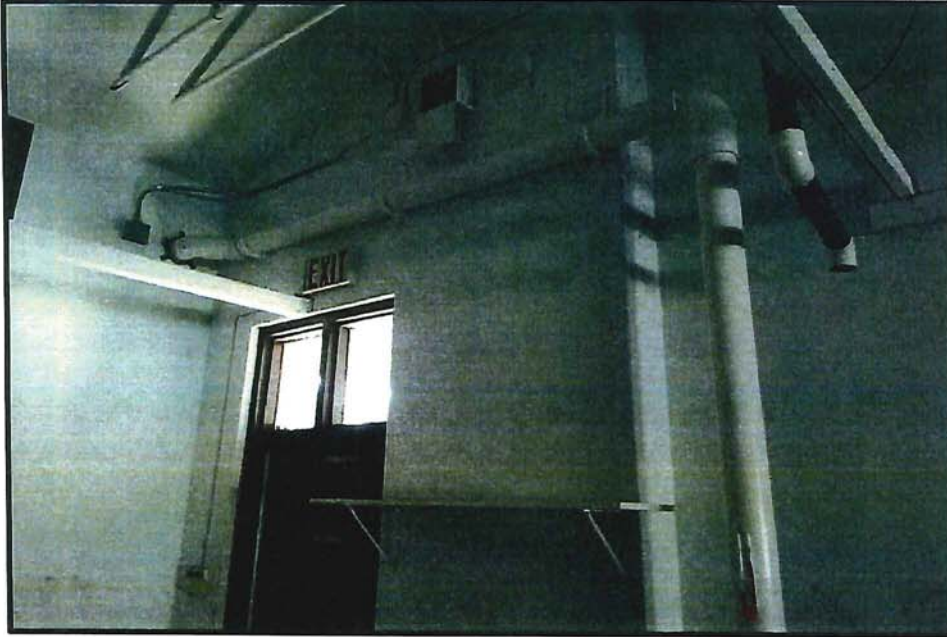
Photo 5 – This photograph shows the upper PVC piping of the VMS and the exit point through the wall. This photograph also shows that the exterior fan is hardwired to the internal power source.

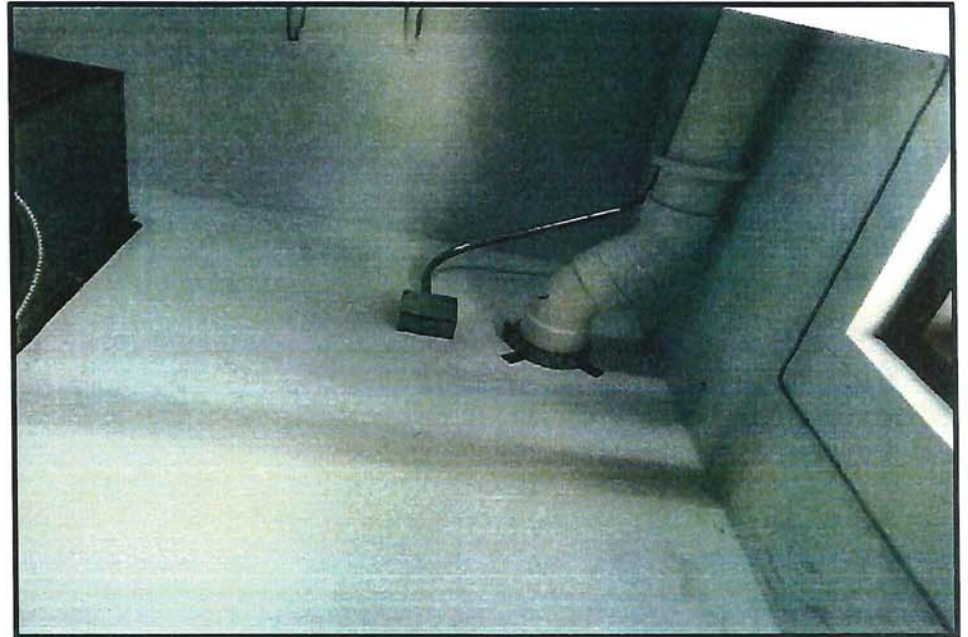
Photo 6 – This photograph shows a close up of the exit point and the interior electrical junction box.

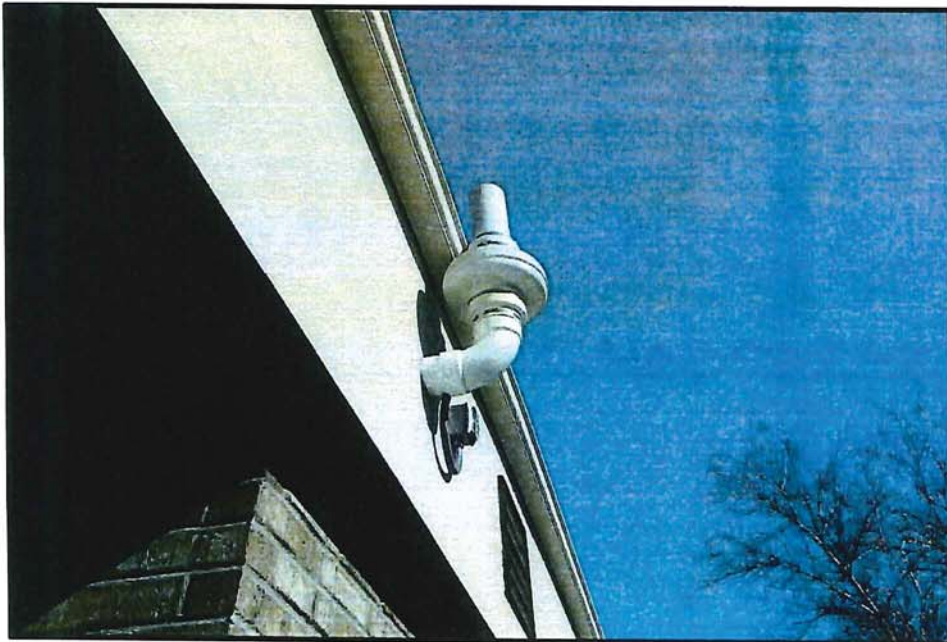
Photo 7 – This photograph looks northeast and up at the exterior fan

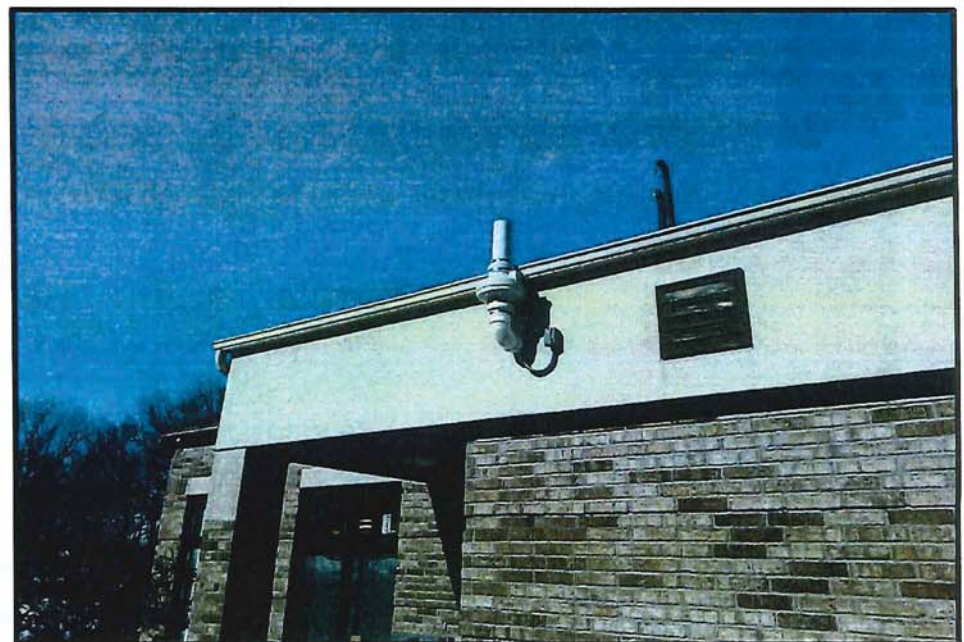
Photo 8 – This photograph looks at the same fan shown in Photo 7 and how the exhaust point terminates above the roof line.
