OFF-SITE INVESTIGATION AND REMEDIAL ACTION OPTIONS REPORT

Former Sunbrite Cleaners
1010 Milwaukee Avenue
South Milwaukee, Wisconsin
BRRTS #02-41-552211 FID #241299630

October 31, 2018
File No. 20.0152070.30

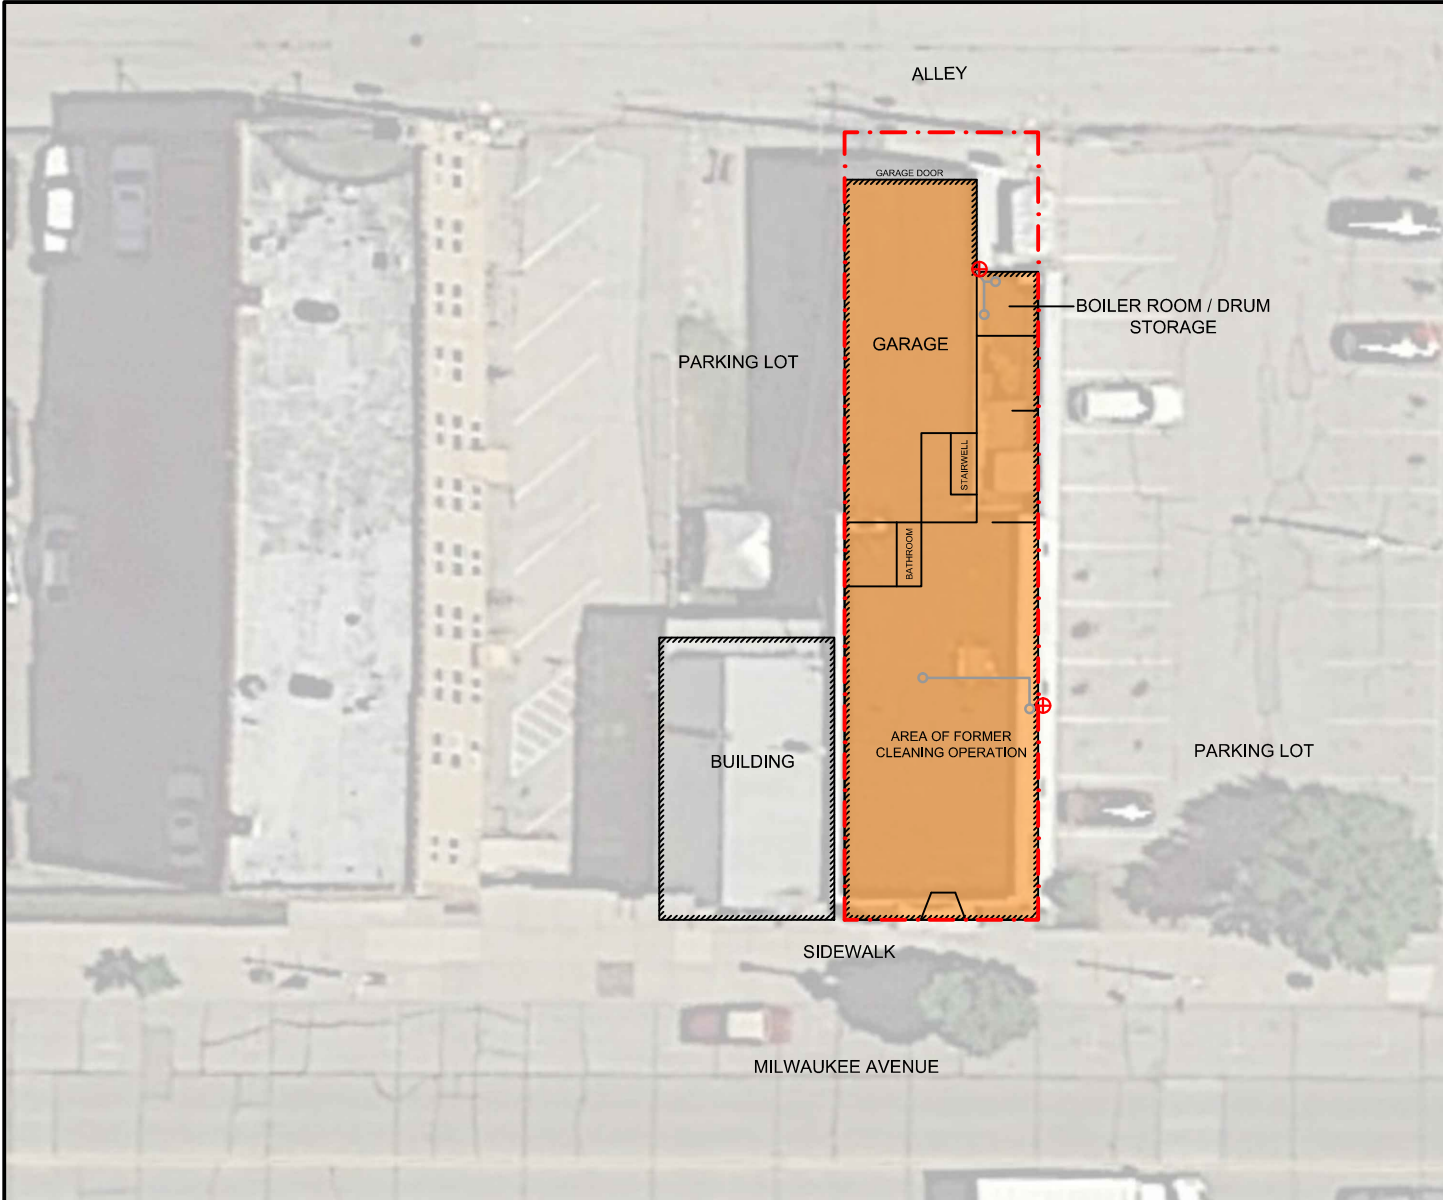
In September 2015, GZA conducted an assessment and evaluation of the existing sub-slab vapor mitigation system. The assessment of the system included an evaluation of fan operation; observation of the system for extraction point and piping leaks; exhaust stack damage or obstructions; a pressure field extension test; and measuring system vacuum pressures. The system consists of two extraction areas (each with two suction points) near GP-2 and GP-5 and two exhaust blowers. Manometers near GP-2 and GP-5 indicated the system was operating correctly with 1.7 and 1.8 inches of water column vacuum, respectively. The two exhaust stacks are above the roofline and are in good condition. The pressure field extension test showed a zone of influence at least 10 feet from the two extraction areas with values ranging from -0.001 inches of water column to -0.033 inches of water column. The results of the post-mitigation indoor/outdoor air sampling performed on September 11, 2015, confirmed that cVOC concentrations are below the respective indoor air VALs within the Site building, and the vapor mitigation system appears to be functioning properly. The sub-slab mitigation system is depicted on Figure 3.

Based on the results of the subsurface sampling conducted to date and remedial options evaluation, additional active remediation or monitoring activities does not appear necessary. Therefore, in accordance with chapters NR 726 and 746, Wisconsin Administrative Code, GZA requests WDNR grant concurrence that sufficient work has been conducted for GZA to prepare a Case Closure request utilizing natural attenuation with a GIS Registry that includes a cover/barrier/engineered cover and an on-Site vapor mitigation system. The proposed cap/barrier maintenance area and GIS registry location recommended for the Site is depicted on Figure 3.

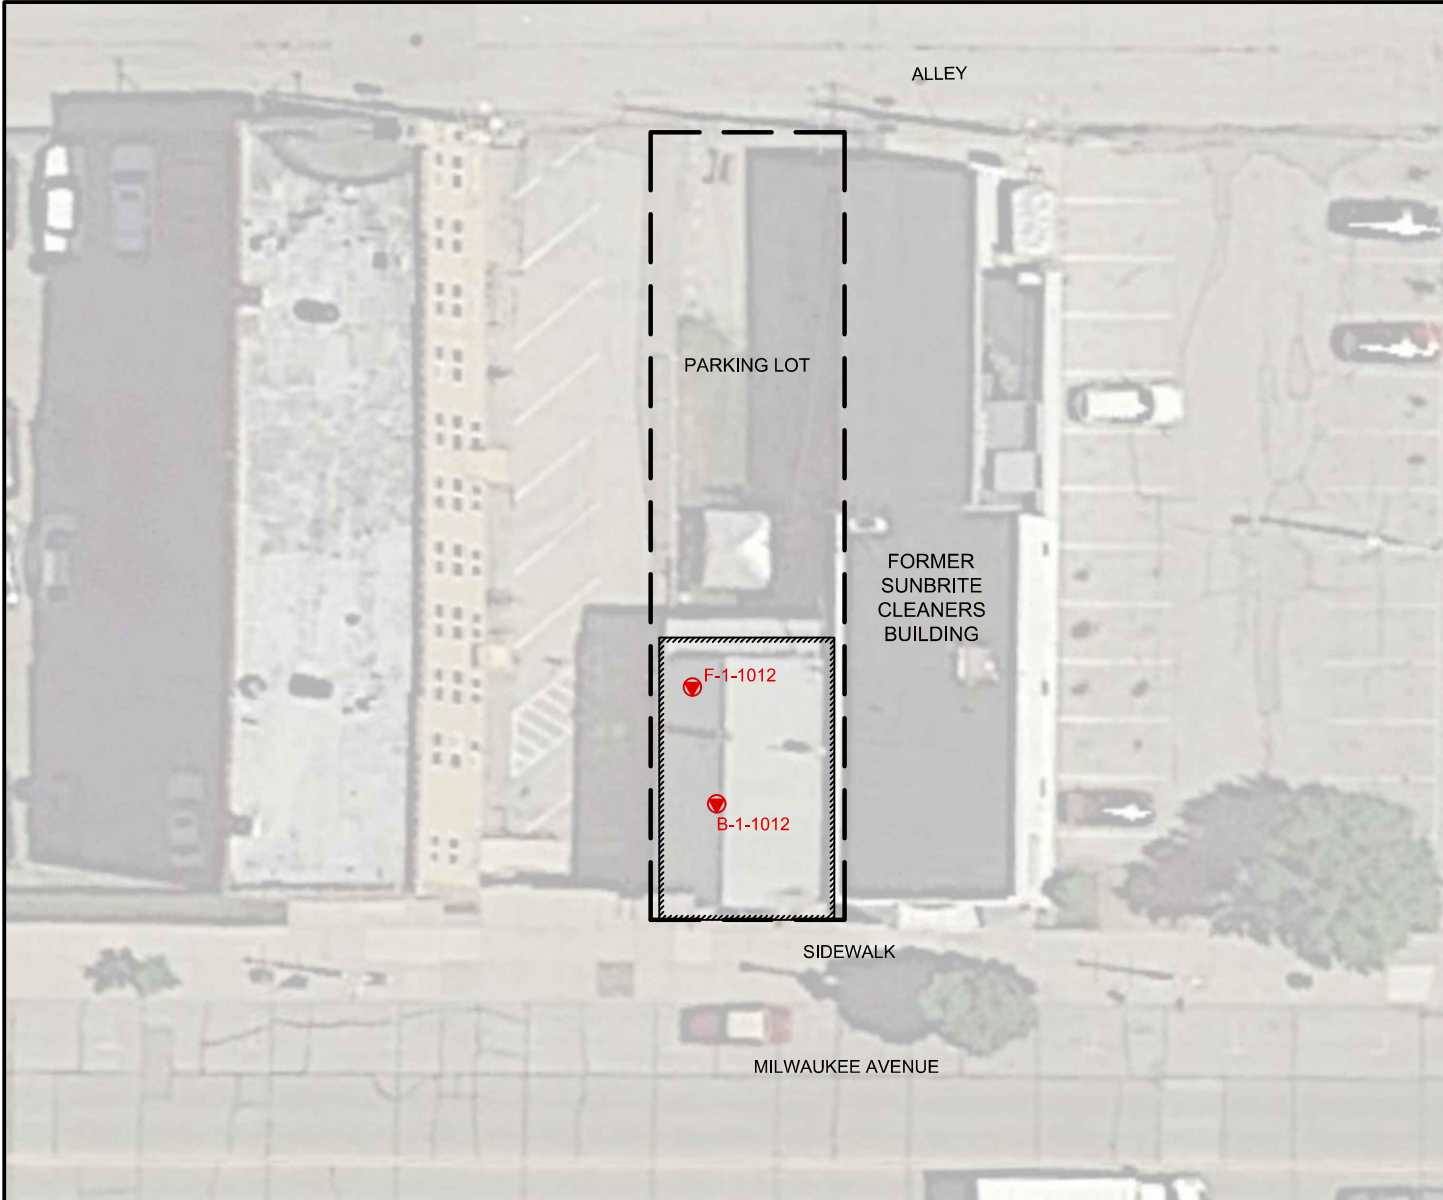
Table 4 presents a summary of the indoor air sampling results. Figure 8 shows the approximate locations for the placement of the sample containers. Analytical results for the basement (B-1-1012) and first floor (F-1-1012) indoor air samples of the adjacent property west of the Site revealed that no contaminants of concern were detected above the respective reporting limits or WDNR screening levels. Based on the results, there is no evidence of vapors relating to the contaminants of concern from the Site entering the adjacent property from beneath the foundation.

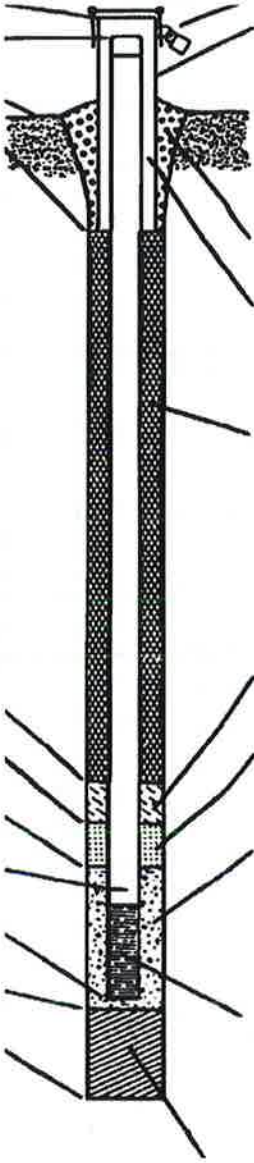
- E. Bentonite seal, top _____ ft. MSL or 0.5 ft.
- F. Fine sand, top _____ ft. MSL or 3 ft.
- G. Filter pack, top _____ ft. MSL or 4 ft.
- H. Screen joint, top _____ ft. MSL or 5 ft.
- I. Well bottom _____ ft. MSL or 15 ft.
- J. Filter pack, bottom _____ ft. MSL or 15 ft.
- K. Borehole bottom _____ ft. MSL or 15 ft.
- L. Borehole diameter 8.5 in.
- M. O.D. well casing 2.38 in.
- N. I.D. well casing 2.07 in.

- 1. Cap and lock? Yes No
- 2. Protective cover pipe:
 - a. Inside diameter: 8 in.
 - b. Length: 1.0 ft.
 - c. Material: Steel 0 4
Other _____
 - d. Additional protection? Yes No
If yes, describe: _____

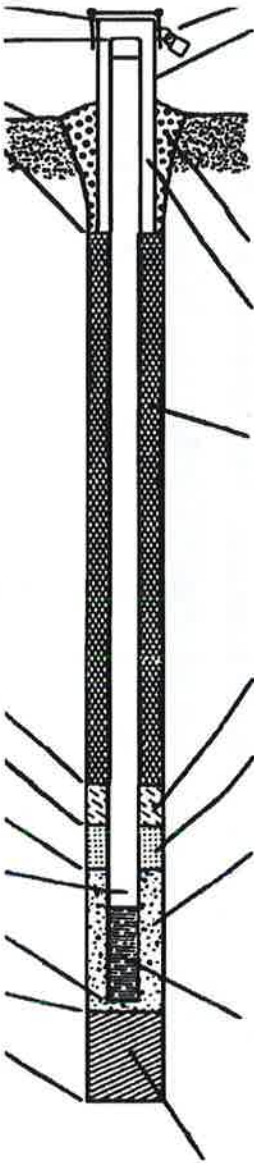
- E. Bentonite seal, top _____ ft. MSL or 0.5 ft.
 F. Fine sand, top _____ ft. MSL or 16 ft.
 G. Filter pack, top _____ ft. MSL or 18 ft.
 H. Screen joint, top _____ ft. MSL or 20 ft.
 I. Well bottom _____ ft. MSL or 25 ft.
 J. Filter pack, bottom _____ ft. MSL or 25 ft.
 K. Borehole bottom _____ ft. MSL or 25 ft.
 L. Borehole diameter 8.5 in.
 M. O.D. well casing 2.38 in.
 N. I.D. well casing 2.07 in.

1. Cap and lock? Yes No
2. Protective cover pipe:
 a. Inside diameter: 8 in.
 b. Length: 1.0 ft.
 c. Material: Steel 0 4
 Other _____
 d. Additional protection? Yes No
 If yes, describe: _____
