Re: **Supplemental Vapor Intrusion Investigation and System Decommissioning Work Plan Technical Review**  
Smoke-Out Cleaners  
1631 Brookfield Avenue, Unit D-4  
Howard, Wisconsin  
BRRTS #02-05-552214  
Terracon Project No. 58187103

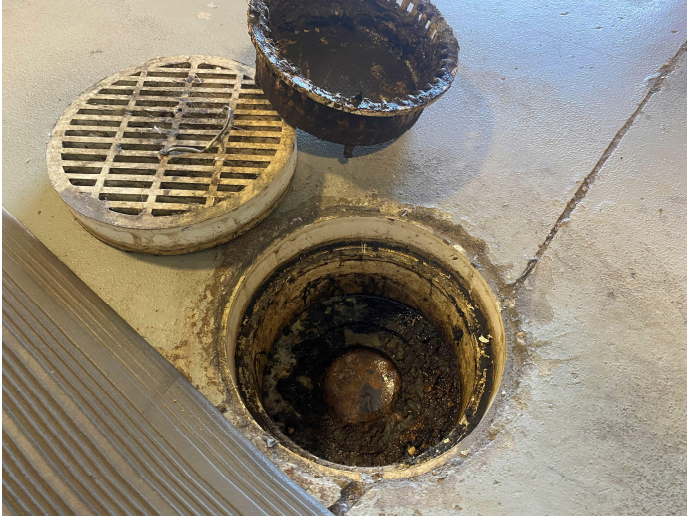
**Photo #1** South floor drain plugged with sediment.

Prior to sampling Terracon proposed inspecting the sanitary sewer cleanout in the Smoke-Out boiler room and the south floor drain to determine conditions, construction, and how best to sample. Because WDNR requested collecting groundwater samples from the piezometers prior to writing this work plan, Terracon mobilized to the site on August 4, 2022, to inspect the sanitary sewer cleanout and floor drain in conjunction with the piezometer sampling.

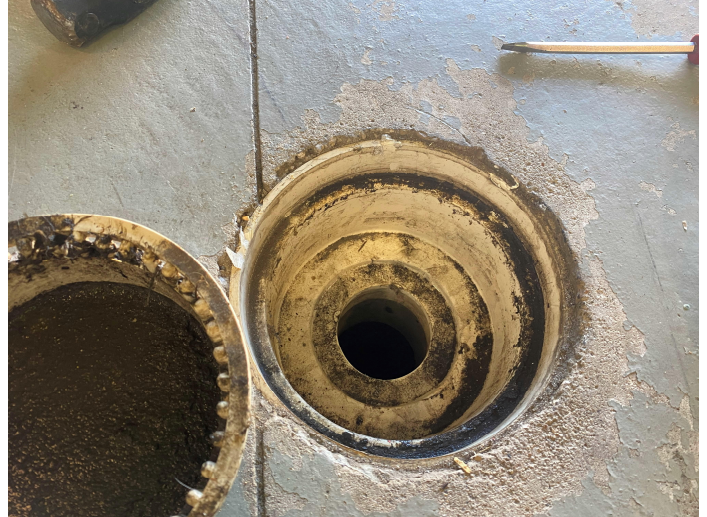
**Photo #2** North floor drain.

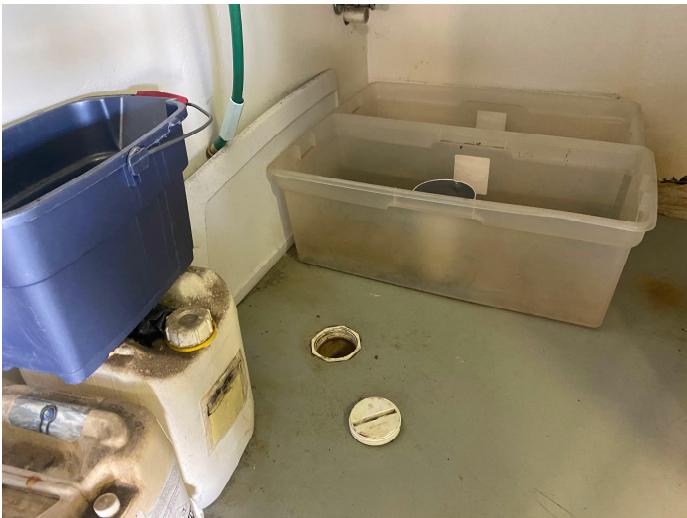
**Photo #3** Approximate 4-inch diameter sanitary cleanout in the boiler room in the north part of Smoke-Out Cleaners.

At the boiler room sanitary lateral cleanout location, the cleanout cap will be removed and replaced with a temporary cap that contains a valved port to connect sample tubing. The sample

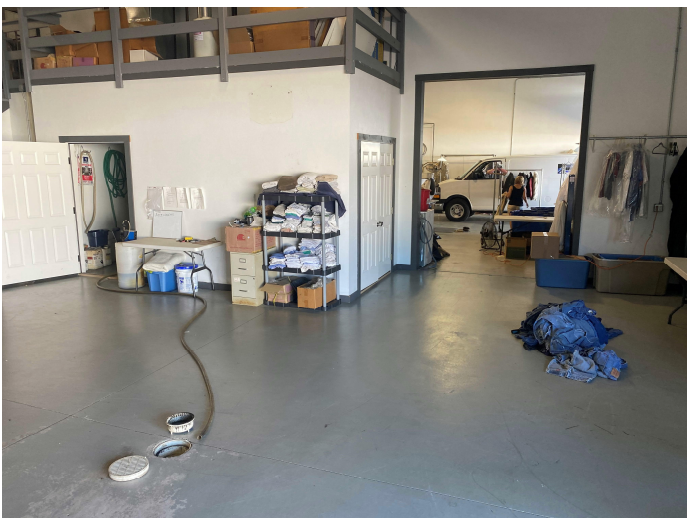
**Photo #5** View of north floor drain looking south-southeast with south floor drain (through center door) and enclosed boiler room with the sanitary cleanout in upper left.

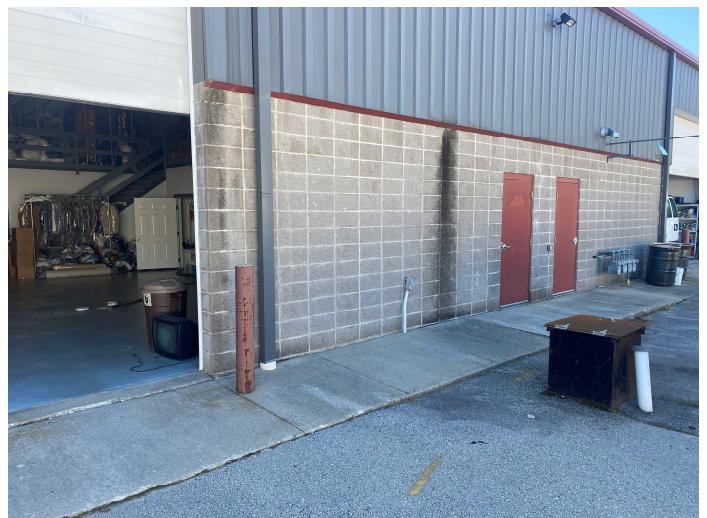
**Photo #6** View from outside the north garage door looking southeast showing the north floor drain inside and the holding tank access box outside.

4. The sanitary sewer preferential pathway should be investigated since this is a former active dry cleaner. If the septic includes a drain field, the drain field should also be investigated if found to be impacted. If the septic is a holding tank, we still need to consider vapor migration into occupied spaces from the sewer, if found to be impacted. **This would include a vapor grab sample from the sanitary clean-out.**
