Additional Site Investigation Report

Prepared For
Westwood Cleaners
(WDNR BRRTS#02-41-552537)
8731 West North Avenue
Wauwatosa, Wisconsin 53226

August 27, 2020

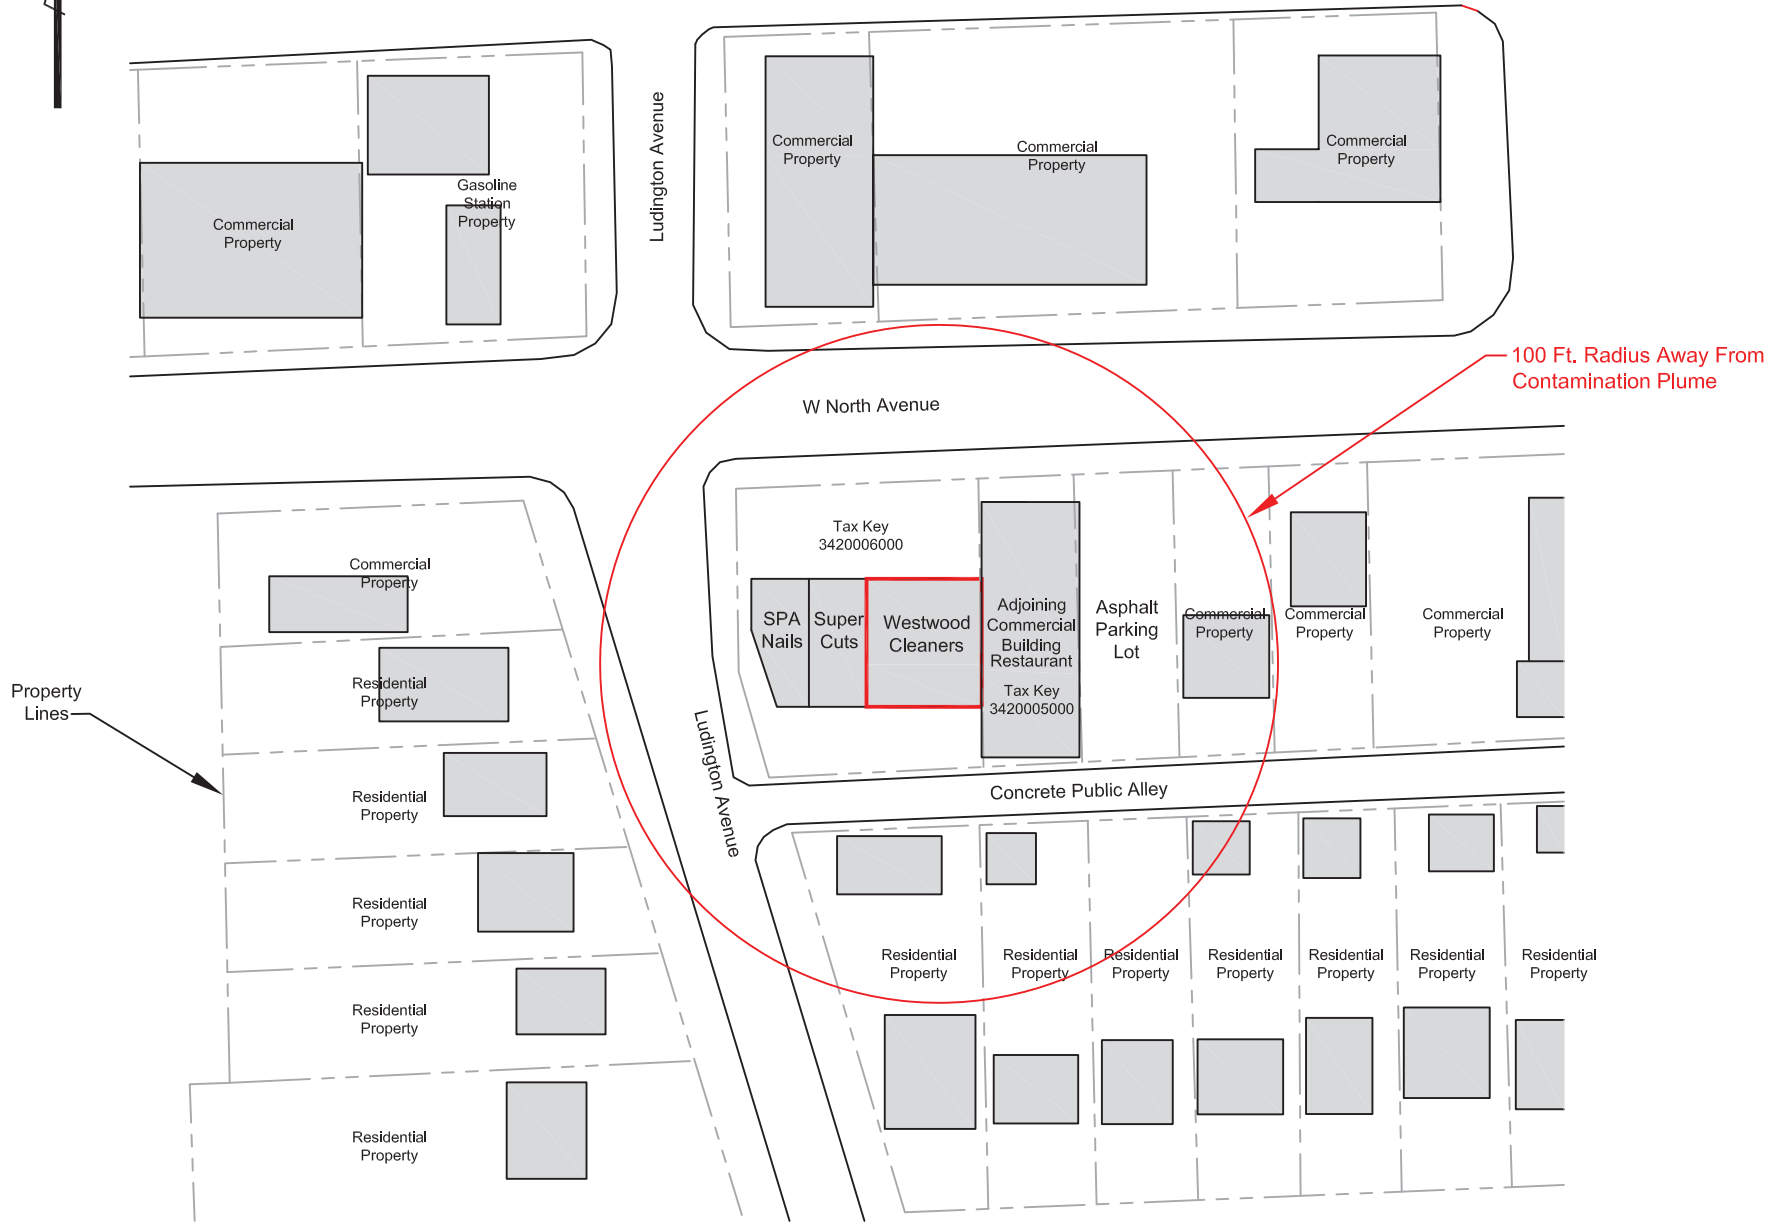
Figure 1 Site Vicinity Map

WDNR BRRTS #02-41-552537/Milwaukee County
Westwood Cleaners
8751 W. North Avenue, Wauwatosa, WI 53226

The subject property is located on the southeast corner of the intersection of West North Avenue and North Ludington Avenue in the City of Wauwatosa, WI (See Site Vicinity Map, Figure 1).

Based on existing soil VOC results, HDC proposed and collected soil vapor samples from 7 vapor ports (existing SV1 to SV5, and new SV6 and SV7, in Figure 5) in the subject property and the adjoining restaurant to the east and the hair salon to the west. HDC has provided a map which shows a 100-foot radius from the soil contamination plume (Please see Figure 1, Site Vicinity Map).

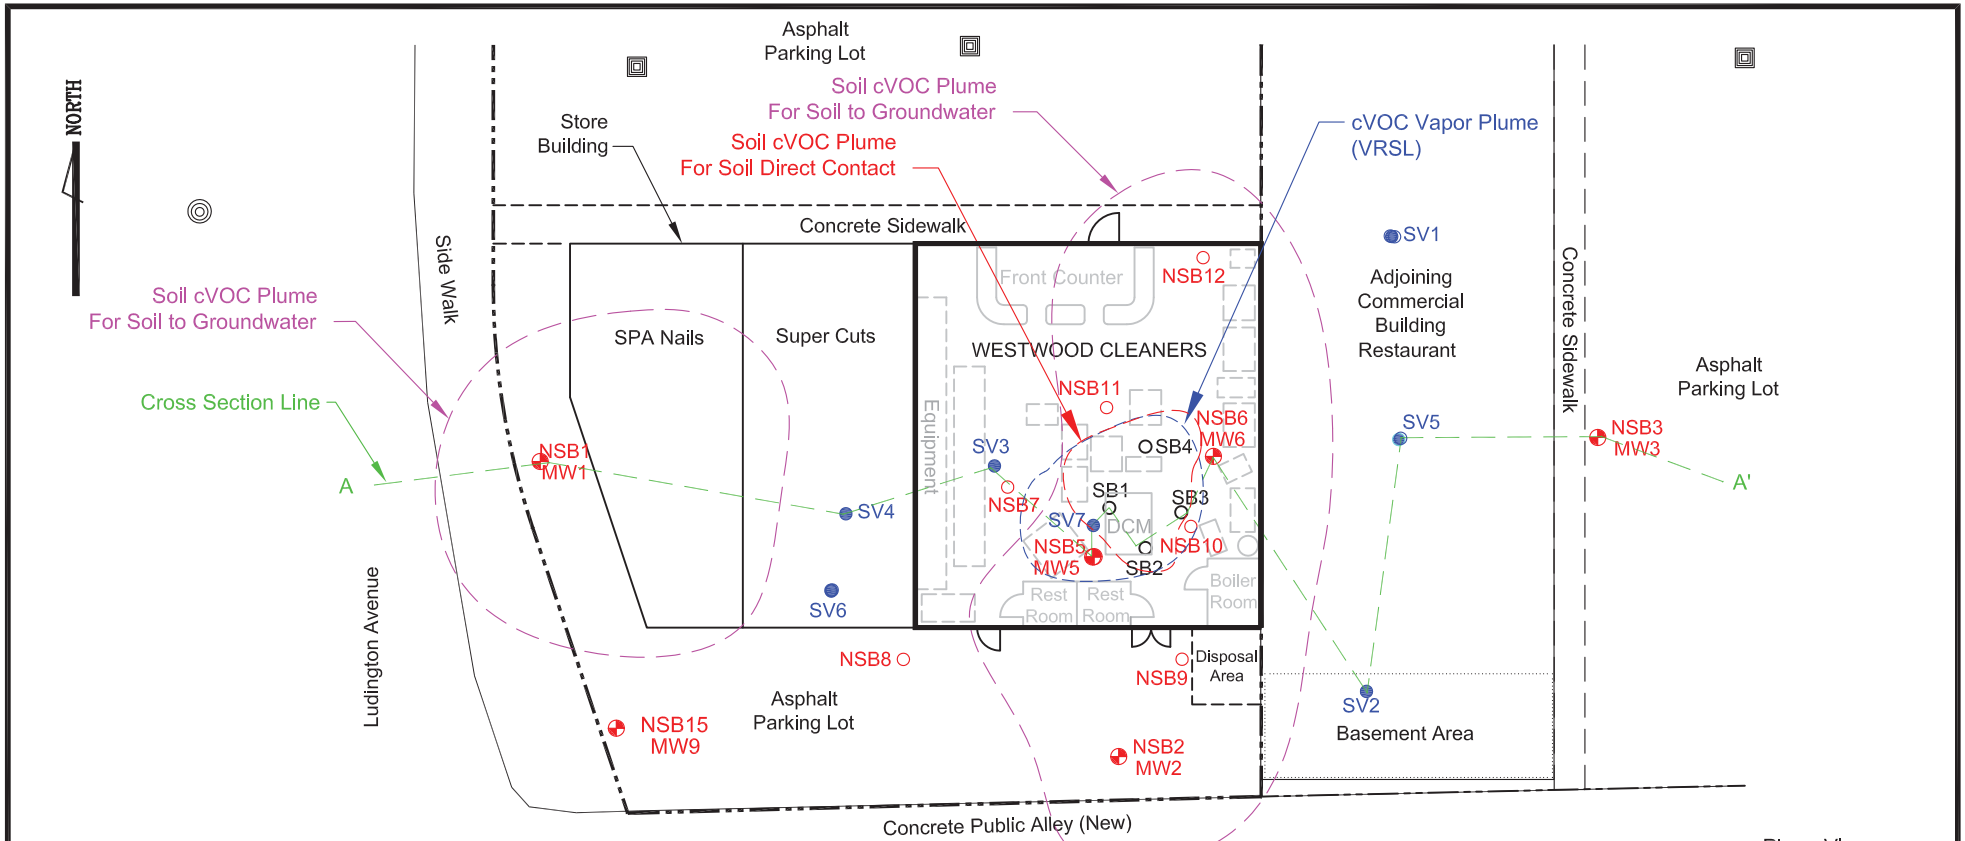
Notes: 1. All sub-slab vapor results are in ug/m³, ppb.
 2. Sub-slab Vapor Risk Screen Levels: 6,000 for PCE and 290 for TCE

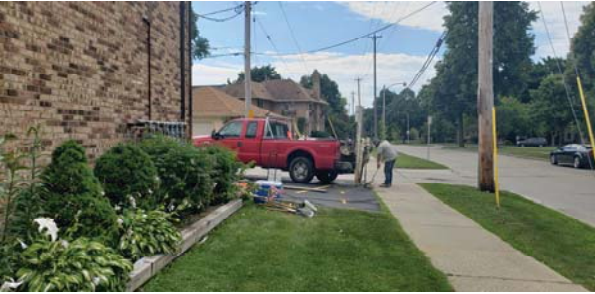
Soil Boring and Monitoring Well Installation

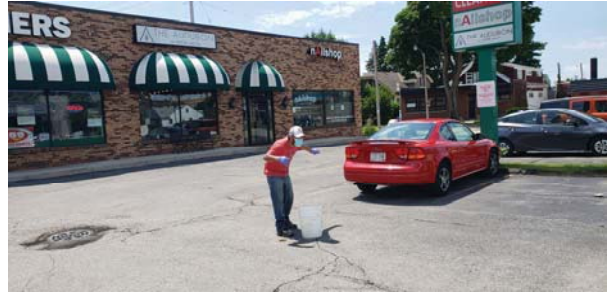
Well Development/Purging

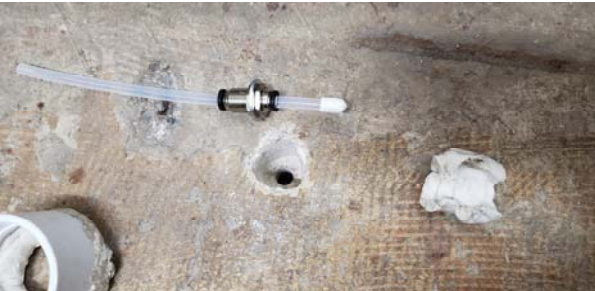
Installation of Soil Vapor Sampling Port on Concrete Floor

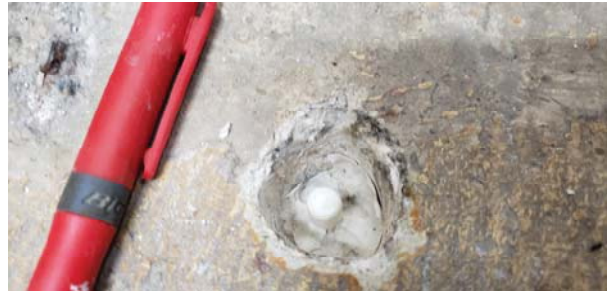
Finished New Soil Vapor Sampling Port

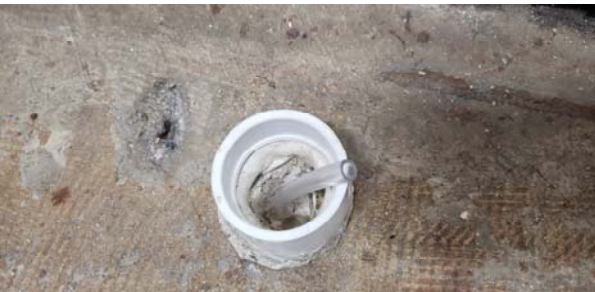
Water Dam Test for Vapor Port Leakage Check

To ensure there is no air leakage from the sampling port, a water dam test will be used and described as following:

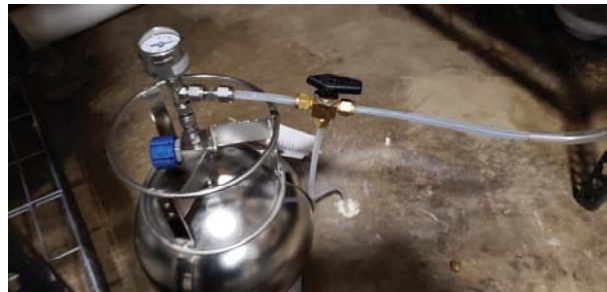
Purge and Sampling for Sub-Slab Vapor

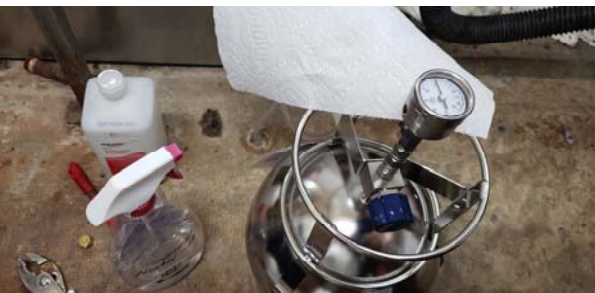
Spray Isopropyl Alcohol on the Paper Towers over the Sampling Train for Potential Leakage Check (QC)

- Turn the 3-way valve to connect the inlet for the Summa canister to allow soil vapor to be sucked into the pre-vacuumed Summa canister from the sub-slab;
- Paper towels are placed over the sampling train and Isopropyl Alcohol tracer fluid is spread over the towels covering the sampling train during the sampling to ensure no leakage into the sampling train.
- Turn on the Summa canister valve to withdraw soil vapor from the sub-slab space and observe the vacuum pressure drop on the gauge from about -30" Hg to about -5" Hg.

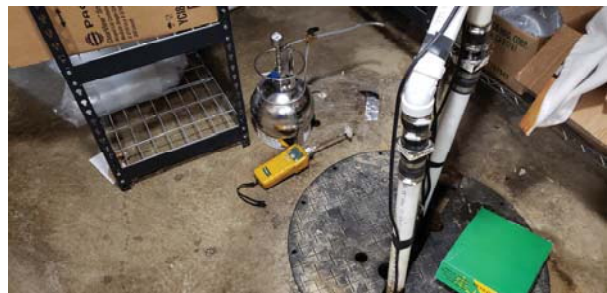
Sampling in the Basement of the Restaurant Building Next to a Sump Manhole

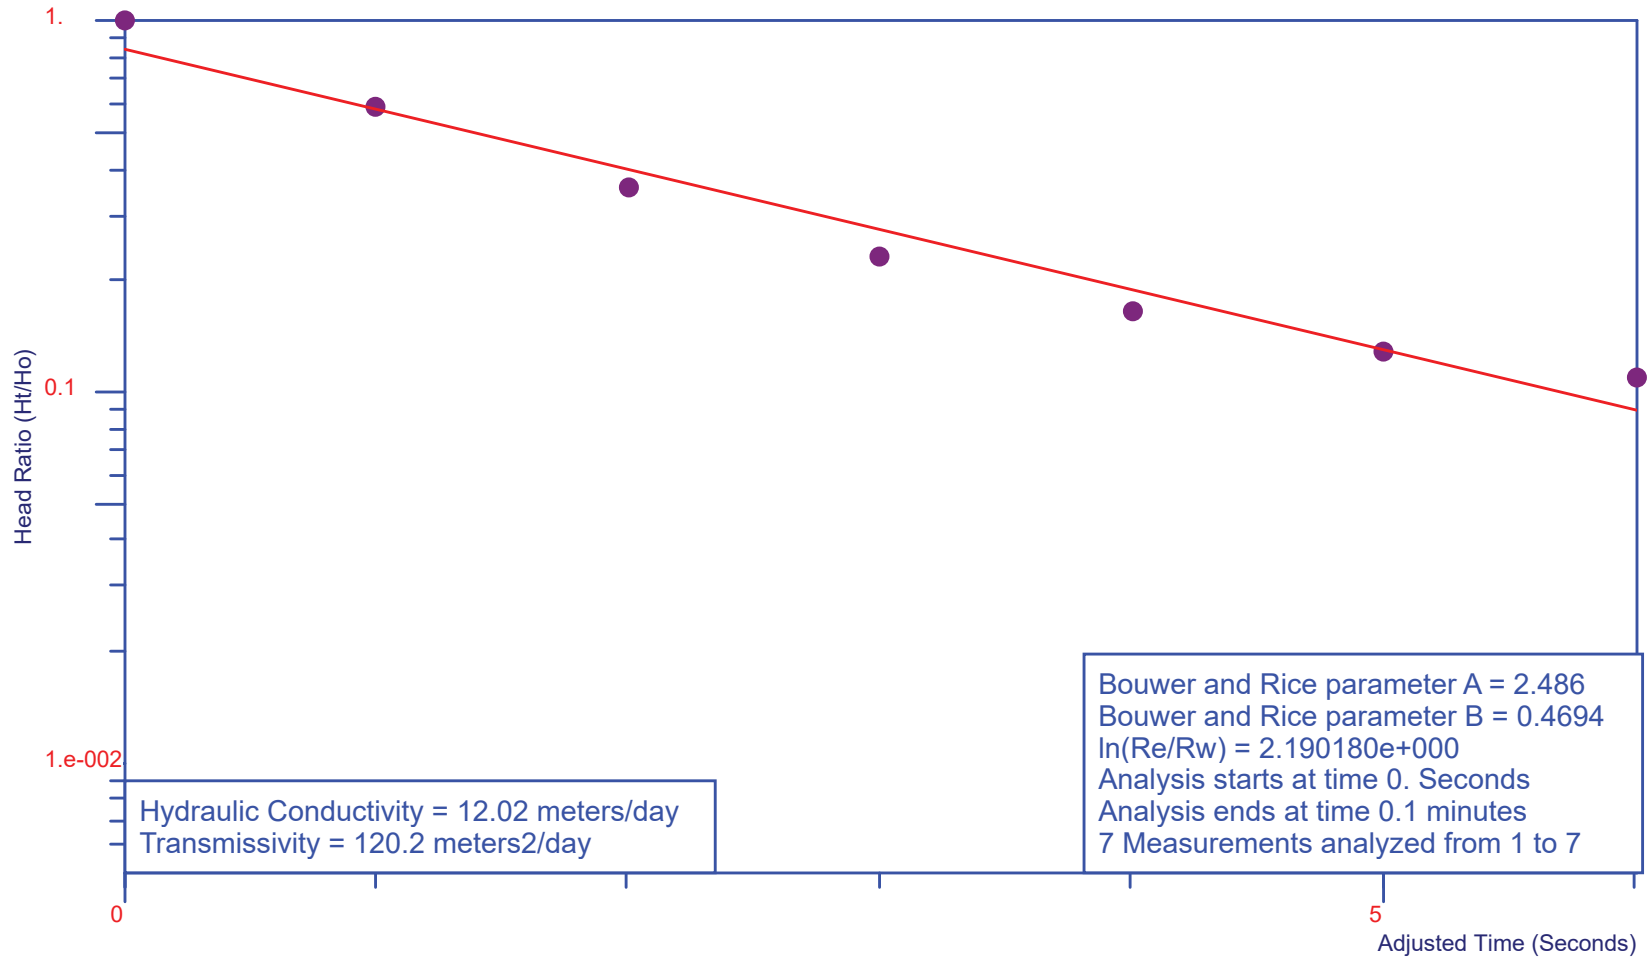
MW1

The hydraulic conductivity of 1.39×10^{-2} cm/sec may be too high and not representative to this sites condition since clay or silty clay is the predominant formation encountered in the borings at this location. The slug test results may have been distorted by the local sandy/gravelly lenses present in the soil boring (NSB1) at MW1.

Ho is 0.2694 Meters at 0. Seconds
