Technical Assistance, Environmental Liability Clarification or Post-Closure Modification Request

Property Name Comedy Club Cafe (Former)	FID No. (if known) 341170170
BRRTS No. (if known) 02-41-553001	Parcel Identification Number 3600045100
Street Address 615 E. Brady Street	City Milwaukee
	State WI
	ZIP Code 53202
County Milwaukee	Municipality where the Property is located <input checked="" type="radio"/> City <input type="radio"/> Town <input type="radio"/> Village of Milwaukee
	Property is composed of: <input checked="" type="radio"/> Single tax parcel <input type="radio"/> Multiple tax parcels
	Property Size Acres 0

SECTION I – INTRODUCTION	1
SITE DESCRIPTION	1
UTILITIES	1
ADJACENT PROPERTIES	1
SECTION II – PROPOSED SITE DEVELOPMENT	5
SECTION III - SITE CHARACTERIZATION	5
SOIL CONDITIONS.....	5
GROUNDWATER OBSERVATIONS	5
SECTION IV – NATURE AND EXTENT OF TCE AND PCE IMPACTS	6
SECTION V – REMEDIAL ACTION.....	8
SOIL EXCAVATION AND OFF-SITE DISPOSAL	8
SUB-SLAB VAPOR DEPRESSURIZATION SYSTEMS	9

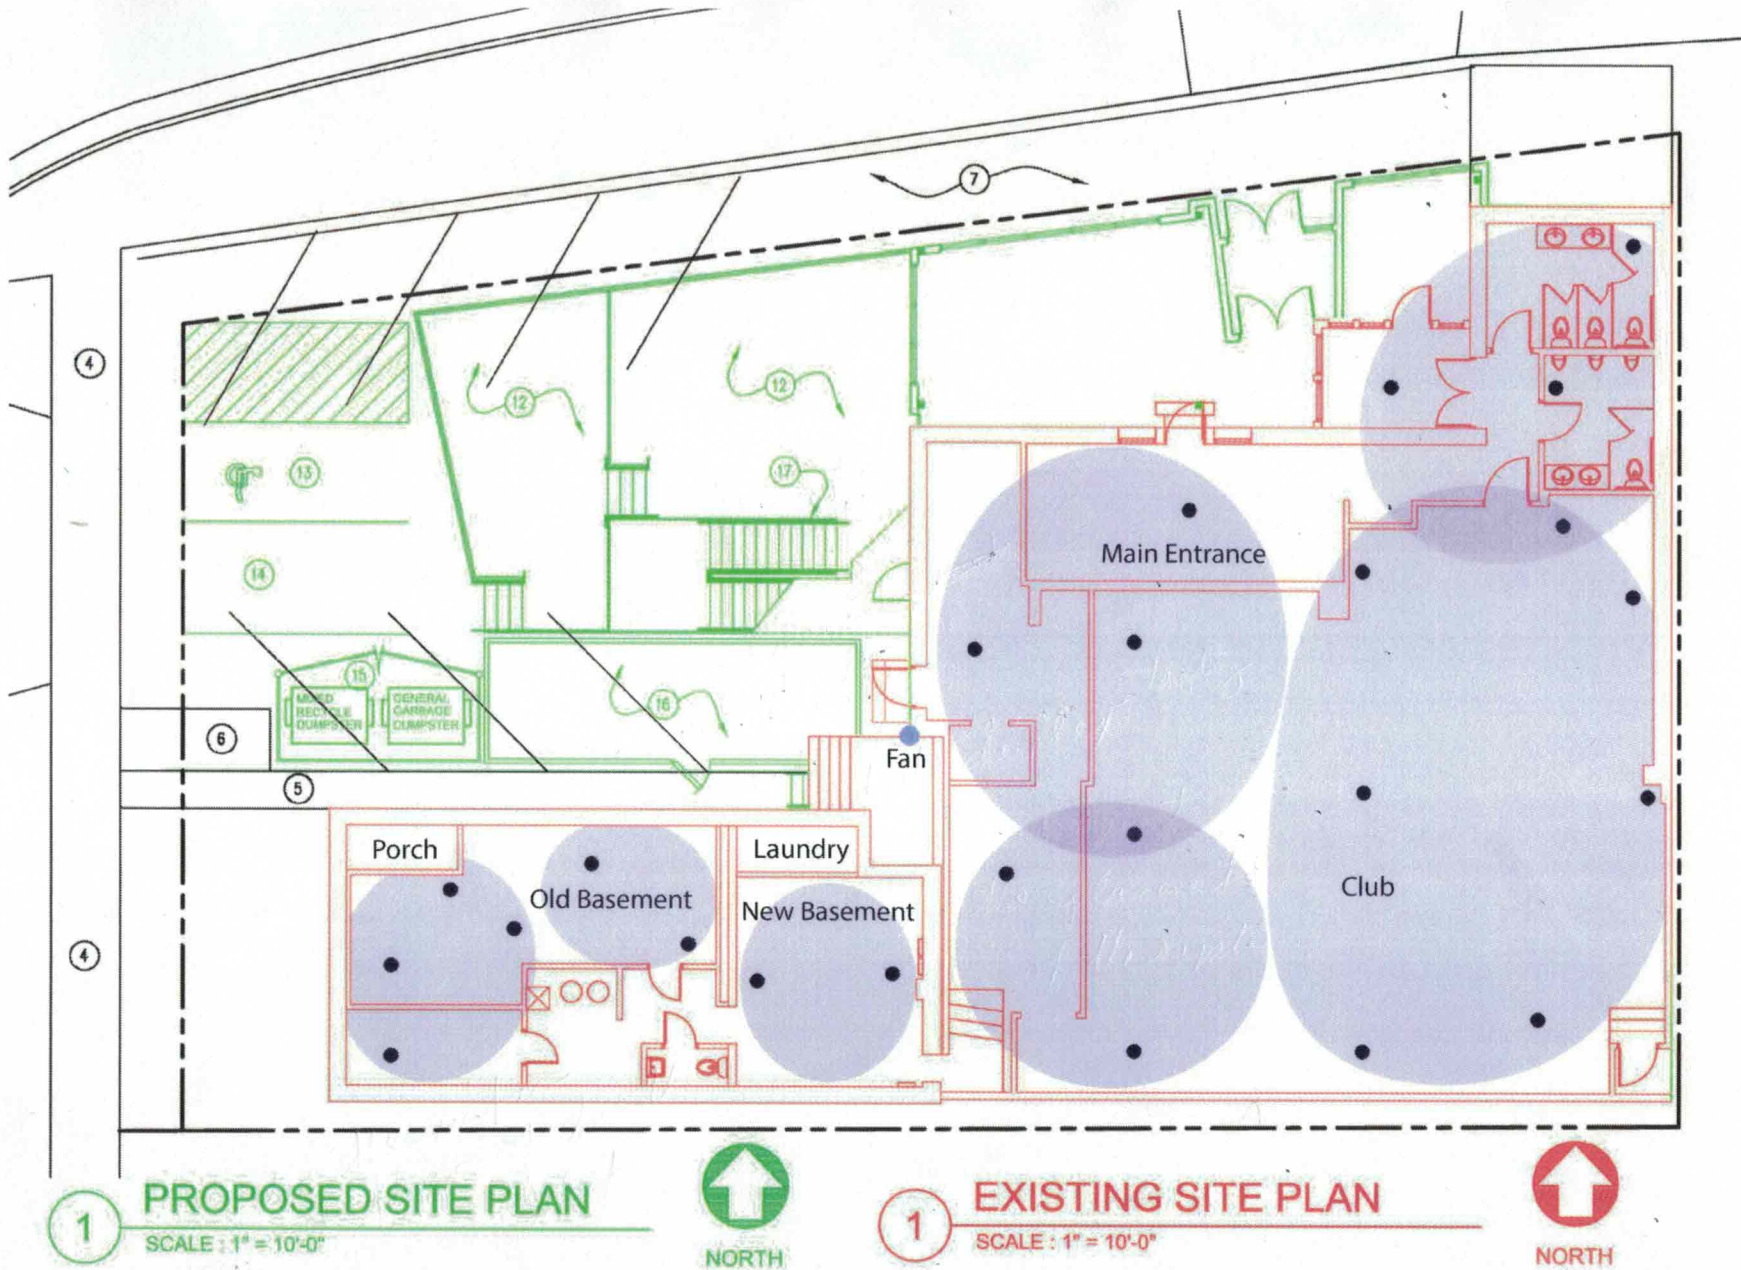
Pressure Field Extension (PFE) Testing Results

Based on the results of the Pressure Field Extension (PFE) or sub-slab vacuum testing it was determined that the entire concrete slab would be removed in the former commercial building footprint and two (2) sub-slab depressurization systems will be installed for the proposed development (See Appendix – Pressure Field Extension (PFE) Testing Results). The system for the planned commercial building will consist of the installation of four (4) inch diameter triple wall perforated Polyvinyl Chloride (PVC) schedule 40 piping around the interior foundation perimeter. The holes in the PVC piping will face downward and laterally and the piping will be surrounded by #1 stone with a minimum of two (2) inches of stone below and adjacent to the piping. Six (6) inches of #1 stone will extend across the entire building footprint to insure total air flow beneath the concrete slab.

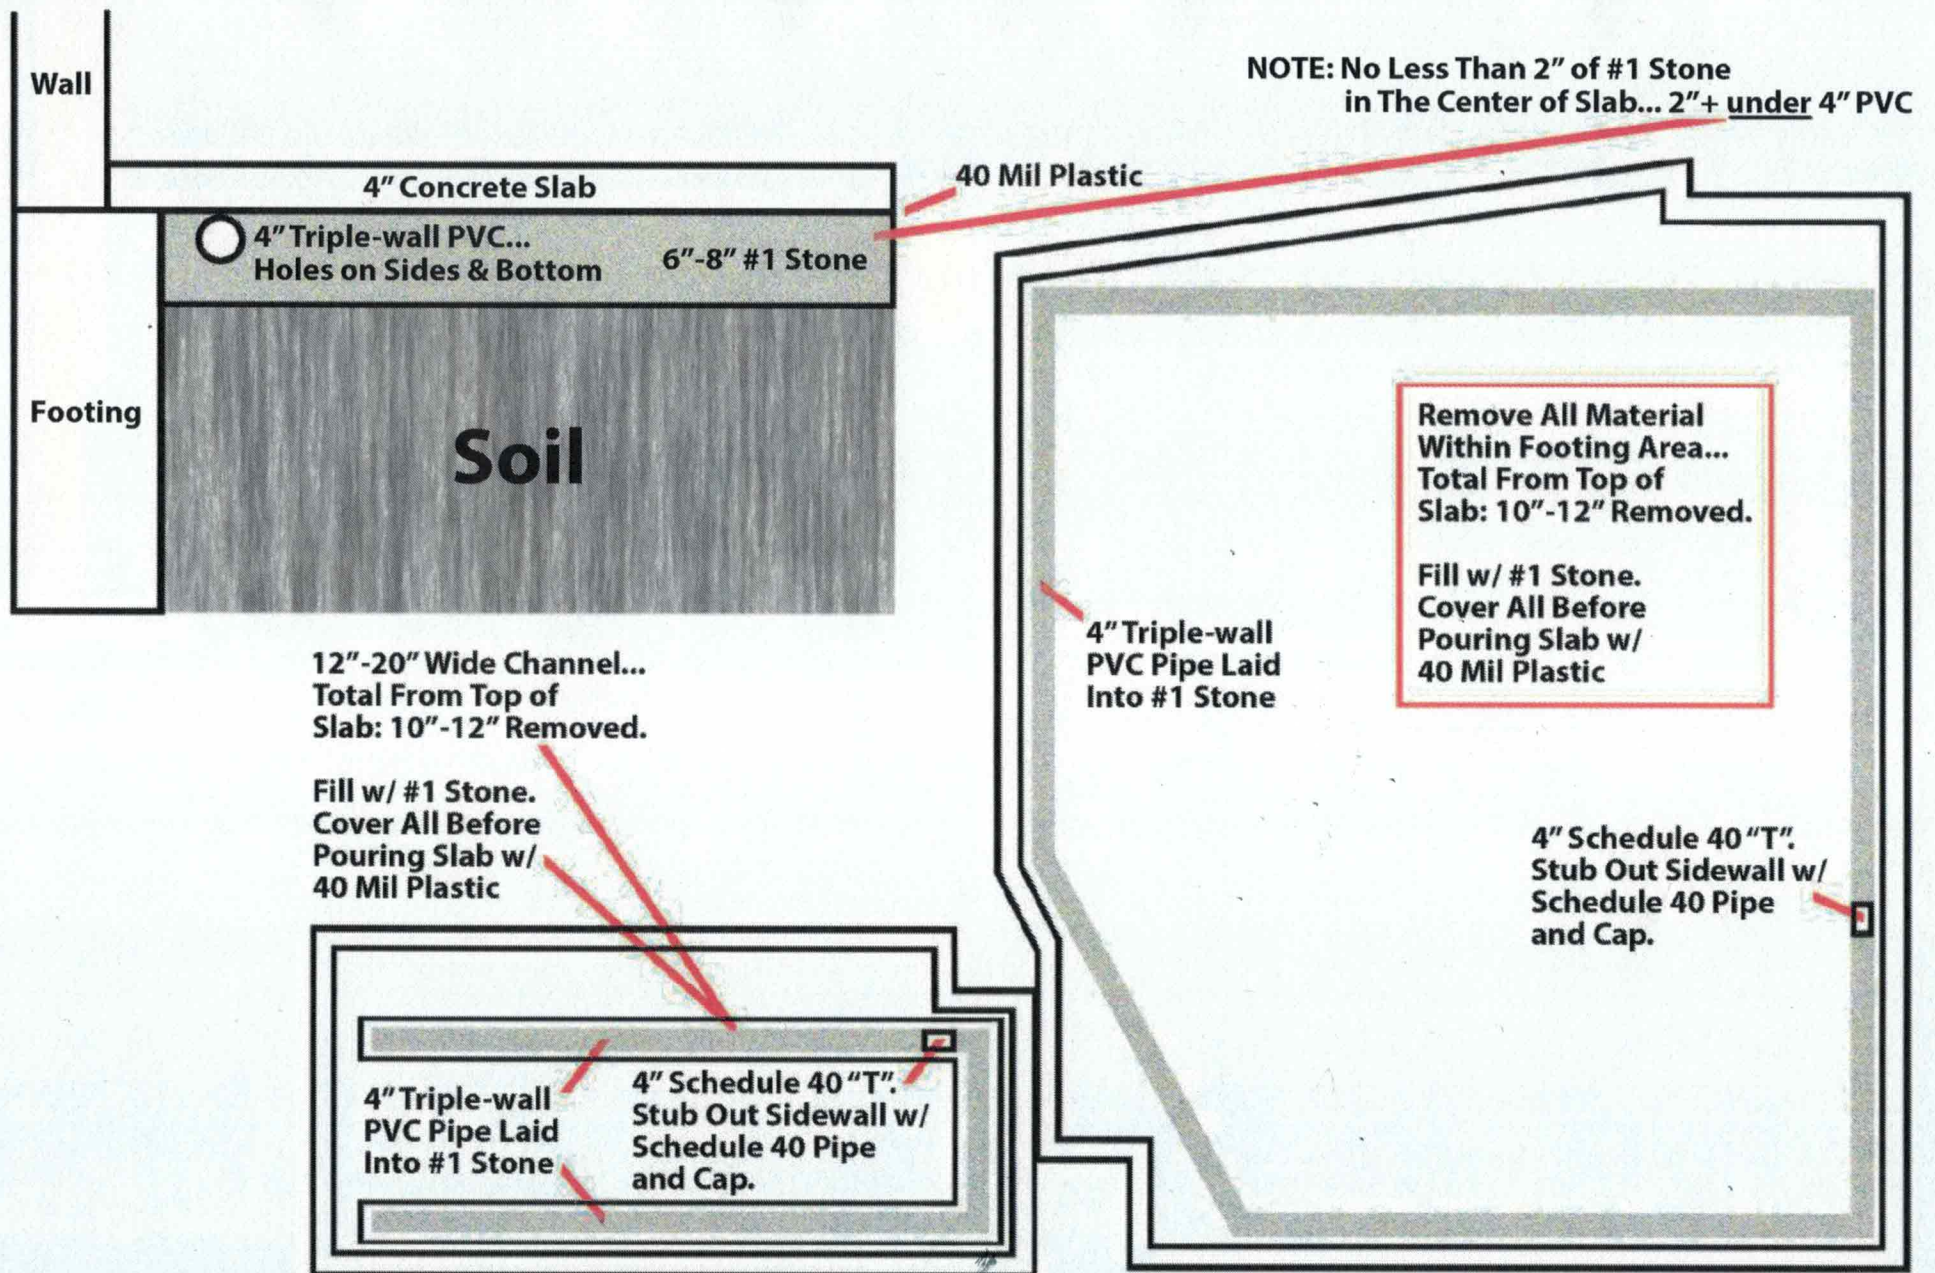
Proposed Commercial Building Sub-Slab Vapor Depressurization System

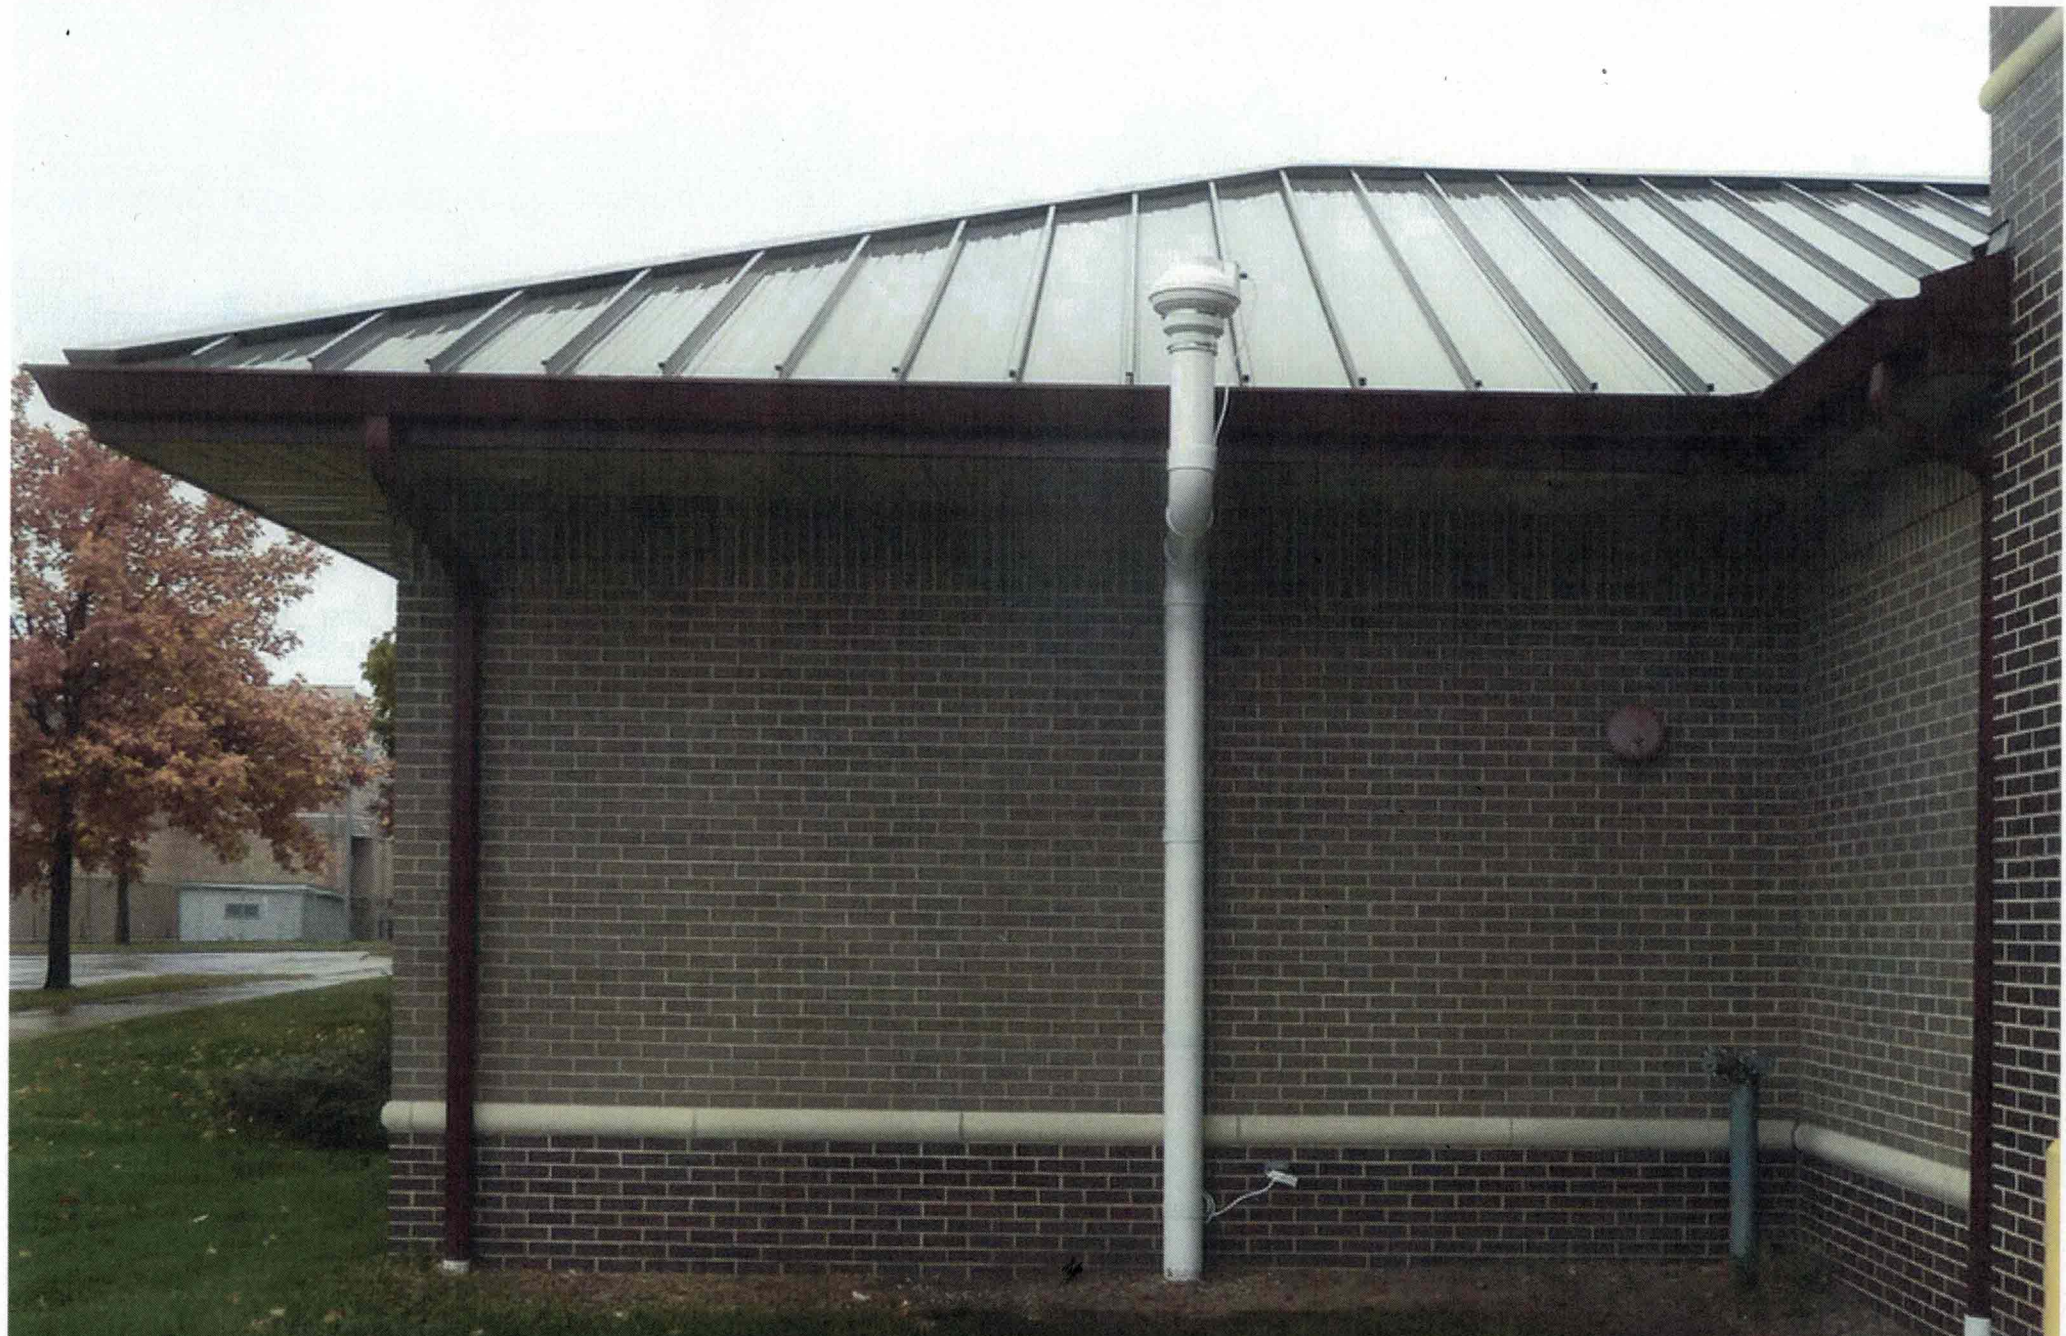
Proposed Exterior Vertical Pipe and Earth Gas Fan for the Commercial Building

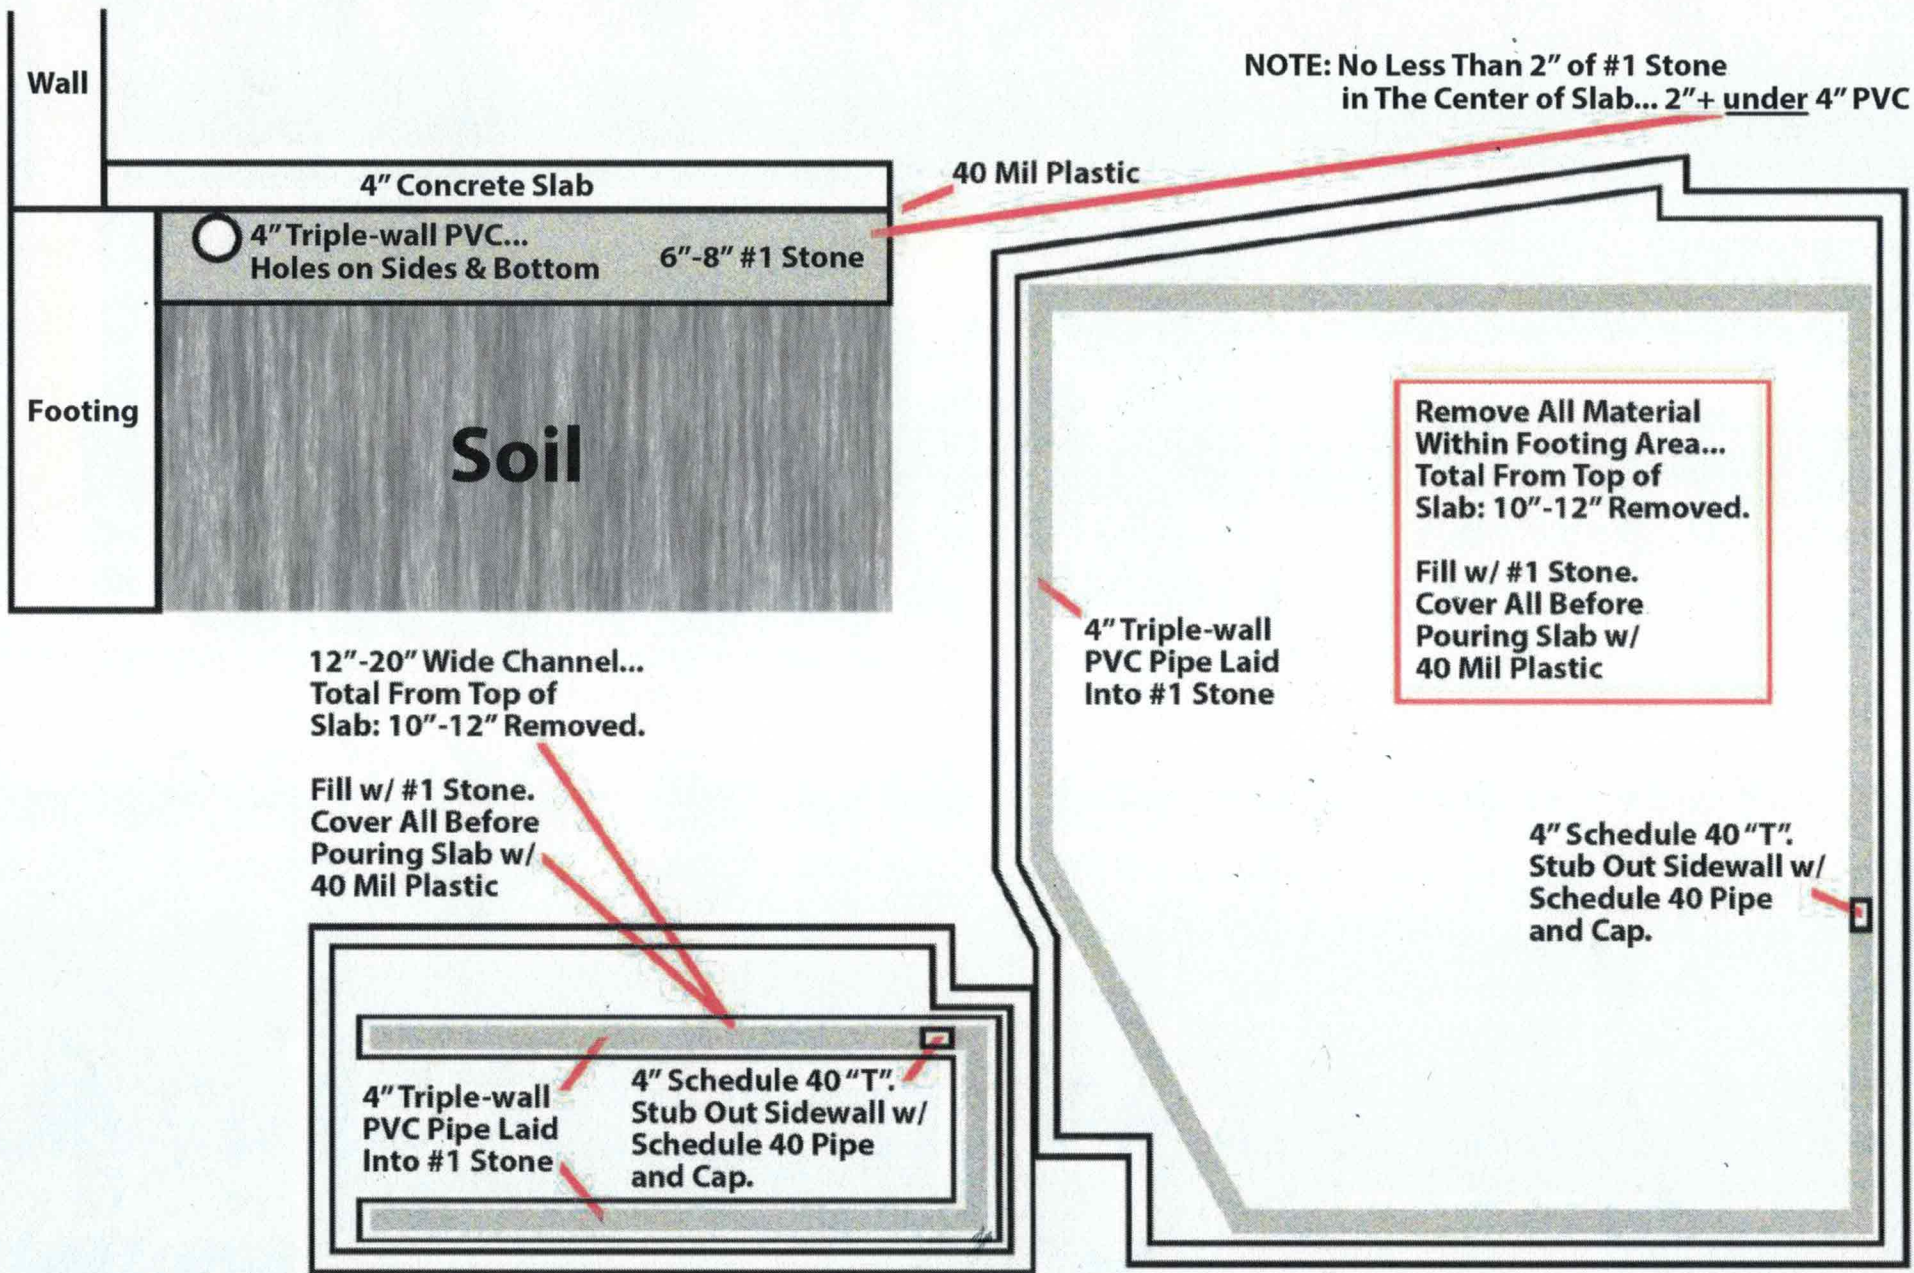
Proposed Residential Sub-Slab Vapor Depressurization System

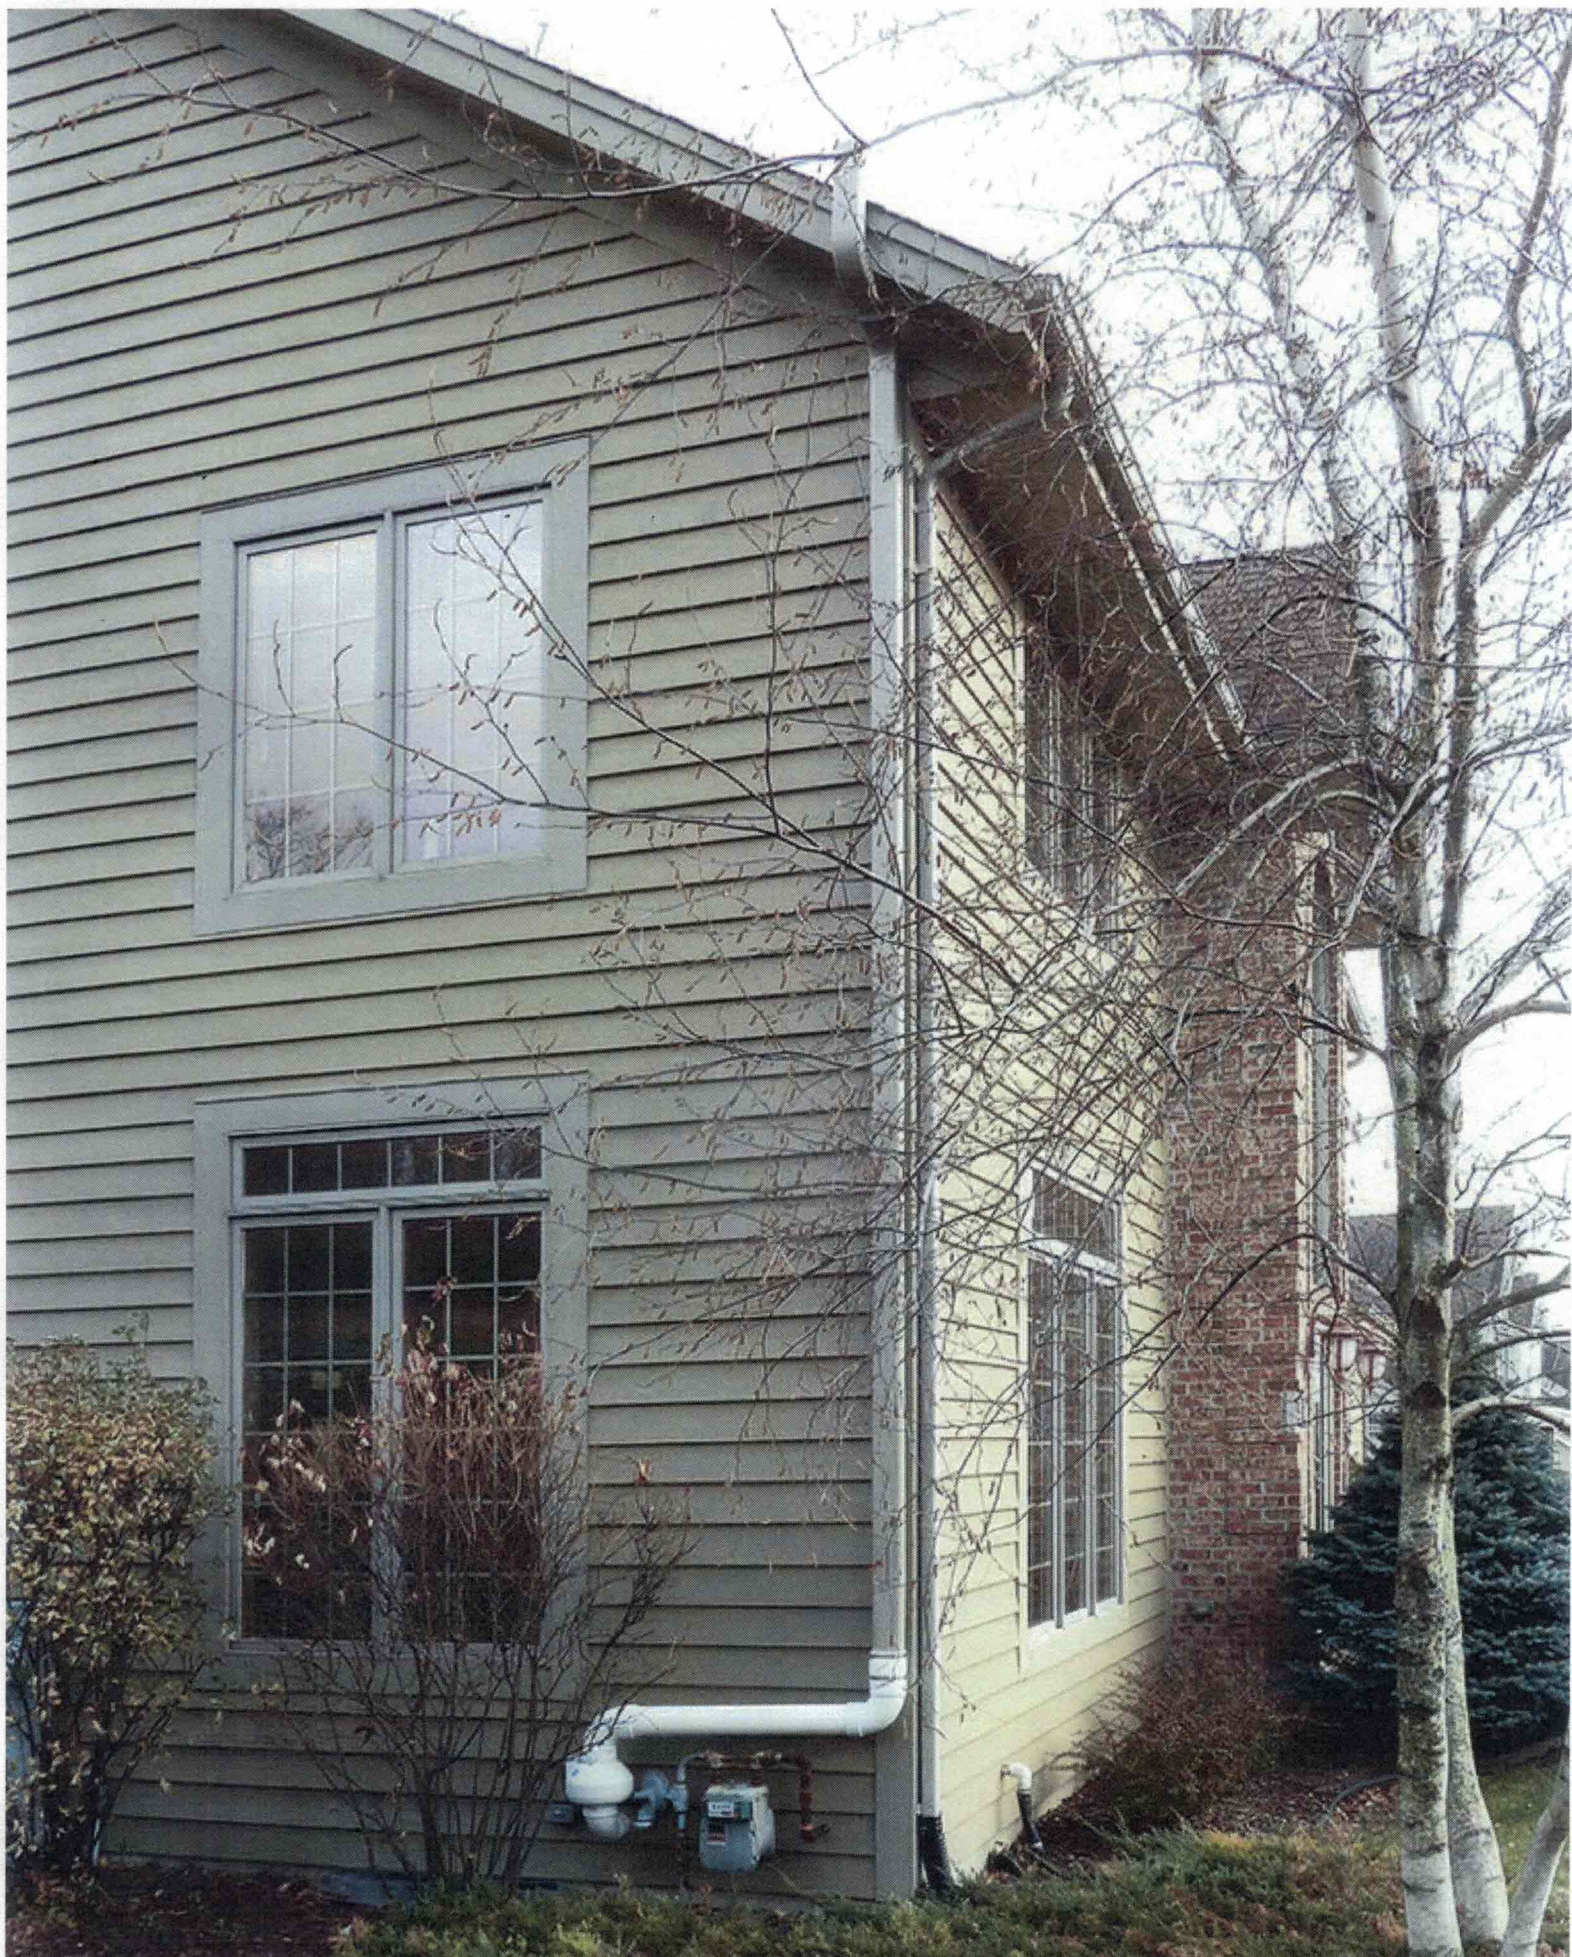
Proposed Exterior Vertical Pipe and Earth Gas Fan for the Duplex
