Phase II Site Investigation

Former Wabash Alloys Aluminum Recycling Facility
Oak Creek, Wisconsin

August 2010

Prepared For
Connell Ltd. Partnership, LLC

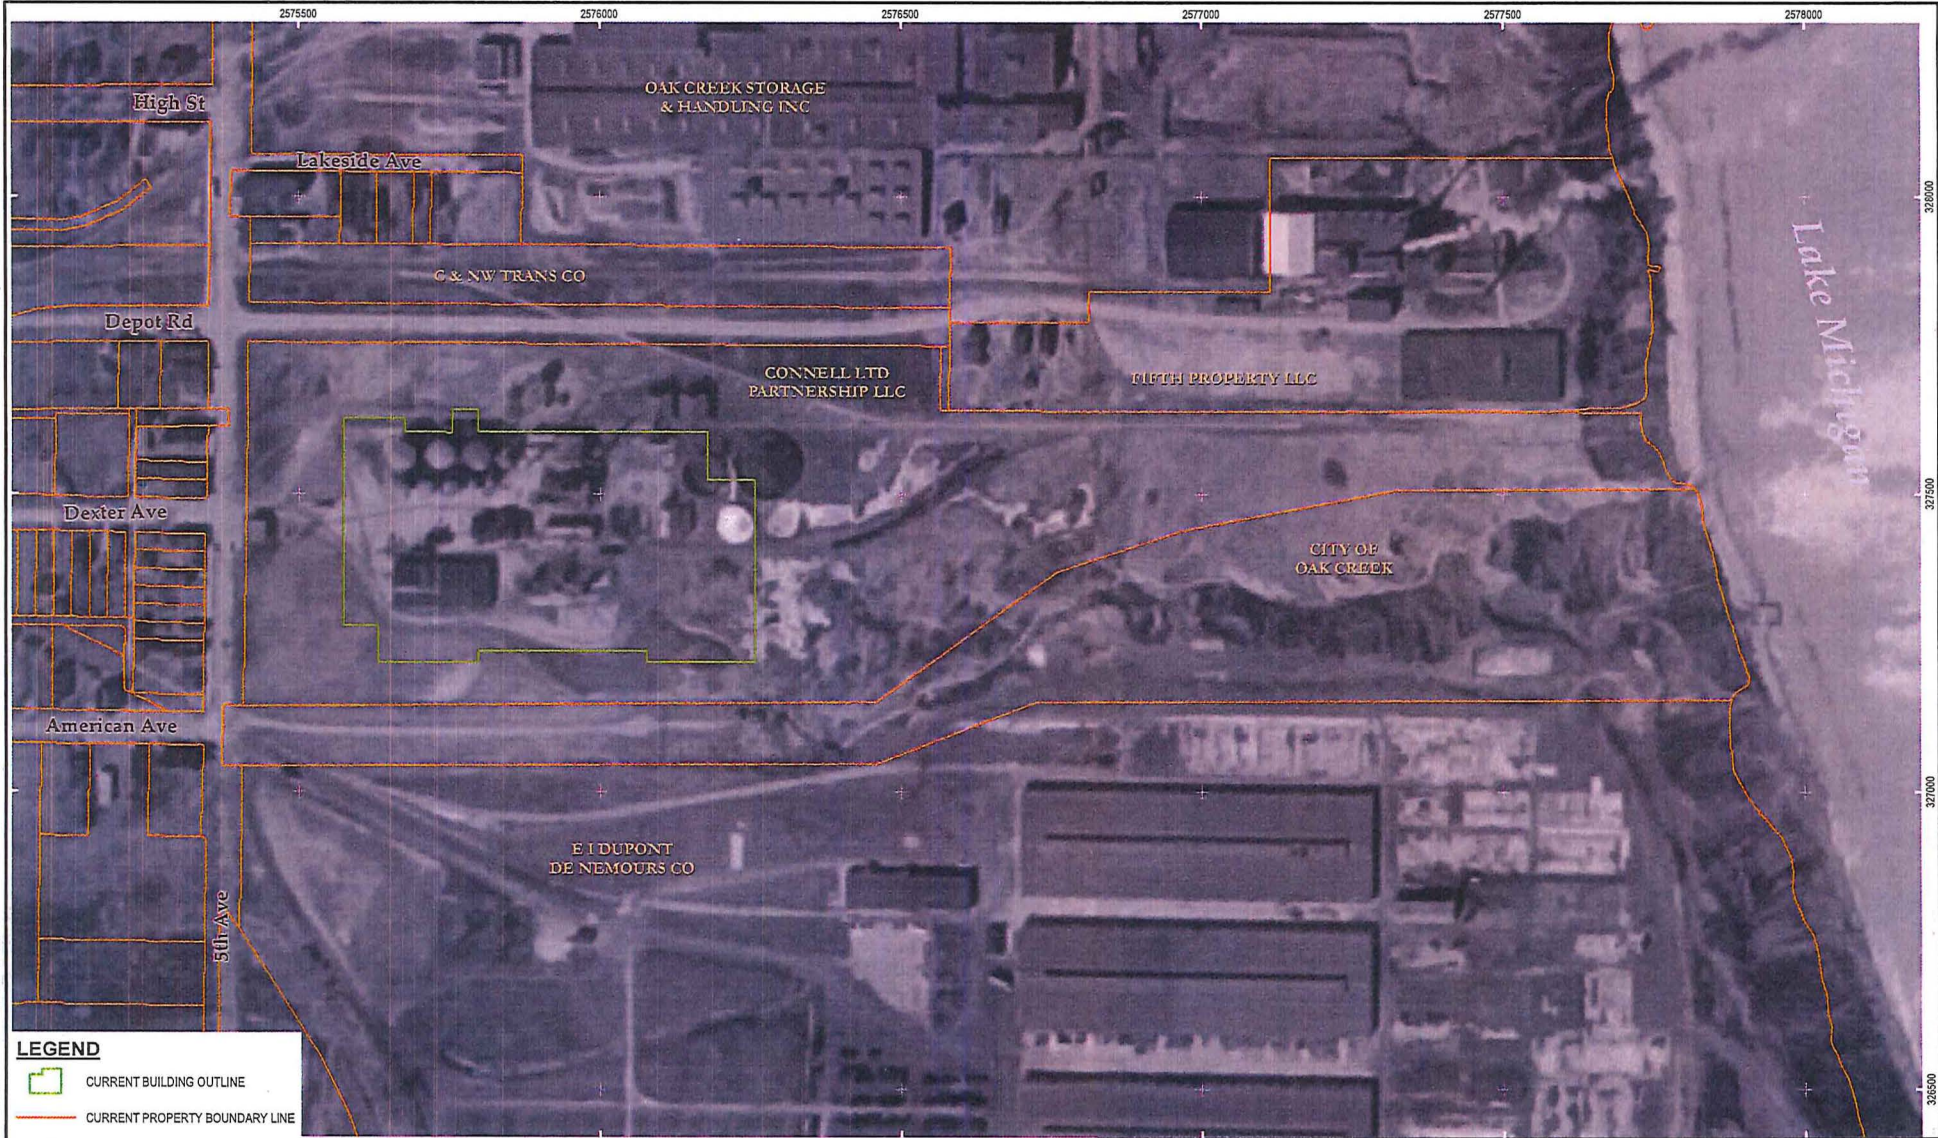
CONNELL LP		OAK CREEK, WISCONSIN	
HISTORICAL SITE LAYOUT 1955			
SCALE:	AS NOTED	PROJECT NO.:	061320-01-002
DWG. NAME:	061320-01-112.mxd	DWG. NO.:	FIGURE 1

No records of specific operations at the former wood treatment facility are available, but buildings and numerous above ground tanks and several surface ponds are visible in Figure 3. The use of the facility to manufacture creosote is consistent with the types of structures seen in this aerial photograph.
