# Robert E. Lee & Associates, Inc.

RE: **TANK-SYSTEM SITE ASSESSMENT AND DOCUMENTATION  
OF REMEDIAL ACTION**  
Marinette Marine Corporation – Building #10 Expansion (SW Diesel UST)  
1600 Ely Street, Marinette, Wisconsin  
BRRTS # 02-38-555082

**MARINETTE MARINE CORP.  
 BLDG NO. 10 EXPANSION  
 SW DIESEL UST CLOSURE  
 MARINETTE, WISCONSIN  
 SOIL SAMPLE LOCATIONS**

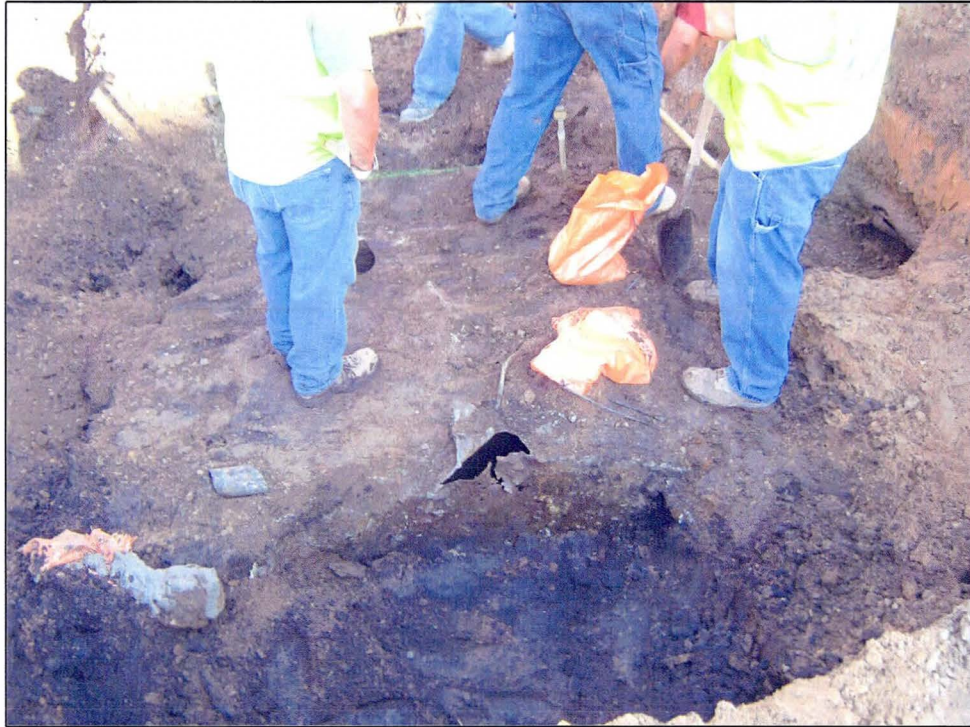
During the UST closure, obvious staining and petroleum odors were observed in soils surrounding the UST. Several small holes were observed in the UST during cleaning. Given the observed contamination and the continuing construction activities, accessible contaminated soil was excavated from around the UST and from within the new storm sewer trench. Excavation north of the UST was prohibited by the new gas line and building foundation. The petroleum-contaminated soil was placed on plastic and stockpiled on-site pending approval for proper off-site disposal. The contaminated soil stockpile was covered with plastic until it was transported off-site by Barley

Photo 1 – Discovery of UST, Soil Staining in Foreground.

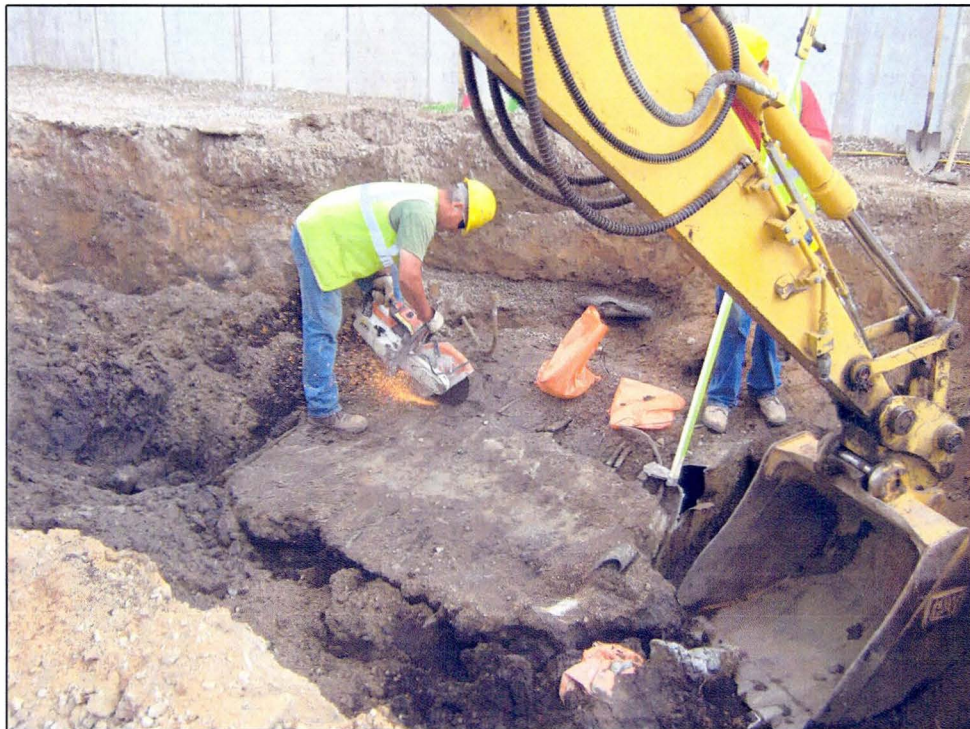
Photo 2 – Uncovering of the UST, Looking North.

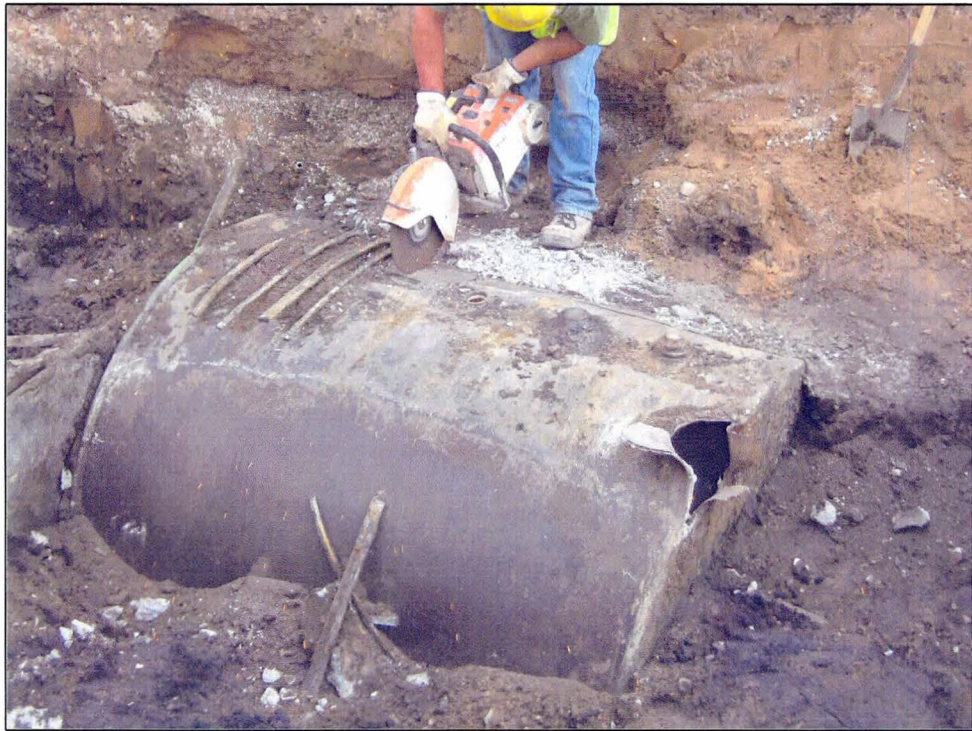
Photo 3 – Cutting Open of UST.

**Location and Method of Cleaning:** The UST was emptied of infiltrated groundwater, cleaned in-place, and inspected. The inside of the tank was scraped by SGS personnel to remove residual sludge. The residual sludge was placed in a 55-gallon steel drum. The tank was then filled with approximately 5 cubic yards of concrete slurry.

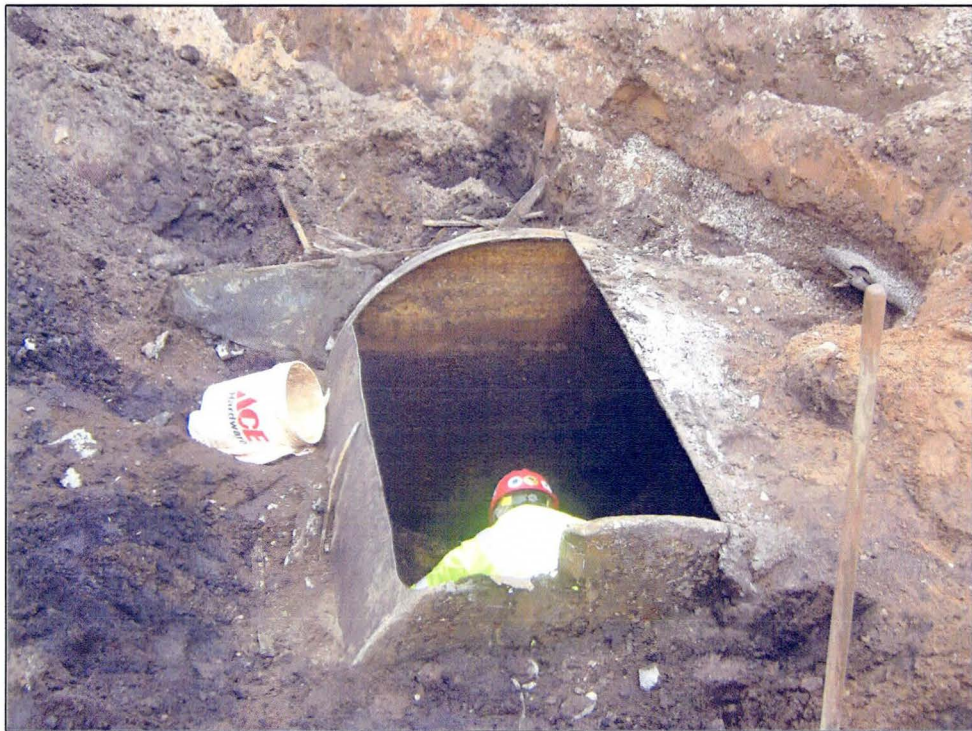
Photo 4 – Cleaning of UST.

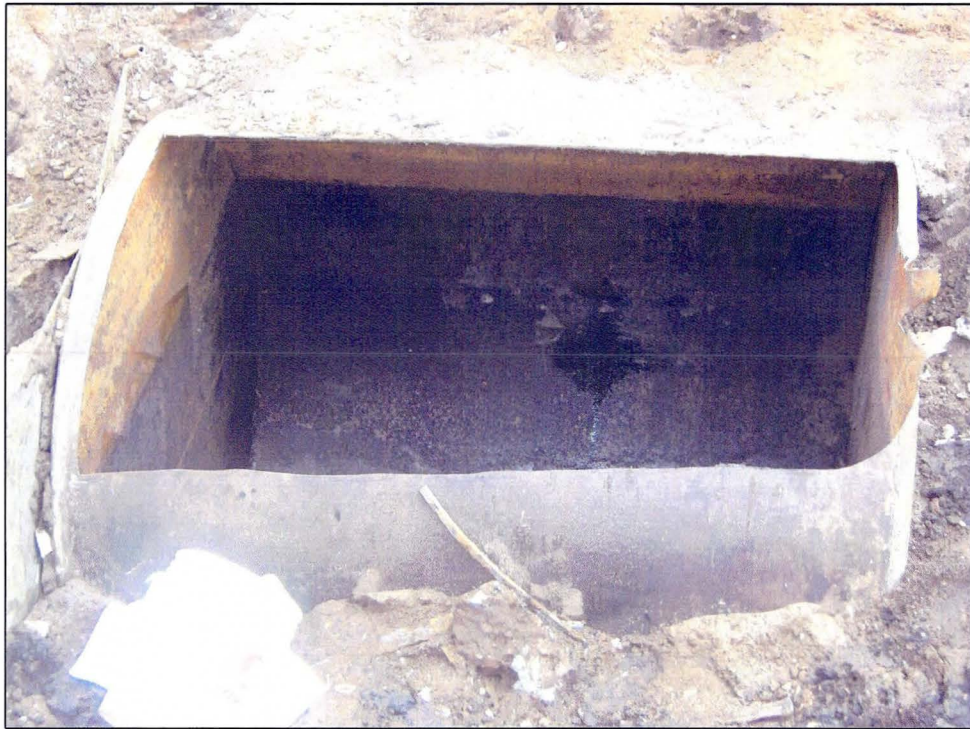
**Tank Condition:** Poor condition; numerous holes were observed in the UST

Photo 5 – Cleaned UST, Hole Observed On Back (North) Wall of UST.

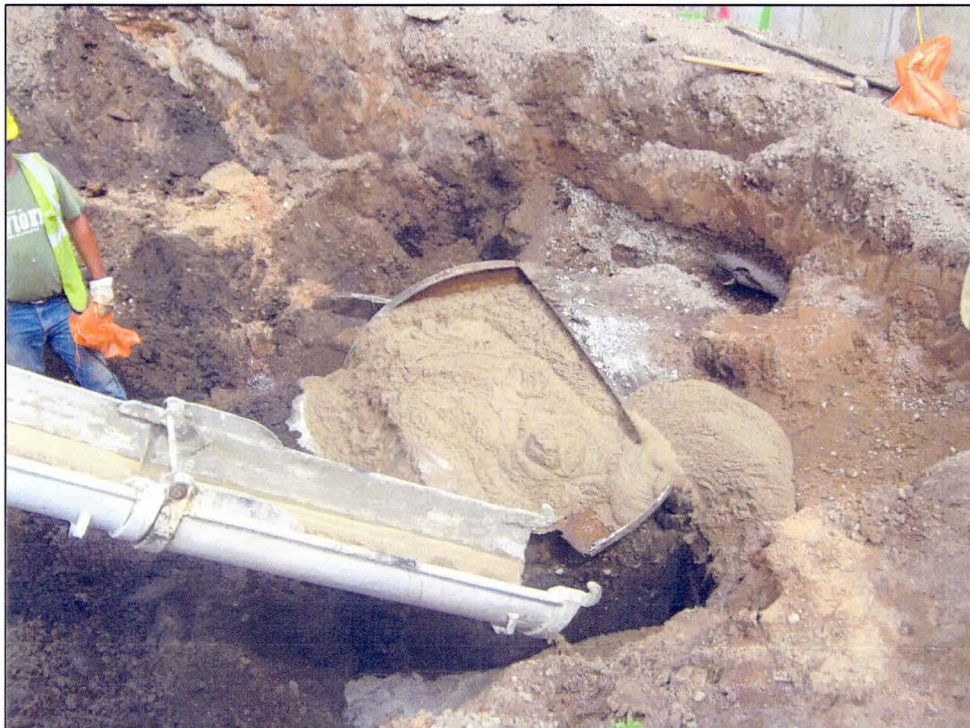
Photo 6 – Abandonment of UST with Concrete Slurry.

On July 12, 2010, REL geologist, Ms. Nicole LaPlant (WDCOMM Certification #46836), was on-site to oversee the closure-in-place of the diesel UST and complete the TSSA. The WDCOMM inspector was present during the closure activities. Barley Excavating & Trucking provided excavation services. The UST was closed-in-place by SGS Environmental Contracting, LLC (SGS) (WDCOMM Certification #42227). The UST was abandoned with approximately 5 cubic yards of concrete slurry.

UST was abandoned-in-place due to its close proximity to the new building foundation and new gas line. The north side of UST was not excavated (due to these structures) to any substantial depth. Excavation on north side only was completed to a depth necessary to open up + abandon the UST. Approx. 114 tons of soil (accessible, were excavated from around south, east + west of UST during closure. Soil was accessible due to on-going construction activities. Contaminated soil was properly disposed at WM Menominee Landfill. See TSSA and documentation of remedial action report for further detail.

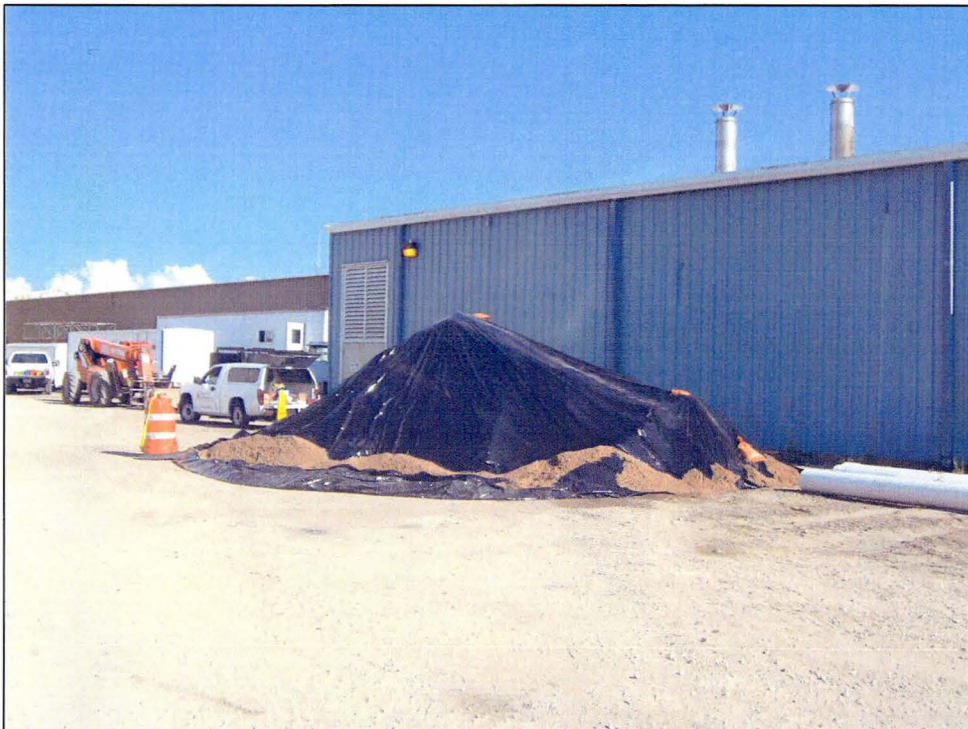
Photo 8 – Covered Soil Stockpile.

**Excavating & Trucking for disposal at Waste Management's Menominee Landfill, Menominee, Michigan.**
