RE: **TANK-SYSTEM SITE ASSESSMENT**
Marinette Marine Corporation – Building #10 Expansion (NE Gasoline UST)
1600 Ely Street, Marinette, Wisconsin
BRRTS #02-38-555082

On behalf of Marinette Marine Corporation (MMC) and Smet Construction Services (Smet), Robert E. Lee & Associates, Inc. (REL), completed a tank-system site assessment (TSSA) for an underground storage tank (UST) at the above-referenced property (the Site). This letter report presents the summary of activities and conclusions based upon the findings of the TSSA.

**MARINETTE MARINE CORP.
BLDG NO. 10 EXPANSION
NE GASOLINE UST CLOSURE
MARINETTE, WISCONSIN**

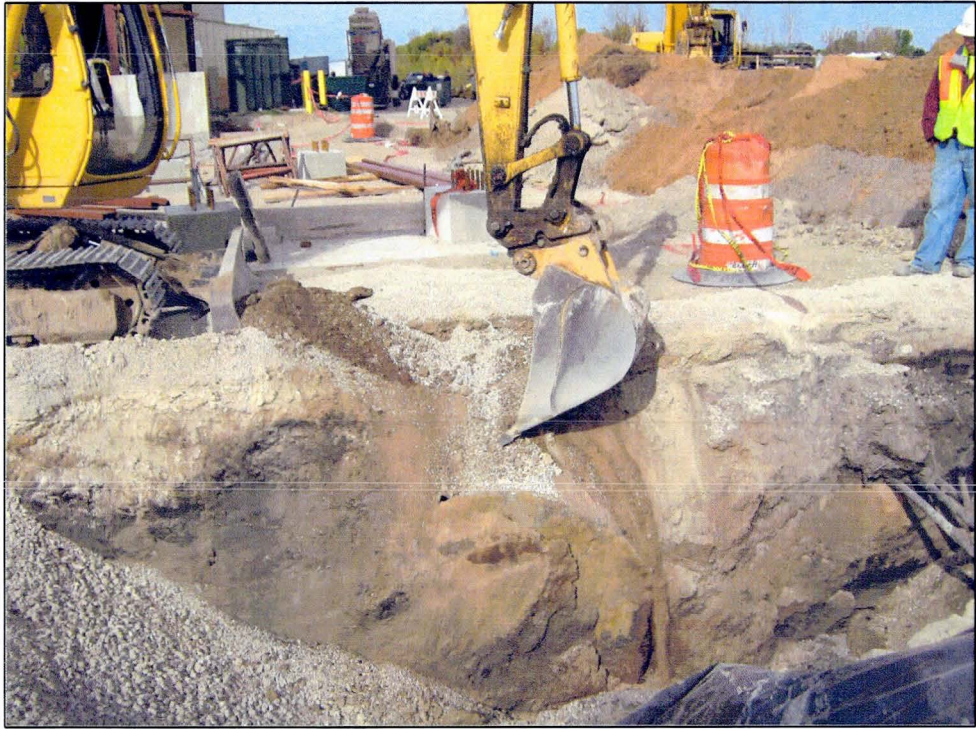
Photo 1 – UST Location.

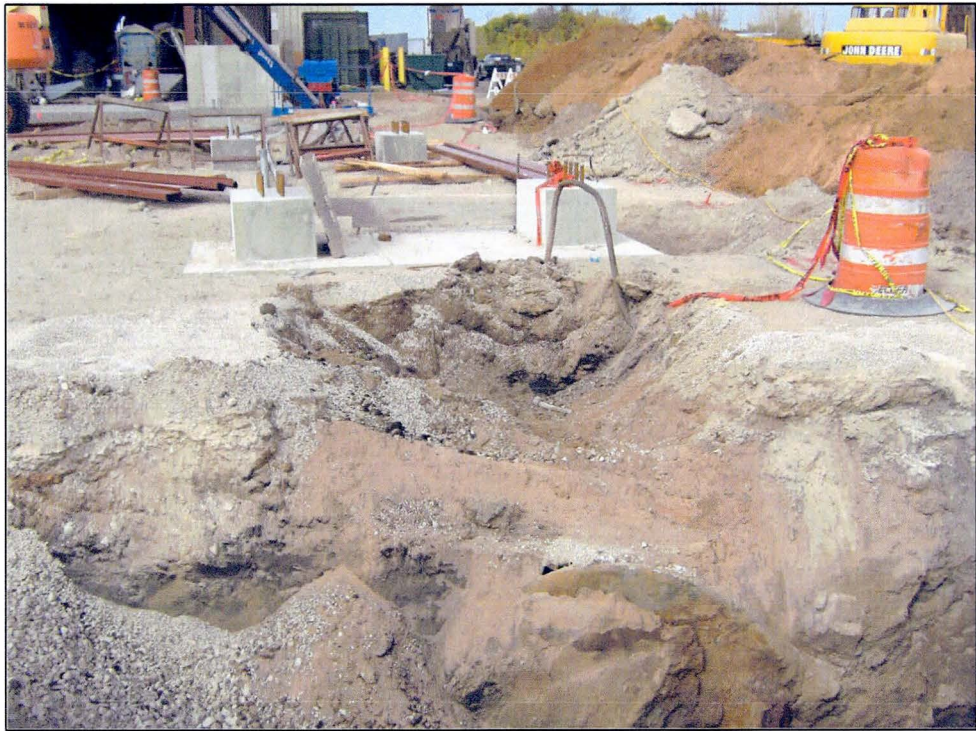
Photo 2 – Location of UST in Relation to Pile Cap.

During further excavation, the UST was observed to be located in close proximity to a new building foundation structure (i.e., pile cap) and several high-voltage underground electric lines. In addition, a high groundwater table was encountered in the excavation. Given the UST's proximity to the structures and the high groundwater table, we believe that the removal of the UST would impact the structural integrity of the pile cap via undermining due the high groundwater table and necessitate the disconnection of the electric line. Therefore on behalf of MMC, Smet Construction Services Corporation requests approval for the UST to be closed in-place.

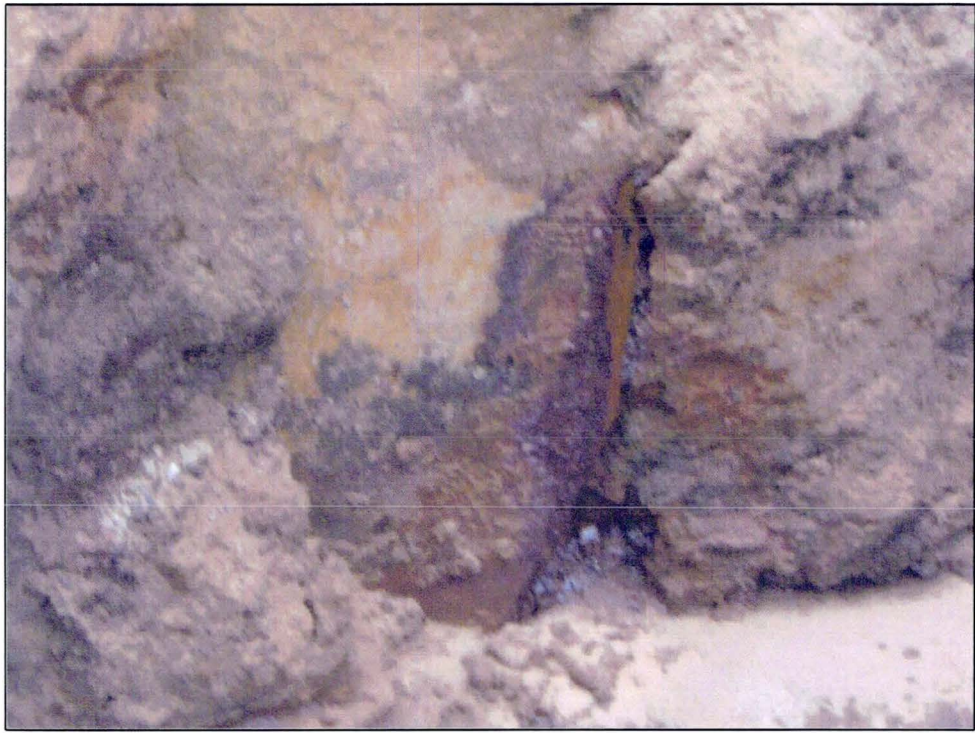
Excavation Conditions: Since the UST was closed-in-place, limited excavation was performed in the vicinity of the UST. Staining and petroleum odors were observed in soils adjacent the UST. Groundwater was encountered in the excavated area at approximately 5 feet below grade. A petroleum sheen was observed on the groundwater that was present within excavation. Materials around the UST consisted mainly of imported sand fill.

Photo 3 – Soil Staining Adjacent to UST.

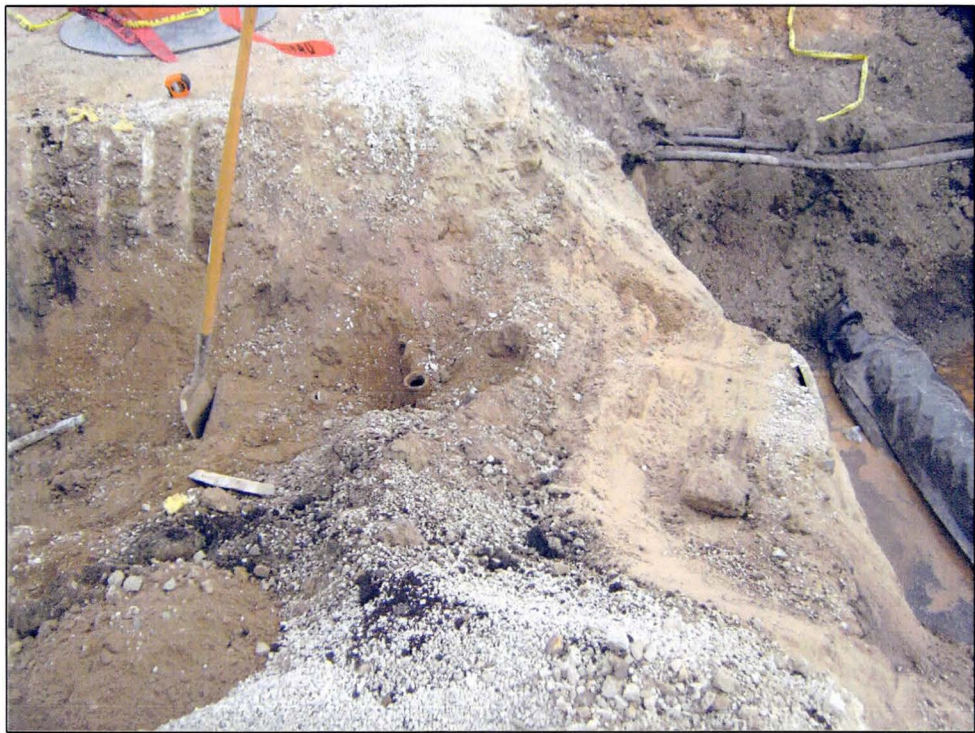
Photo 4 – Location of UST in Relation to Water Line and High Voltage Underground Electric Lines

The UST was abandoned-in-place due to the location of the UST in close proximity to a new building foundation structure and several high-voltage underground electric lines

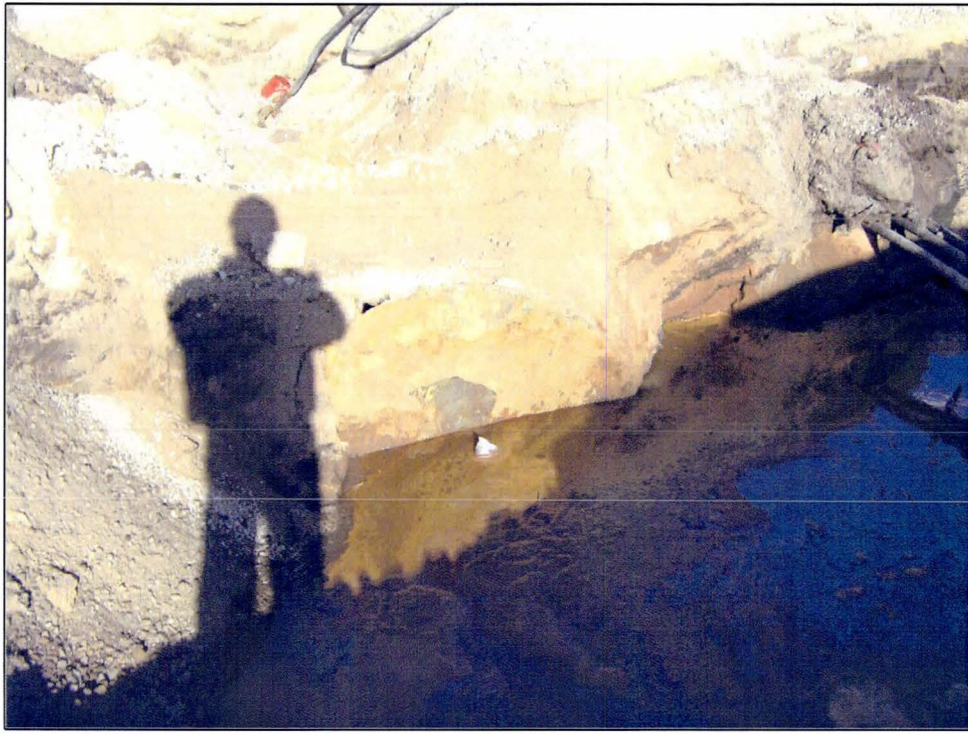
Photo 5 – Water in Excavation for Water Line Adjacent to UST.

Prior to the closure, approximately 2,500 gallons of water was pumped from the UST and the adjacent water line trench excavation to a vac truck by Chief Liquid Waste. In addition, 239.7 tons of soil was excavated from the water line trench and was handled as potentially containing petroleum compounds. The soil was stockpiled on-site pending approval for off-site disposal at Waste Management's Menominee Landfill in Menominee, Michigan. Barley Excavating & Trucking subsequently transported the stockpile soil for landfill disposal on October 27, 2010. Soil disposal documentation is included in Attachment F.

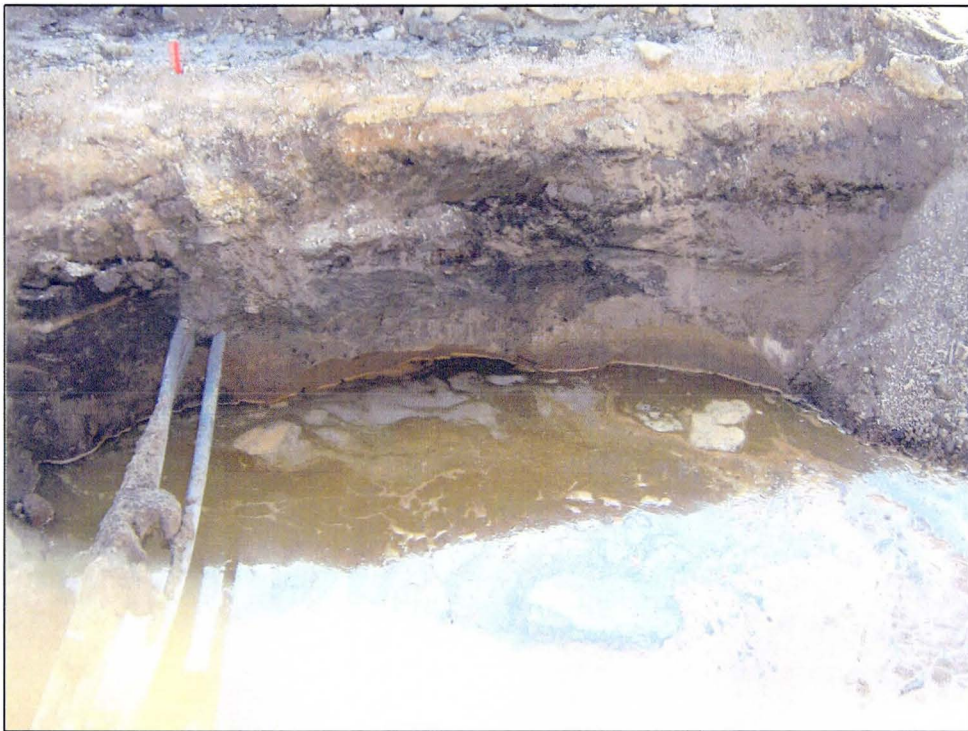
During the UST closure, obvious staining and petroleum odors were observed in soil surrounding the UST. The UST was observed to be in poor condition with rusting, pitting, and contained multiple holes. A petroleum sheen was observed on the groundwater present in the excavation. Two soil samples (S1 and S2) were collected to evaluate soil conditions. The samples were collected from native soil adjacent the UST located above the apparent water table. Each soil sample was described in the field and properly containerized for field screening and possible laboratory analysis. Soil sample collection, handling, and field-screening procedures followed WDNR guidance. Field screening was performed using an Ion Science Photocheck 1000 photoionization detector (PID). The soil sample locations are shown in Figure 2.

Photo 6 – Sheen on Water Surface.

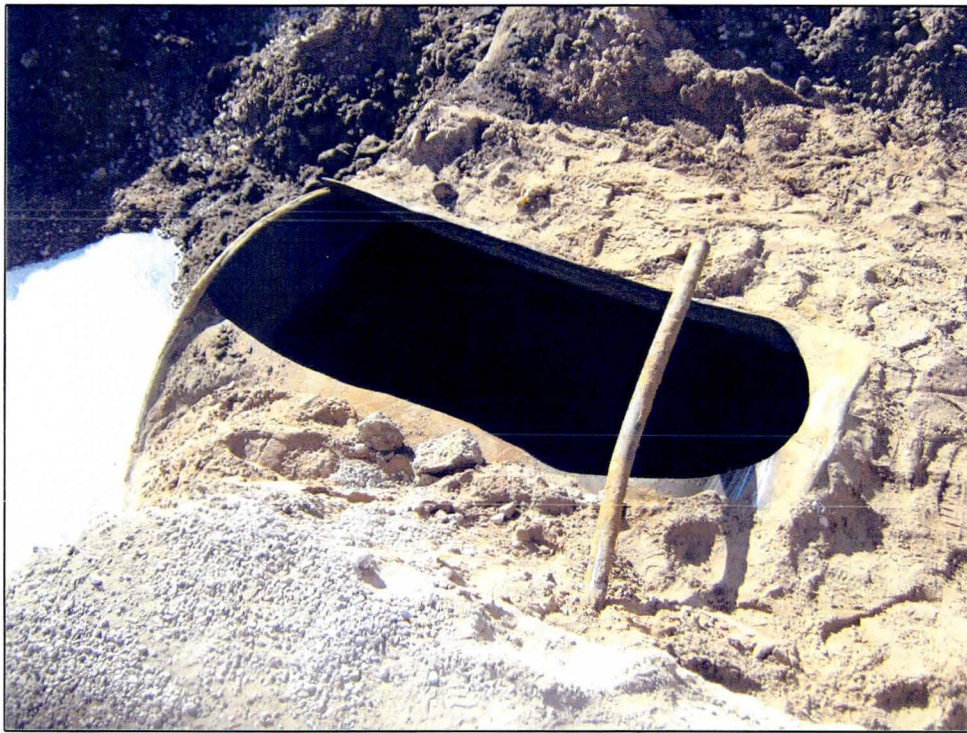
Photo 7 – Hole in UST for Cleaning.

Location and Method of Cleaning: A hole was cut in the top of the UST, and the UST was then emptied of infiltrated groundwater, cleaned in-place, and inspected. The inside of the UST was wiped clean by SGS personnel.

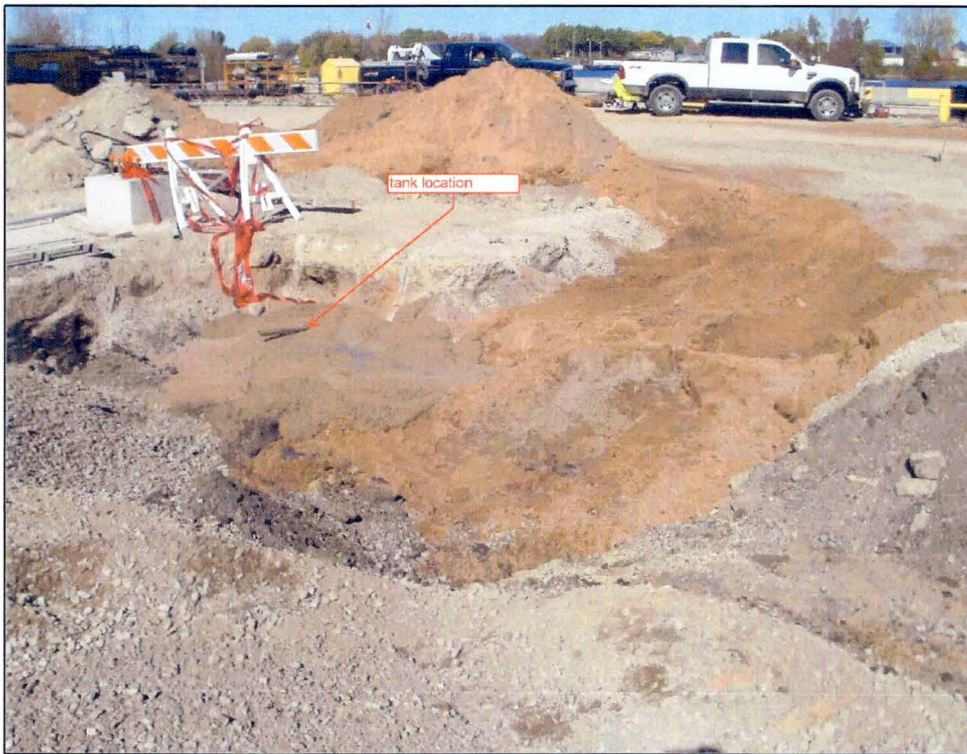
Photo 8 – UST Abandoned in Place with Concrete Slurry.

On October 13, 2010, REL environmental scientist, Mr. Kevin Eibenholz (WDCOMM Certification #649863), was on-site to oversee the closure-in-place of the gasoline UST, and complete the TSSA. Barley Excavating and Trucking provided excavation services. The UST was cleaned and closed-in-place by SGS Environmental Contracting, LLC (SGS) (WDCOMM Certification #42227). The UST was abandoned with approximately 5 cubic yards of concrete slurry.
