Subject: Site Investigation Report – Not Approved  
Realty Opus Property, 867 W. Valley Road, Menasha WI  
BRRTS# 02-71-555288 & 06-71-578231

SUBJECT: Site Investigation Completeness Review –Additional SI Work Required

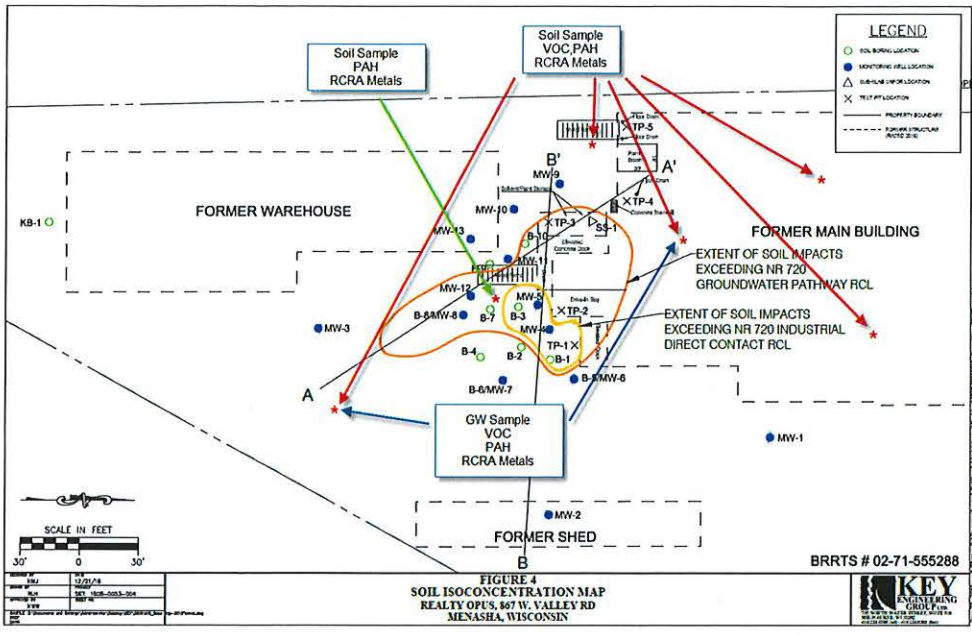
- Site Investigation should be tracked as “not approved”
- Request additional soil sampling for VOC, PAH, RCRA Metals in 5 locations identified on Figure 4 attached.

- Request additional soil sampling for PAH and RCRA Metals in 1 location identified on Figure 4.
- Collect groundwater samples for VOC, PAH and RCRA Metals in 2 of the soil sample locations as identified on Figure 4.
