INTERIM ACTION DOCUMENTATION REPORT & OPERATION, MAINTENANCE & MONITORING PLAN

November 5, 2021

Jagemann Plating Company
1324 S. 26th Street
Manitowoc, WI 54224 **WDNR**
BRRTS# 02-36-555544

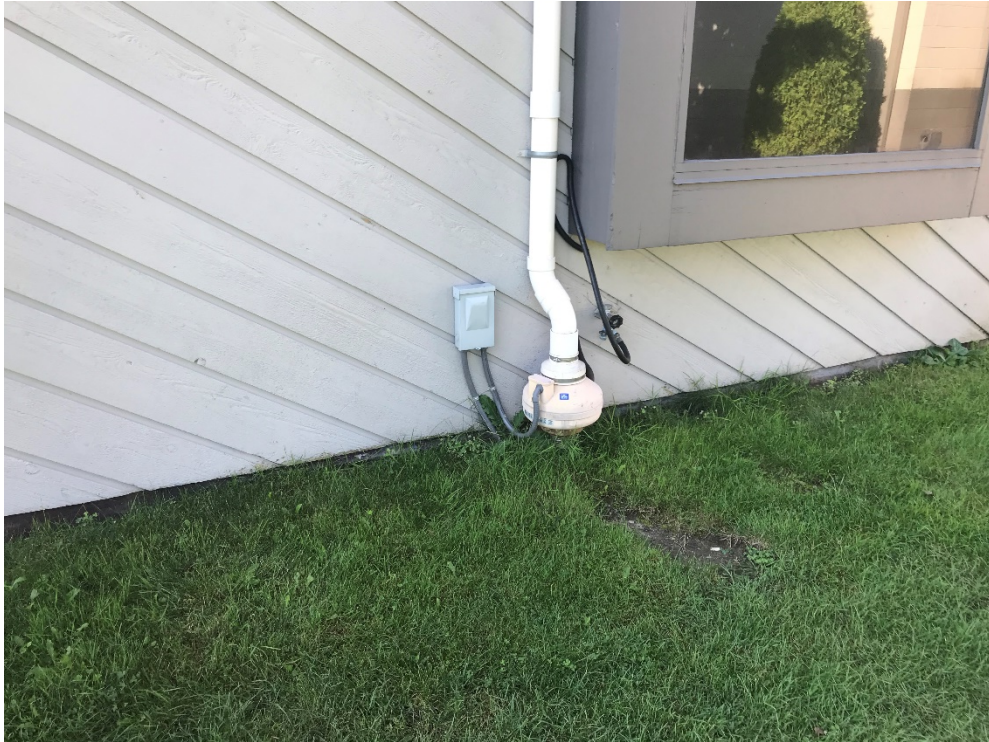
PHOTO 1

Comments: View of the SSDS RadonAway Fan and disconnect.

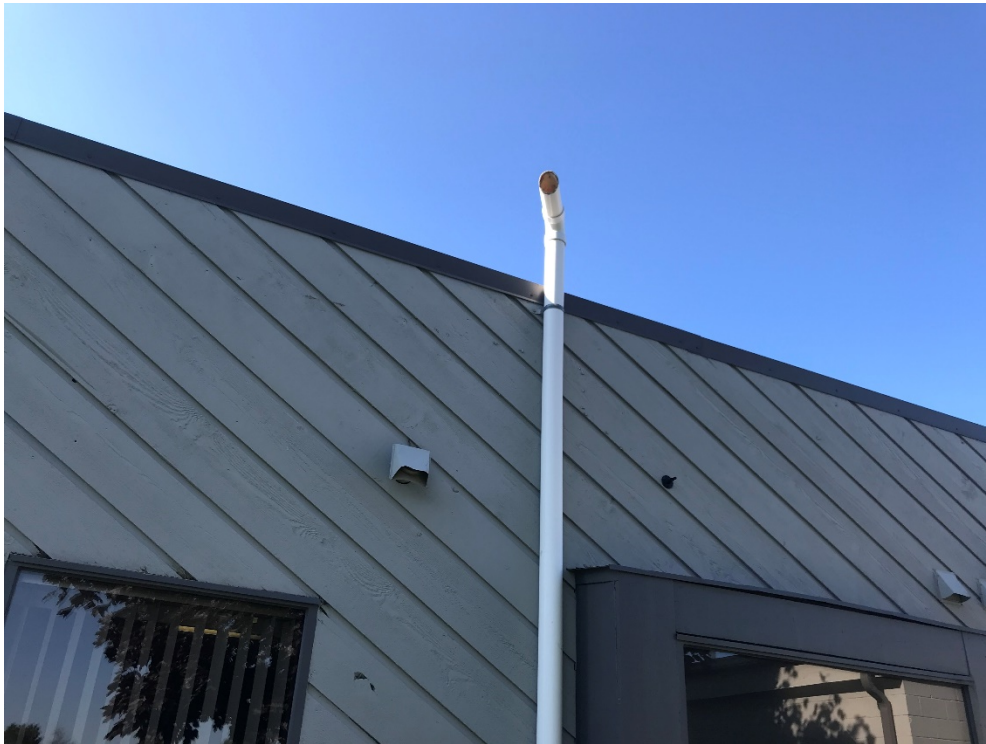
PHOTO 2

Comments: View of the SSDS discharge stack
