RE: Post-Closure Modification Request
Kwik Trip #314 Rebuild
108 N Main Street
Pardeeville, Wisconsin
Closed BRRTS #03-11-002628 & #03-11-555987

Kwik Trip, Incorporated (Kwik Trip) is submitting this Post-Closure Modification Request (Form 4400-237) in preparation of the Kwik Trip Store #314 site redevelopment. Planned activities are to demo all the existing structures and redevelop the property with a new Kwik Trip gas station/convenience store.

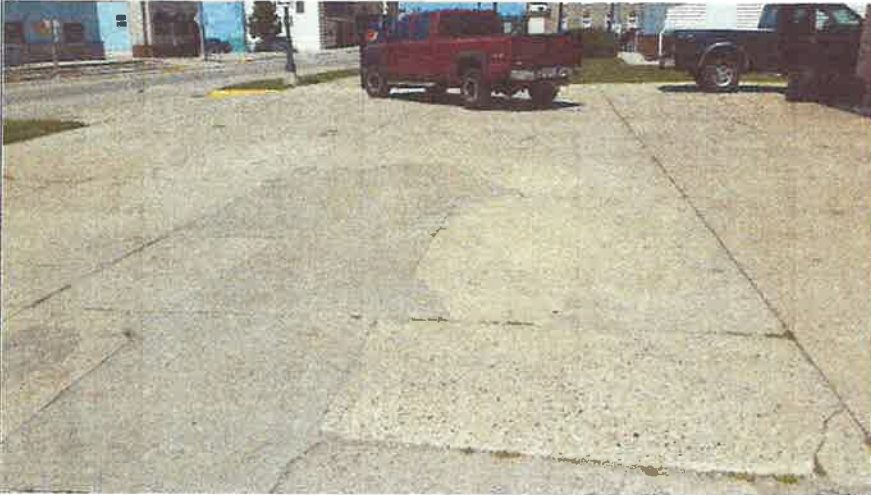
Title: Concrete cap on the western portion of the property

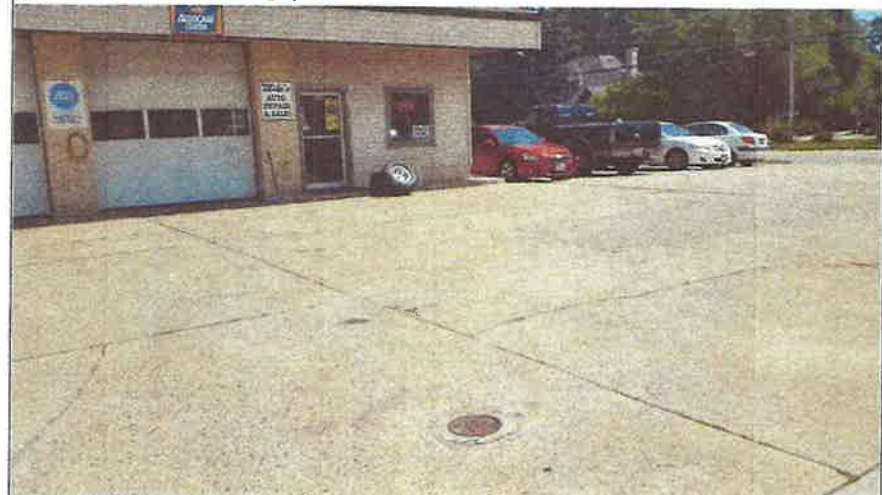
Title: Concrete cap on the western/southwestern portion of property/MW-3
